March 30, 2023

**SUBJECT: Geotechnical Assessment  
State Route 88 (Apache Trail), MP 222 to 229  
Design Concept Report & Environmental Overview Study  
ADOT TRACS No. F0494 01L  
ADOT Contract No. 2022-020  
Pinal County, Arizona**

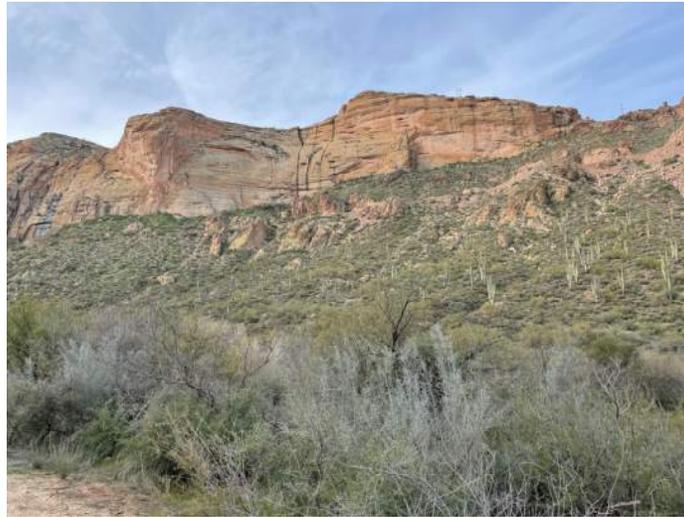
The majority of roadway damage is concentrated in the steep section of roadway west of Fish Creek Canyon (approximate MP 222.6 to 223.6). This stretch of road is characterized by a variety of steep overlying rock faces, and rock debris and colluvial slopes which contain loose rock with sizes varying from cobble to large vehicle-size boulders immediately adjoining the road. Higher, near vertical canyon forming rock walls are set back from the road generally a few hundred feet. Photograph No. 1 shows the steeply faced canyon walls set above SR 88 within this section.

**Photograph No. 1 – High rock walls west of SR 88 at MP 223 (looking west)**

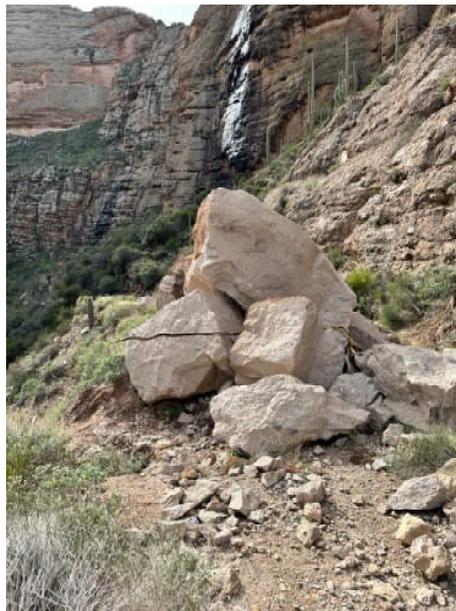
Bedrock within this stretch of road and in the slopes high above the road, consists of volcanic rock, primarily andesite, dacite and tuff, extending from the west project limits to about MP 223.2. A southeast to northwest trending fault separates this volcanic rock from sedimentary sandstone, siltstone, and conglomerate rock. It is apparent from review of aerial photos that faulting has tilted this once horizontally bedded rock unit to a near vertical orientation along the canyon walls. It further appears that the large rock fragments, which closed the road at MP 223.3, detached from the vertically oriented bedding planes. Photograph No. 2 shows the location where falling rock completely blocked the road. Photograph No. 3 shows the rock wall where the rock blocking the road likely originated.

**Photograph No. 2 – Large rockfall that closed SR 88 at MP 222.3 (looking south)**

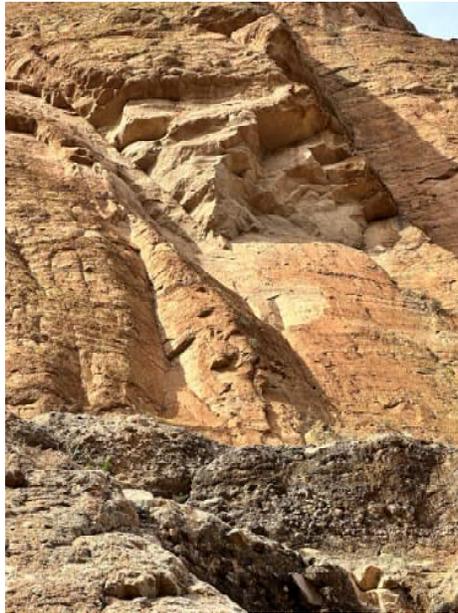
**Photograph No. 3 – Fresh face of rock slope where large rock in road likely originated (looking west)**

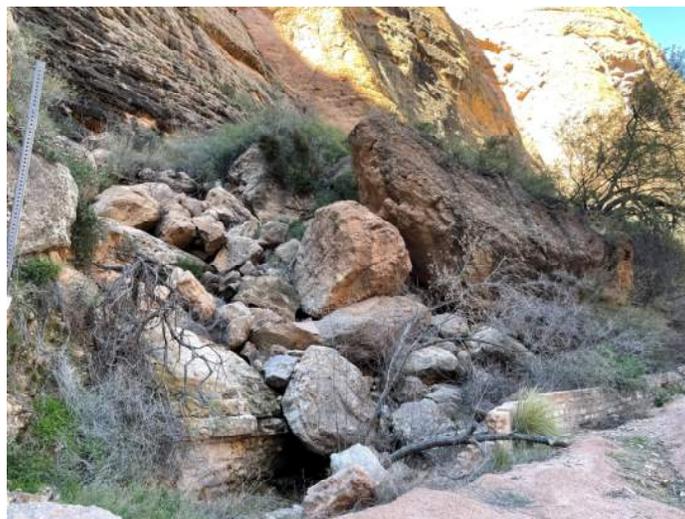
Other damage in this section includes rock debris flows which have infilled drainages with variably sized rock, often blocking cross-road culverts. This is indicative of large storm flows concentrated into natural drainages. It is evident the roadside ditch on the cut side of the road overtopped at many locations resulting in surface overflows, which often eroded the existing roadbed, outboard fills and in some cases existing rock walls. Erosion on the roadbed exposed the underlying rock cut surface. The fills were, at some locations, extensively eroded on the outboard slopes causing significant erosion of the slope and edge of road. Storm induced erosion of exposed colluvial and rock debris slopes also deposited rock onto the road at many locations. Photograph No. 4 shows a debris flow and Photograph No. 5 shows erosion of the roadbed and the outboard slope.

**Photograph No. 4 – Rock debris flow near MP 222.4 (looking west)**

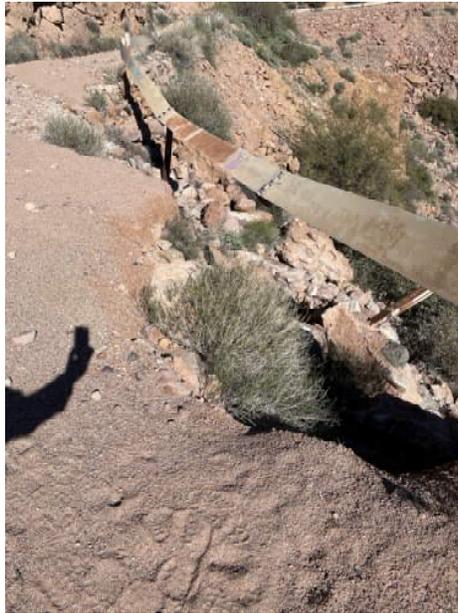
**Photograph No. 5 – Erosion of roadbed and outboard slope at approximately MP 223 (looking north)**

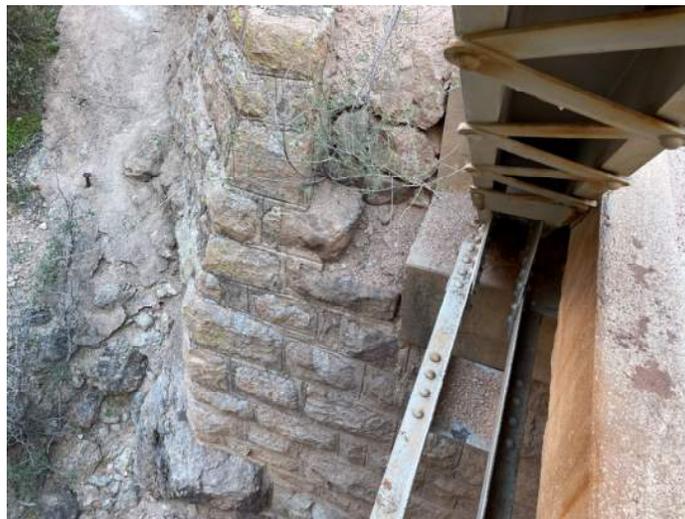
As-built plans were not available for any of the three single-lane, single-span bridges located within the project limits. The bridge, which crosses Fish Creek Canyon at approximate MP 223.6, appears to be supported directly on intact rock at the west abutment. The east abutment appears to be supported on a stacked block/mortar system which extends up from intact rock several feet. The overall foundation system appears to be in good condition. Photograph No. 6 shows the north corner of the east bridge abutment.

**Photograph No. 6 – Northeast corner of Fish Creek Hill Bridge, East Abutment at MP 223.6 (looking east)**

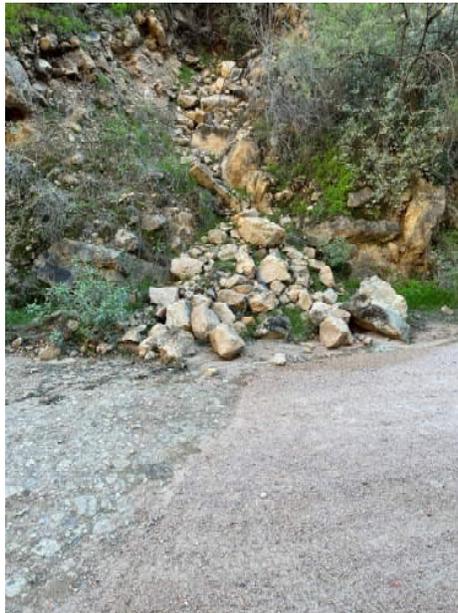
SR 88 follows the east bank of Fish Creek from the bridge to about MP 224.3. This relatively flat section of road sits several feet above the adjacent creek bed. Though some damage was noted along the roadways outboard slope more significant damage in the form of debris flows are apparent along the east side of the road from uphill water induced erosion. Much of the uphill slope within this stretch consists of highly fractured rock, colluvium and rockfall debris. These loosely held materials, when inundated with water, dislodge and collect as rock and soil debris within the natural drainages. At least four debris flows were observed which required some earthmoving by ADOT Maintenance to make the road passible to the bridge. Photograph No. 7 shows one of the partially removed debris flows.

**Photograph No. 7 – Rock debris within drainage at MP 223.9 (looking south)**

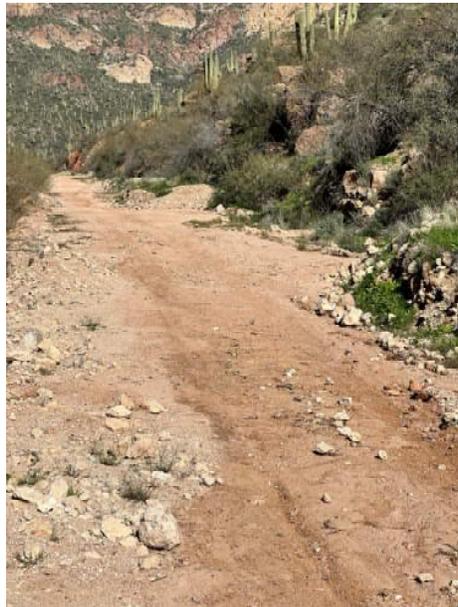
**Photograph No. 8 – Series of debris flows adjacent to road at MP 223.9 (looking south)**

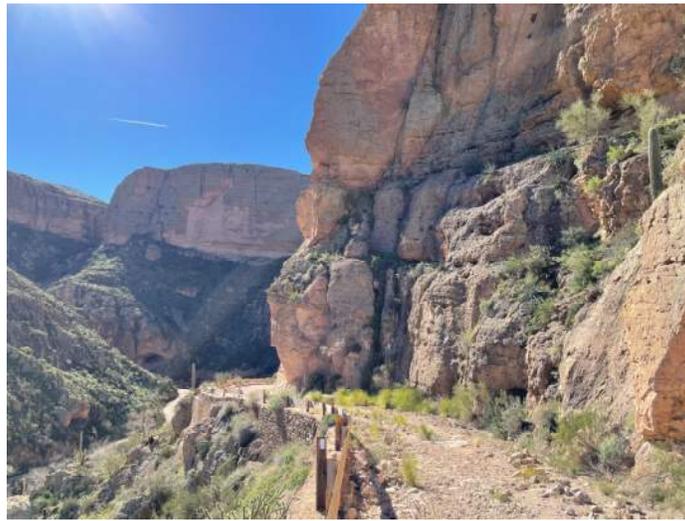
The most significant cost impact to the project will be the determination of a final roadway width. In localized areas, the existing road is less than 20 feet in width. Creating extra width in areas west of Fish Creek Hill Bridge will have significant cost impacts to widen either to the cut or fill sides of the road. Photograph No. 9 shows an existing rock face where the existing road measures close to 15 feet. Though these instances are localized generally to bends in the road, consideration of whether to widen to the cut or fill side (or both) will have large cost and visual impacts.

**Photograph No. 9 – Narrow Road at base of cliff at approximate MP 223 (looking south)**
