**ARIZONA DEPARTMENT OF TRANSPORTATION
BRIDGE GROUP
BRIDGE DESIGN SECTION C**

INITIAL BRIDGE STUDY

**State Route 88 (Apache Trail)
MP 222 - MP 229**

DATE: October 2023

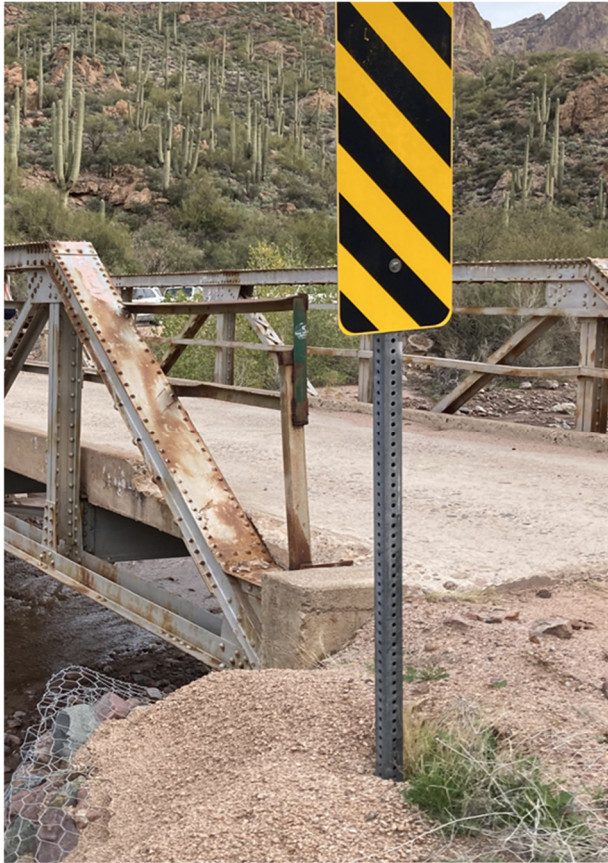
Figure 3: Existing Conditions at Lewis Pranty Creek Bridge

Figures 3 and 4 below illustrate some of the improvements at Lewis Pranty Creek Bridge. Improvements at Fish Creek Bridge and Dry Wash Bridge are similar. The intent is to extend the service life of the bridge while also maintaining the structure’s historic character.

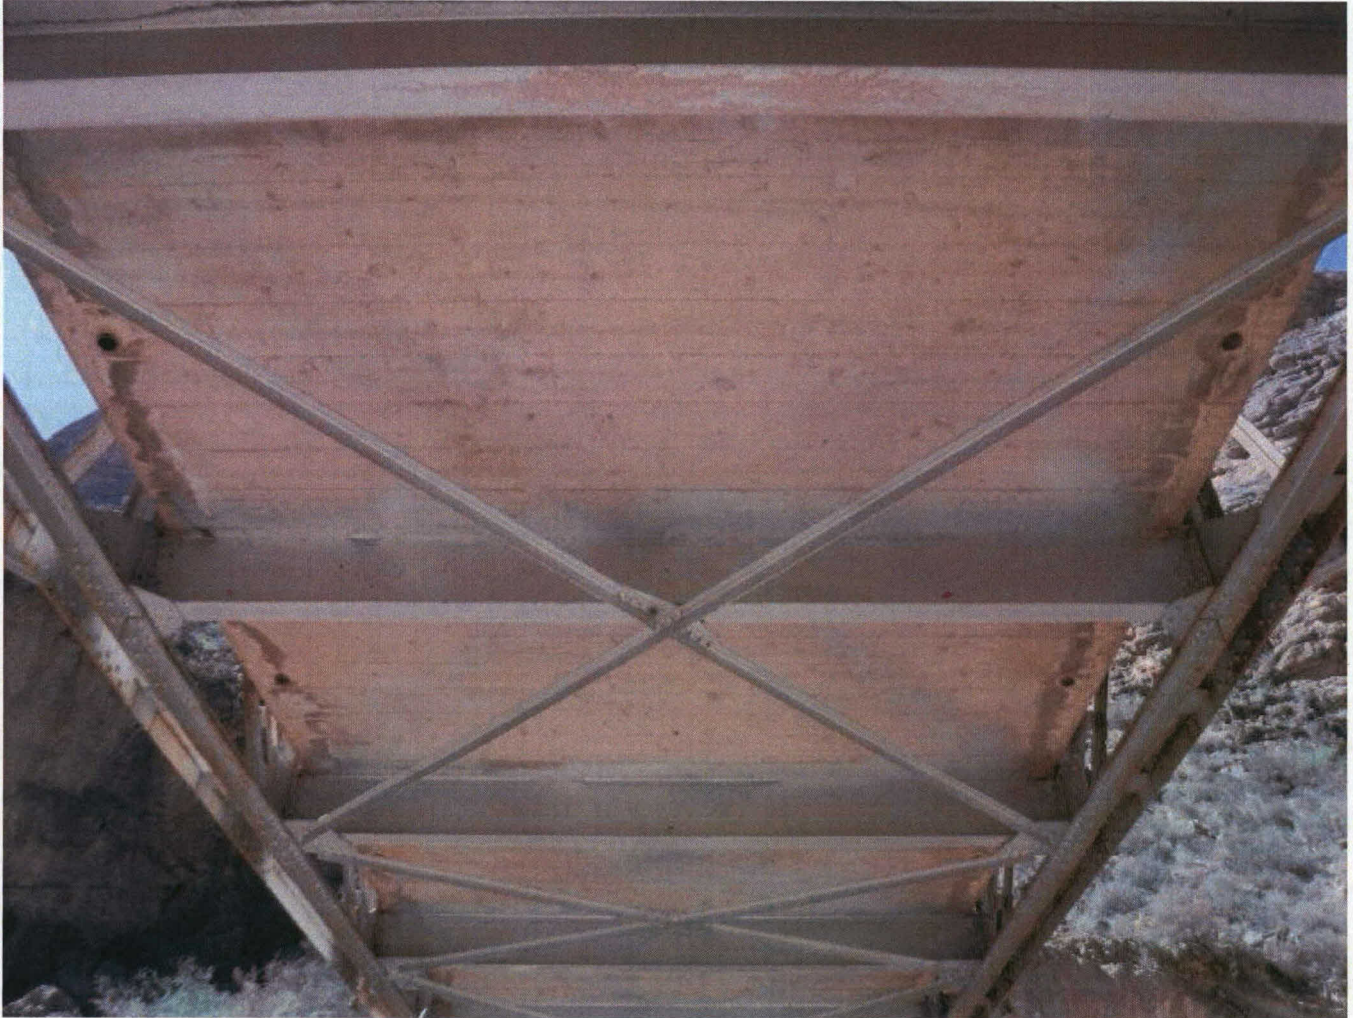
File Name : 00027-2018-09-08-Photo-D.jpg

1080	Delamination/Spall/Patched Area	10	each	0	0	10	0	0
1. The fasciae have minor spalls at random locations.								
1130	Cracking (RC and Other)	390	each	0	0	390	0	0
1. Narrow-to-medium width dense map cracking and scaling observed throughout the top of the deck. See Photo C.								
2. Random hairline to narrow longitudinal cracks exist in the deck underside. See Photo D.

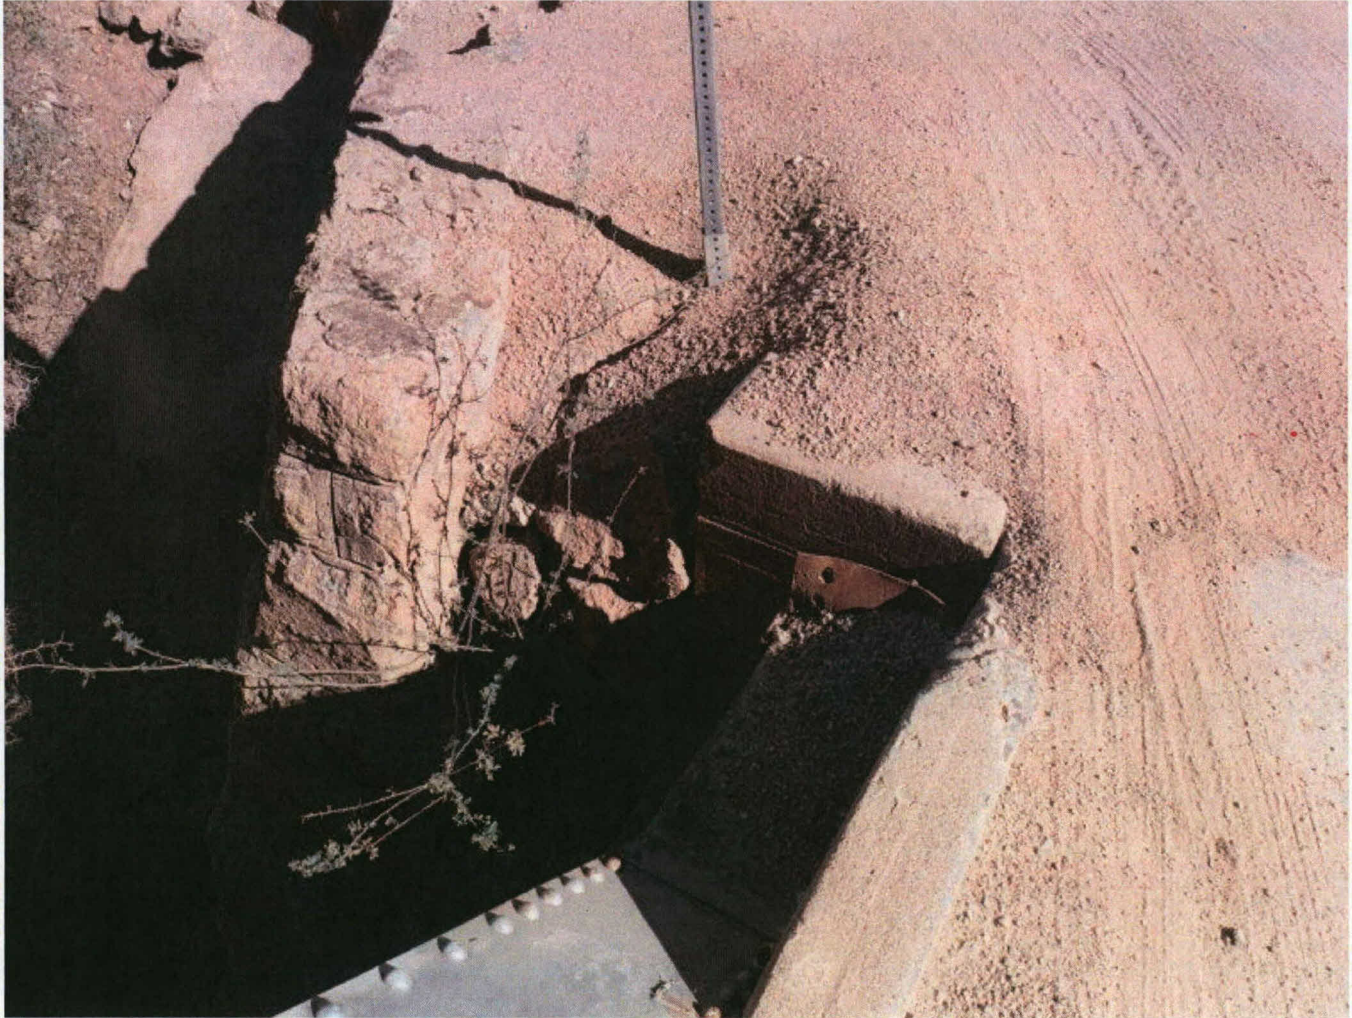
File Name : 00027-2018-09-08-Photo-G.jpg
Description : Photo G. Northwest corner minor fill erosion

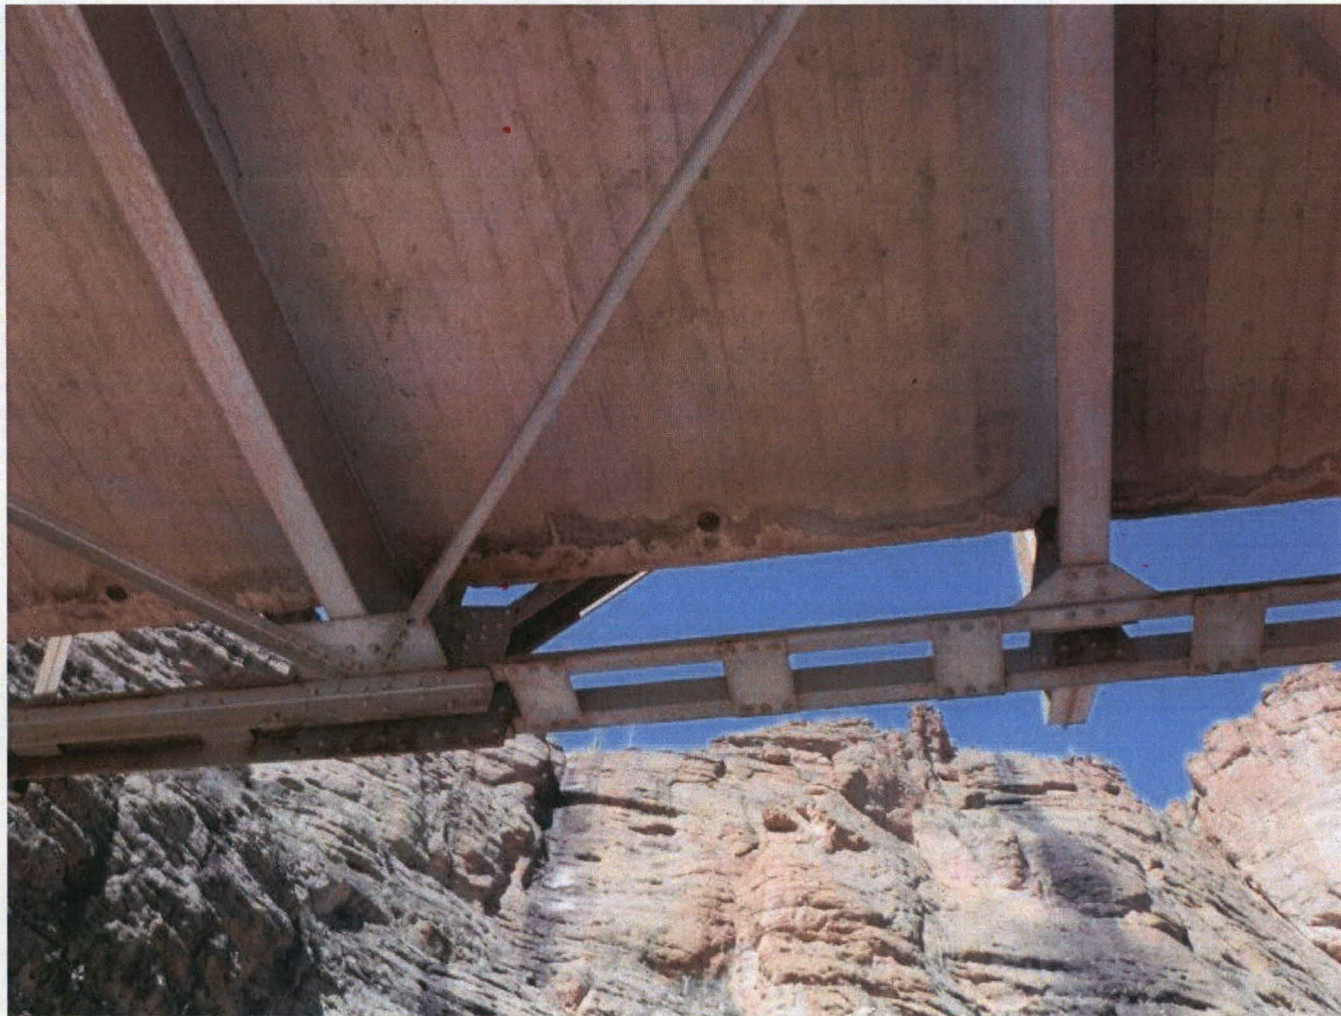
File Name : 00027-2018-09-08-Photo-H.jpg

- Water staining exists on exterior edges of the deck underside, especially near the deck drains. See Photo H.

Description : Photo H. Typical water staining along the exterior edge on the underside of the deck

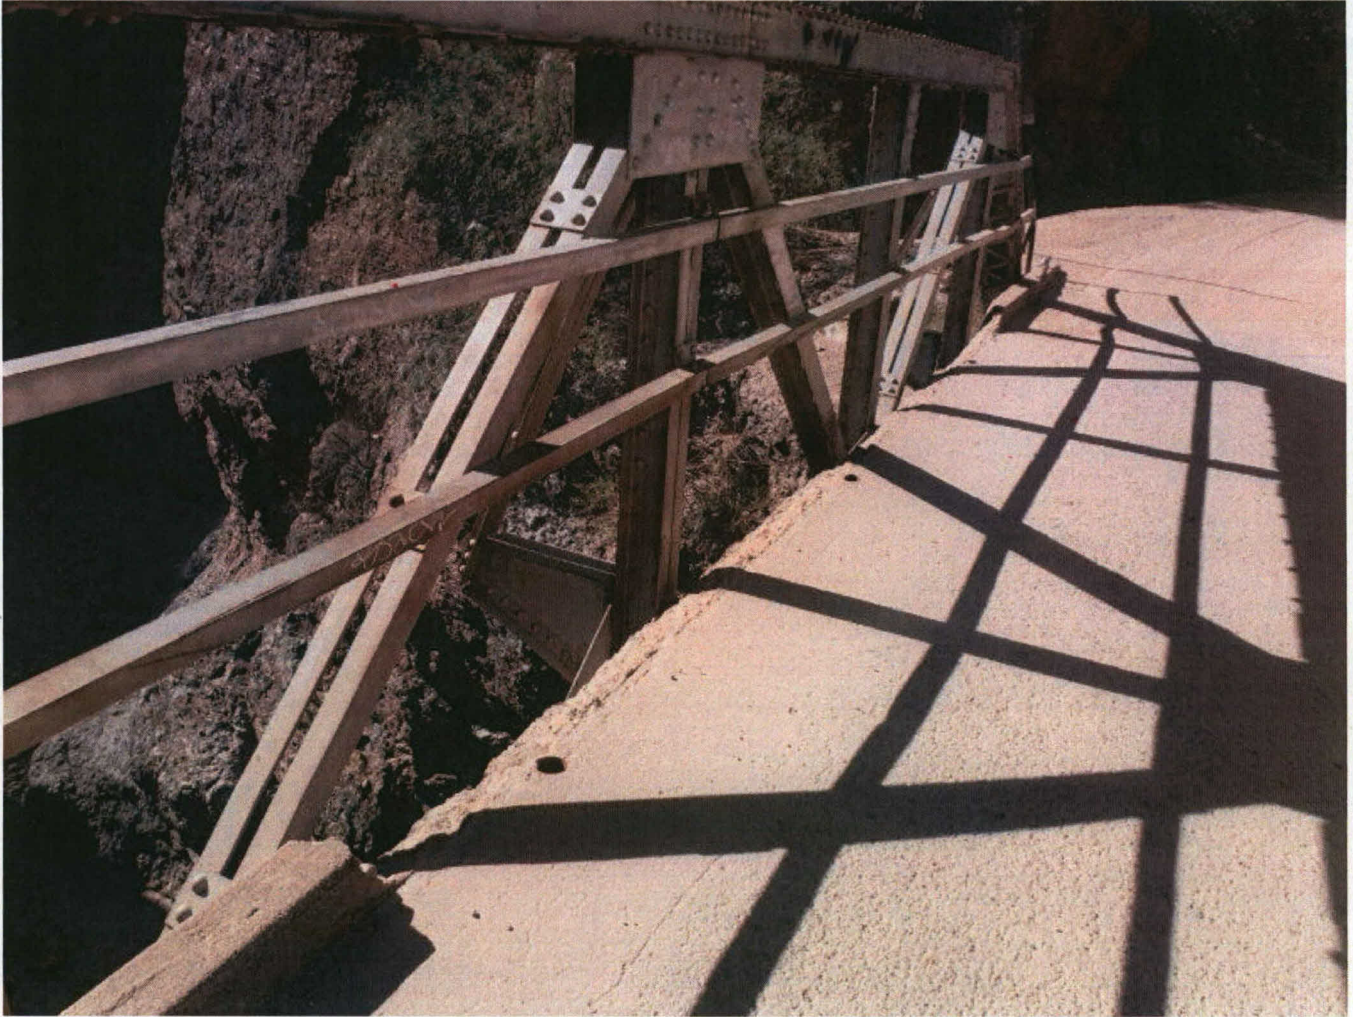
File Name : 00027-2018-09-08-Photo-I.jpg

- A 6 inch curb is present on both sides of the bridge. The east curb has an approximately 21-foot x full height x full width spall between panel points 1 and 4. See Photo I.
- Deck drains are located at the front face of the curb on both sides. There is approximately 1-inch of sand and gravel against the west curb. The deck drains are clear.

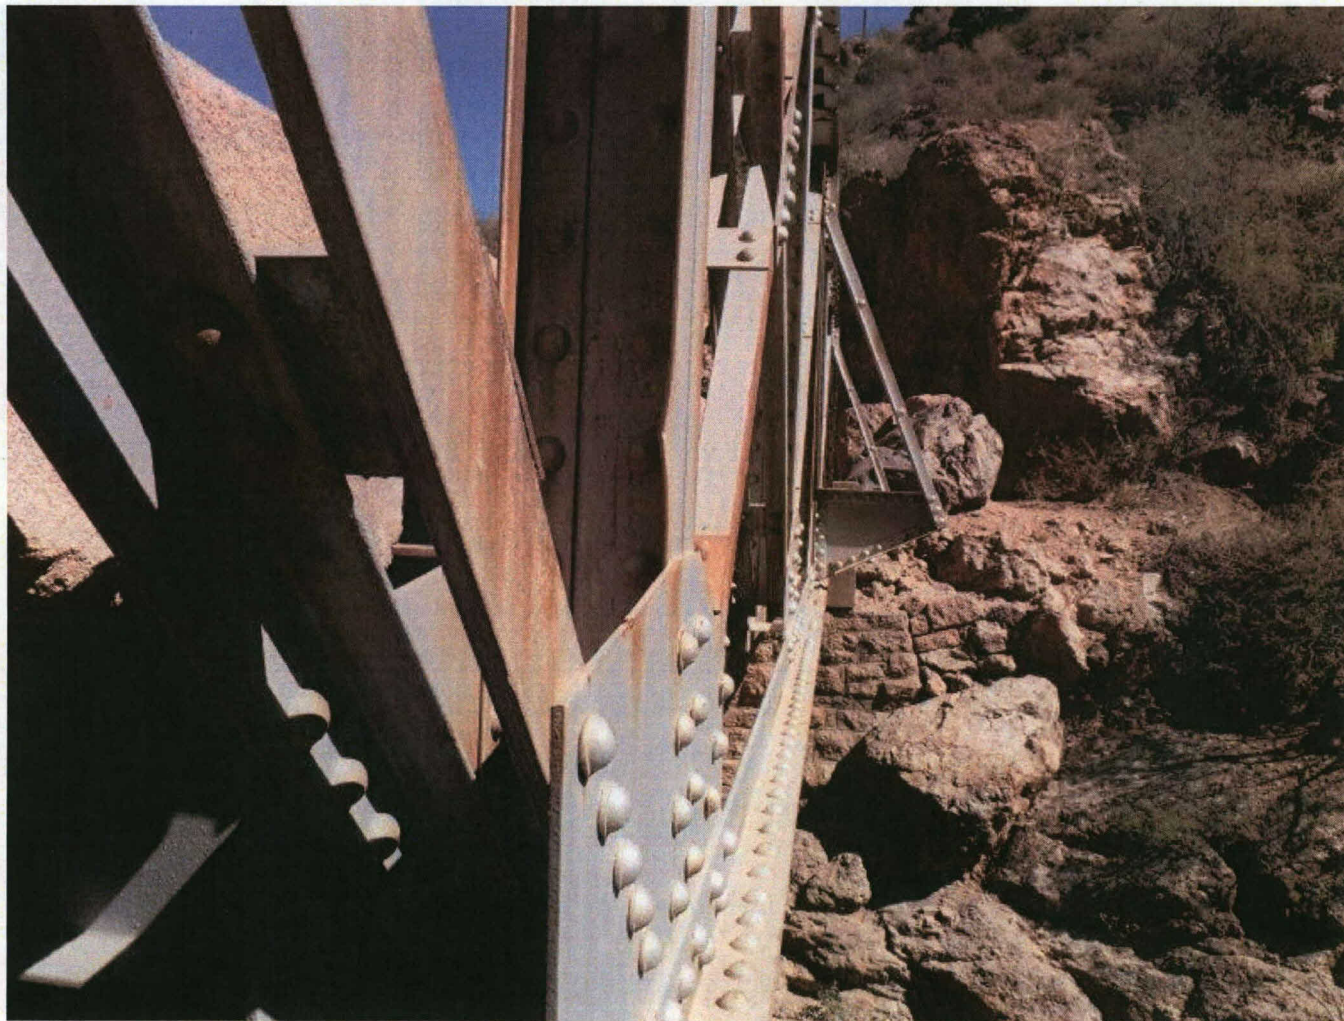
File Name : 00027-2018-09-08-Photo-J.jpg

1. The south exterior flange on the east truss member U4L4 is bent approximately 1/2-in. See Photo J.
 2. The knee brace of the east truss at Panel Point 8 is bent to the south approximately 6 inches. See Photo K.
 3. There is a small tear in the north end post of the west truss from impact damage to the metal bridge railing. See Photo L.

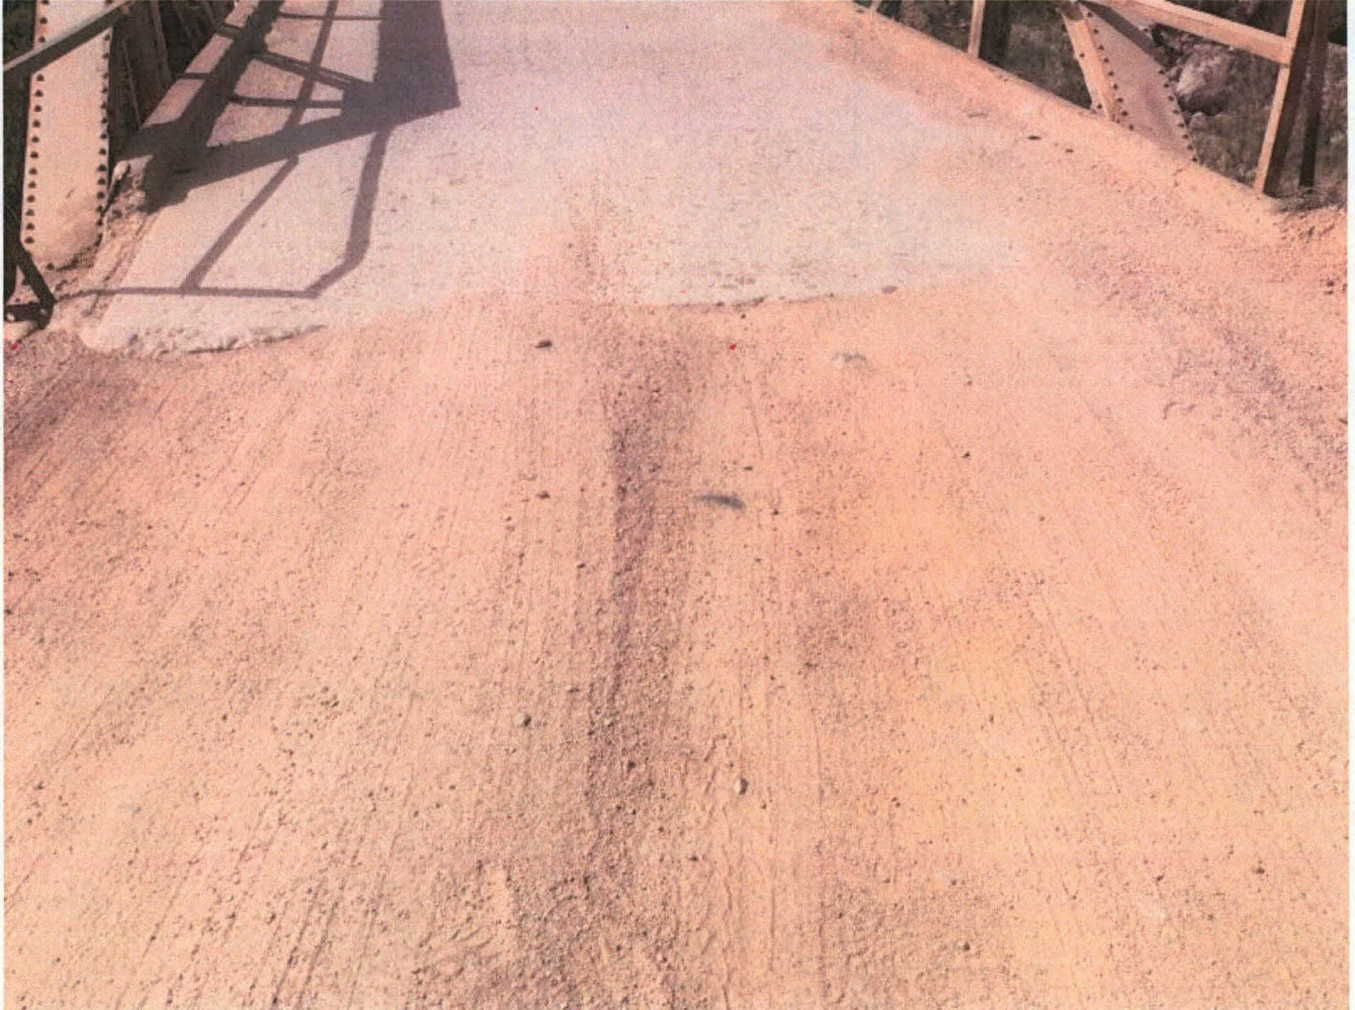
File Name : 00028-2018-08-30-Photo-F.jpg
Description : Photo F – North Approach Condition
