Outfalls inspected FY 2019

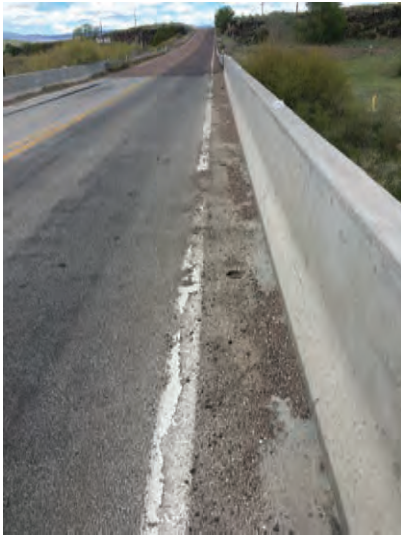
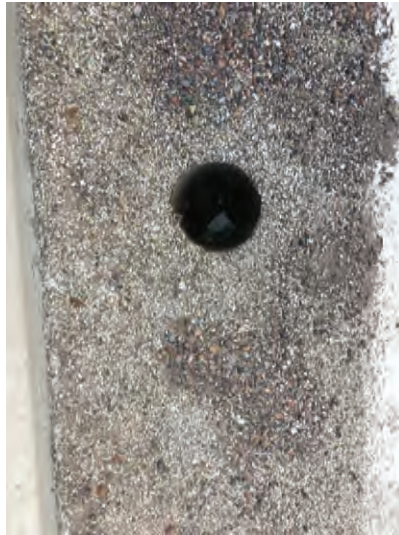
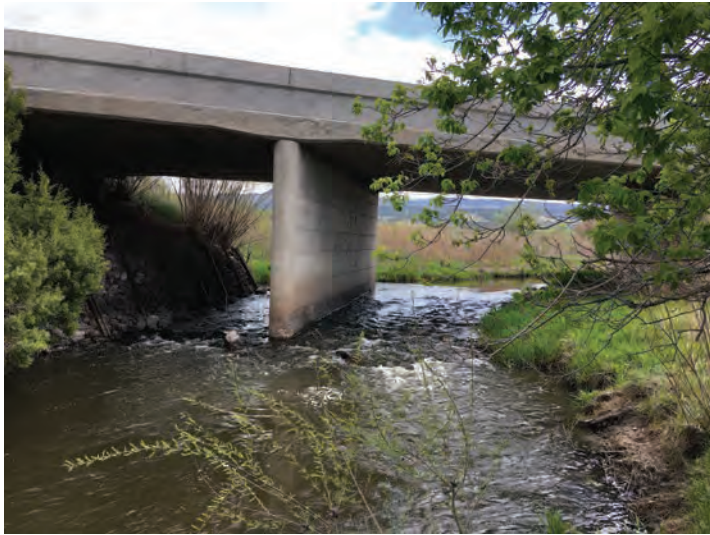
Outfall ID: 936727

water stain visible
on the inside of
one scupper hole

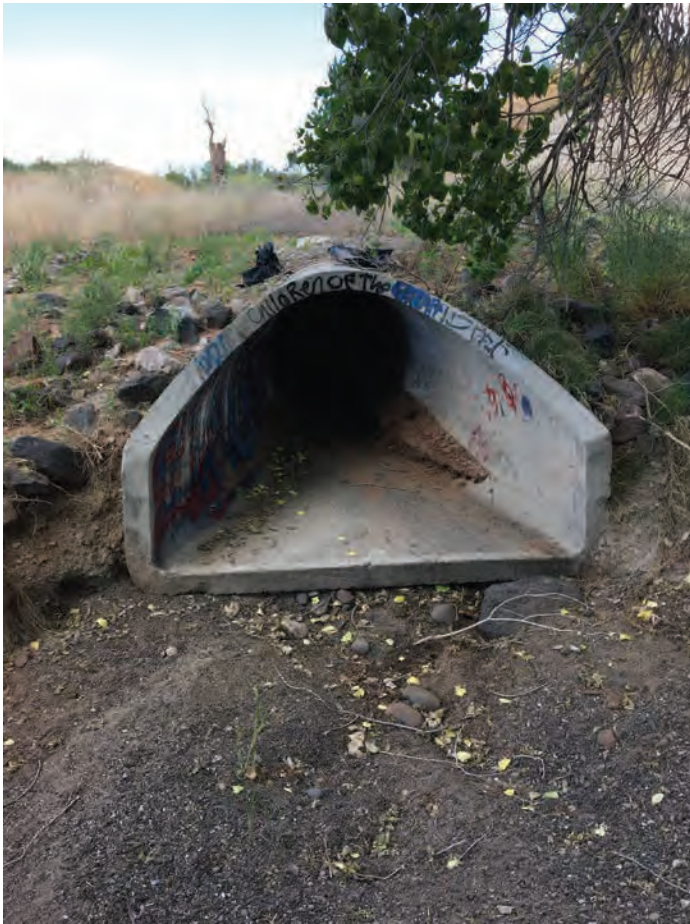
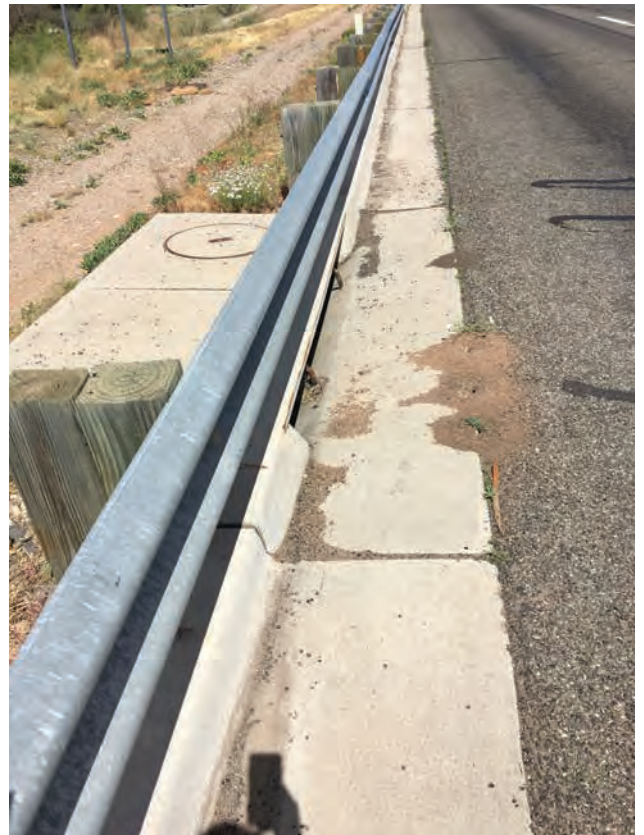
969092

Inlet on abutment releases to large concrete pipe. Dry sediment and water line observed at outlet.

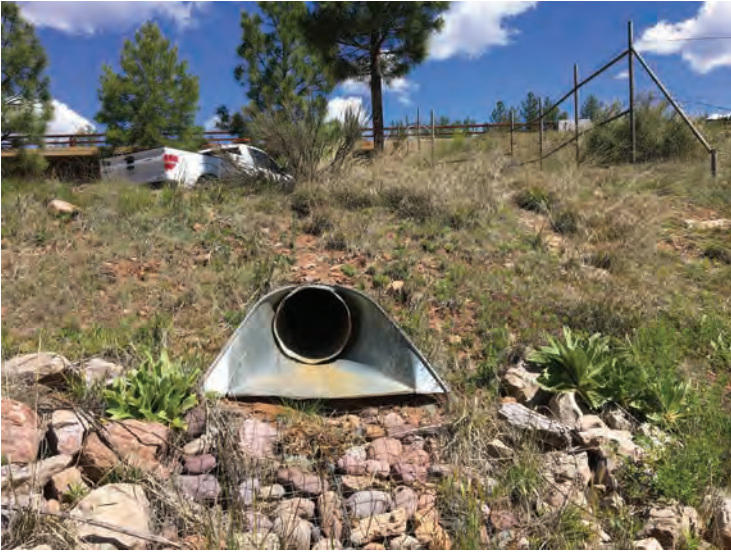
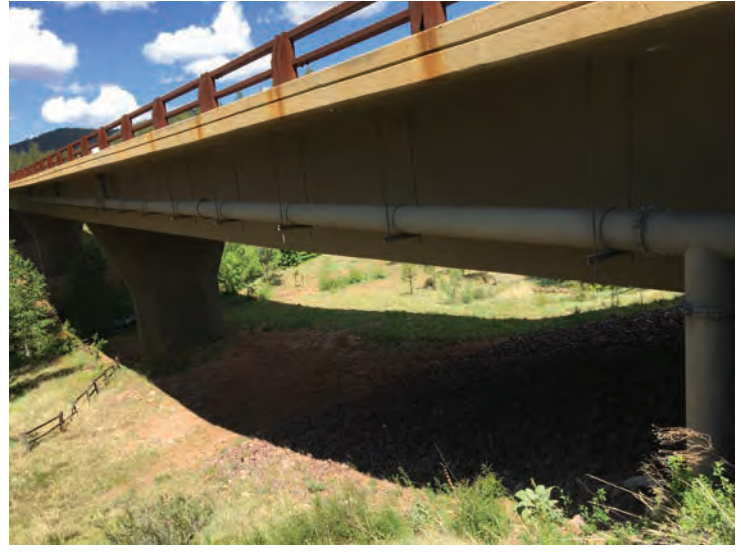
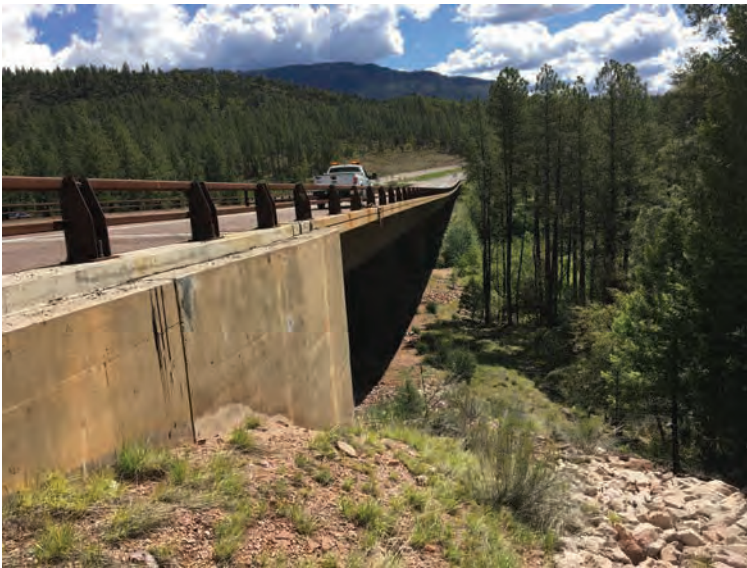
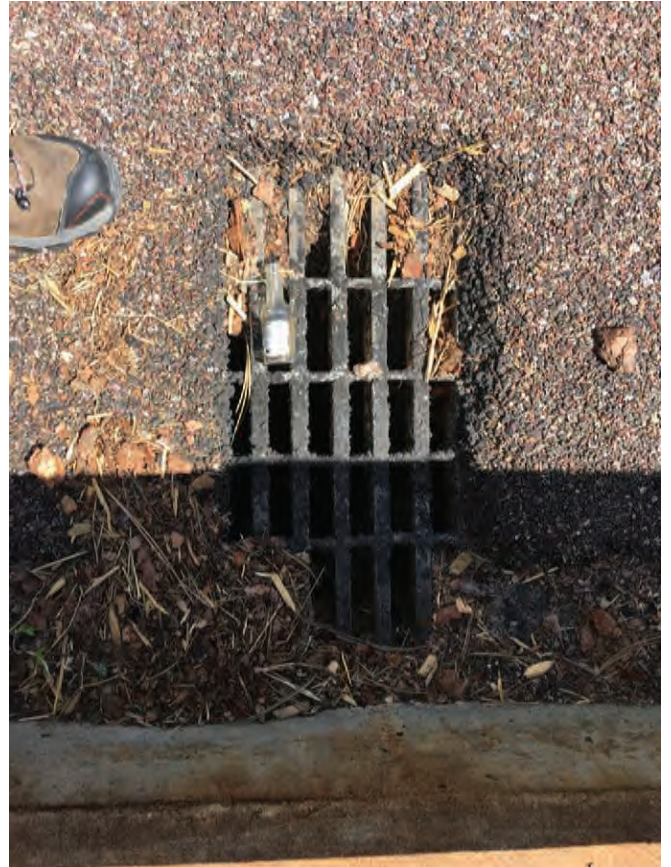
Outfall ID: 972140

Deck drains at eastern end into collection pipe, which outlets to drainage channel south of Tonto Creek along road to Kohls Ranch. Water line stain in outlet.

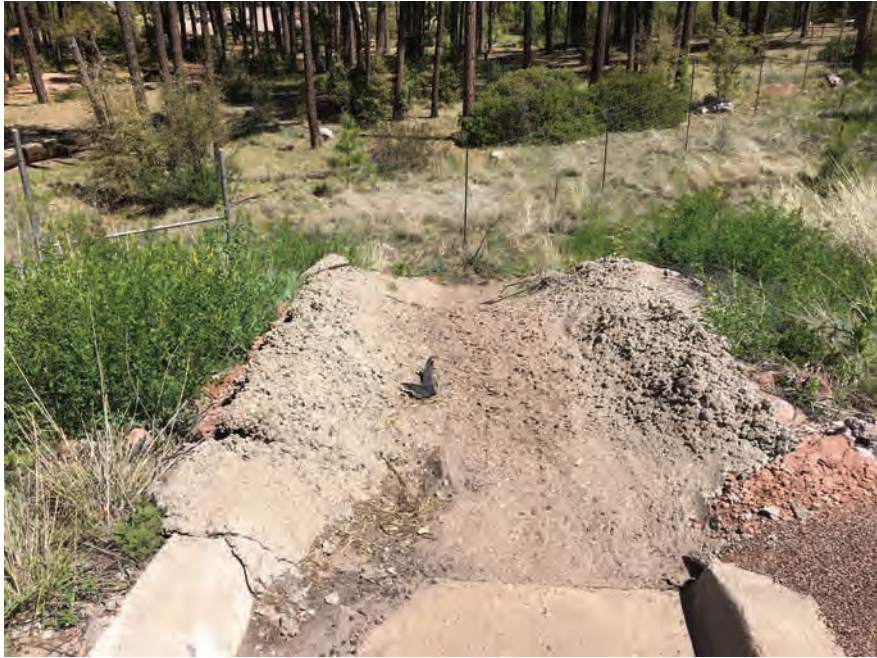
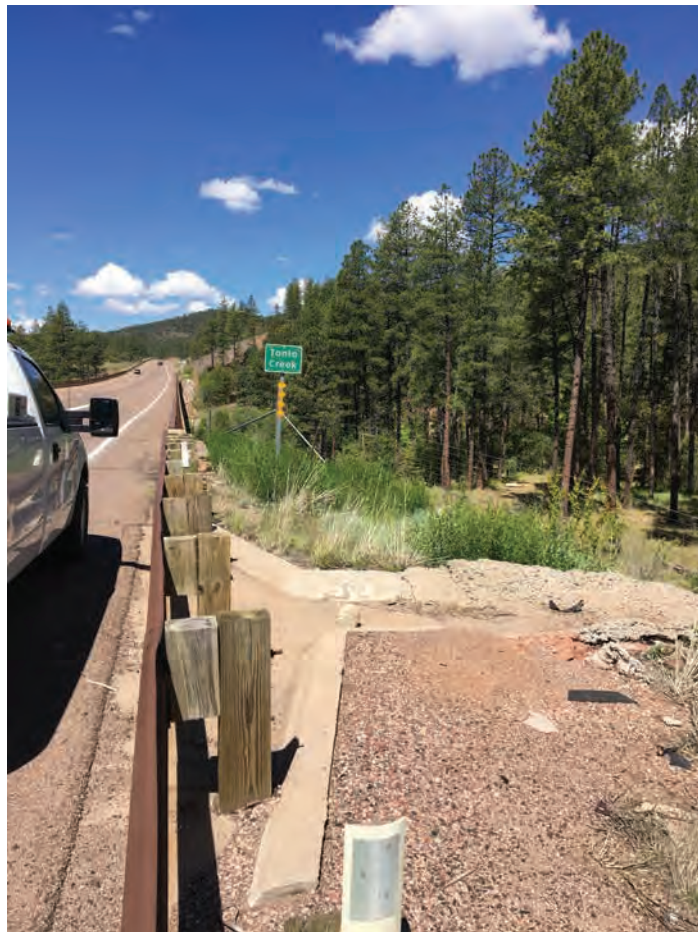
Outfall ID: 974993

Deck drains to spillway on northeast corner of bridge. Spillway outlets to rock lined drainage ditch. Sediment and debris deposit on spillway.

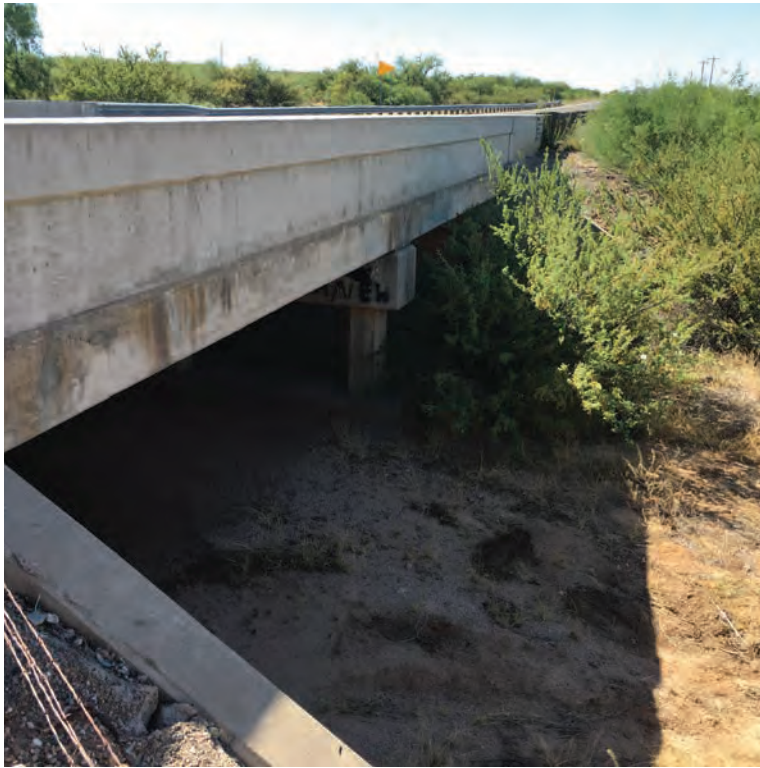
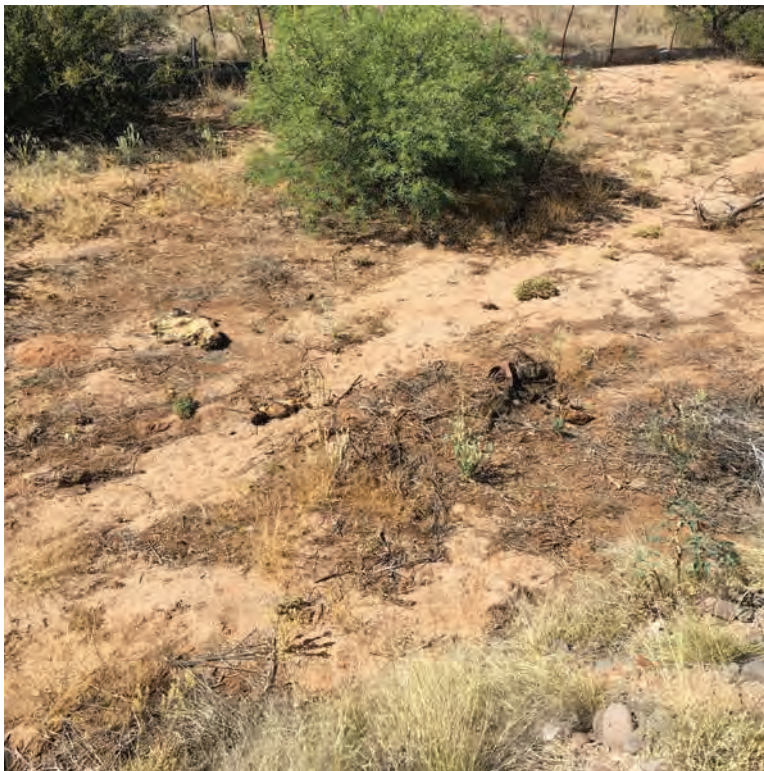
Outfall ID: 982481

Several dead animals were observed with in the ROW. The animals were giving of fa dead animal smell.

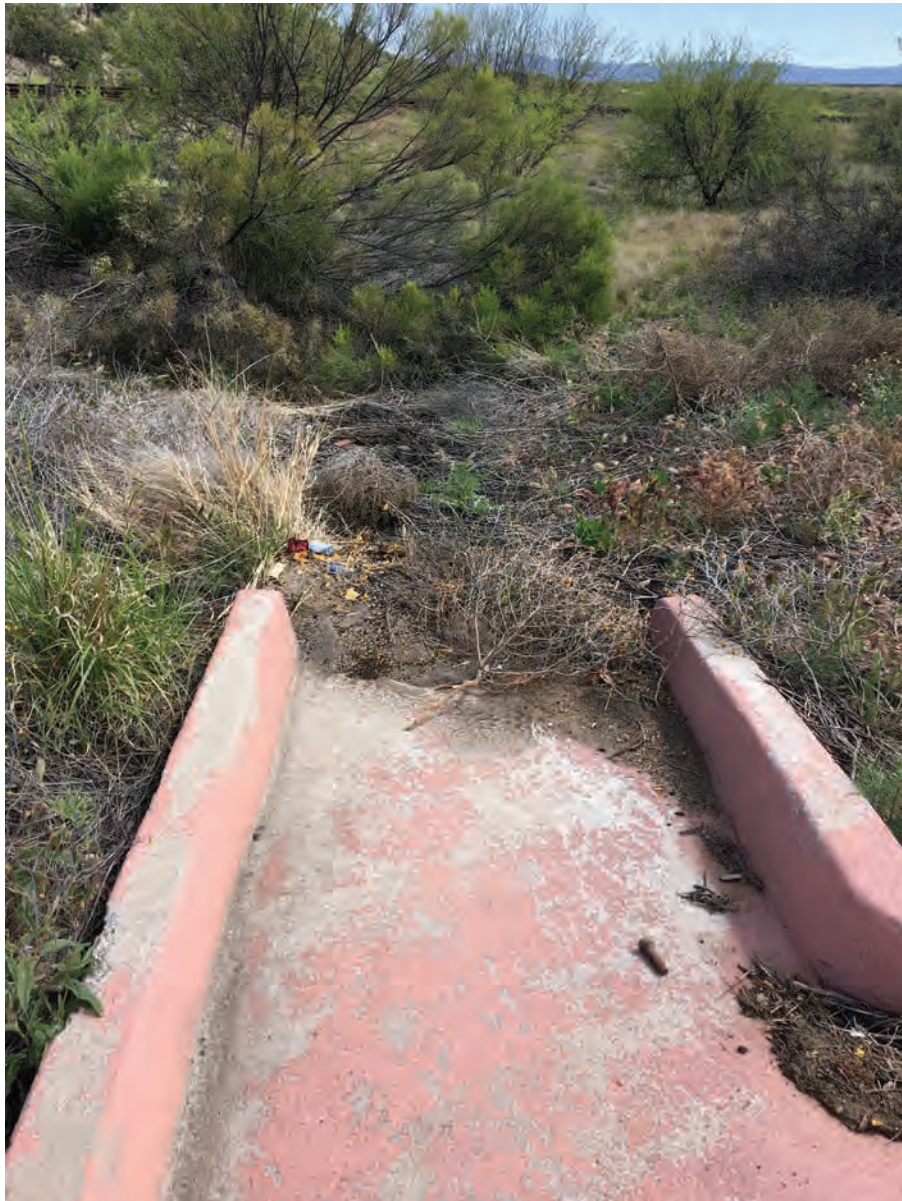
Outfall ID: 1443296

Spillway empties into median. Build up of debris and sediment at outlet. Water stain visible.

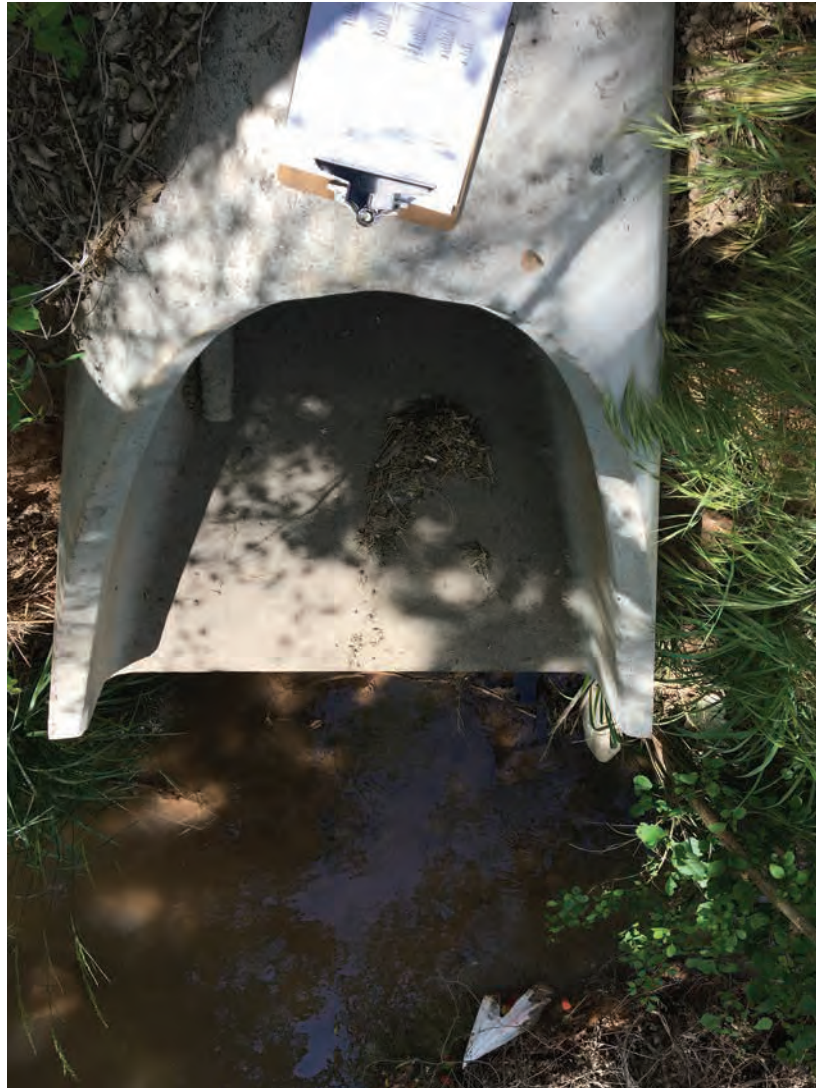
Outfall ID: 1058413

Minor amount of debris deposited in pipe

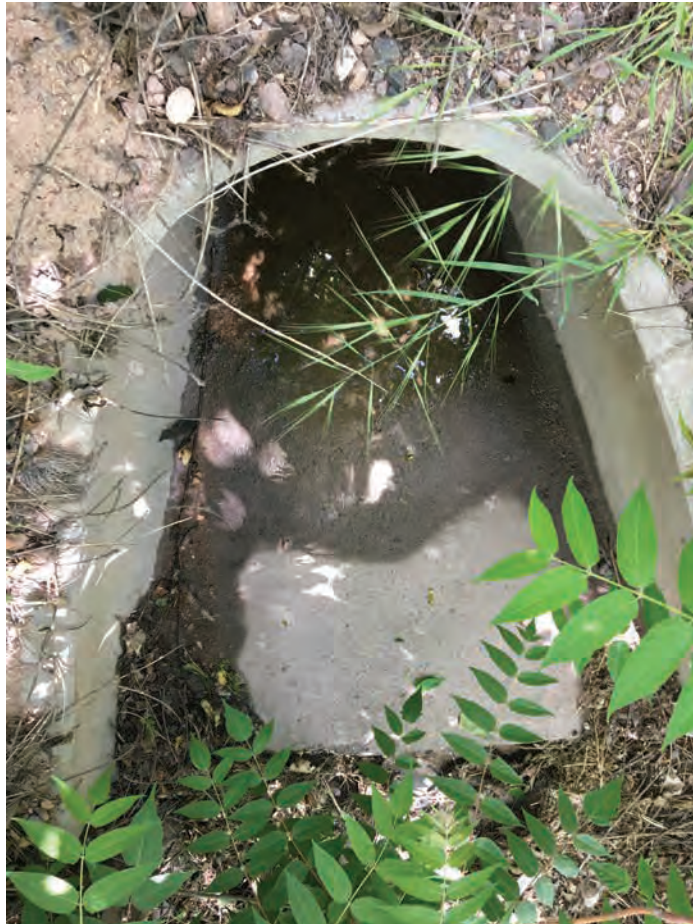
Outfall ID: 1059127

Discharge is likely stormwater.

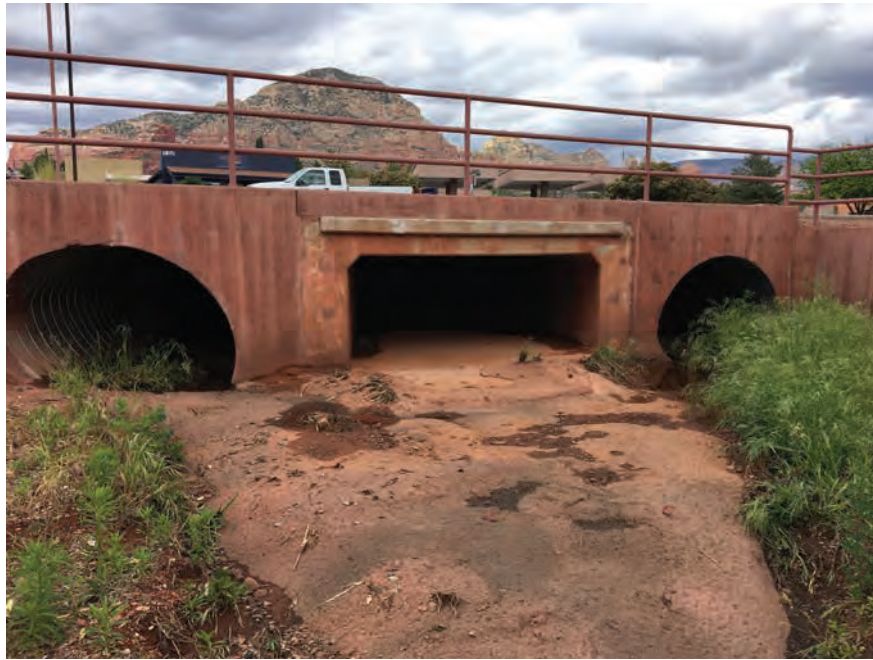
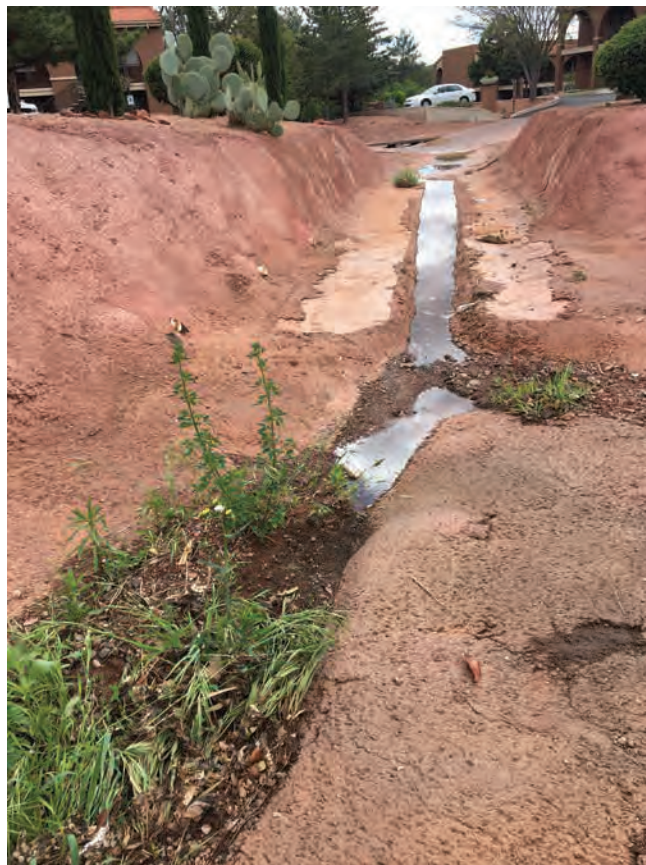
Outfall ID: 1059732

This is likely stormwater rather than an illicit discharge.

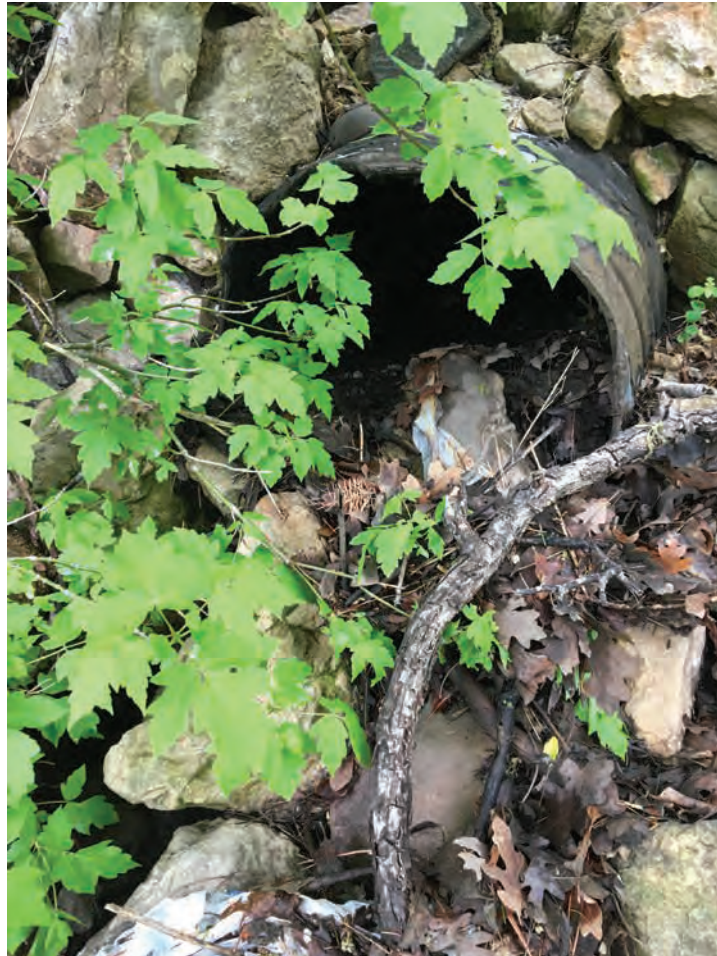
1062471

Trash and leaf litter present in pipe opening

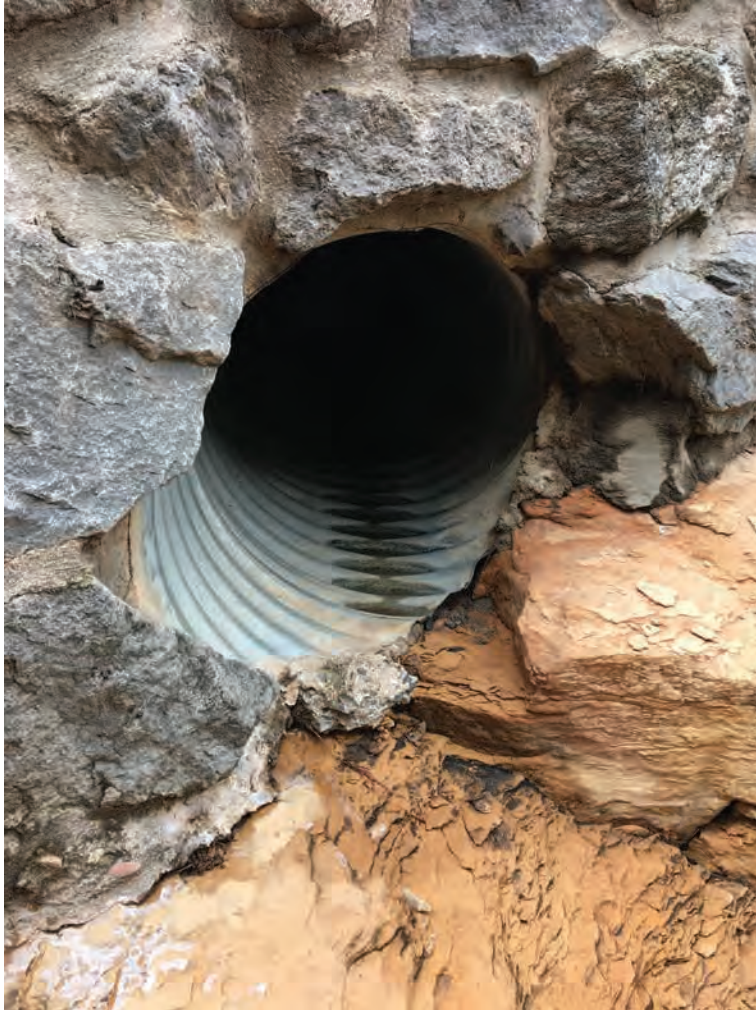
Outfall ID: 1062689

This is likely stormwater rather than an illicit discharge.

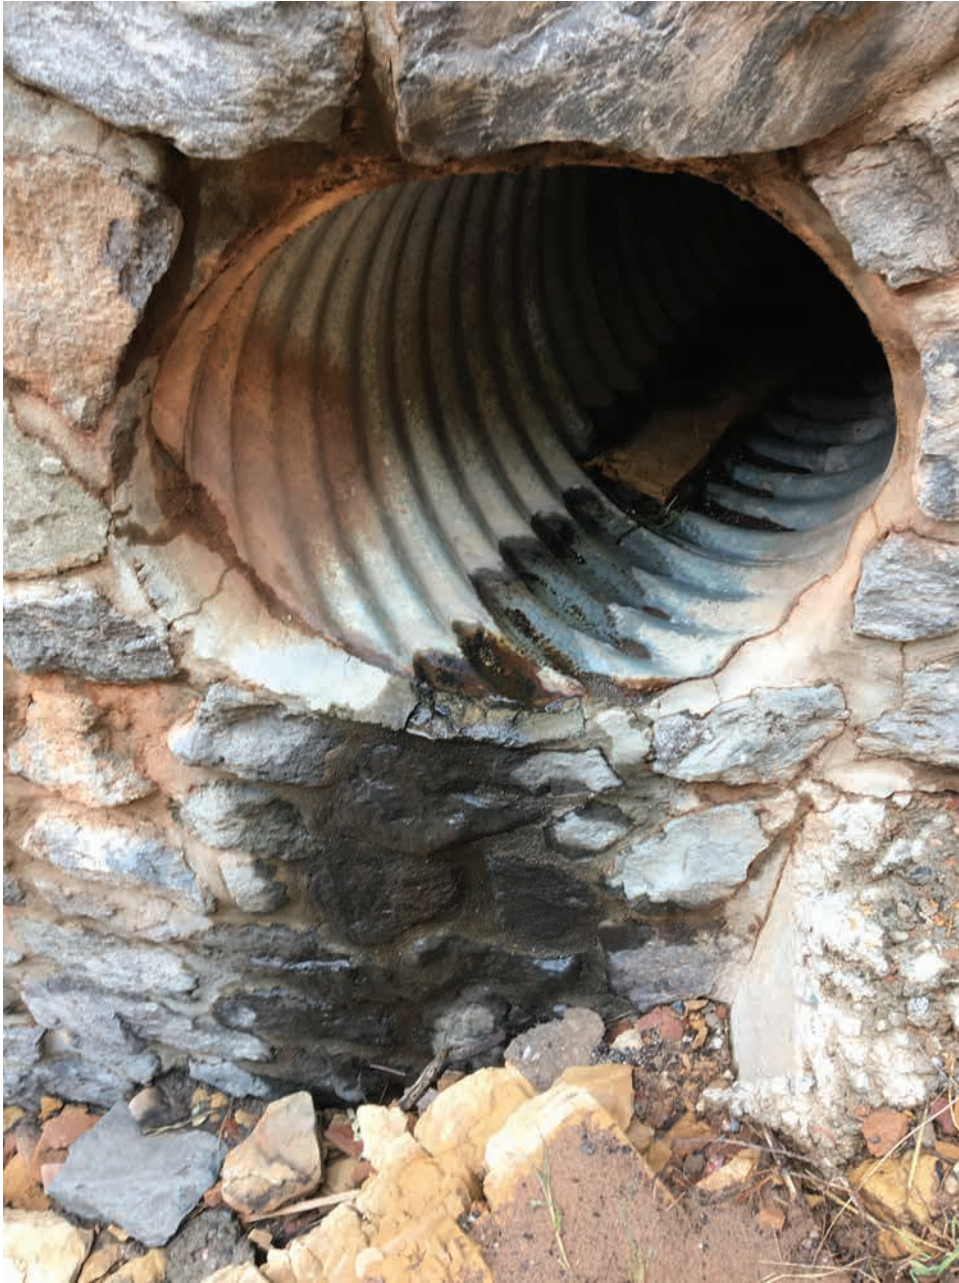
Outfall ID: 1062690

This is likely stormwater rather than an illicit discharge.

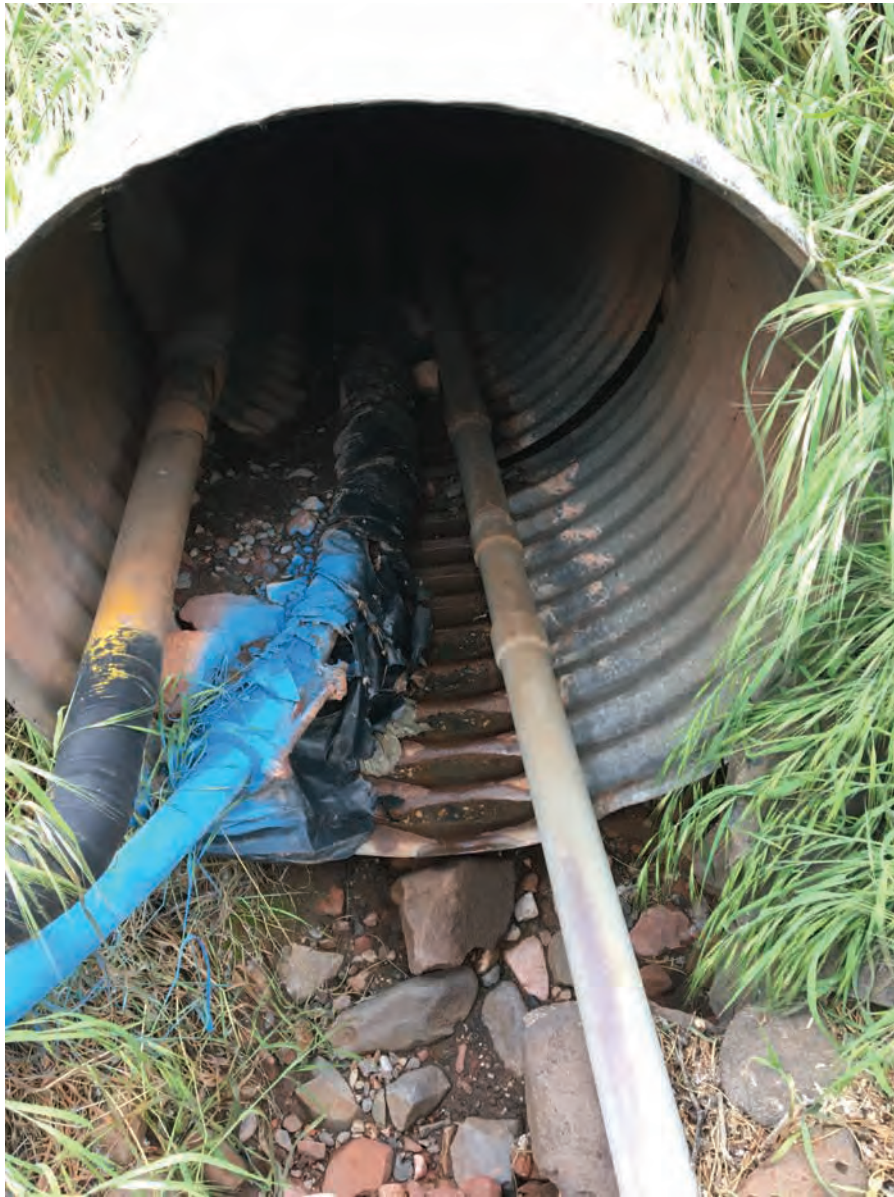
Outfall ID: 1062738

This is likely stormwater rather than an illicit discharge.

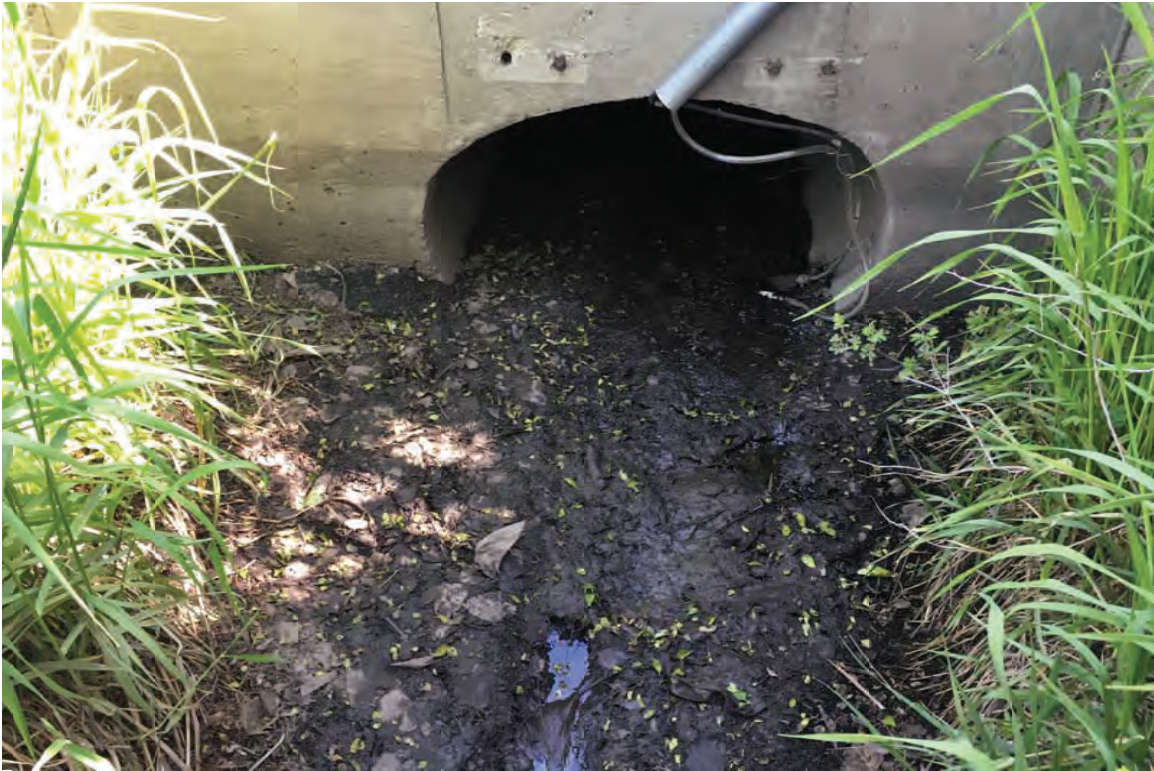
Photograph 1 Monitor at outfall (Humphreys and B I-40)

Two of the three pipes are blocked with sediment. Operational pipe has approximately 4" of sediment in pipe at outlet. Very wet May has left standing water in Rio de Flag and at outlet.

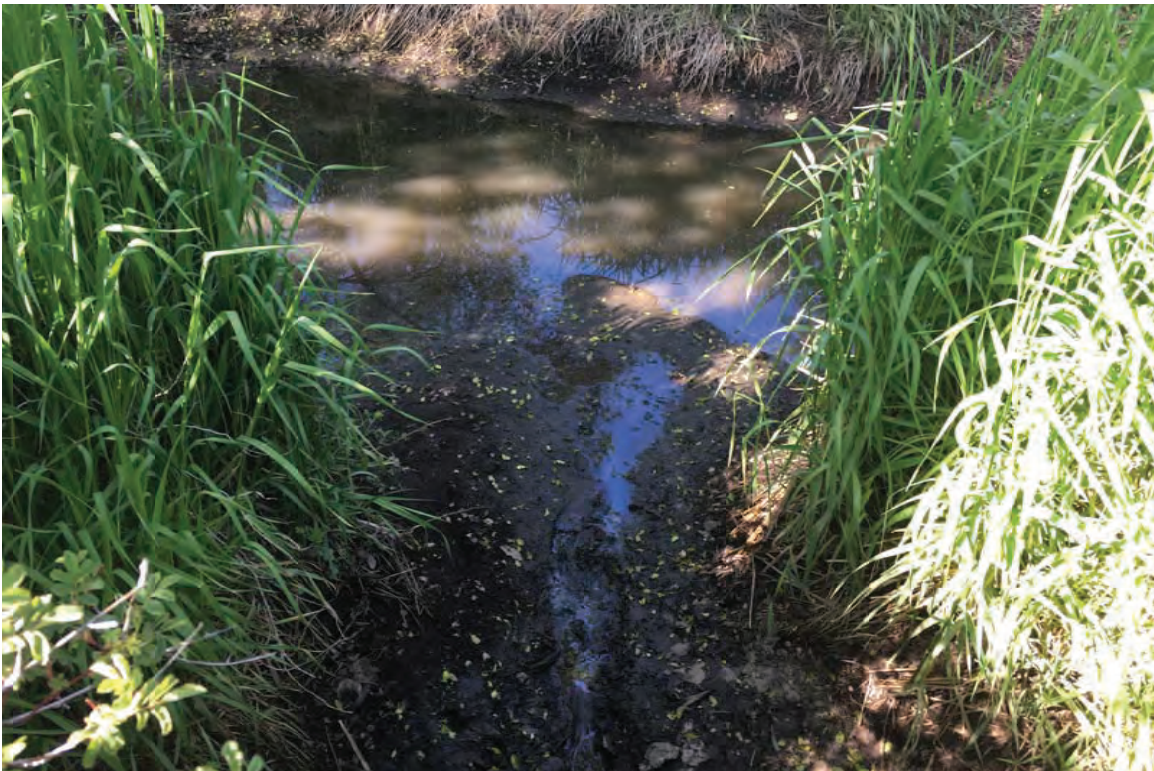
Photograph 2 View is continuation of above
drainage (Rio de Flag)

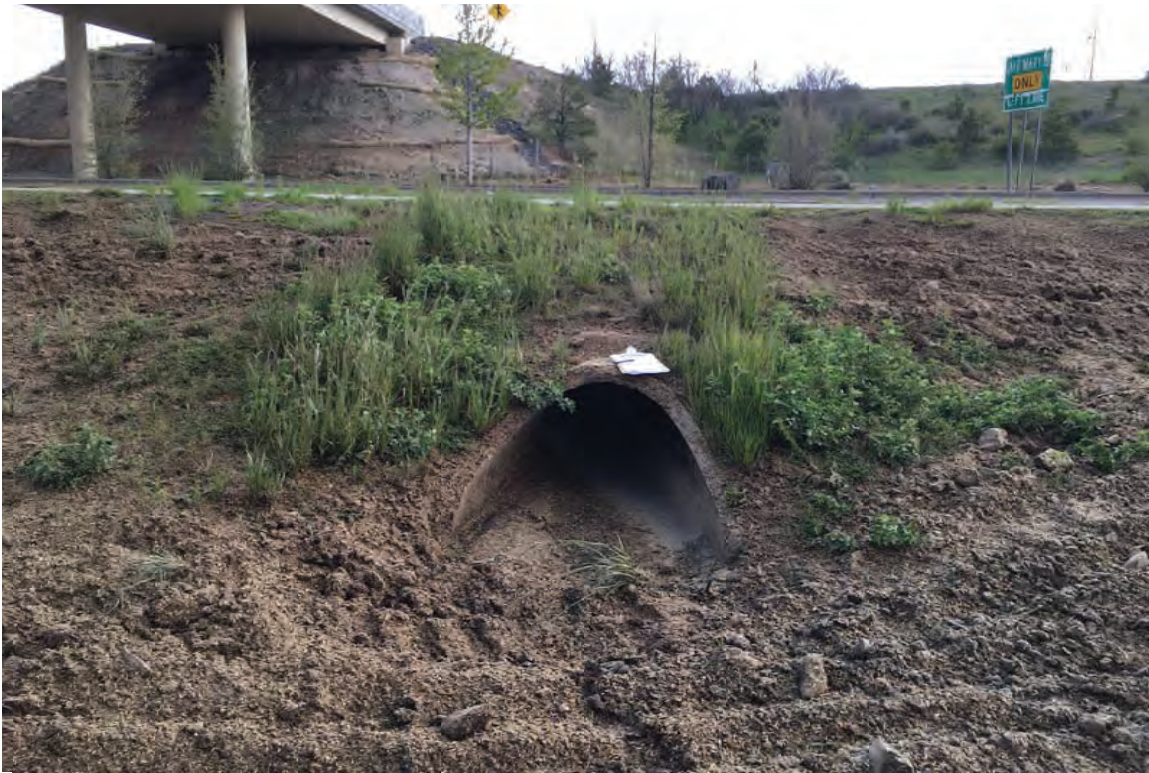
Photograph 1

Pipe drains from Hwy 89a storm sewer system and not from I-40. Flow drains to graded and seeded area approximately 10 meters from Sinclair Wash.

24 inch flaired concrete culvert. Collects stormwater from 89a storm sewers. No I-40 or I-17

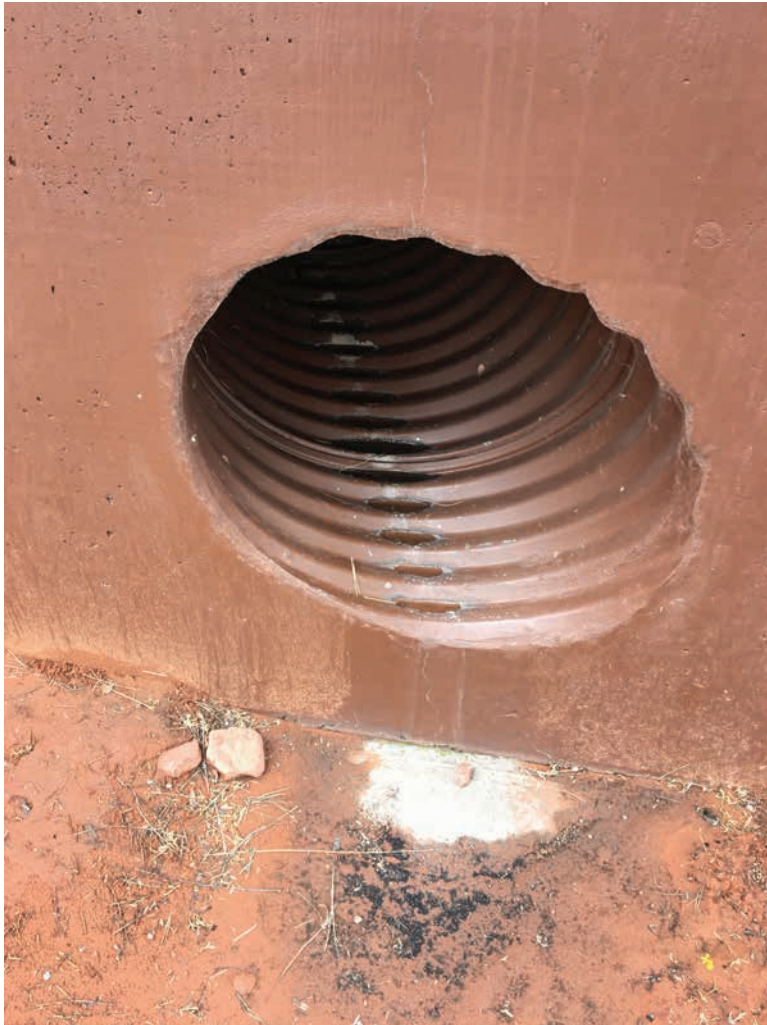
Outfall ID: 1433577

Small amount of sediment deposited in pipe corrugated ridges.

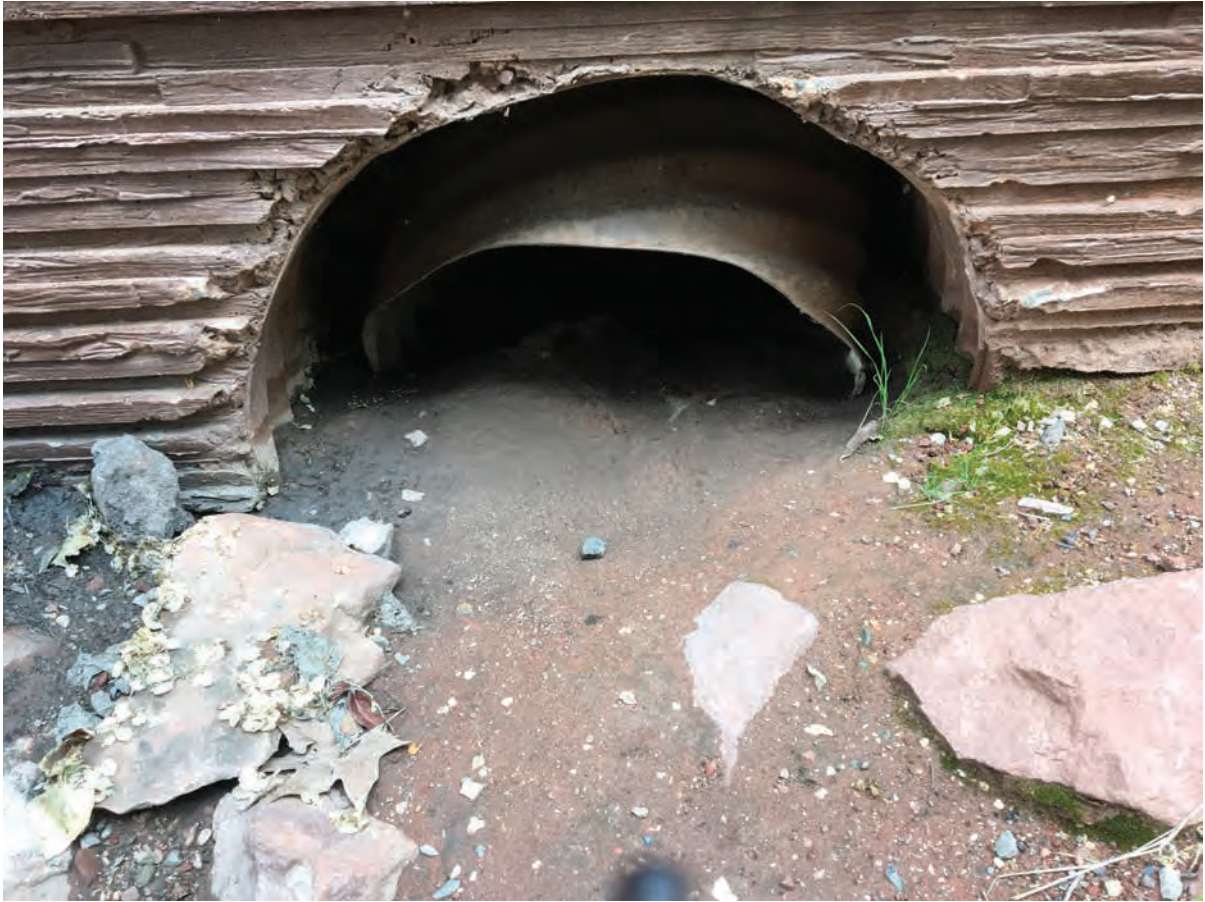
Outfall ID: 1433627

Outlet is on SB shoulder (rather than NB as shown on spreadsheet). Sediment has deposited several inches in this general area. Invert of pipe appears to be below current grade of shoulder.

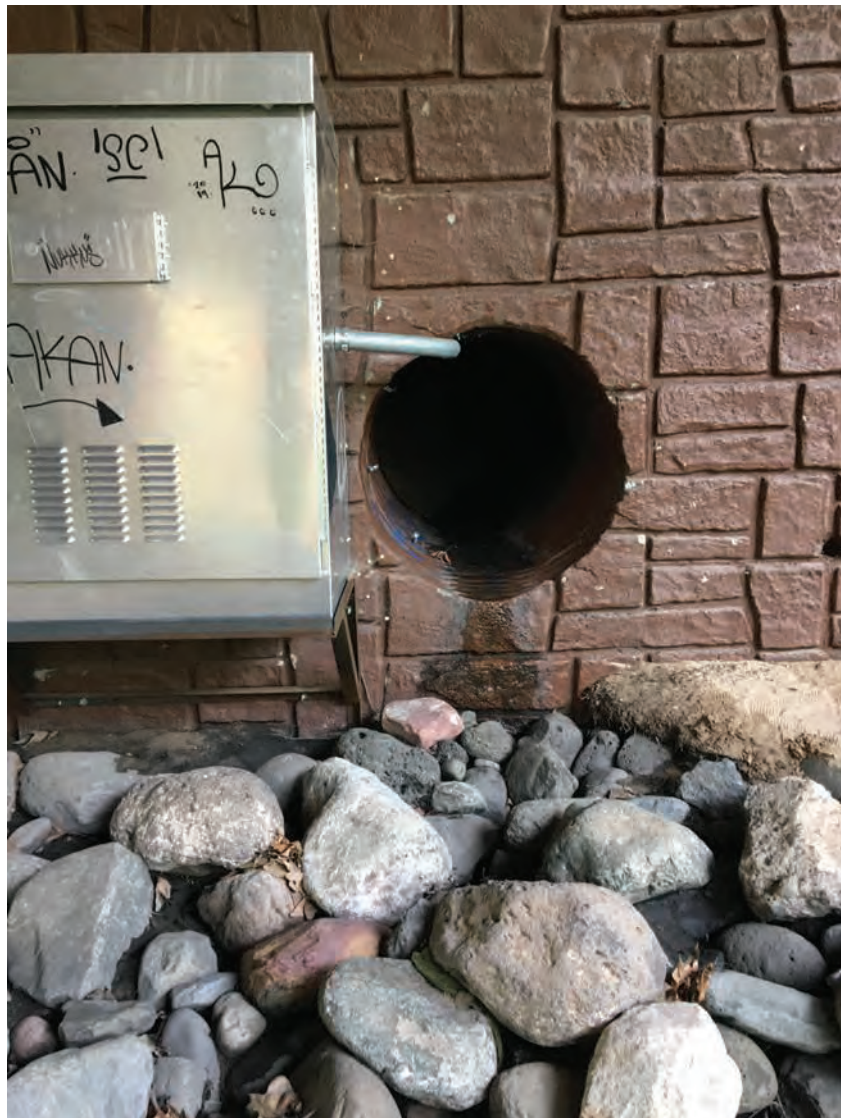
Outfall ID: 1433633

This is likely stormwater rather than an illicit discharge.

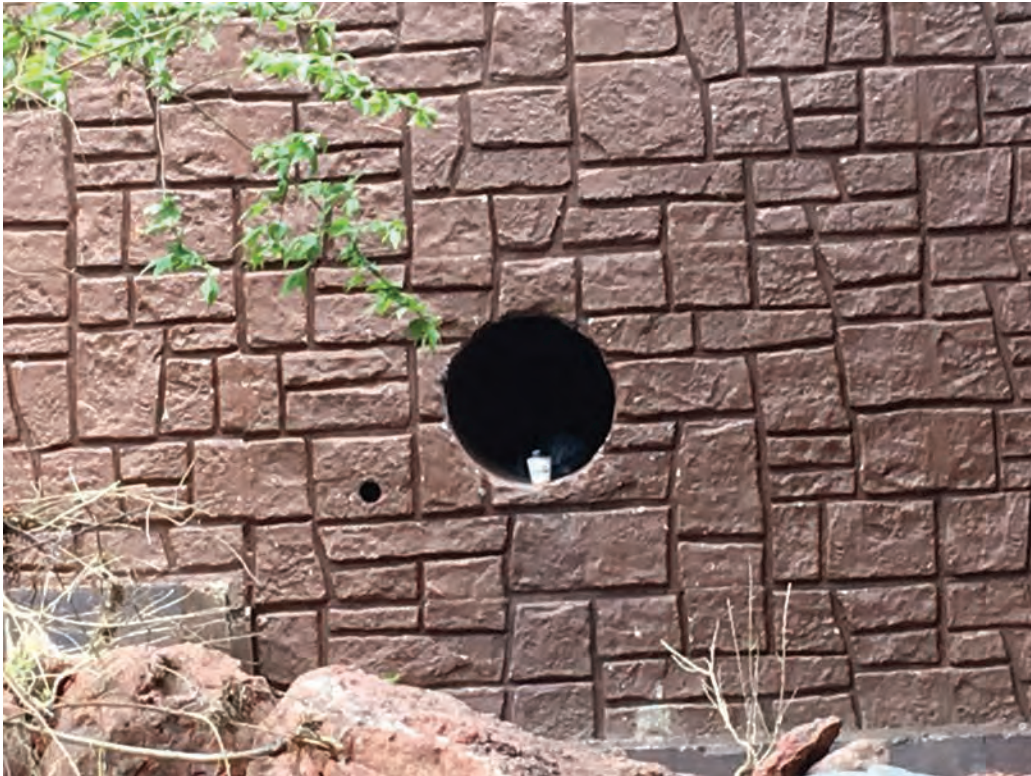
Outfall ID: 1433709

Trash in outlet.

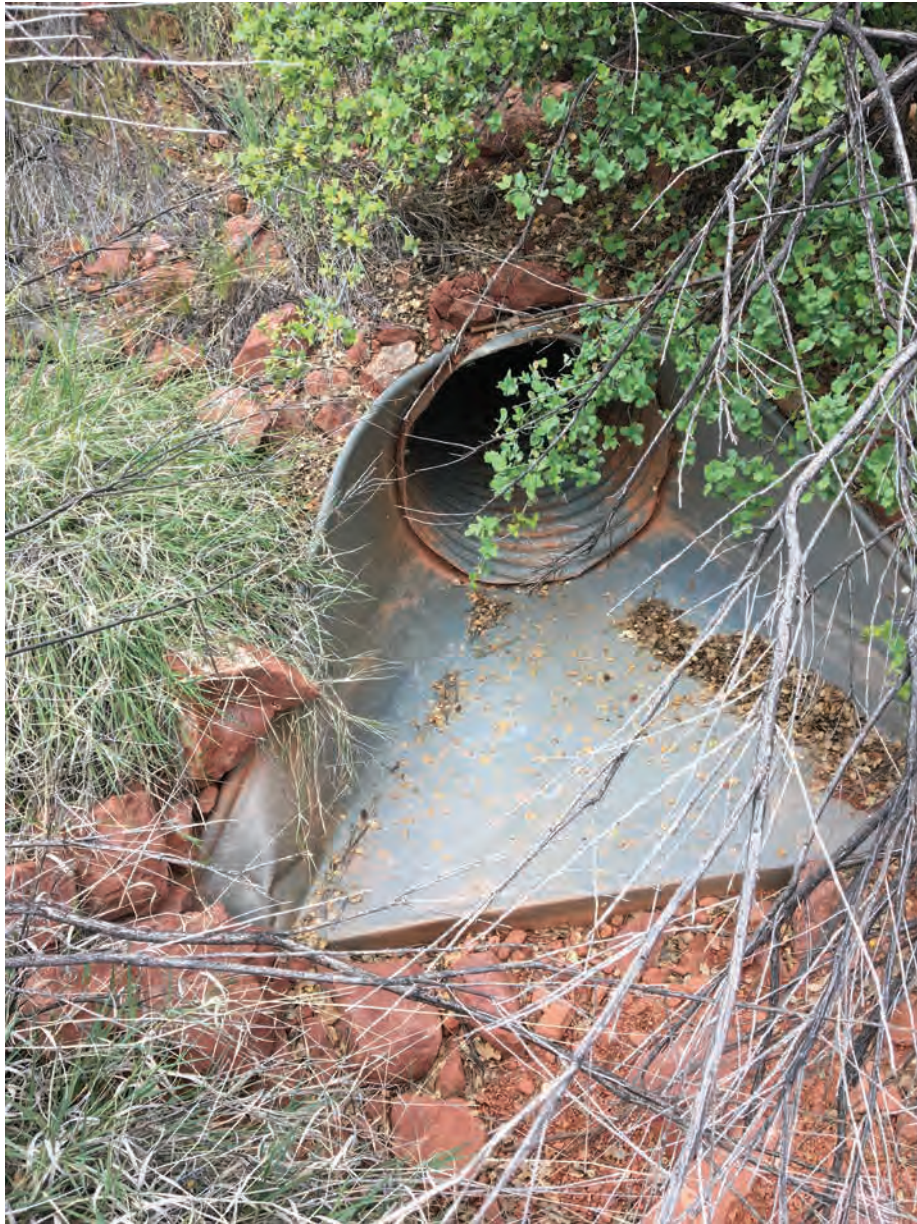
Outfall ID: 1443218

Water stain visible and debris (leaves) present in outlet.

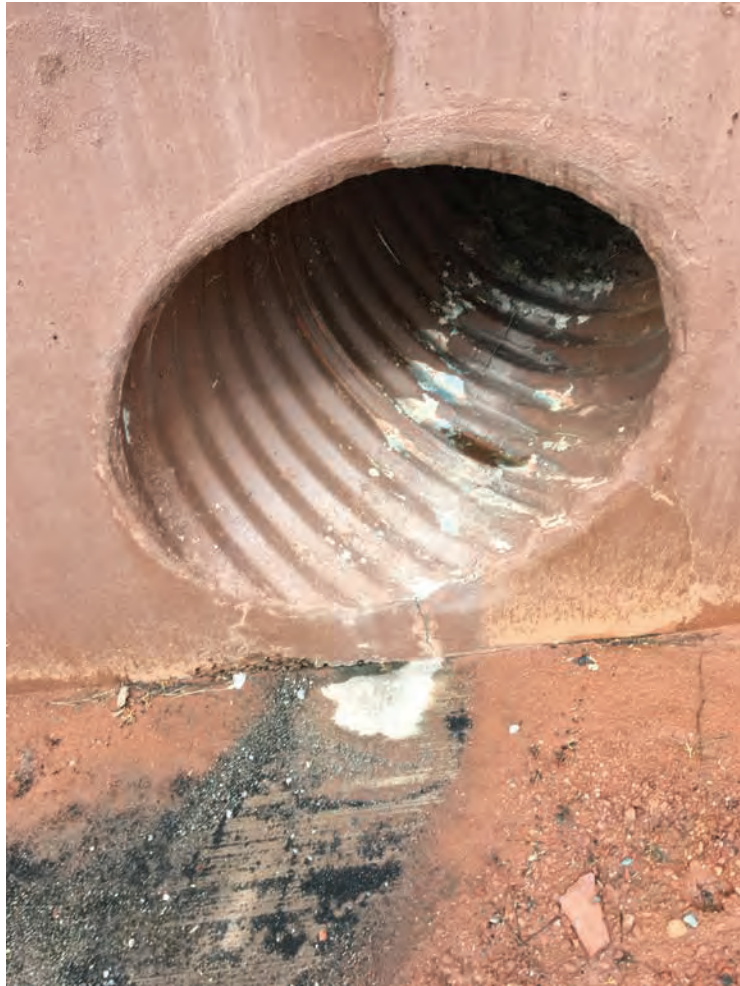
Outfall ID: 1443296

Discharge is likely stormwater.

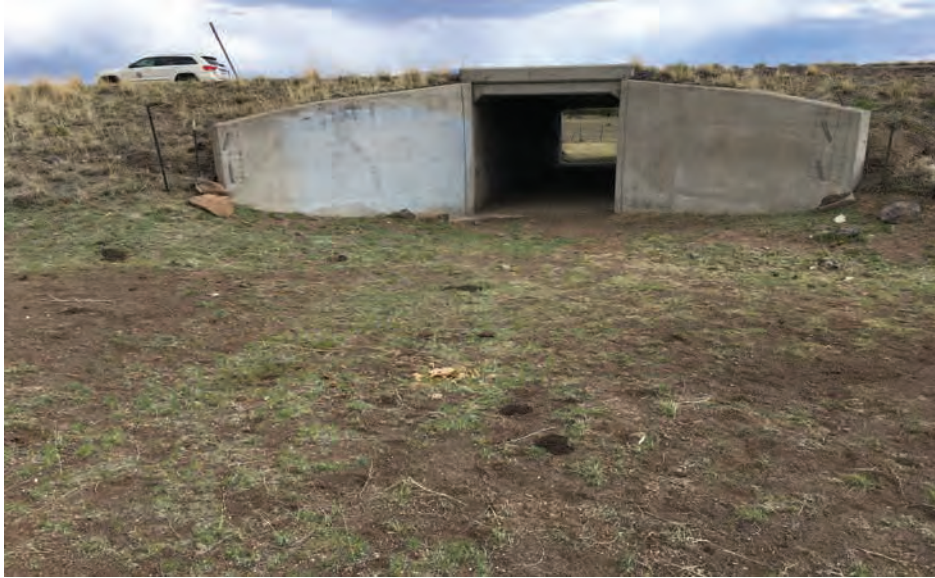
1484925

adjacent permittee is using ADOT ROW to fence and contain cattle on either side of outfall
