Outfalls inspected FY 2019

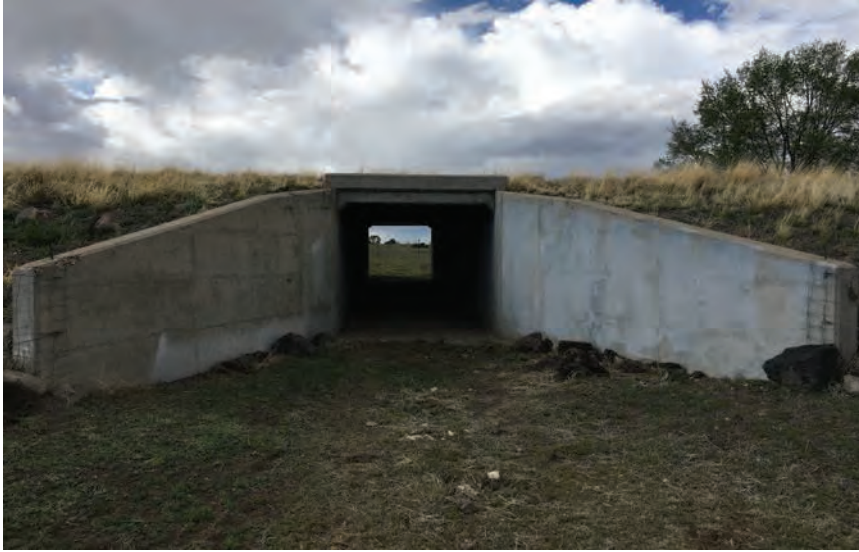
1485179

USFS grazing permittee is using ADOT ROW and CBC to corral cattle.

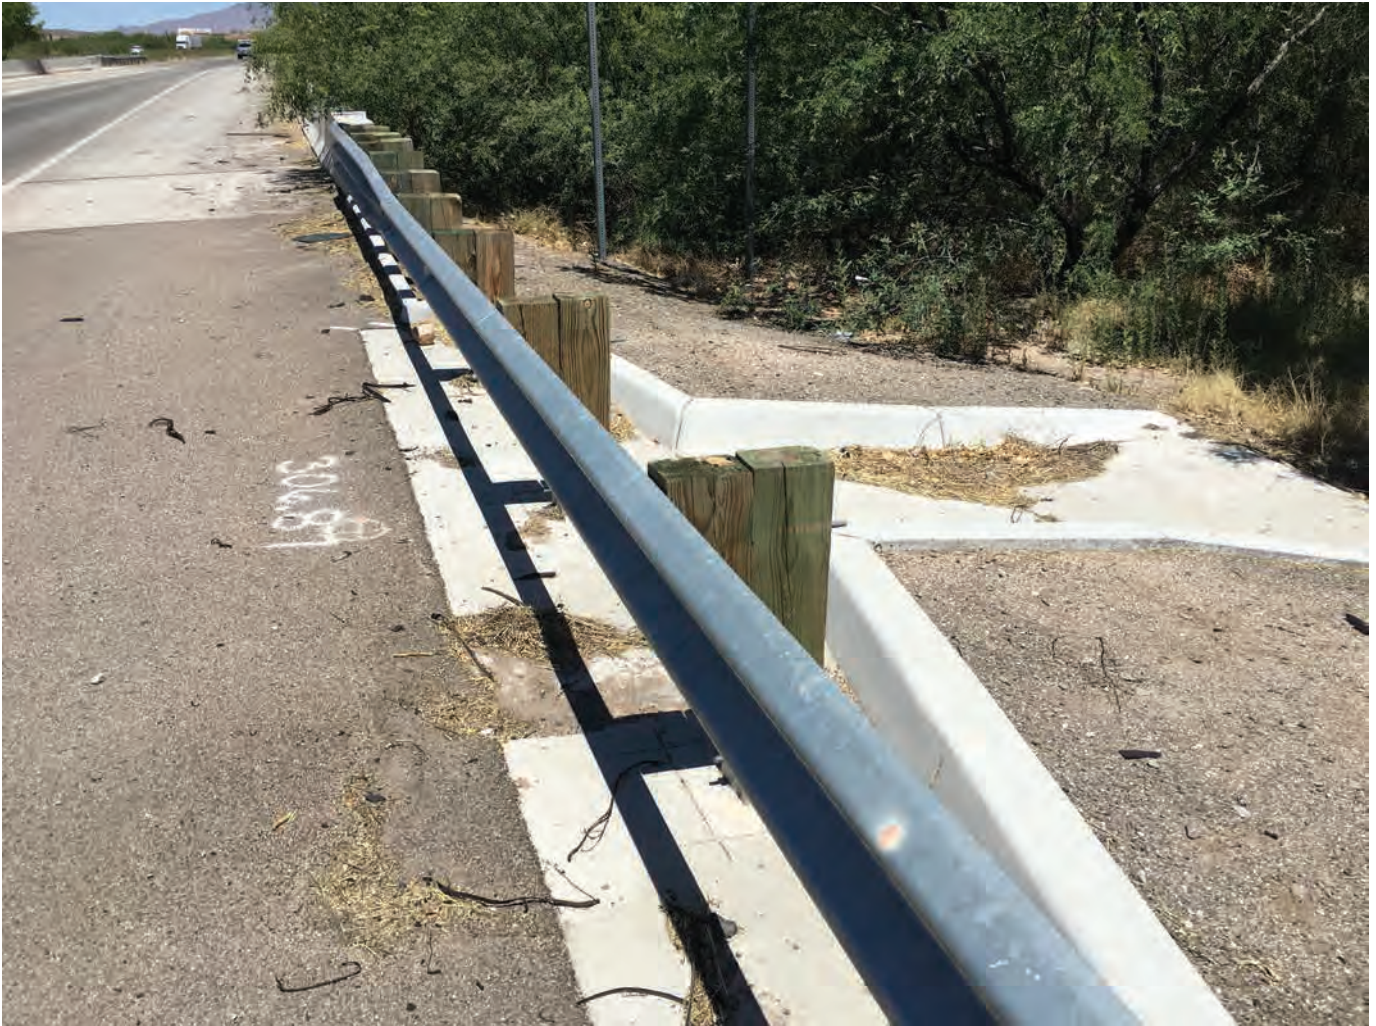
1510611

Outfall type misidentified as "pipe opening" in FIS

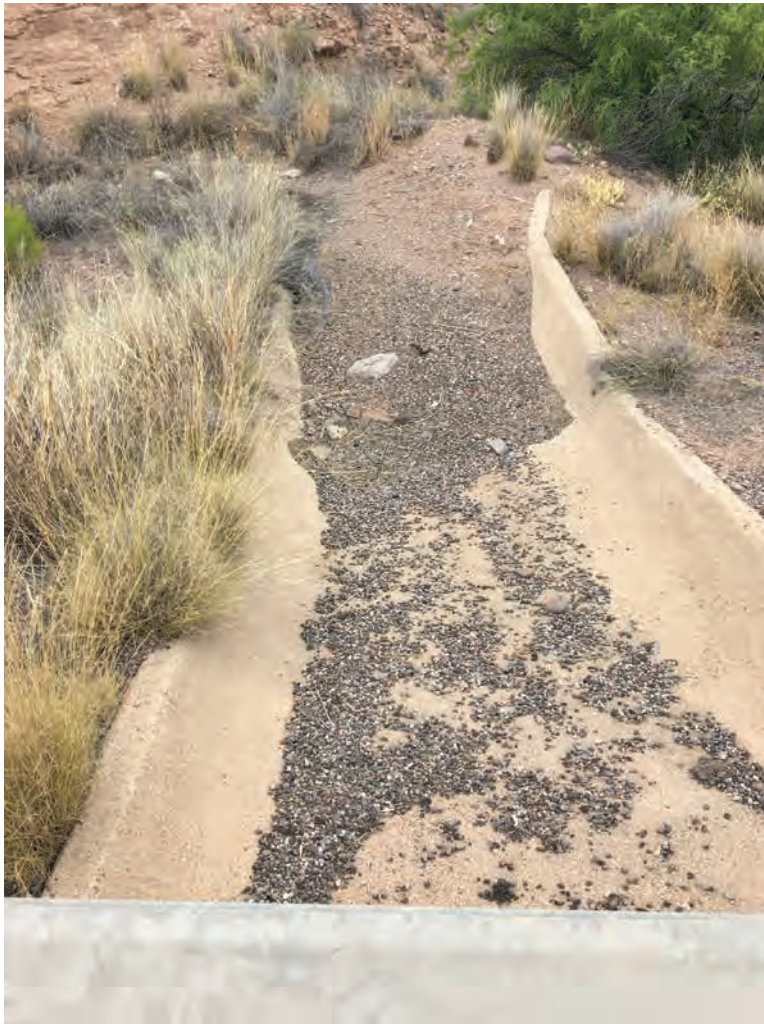
1510625

Sediment deposit in outlet

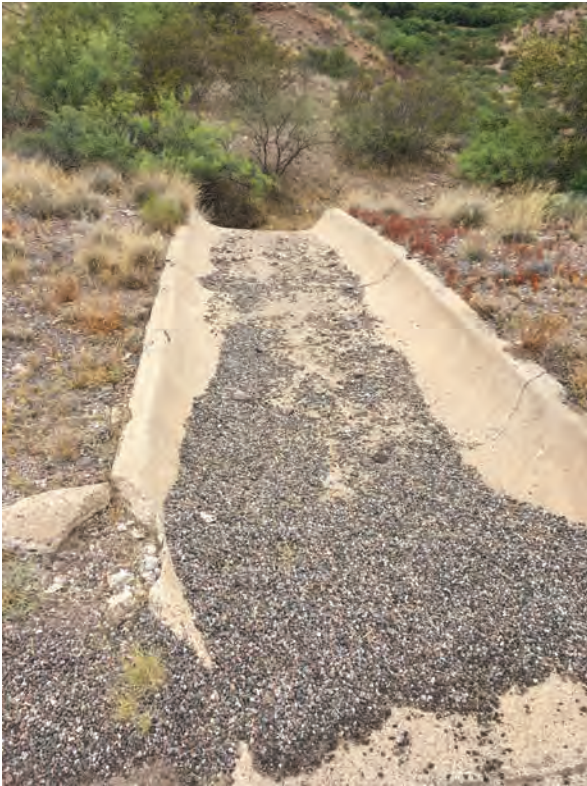
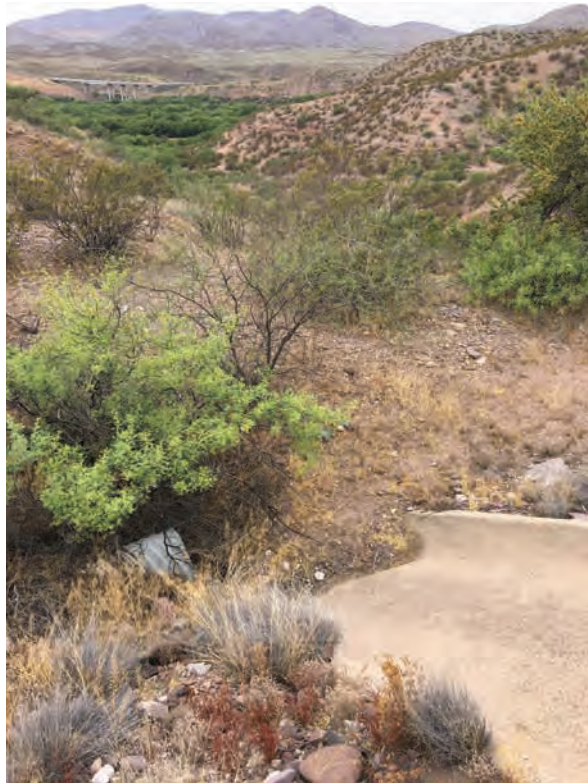
1510626

Sediment deposited in top portion of spillway

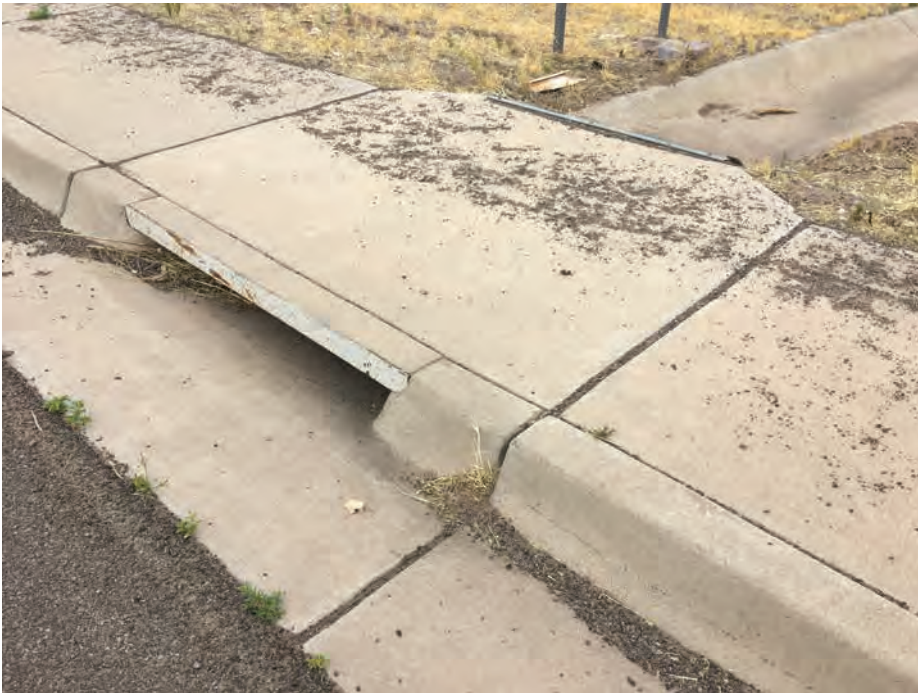
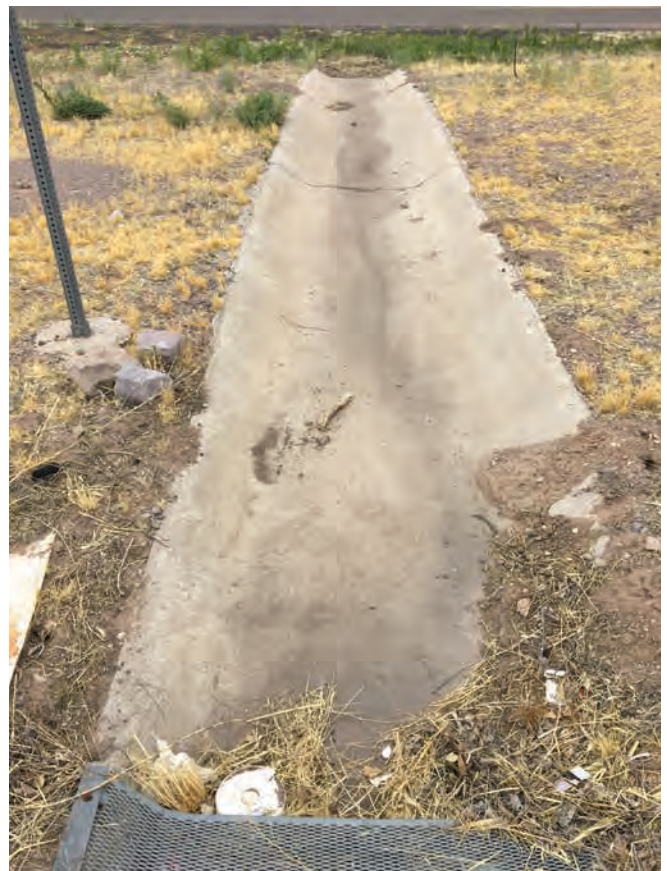
Outfall ID: 1510628

Scupper outlet clogged with debris and sediment. Spillway has dark water line stain.

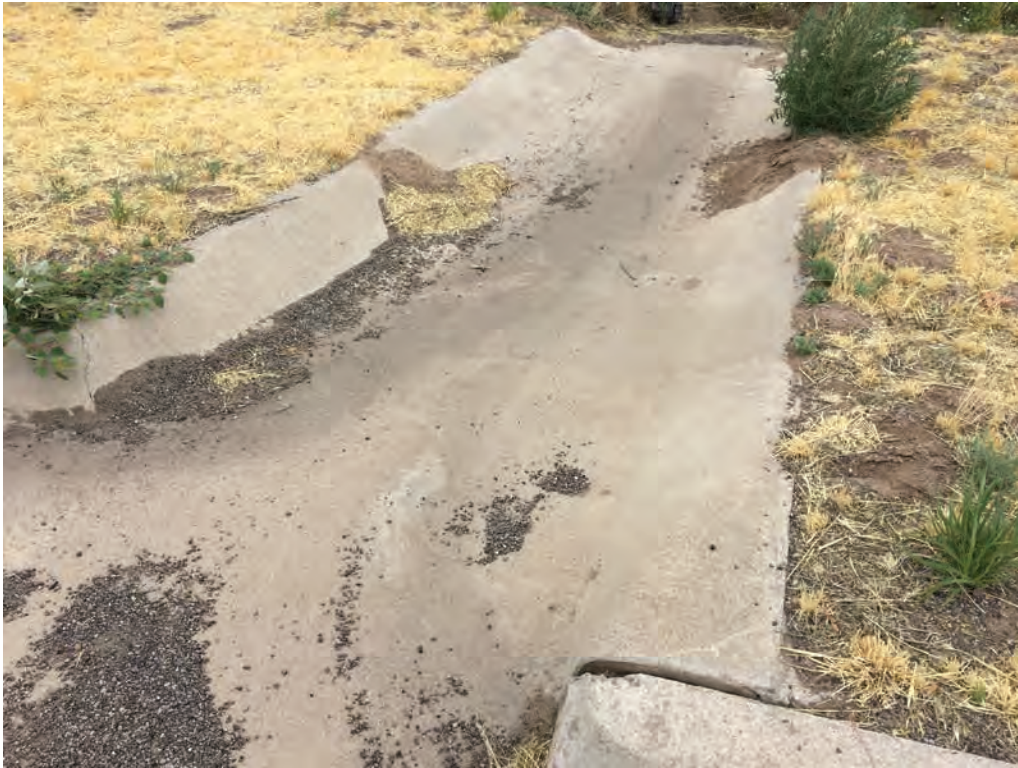
Outfall ID: 1510629

Sediment deposit in spillway and water stain
