March 30, 2023

**SUBJECT: Geotechnical Assessment
State Route 88 (Apache Trail), MP 222 to 229
Design Concept Report & Environmental Overview Study
ADOT TRACS No. F0494 01L
ADOT Contract No. 2022-020
Pinal County, Arizona**

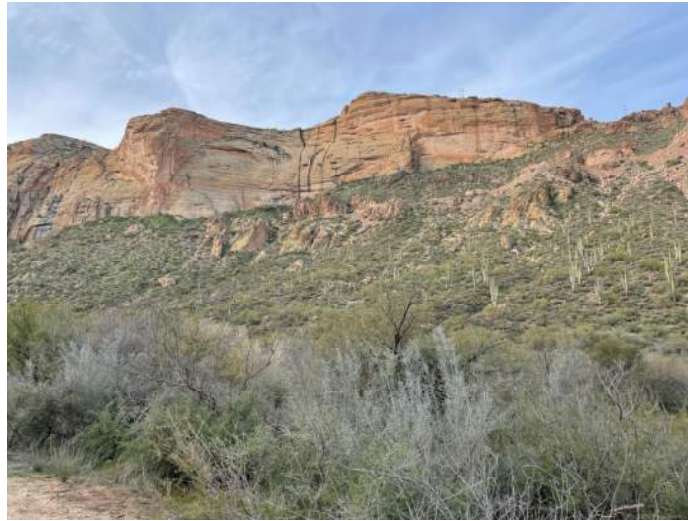
The majority of roadway damage is concentrated in the steep section of roadway west of Fish Creek Canyon (approximate MP 222.6 to 223.6). This stretch of road is characterized by a variety of steep overlying rock faces, and rock debris and colluvial slopes which contain loose rock with sizes varying from cobble to large vehicle-size boulders immediately adjoining the road. Higher, near vertical canyon forming rock walls are set back from the road generally a few hundred feet. Photograph No. 1 shows the steeply faced canyon walls set above SR 88 within this section.

Photograph No. 1 – High rock walls west of SR 88 at MP 223 (looking west)

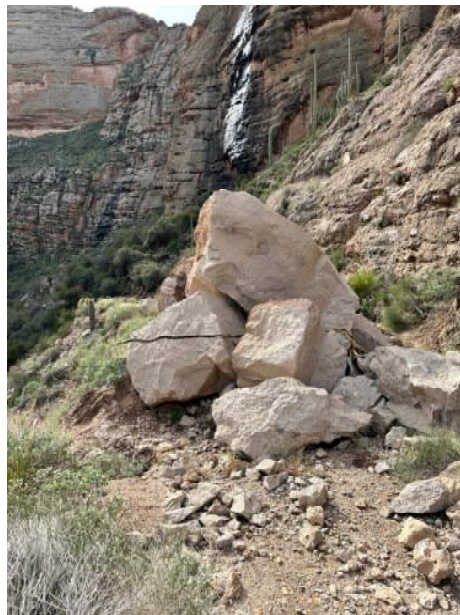
Bedrock within this stretch of road and in the slopes high above the road, consists of volcanic rock, primarily andesite, dacite and tuff, extending from the west project limits to about MP 223.2. A southeast to northwest trending fault separates this volcanic rock from sedimentary sandstone, siltstone, and conglomerate rock. It is apparent from review of aerial photos that faulting has tilted this once horizontally bedded rock unit to a near vertical orientation along the canyon walls. It further appears that the large rock fragments, which closed the road at MP 223.3, detached from the vertically oriented bedding planes. Photograph No. 2 shows the location where falling rock completely blocked the road. Photograph No. 3 shows the rock wall where the rock blocking the road likely originated.

Photograph No. 2 – Large rockfall that closed SR 88 at MP 222.3 (looking south)

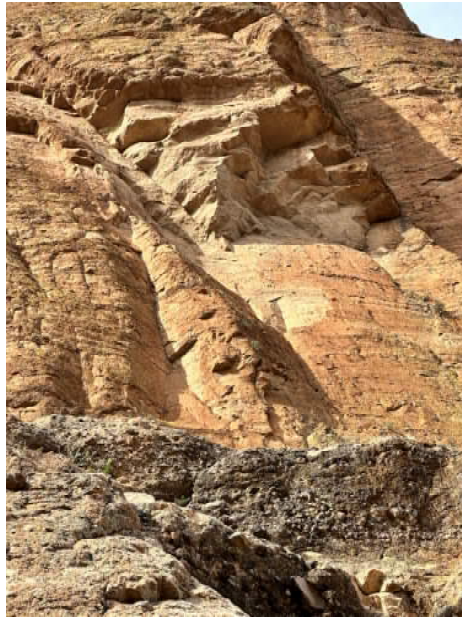
Photograph No. 3 – Fresh face of rock slope where large rock in road likely originated (looking west)

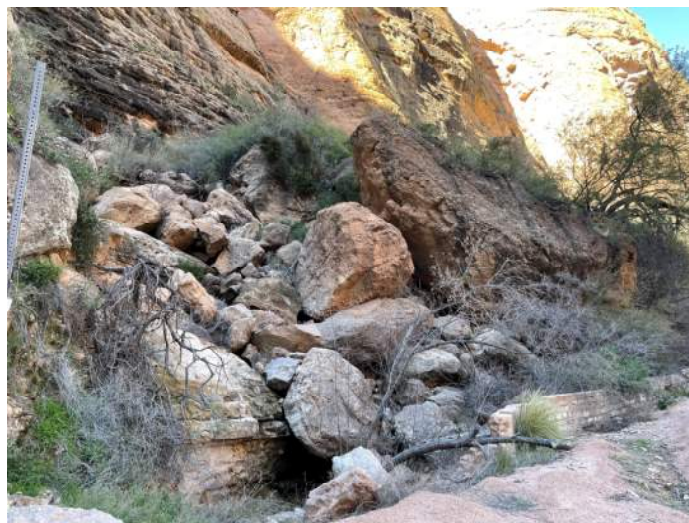
Other damage in this section includes rock debris flows which have infilled drainages with variably sized rock, often blocking cross-road culverts. This is indicative of large storm flows concentrated into natural drainages. It is evident the roadside ditch on the cut side of the road overtopped at many locations resulting in surface overflows, which often eroded the existing roadbed, outboard fills and in some cases existing rock walls. Erosion on the roadbed exposed the underlying rock cut surface. The fills were, at some locations, extensively eroded on the outboard slopes causing significant erosion of the slope and edge of road. Storm induced erosion of exposed colluvial and rock debris slopes also deposited rock onto the road at many locations. Photograph No. 4 shows a debris flow and Photograph No. 5 shows erosion of the roadbed and the outboard slope.

Photograph No. 4 – Rock debris flow near MP 222.4 (looking west)

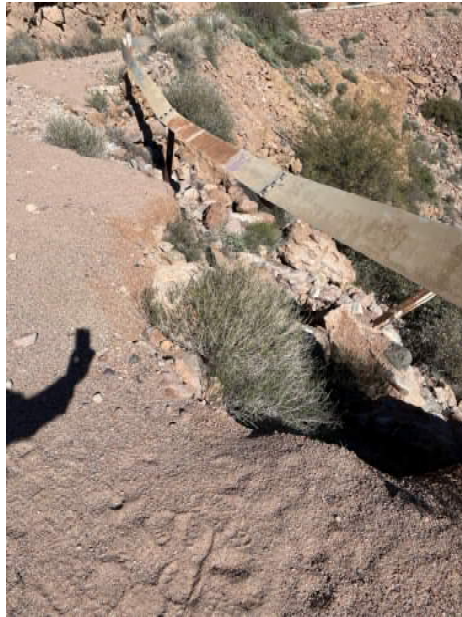
Photograph No. 5 – Erosion of roadbed and outboard slope at approximately MP 223 (looking north)

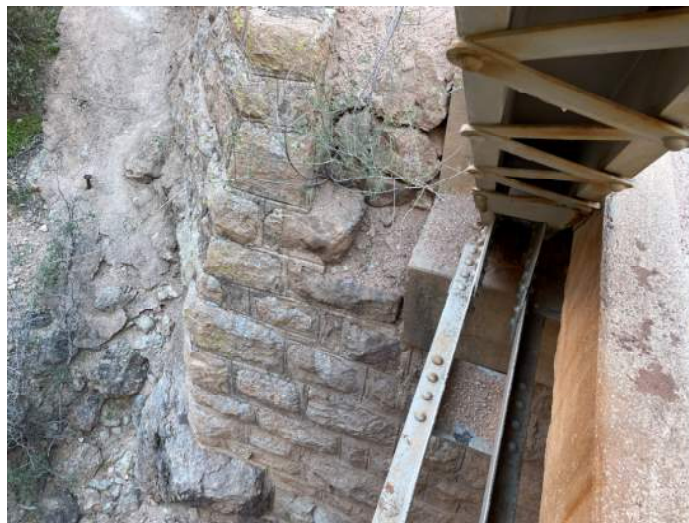
As-built plans were not available for any of the three single-lane, single-span bridges located within the project limits. The bridge, which crosses Fish Creek Canyon at approximate MP 223.6, appears to be supported directly on intact rock at the west abutment. The east abutment appears to be supported on a stacked block/mortar system which extends up from intact rock several feet. The overall foundation system appears to be in good condition. Photograph No. 6 shows the north corner of the east bridge abutment.

Photograph No. 6 – Northeast corner of Fish Creek Hill Bridge, East Abutment at MP 223.6 (looking east)

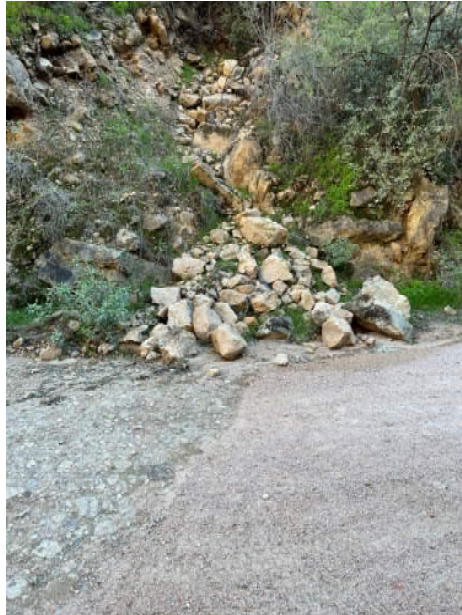
SR 88 follows the east bank of Fish Creek from the bridge to about MP 224.3. This relatively flat section of road sits several feet above the adjacent creek bed. Though some damage was noted along the roadways outboard slope more significant damage in the form of debris flows are apparent along the east side of the road from uphill water induced erosion. Much of the uphill slope within this stretch consists of highly fractured rock, colluvium and rockfall debris. These loosely held materials, when inundated with water, dislodge and collect as rock and soil debris within the natural drainages. At least four debris flows were observed which required some earthmoving by ADOT Maintenance to make the road passible to the bridge. Photograph No. 7 shows one of the partially removed debris flows.

Photograph No. 7 – Rock debris within drainage at MP 223.9 (looking south)

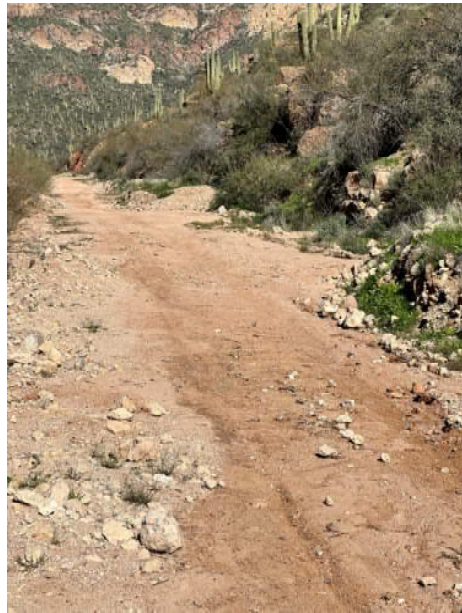
Photograph No. 8 – Series of debris flows adjacent to road at MP 223.9 (looking south)

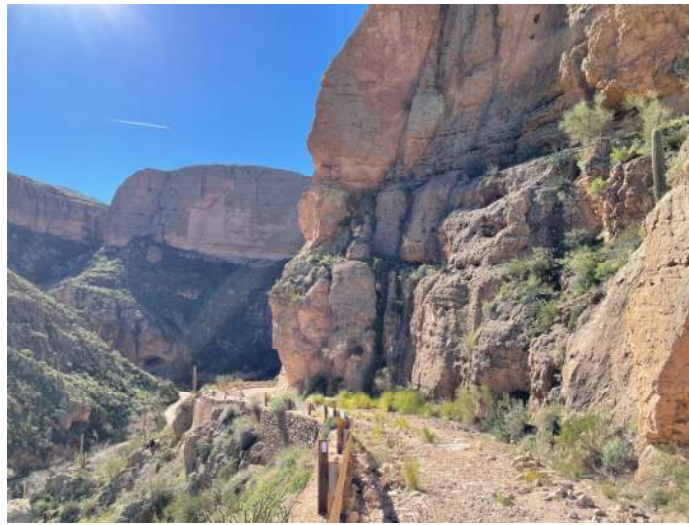
The most significant cost impact to the project will be the determination of a final roadway width. In localized areas, the existing road is less than 20 feet in width. Creating extra width in areas west of Fish Creek Hill Bridge will have significant cost impacts to widen either to the cut or fill sides of the road. Photograph No. 9 shows an existing rock face where the existing road measures close to 15 feet. Though these instances are localized generally to bends in the road, consideration of whether to widen to the cut or fill side (or both) will have large cost and visual impacts.

Photograph No. 9 – Narrow Road at base of cliff at approximate MP 223 (looking south)
