**MEMORANDUM**

RE: Site Review for Central District

Location: SR101L (Agua Fria) x McDowell Road Structure S-E/W

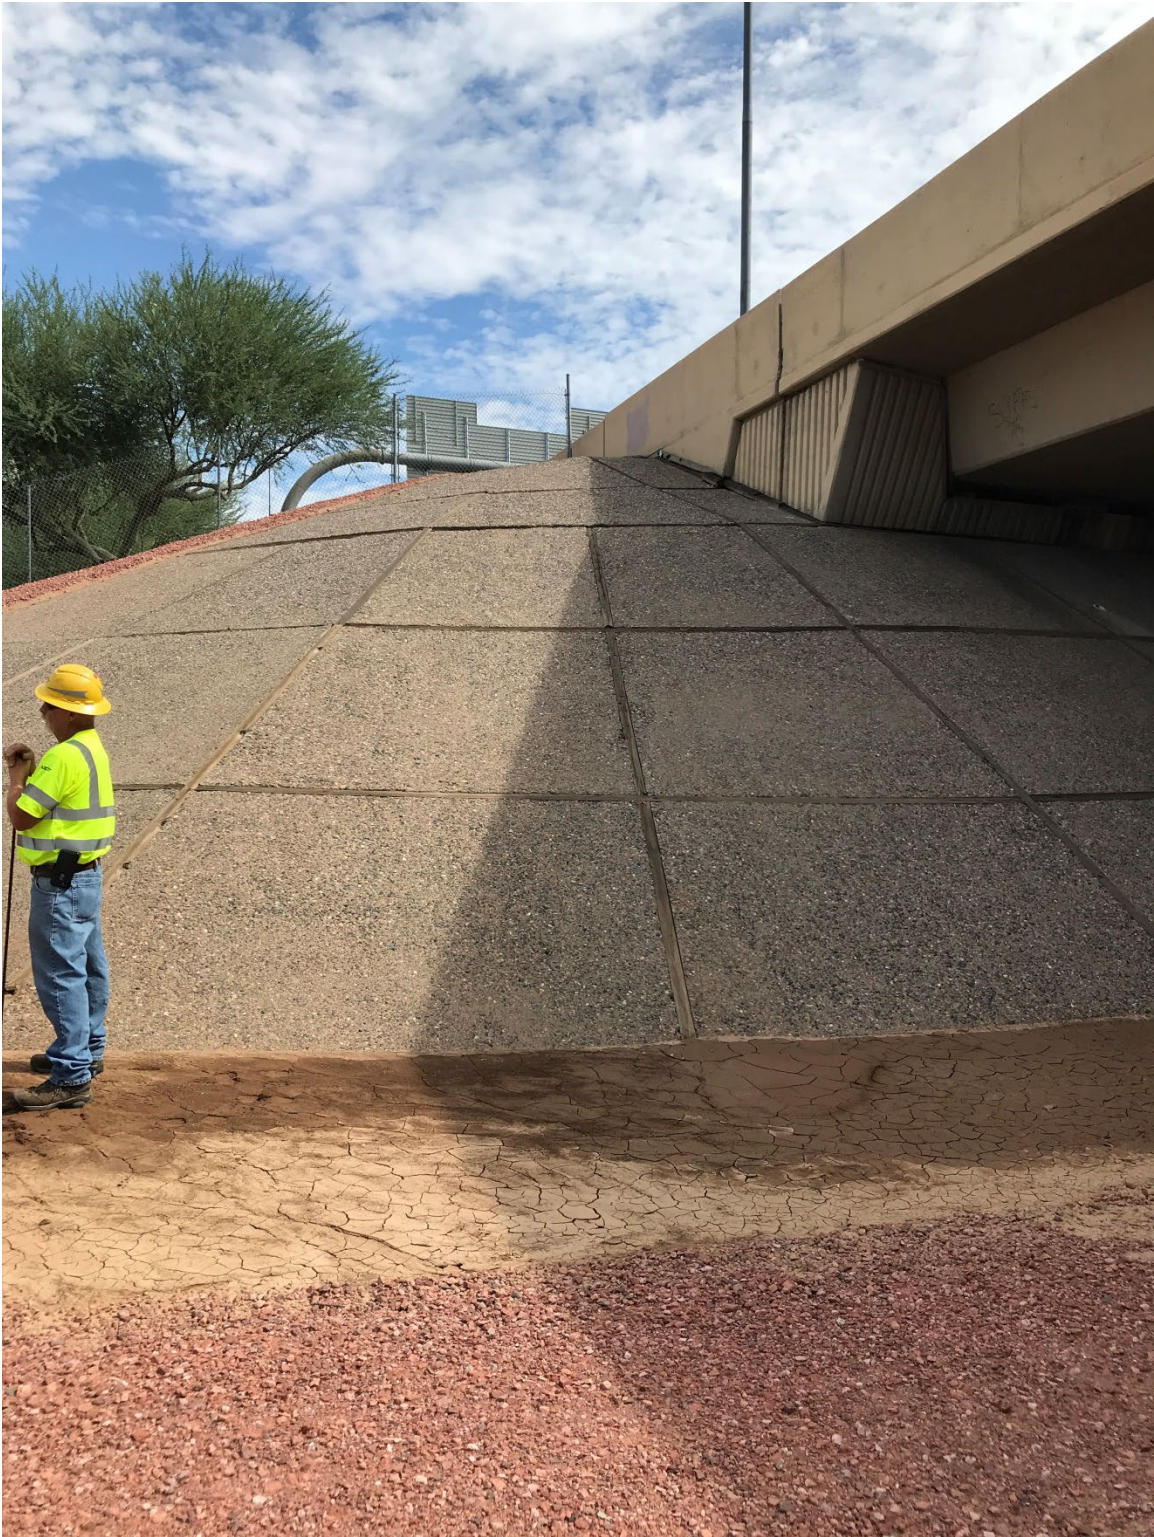
**Figure 2**

On August 25, 2022, representatives from the Central District and Bridge Group met on site to perform an inspection. (See list of participants above). As reported by the District, there was considerable evidence of excessive erosion including accumulation of soil at the base on the slope paving (See Figure 2), as well as voids under the slope paving as detected by sounding at the concrete surface (i.e. chaining). Settlement of the slope paving was also noted by observing the paint line at the interface between the abutment and the slope paving (See Figure 3). This condition was also observed at adjacent bridge abutments and is likely due to poor compaction of the slope paving subgrade during construction. However, it is also likely that the erosion problem at this specific location has exacerbated the extent of the voids. During the inspection, the District noted that in the recent past two or more 10-wheel dump trucks of eroded soil material had been removed from the toe of the slope paving. They also reported that two mixer truck loads (presumably about 20 cubic yards) of slurry had been placed in a void at the very top of the slope paving adjacent to the abutment wing wall. Despite these efforts, the erosion

appears to have continued as evidenced by the continued deposition of the fine grained soil at the toe of the northwest corner of the slope paving.

Soil accumulation at the base of the slope paving

Given the void depth where the slope paving meets the wing wall, it is also recommended that lean grout be used to fill this area. This repair should occur after the approach area repair has been completed and the grout has reached initial set. Otherwise, grout from the approach area could flow out of the hole created to pump grout under the slope paving.

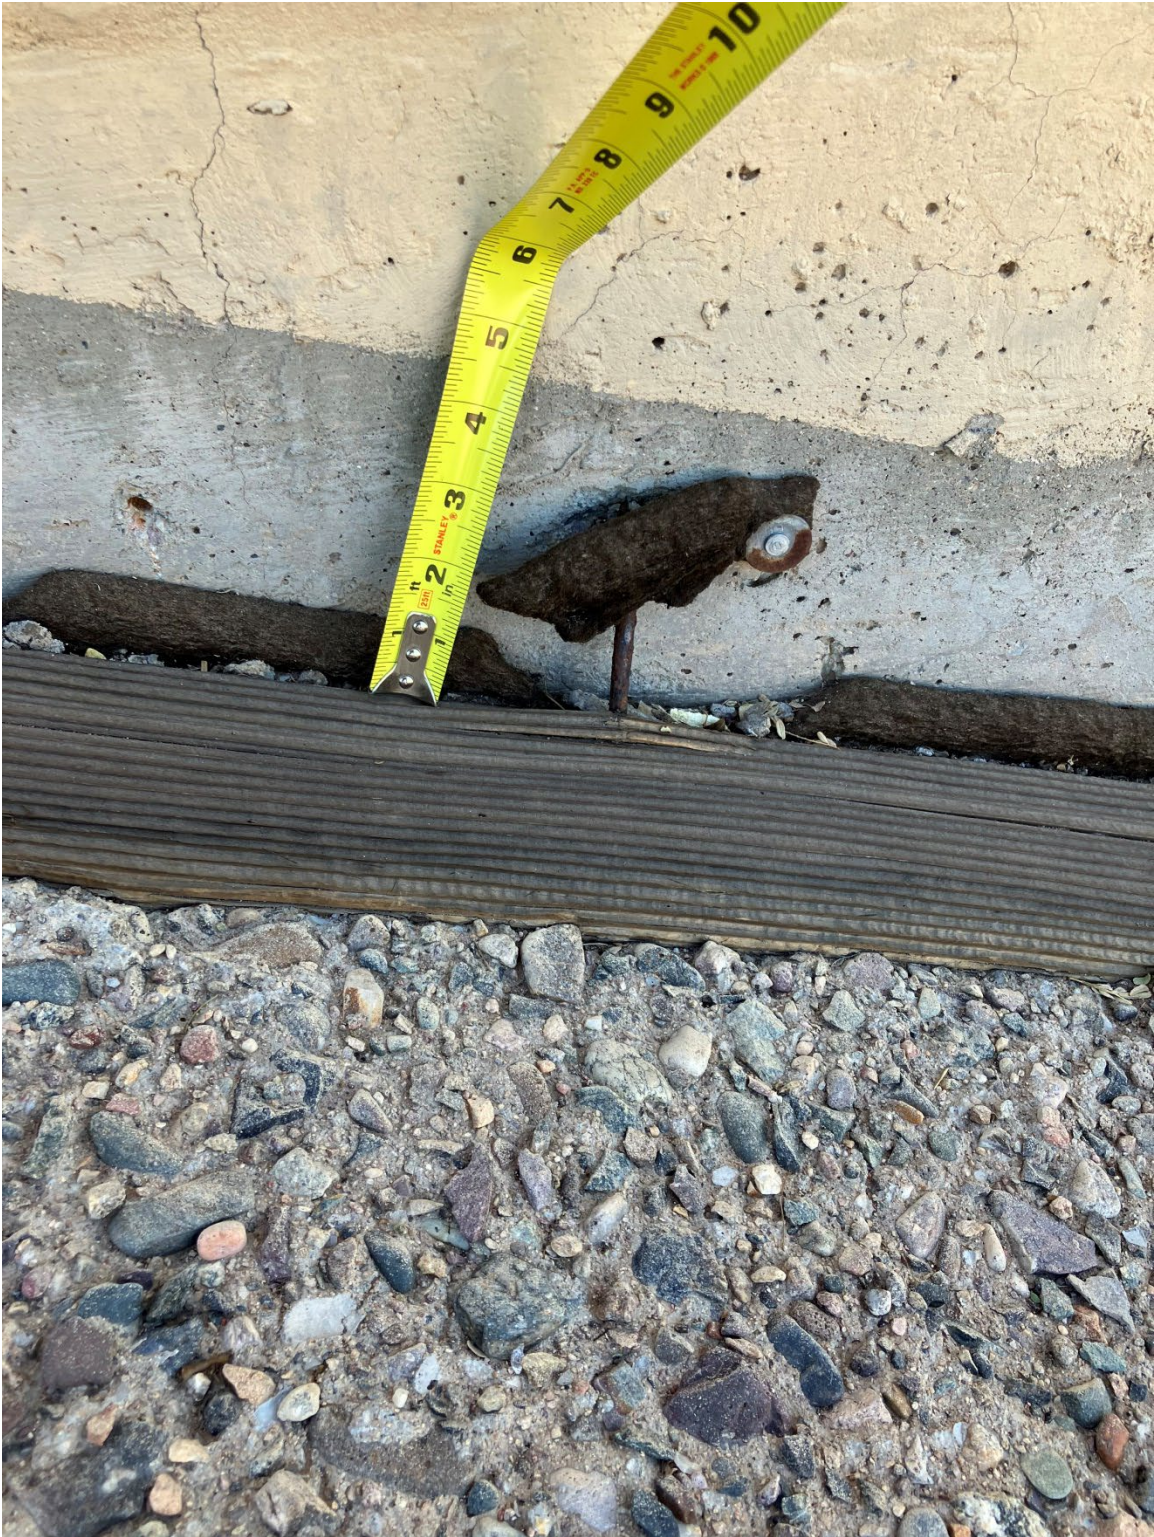
**Figure 3**

Settlement of slope paving adjacent to wing wall

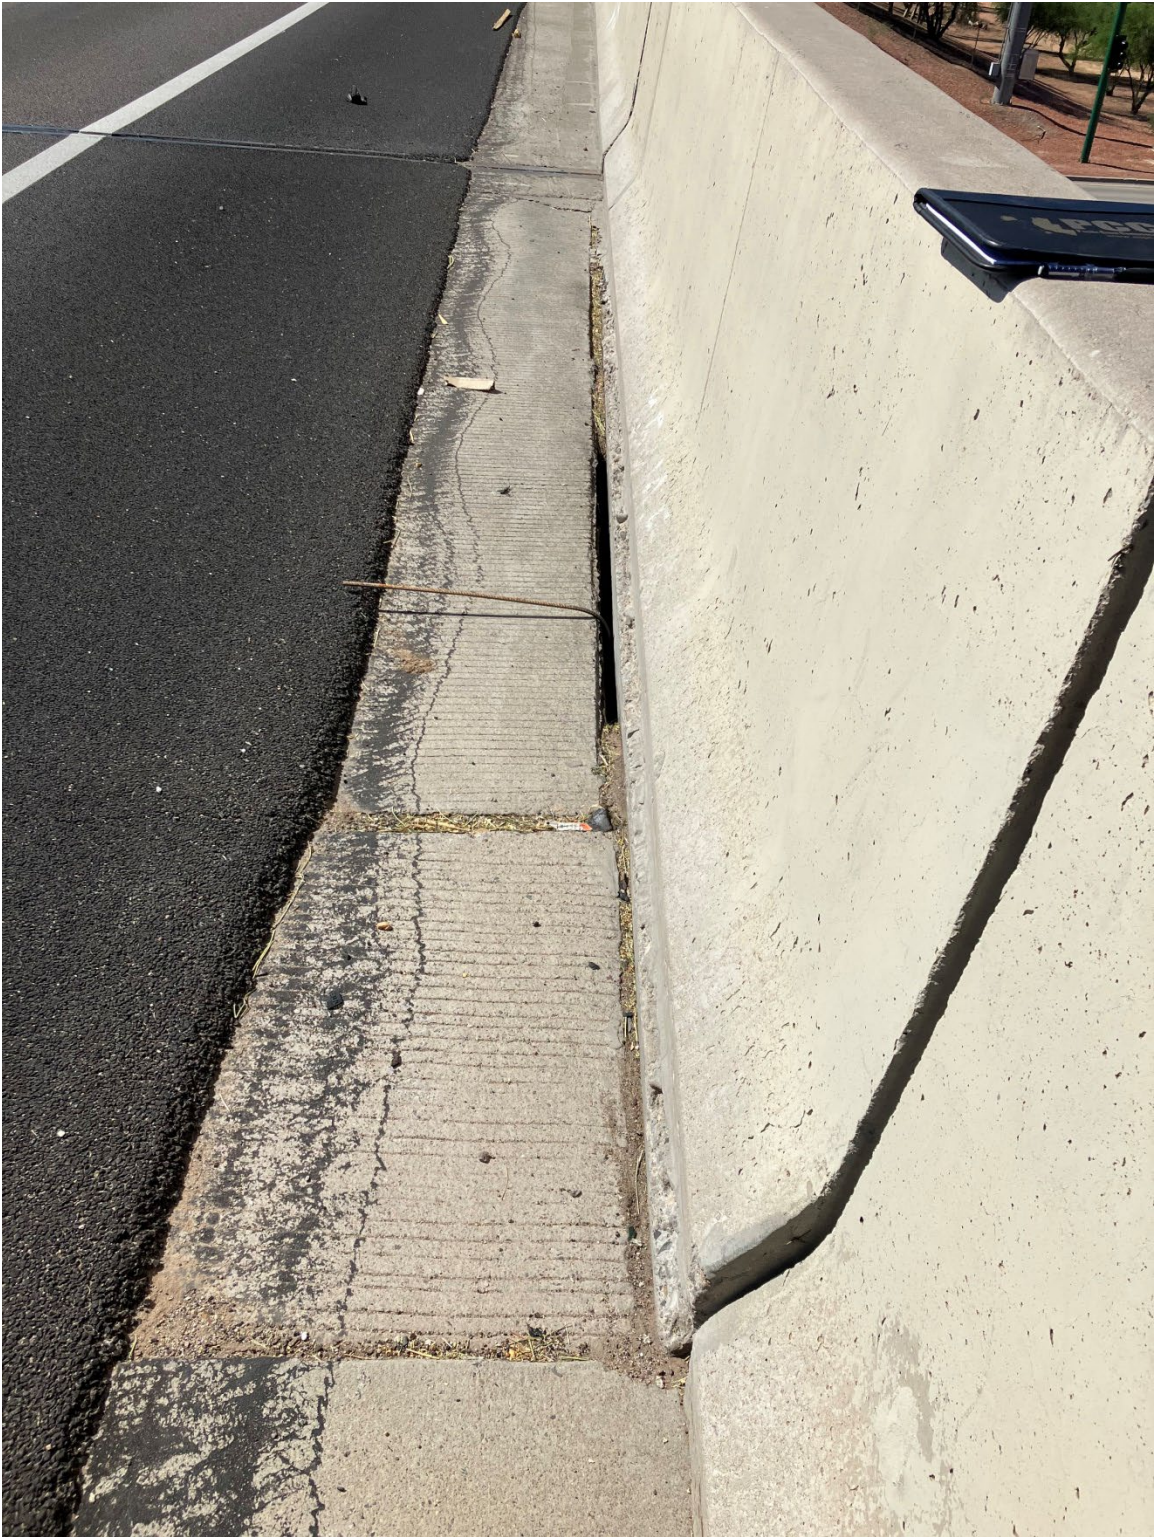
**Figure 4**

As reported by the District, a significant gap does exist between the approach slab and the approach barrier at the northwest corner of the structure (See Figure 4). This appears to be where water is entering the abutment area. However, at this point it is unclear how the water could be migrating from the roadway side of the approach to the outside of the wing wall. A 4.5 foot long piece of rebar was made available by the District which was placed down into the gap between the approach slab and the inside of the barrier wall without reaching the bottom of the void.

The gap between the approach slab and the approach barrier measures 1-1/8 to 1-1/4 inches wide, by about 4.5 feet long. The gap begins approximately 16 inches south of the joint between the approach slab and the anchor slab and extends to the south (see Figure 4). Using a metal tape measure, the bottom of the void near the inside of the wing wall is estimated to be 11 feet below the top of pavement. Using the rebar feeler gauge, the void at a depth of 6 feet below the top of pavement is at least 3 feet wide towards the north end of the gap, as well as in a northerly direction towards the sleeper slab (See Figure 7). It should be noted that the sleeper slab runs below and supports the approach slab and anchor slab where they meet. At a depth of about 6 feet, the void is between 2 and 3 feet wide towards the south end of the gap.

Given the likely extent of the void as estimated with the rebar feeler gauge, as well as the location of the gap between the approach slab and the approach barrier, it is likely that some of the soil beneath the sleeper slab has eroded away. This is a significant concern that needs to be addressed as soon as possible. The voids and erosion beneath the slope paving is a secondary concern but not as problematic as the void under the approach.

Gap between the approach slab and wing wall/approach barrier

In order to provide stable support for the roadway and structural elements at the northwest corner of the bridge, it is recommended that grout be pumped into the void space beneath the approach slab. This could be accomplished by drilling or coring a hole in the approach slab near the gap where water enters the fill, and pumping grout from that location. Grout should be lean (one or two sack), flowable (high slump), and have a maximum aggregate size of 3/8-inch. The top of grout should be placed no higher than the bottom of the approach slab to avoid filling the existing expansion joint between the approach slab and approach barrier. Following the grouting operation, the gap (joint) between the approach slab and approach barrier should be filled/sealed with a polymerized bituminous, or asphalt rubber, joint filler. It is imperative that the gap be filled or sealed to prevent water from entering the abutment backfill area in the future.

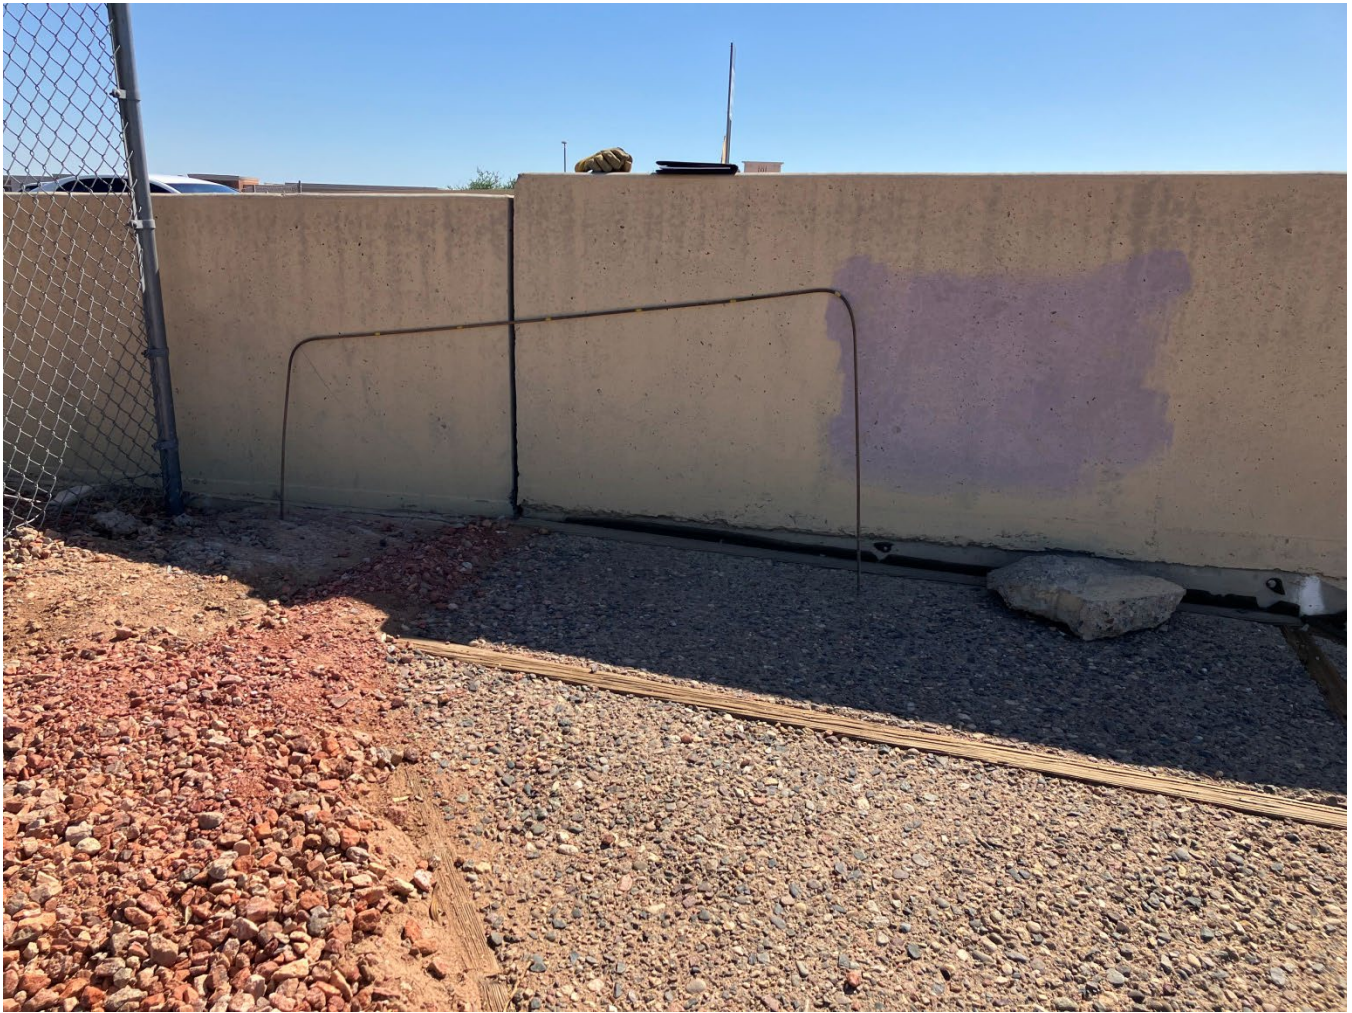
**Figure 6**

“U” shaped rebar feeler gauge leaning against the barrier wall

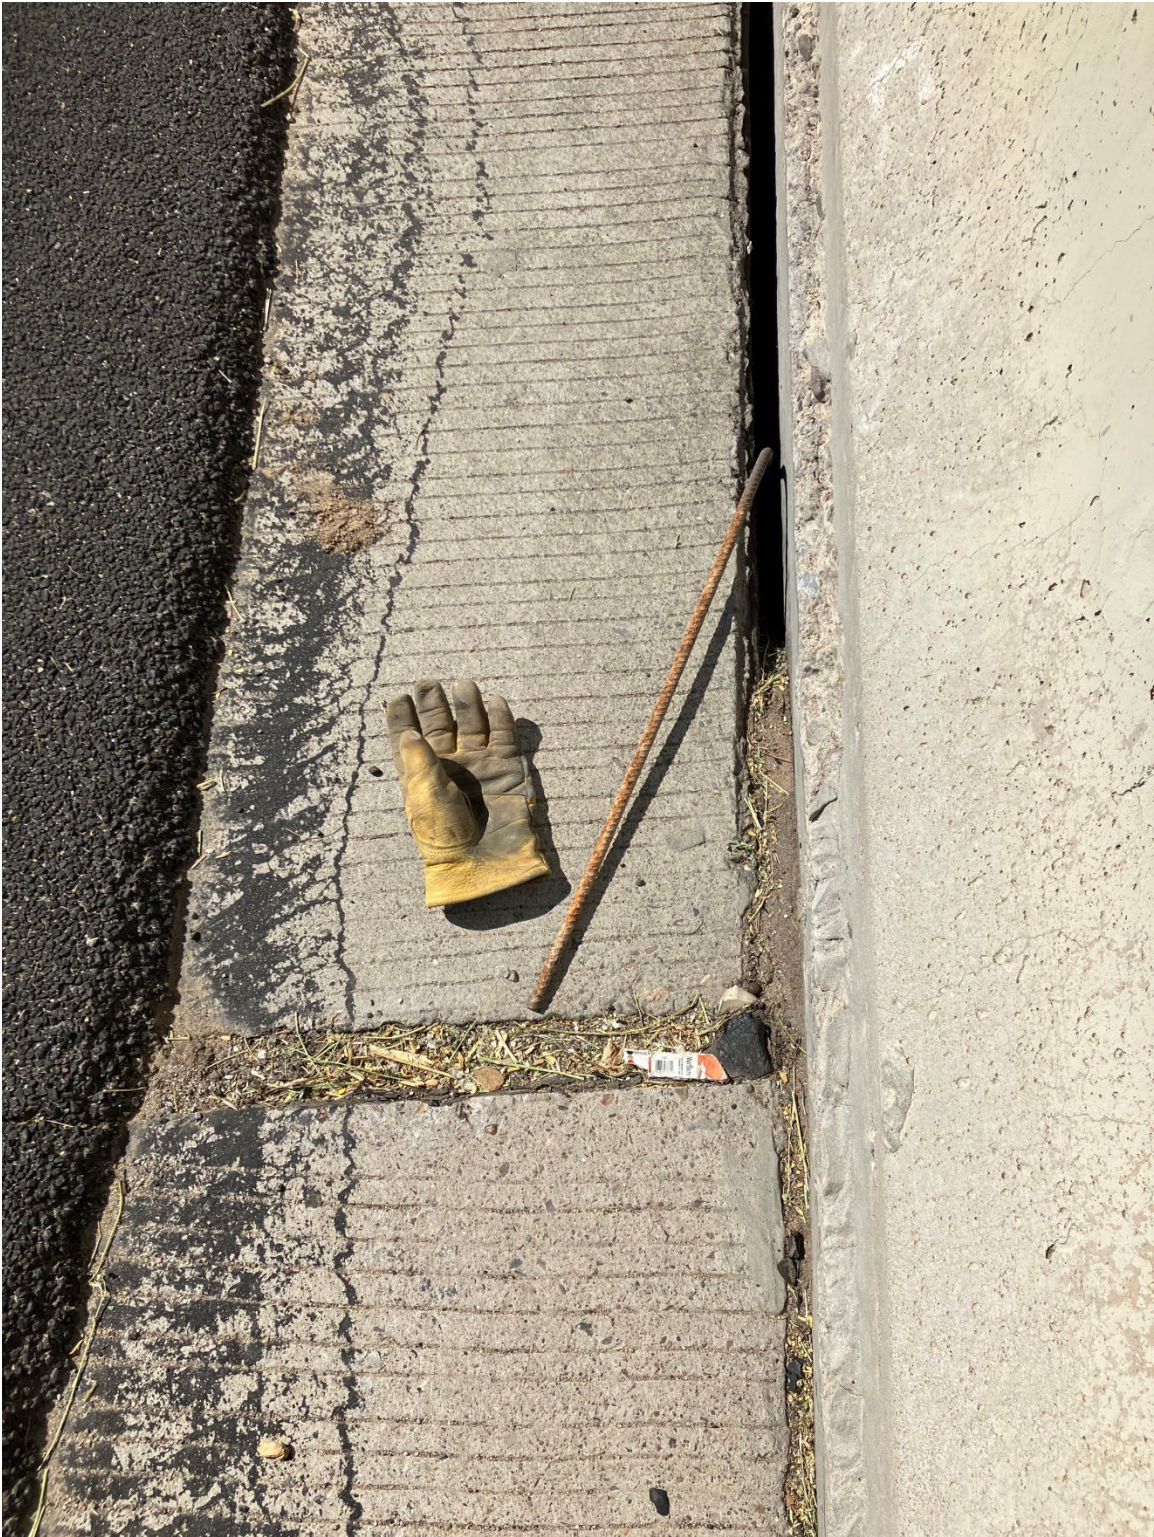
**Figure 7**

“U” shaped rebar inserted into the north end of the gap. Note that the 2 foot leg is laying on the surface of the approach slab. The 3 foot leg is 6 feet below the slab within the void.

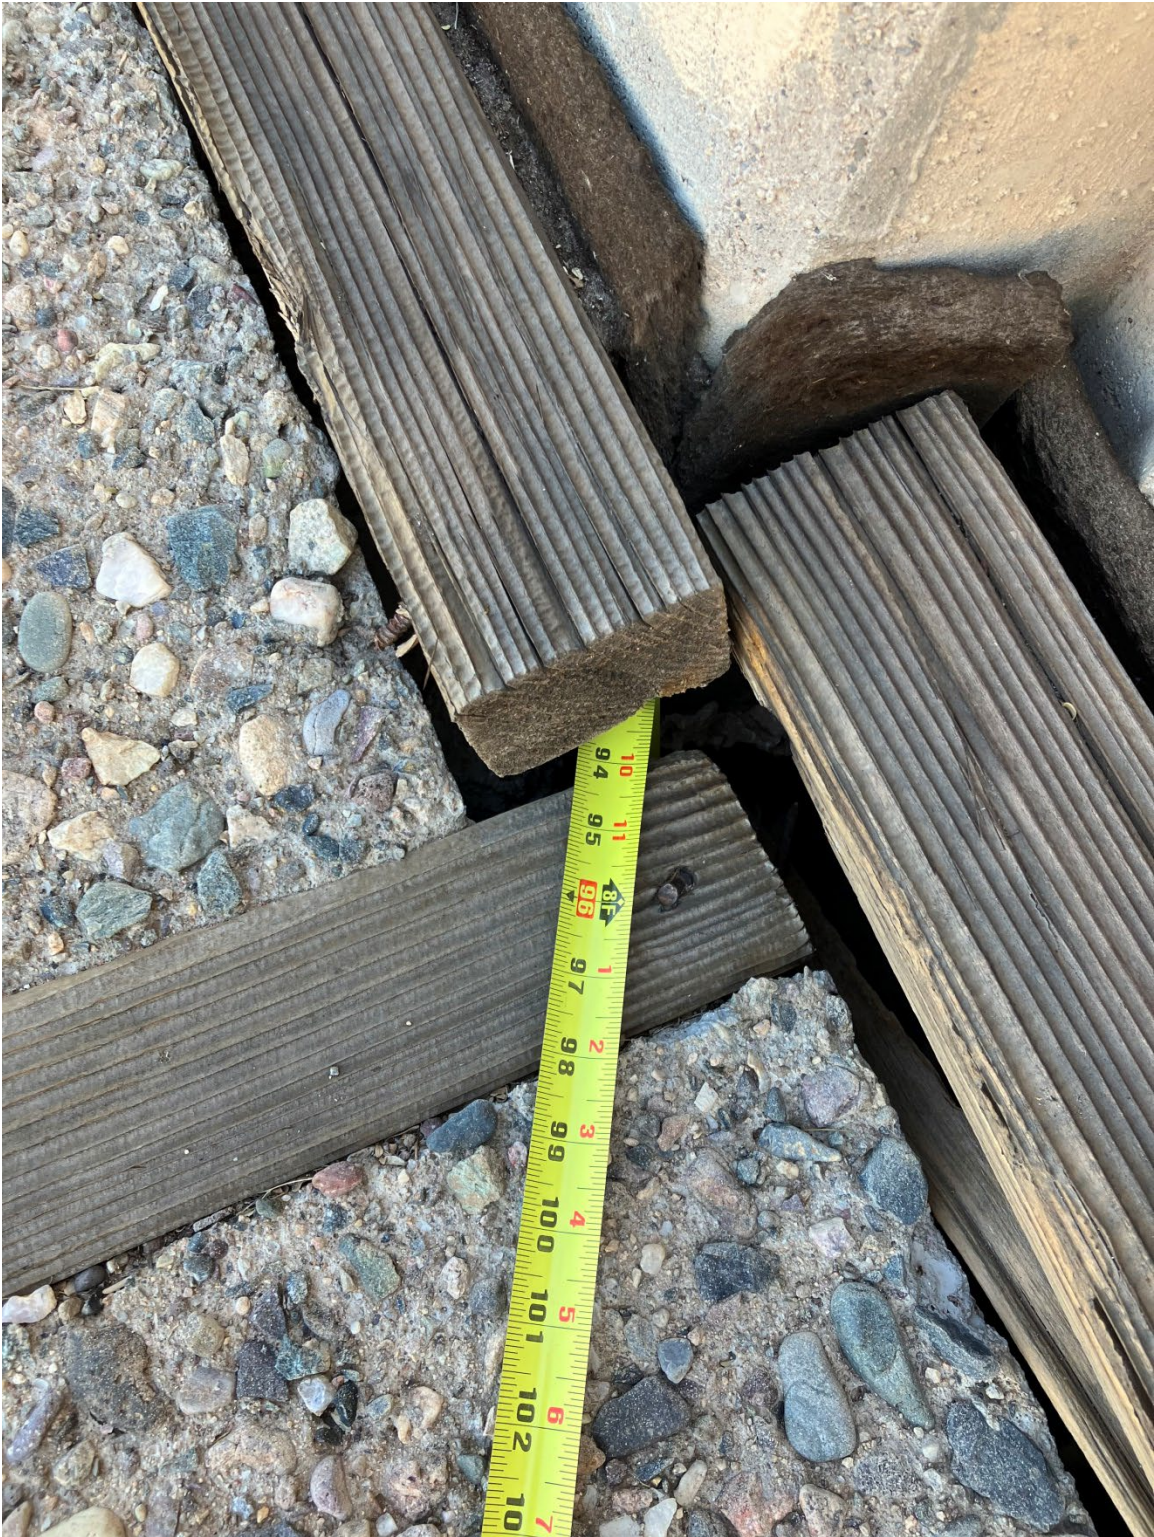
**Figure 8**

Along the outside of the wing wall, a metal tape measure was used to estimate the depth of void (see Figure 8). At this location, the void appears to extend to a depth of about 8 feet below the surface of the slope paving. This is not surprising given the observed depth of the bottom of the void on the inside of the wing wall being about 11 feet below the pavement surface.

Depth of void measures approximately 8 feet where the slope paving meets the wing wall
