ROADWAY DISTRESS ASSESSMENT

LOOP 303 MAINLINE MP 135.7 AND MP 137.2

Arizona Department of Transportation

March 28, 2022

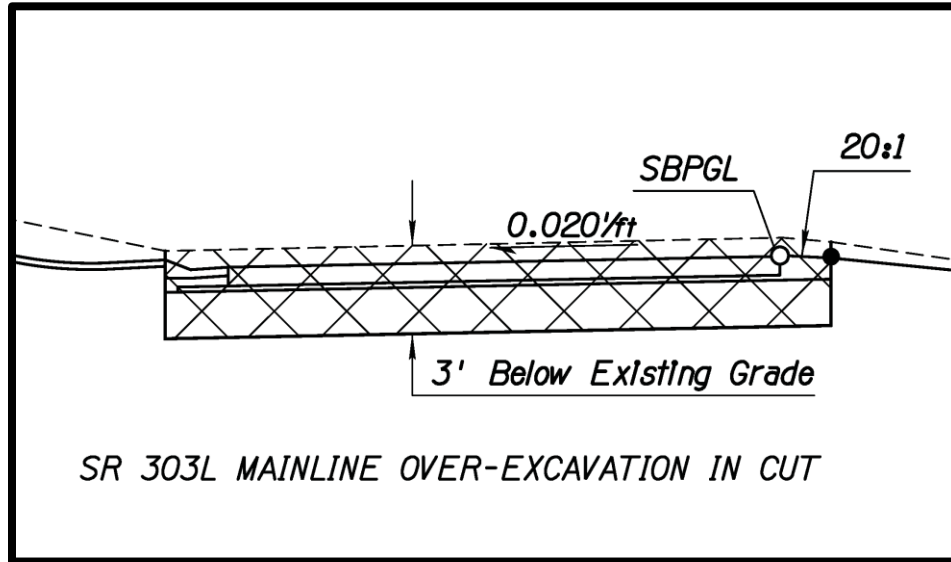
Figure 5 – Over-excavation in cut locations

Investigation at the distressed locations determined that the aggregate base and subgrade are saturated or nearly saturated beneath the pavement. Figure 5 above details the placement requirements beneath the pavement section. The placement of subgrade soils with higher permeability above the silt and clay floodplain soils in a “bath tub” configuration may be contributing to the level of saturation encountered in the AB and subgrade soils directly beneath the pavement.

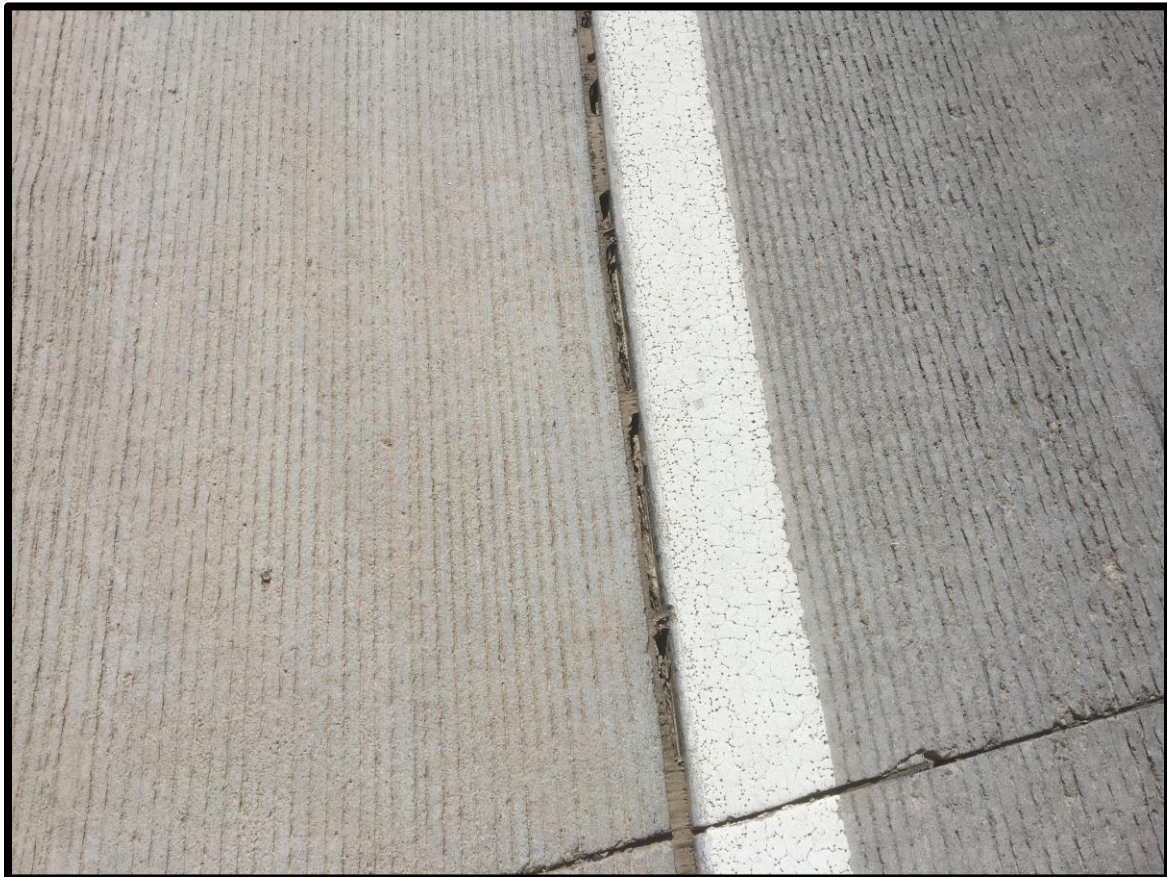
Figure 8 – Joint sealing and gapping

Joints were installed alternating at 13 ft, 15 ft and 17ft intervals. The longitudinal joint between the travel lane and shoulder was observed in the distressed locations to have large gaps up to ¾" in width and no tie bars. A high rate of moisture infiltration is believed to be occurring at all of the joints and is contributing to the periodic saturation in the AB and subgrade beneath the pavement.

Significant water is infiltrating the AB and subgrade beneath the PCCP. The joints were observed to be porous and do not provide a barrier to water infiltration. Saturation of the subgrade with loading from vehicles is likely producing lateral forces which have caused gapping of the longitudinal joint between the travel lane PCCP and shoulder.

Routing and sealing all joints based on ADOT standard 402PCCPR is recommended to decrease water infiltration into the AB and subgrade. The longitudinal joint between the travel lane PCCP and shoulder will benefit greatly with the installation of a backer rod and sealing.

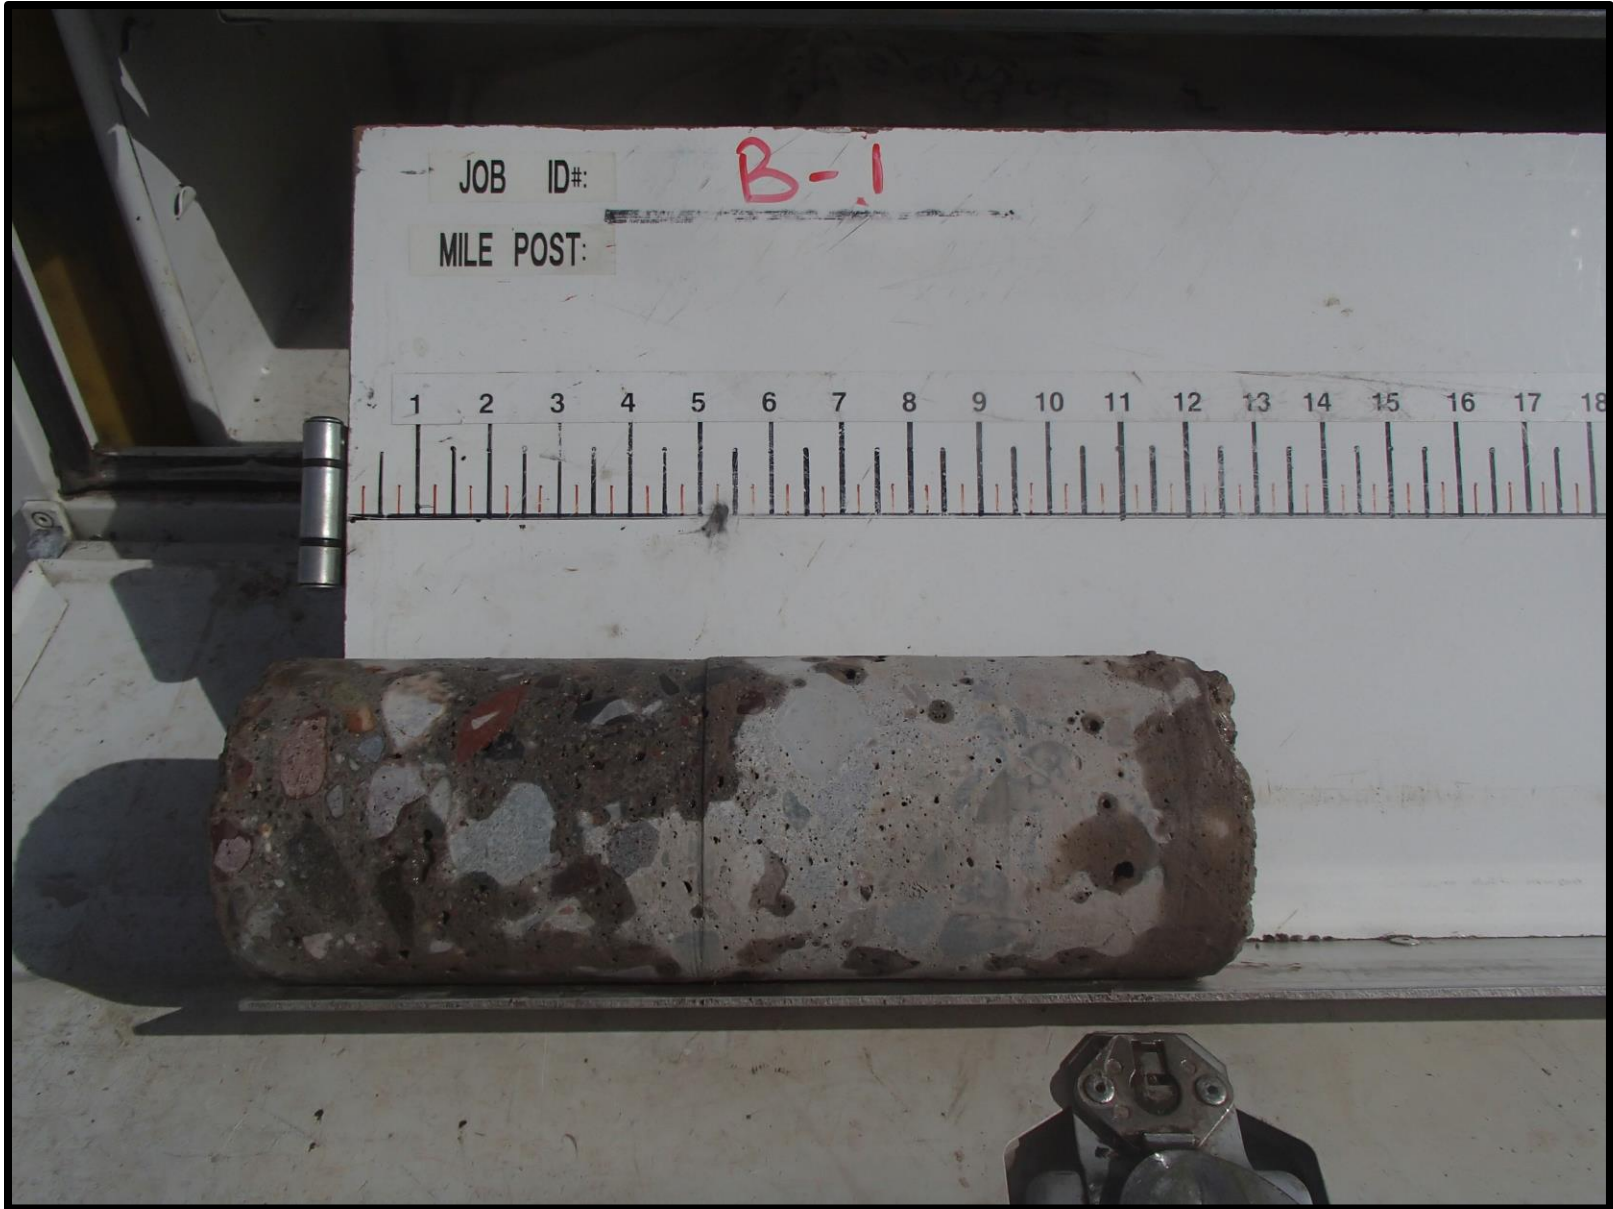
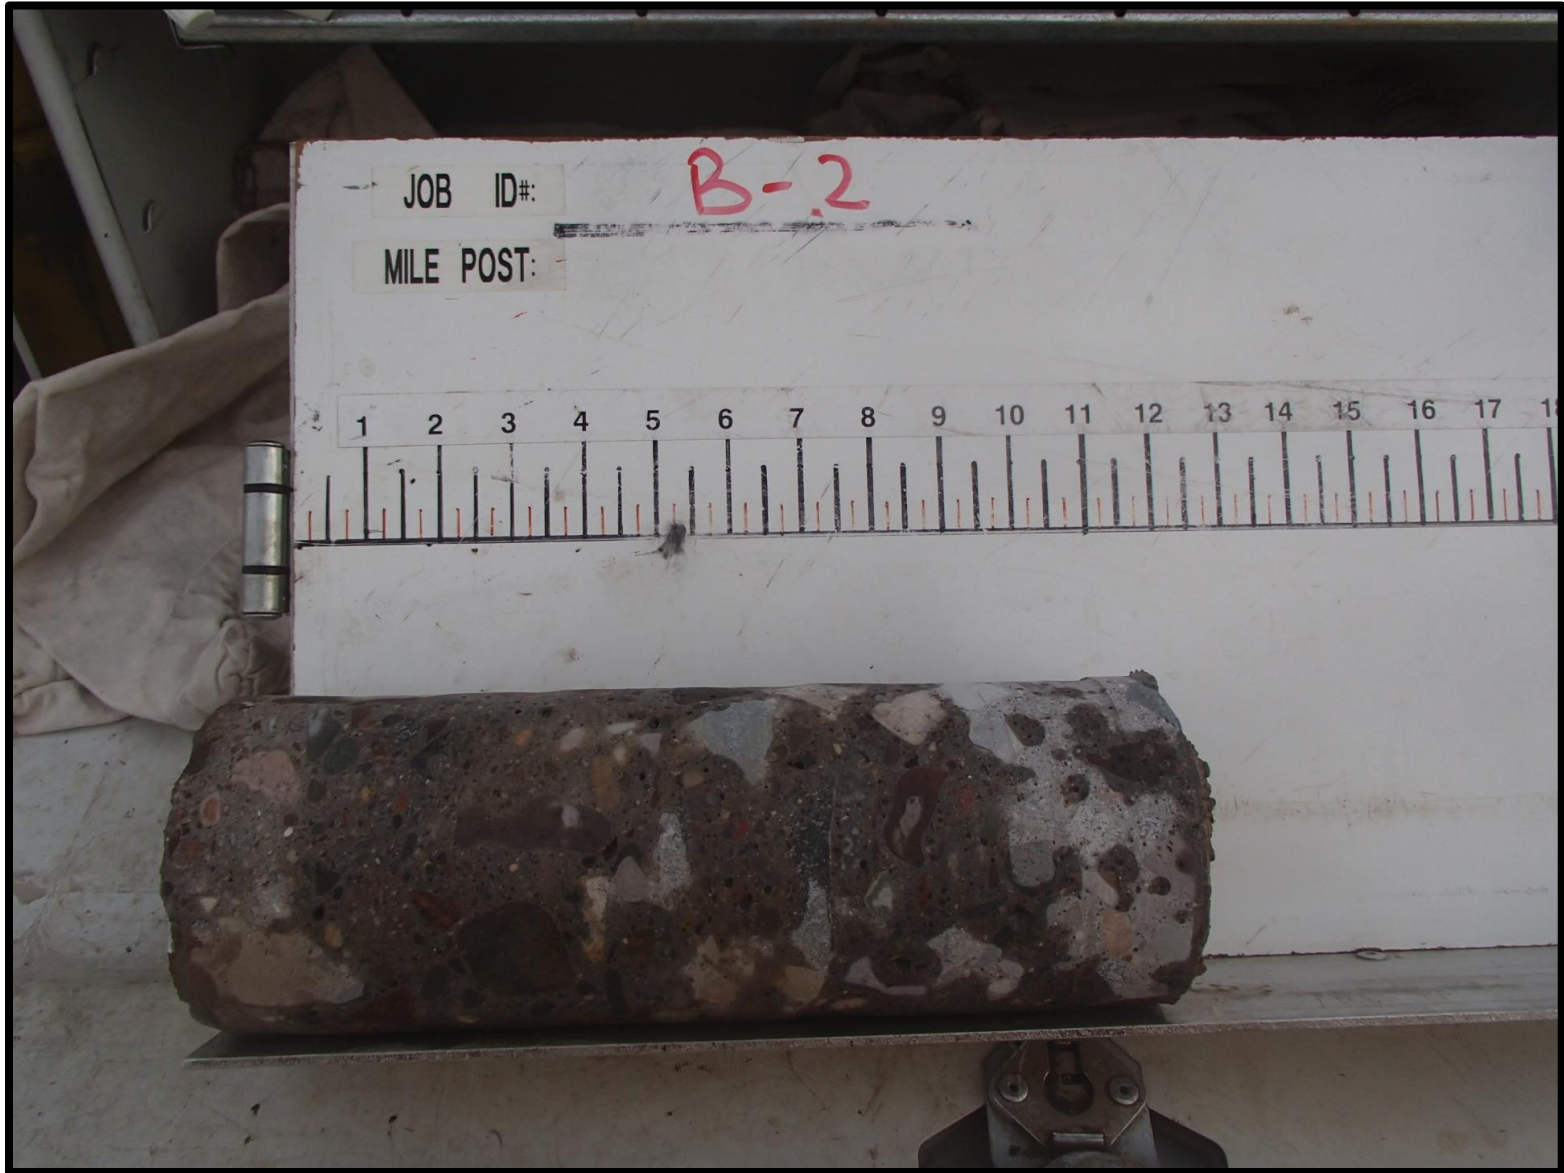
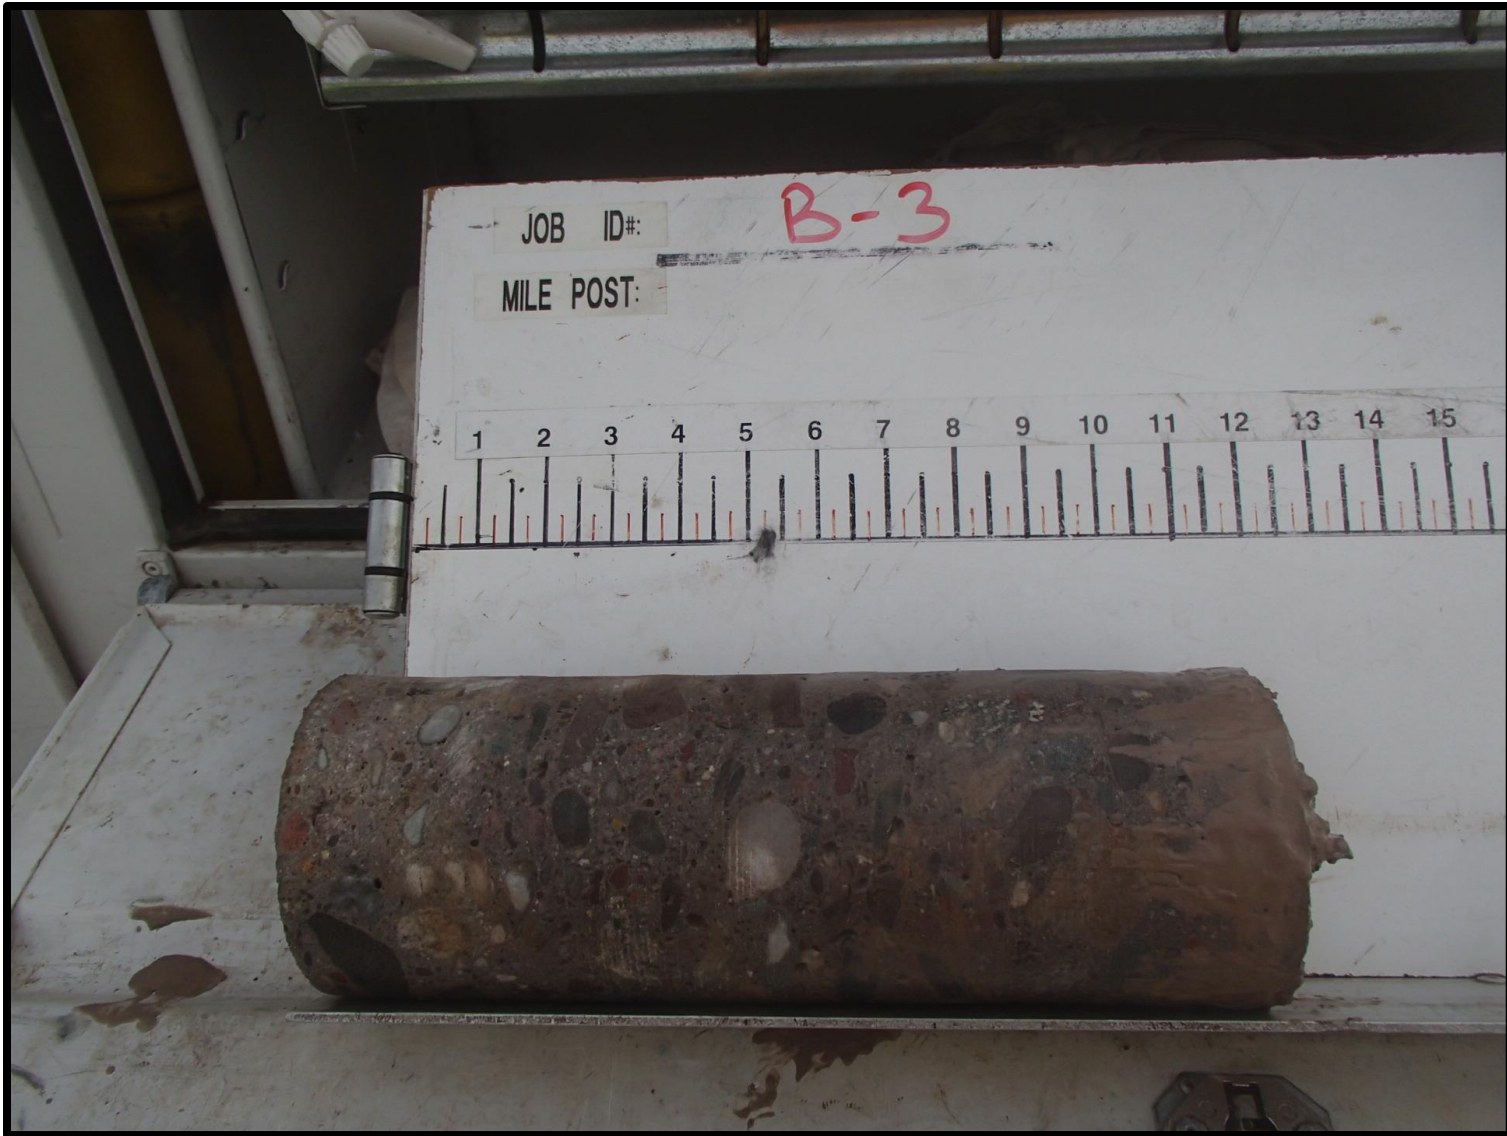
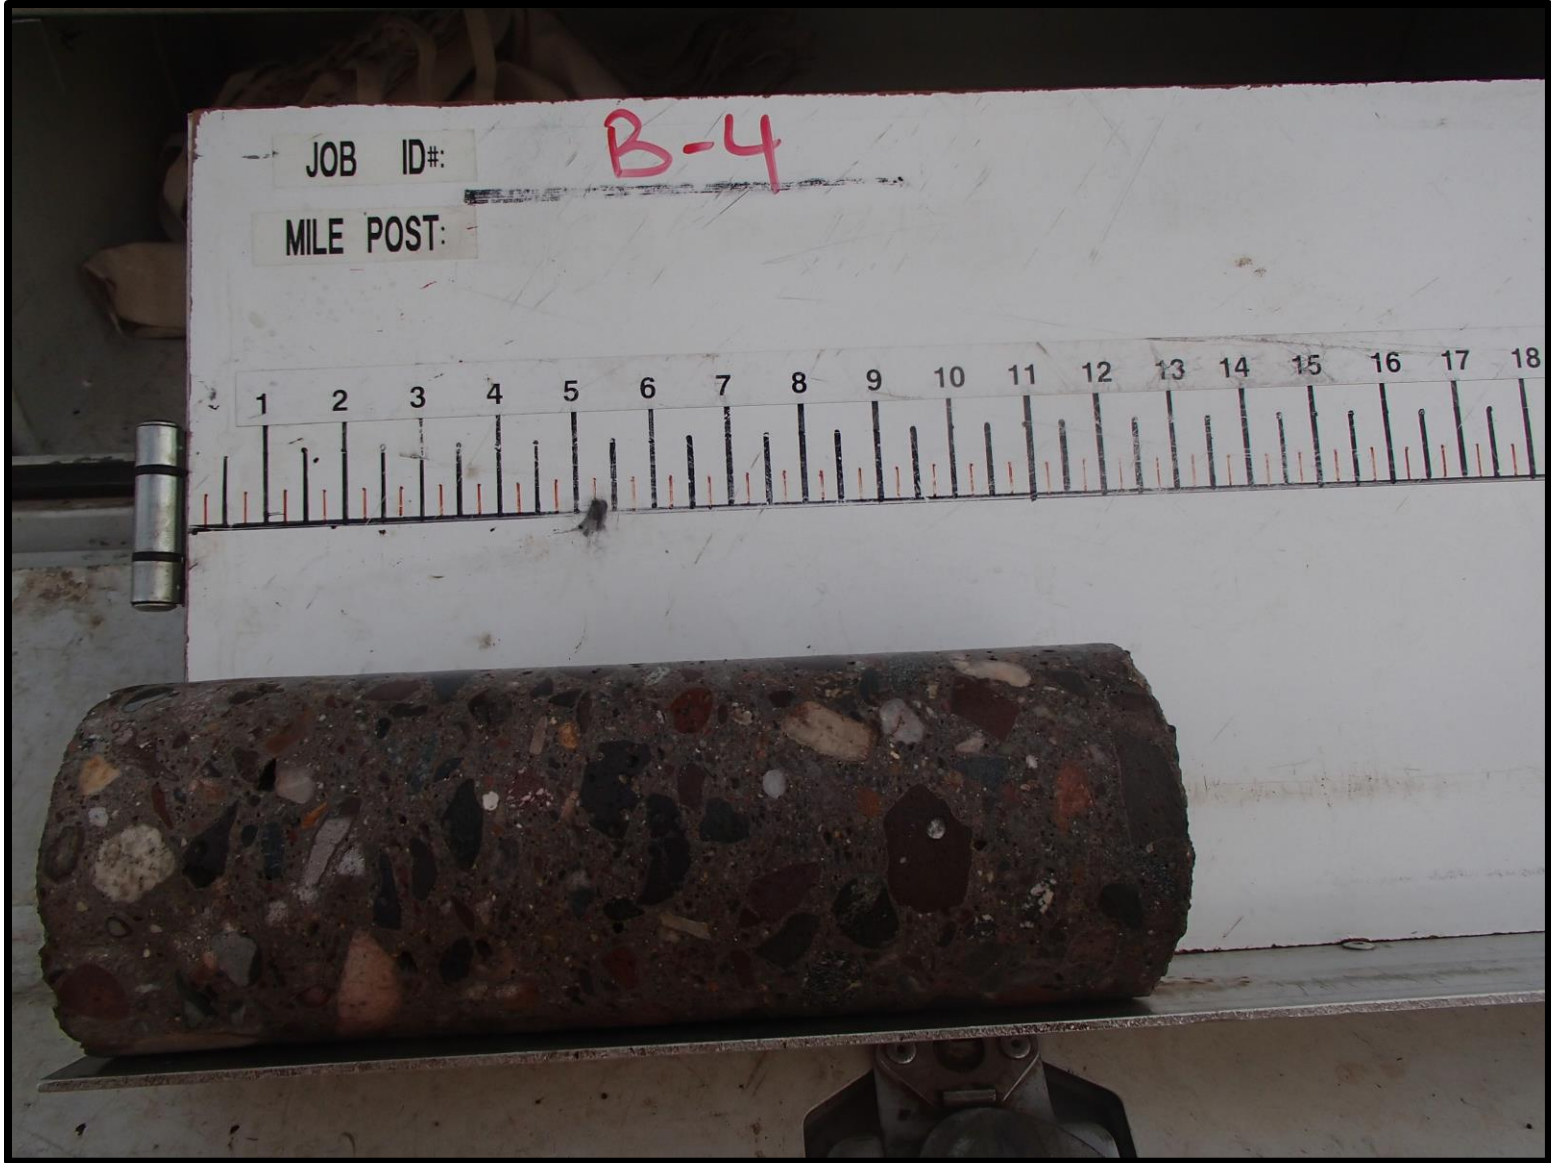
APPENDIX A
Concrete Core Photos

Test Number	Location (Southbound)	Length (Inches)	Unit Weight (PCF)	Design Compressive Strength (PSI)	Compressive Strength Test Result (PSI) (See Note)*
B1	2087+27	11.75	141.6	4000	7130
B2	2086+40	11.375	141.8	4000	6930
B3	2007+93	11.625	142.7	4000	7700
B4	2005+88	11.125	143.9	4000	6910

The investigation determined that the quality of the PCC in the distressed locations exceeds the design 28 day strength of 4000 psi. A review of the testing performed on the PCCP shows 65 lots with 5 sets of samples taken for each lot with tested conformance to design. The construction phase testing did not indicate any concrete that did not meet design strength. The testing process appears to conform to ADOT standards for scope.

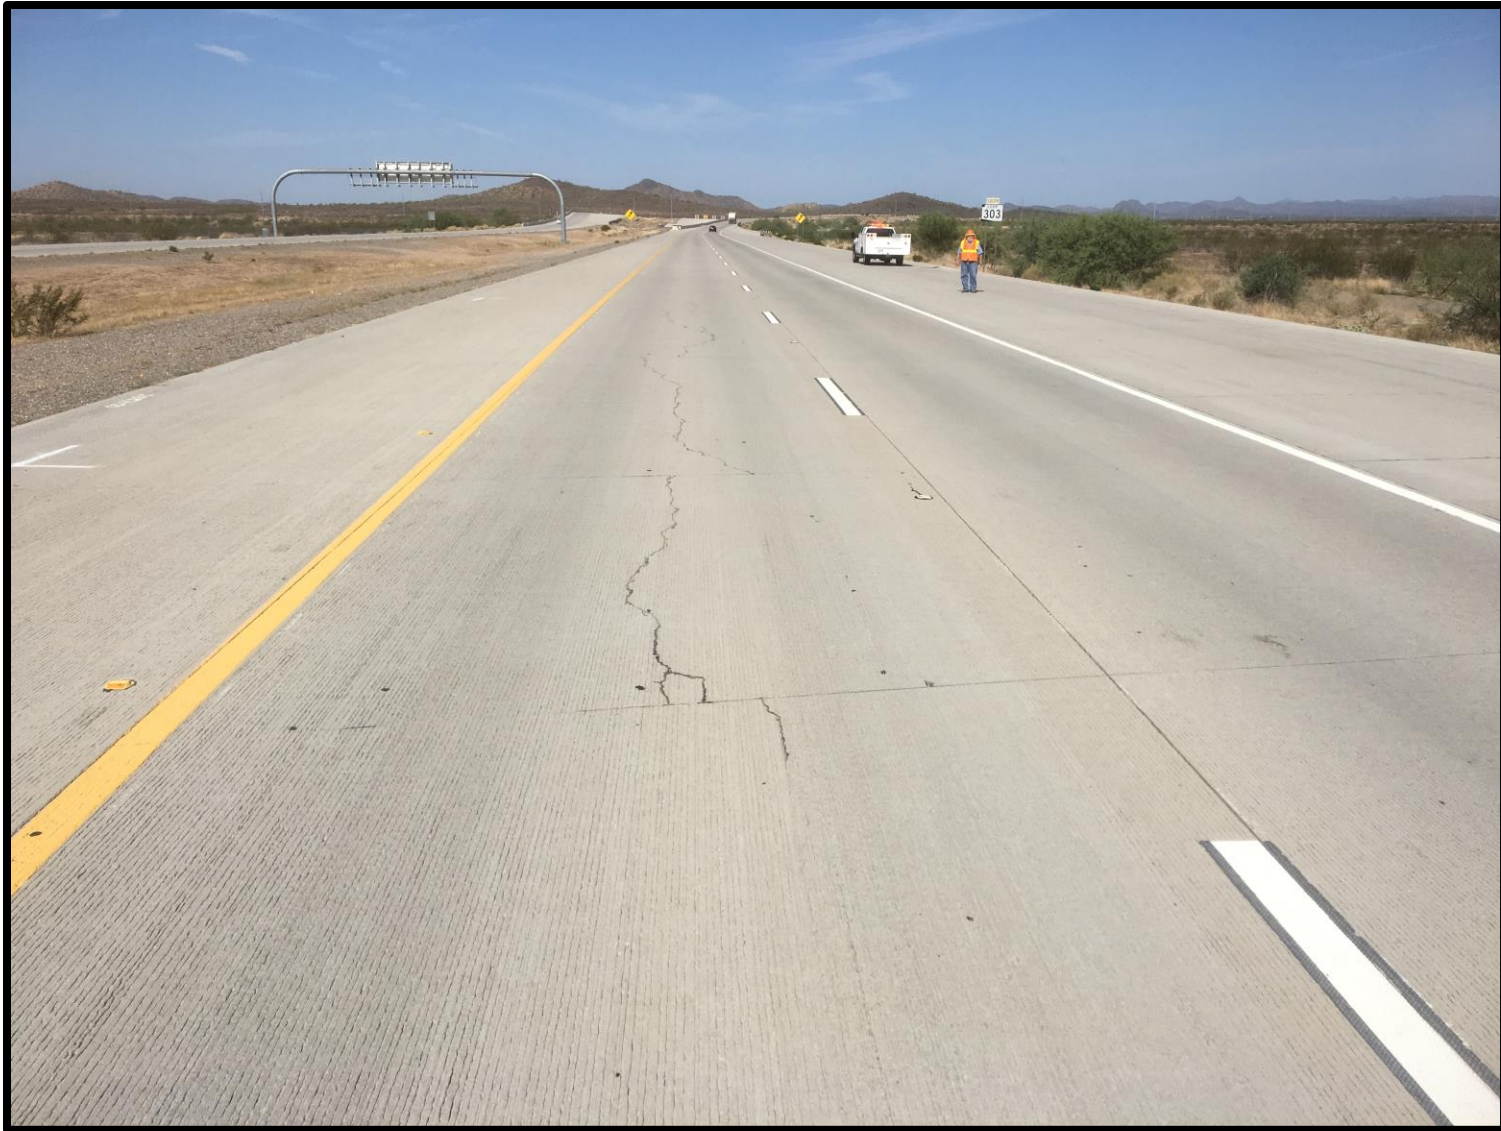
Loop 303 MP 137.2

APPENDIX B
Longitudinal Cracking Photos
