Outfalls inspected FY 2020

# Dry Weather Field Screening

## Site Report Form

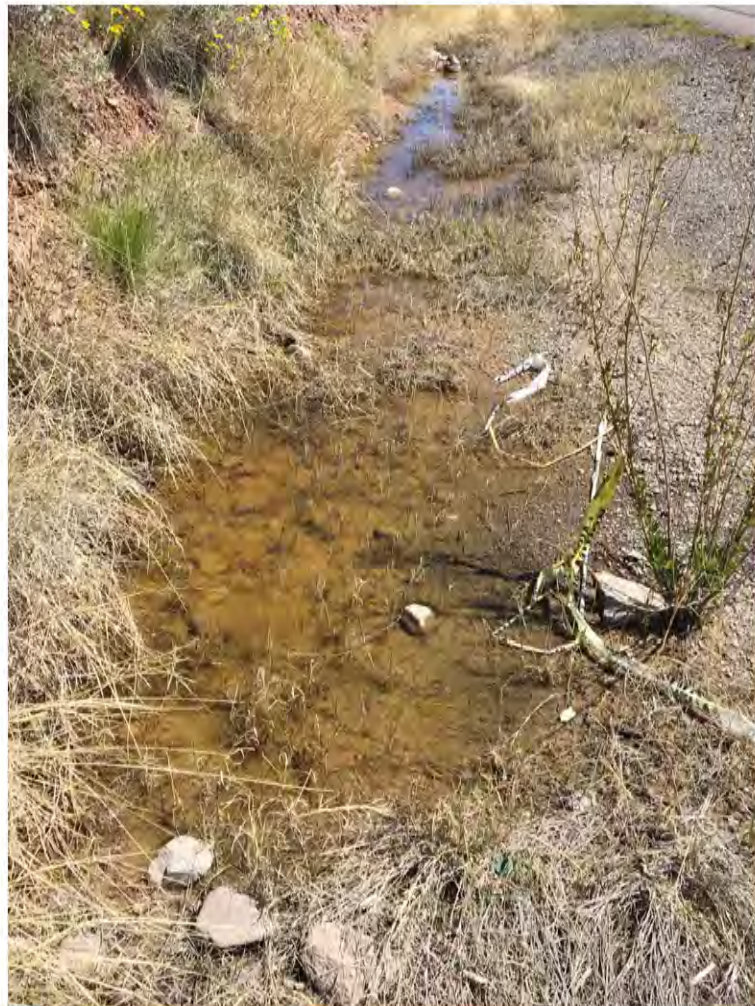
1006202

- ☐ Dry  
☒ Standing  
☐ Slow  
☐ Moderate  
☐ Fast

- ☐ None  
☒ Minimal  
☐ Normal  
☐ Excessive

Cut ditch drainage blocked by debris preventing flow

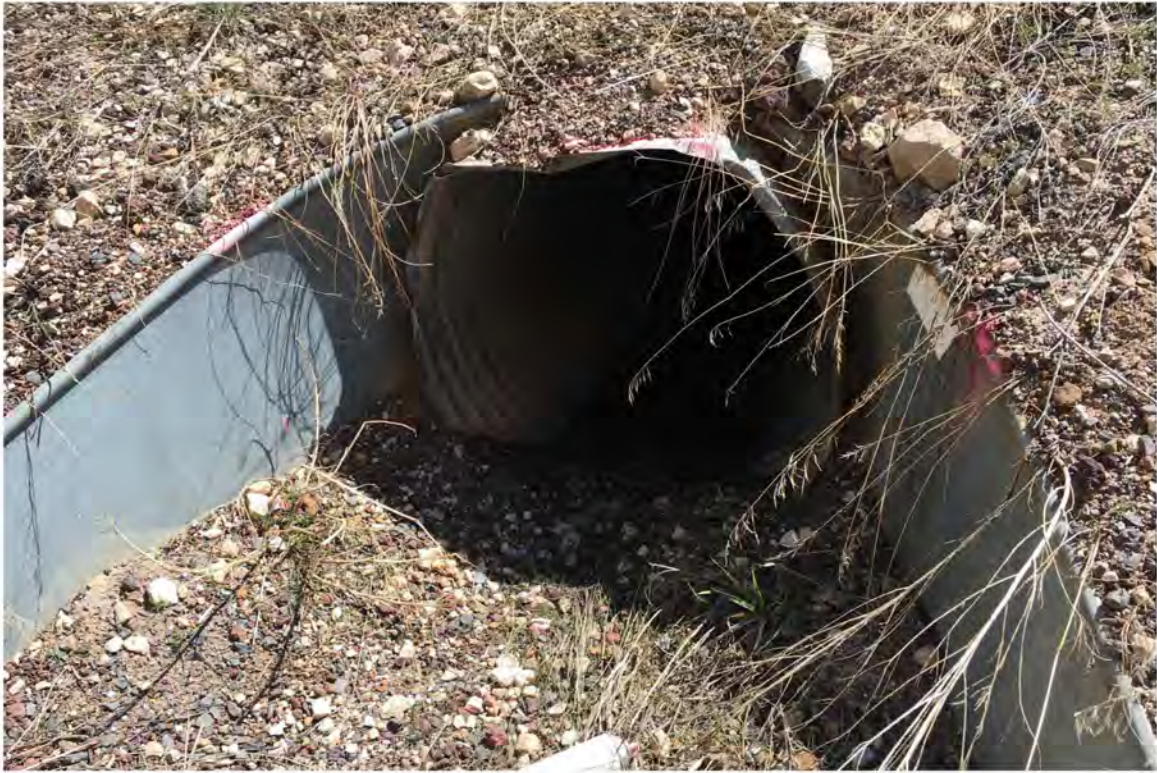
Photograph 1

Outfall 29  
I-17, MP339.85

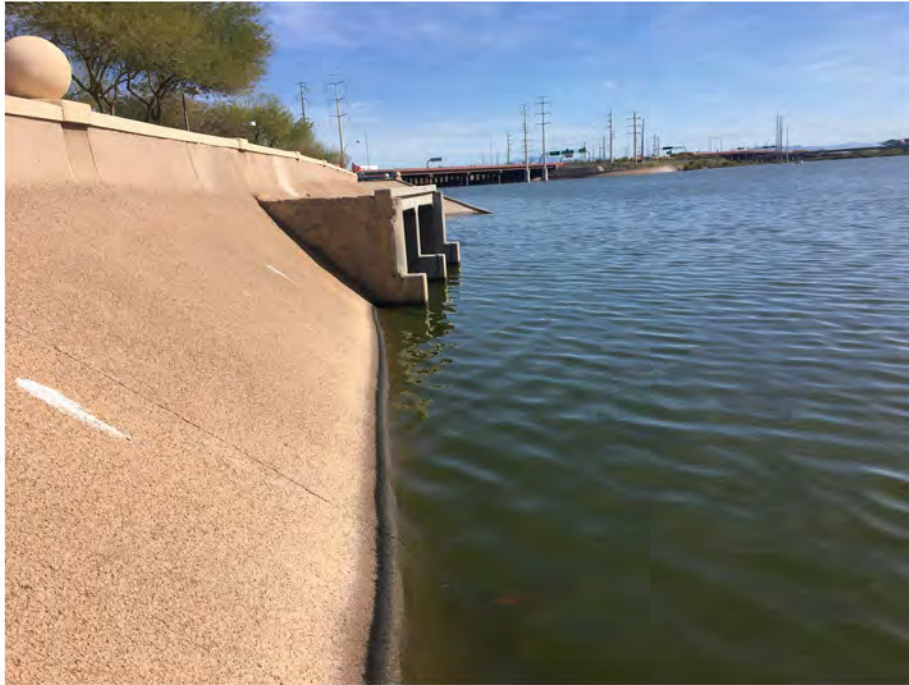
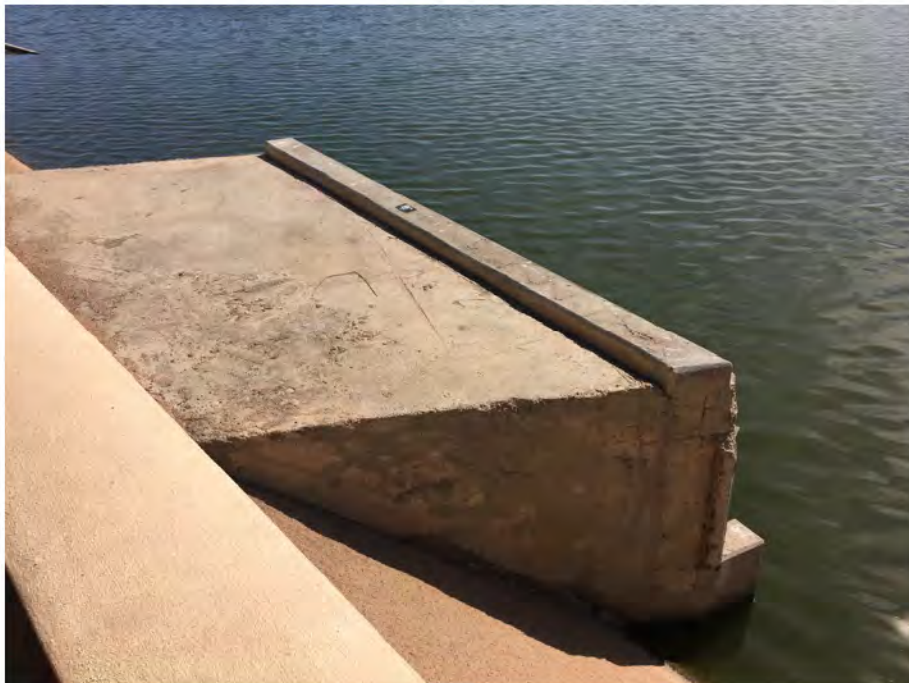
Outfall ID: 1512474

Outfall submerged in Tempe Town Lake

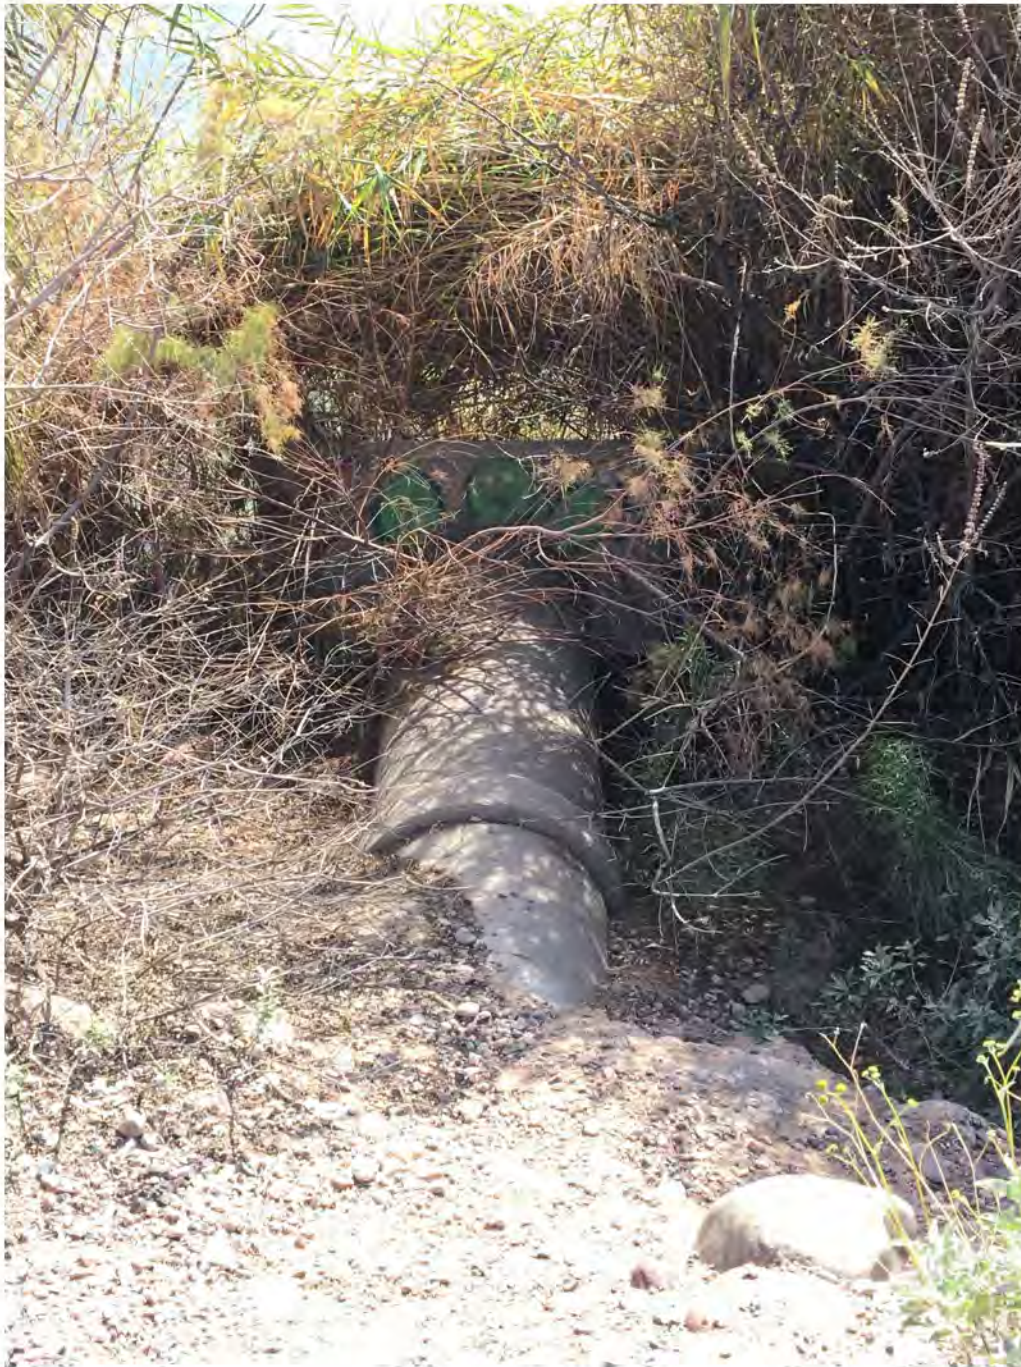
Outfall ID: 1512476

Pipe opening partially submerged by lake

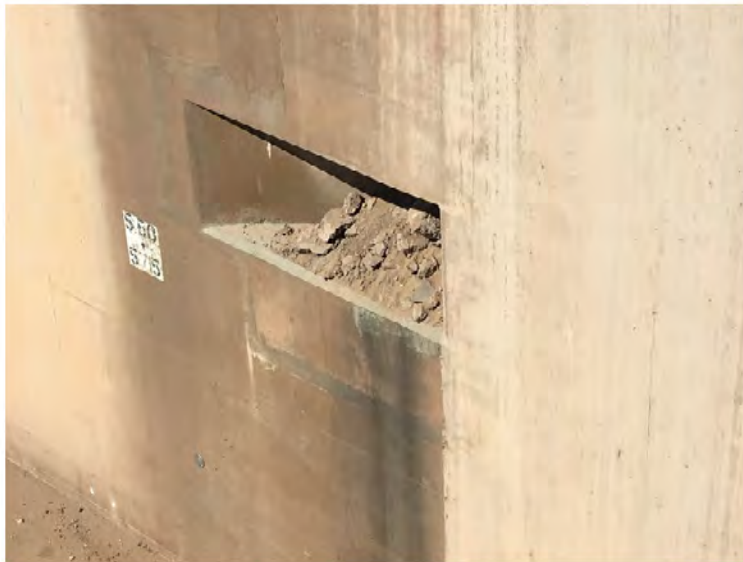
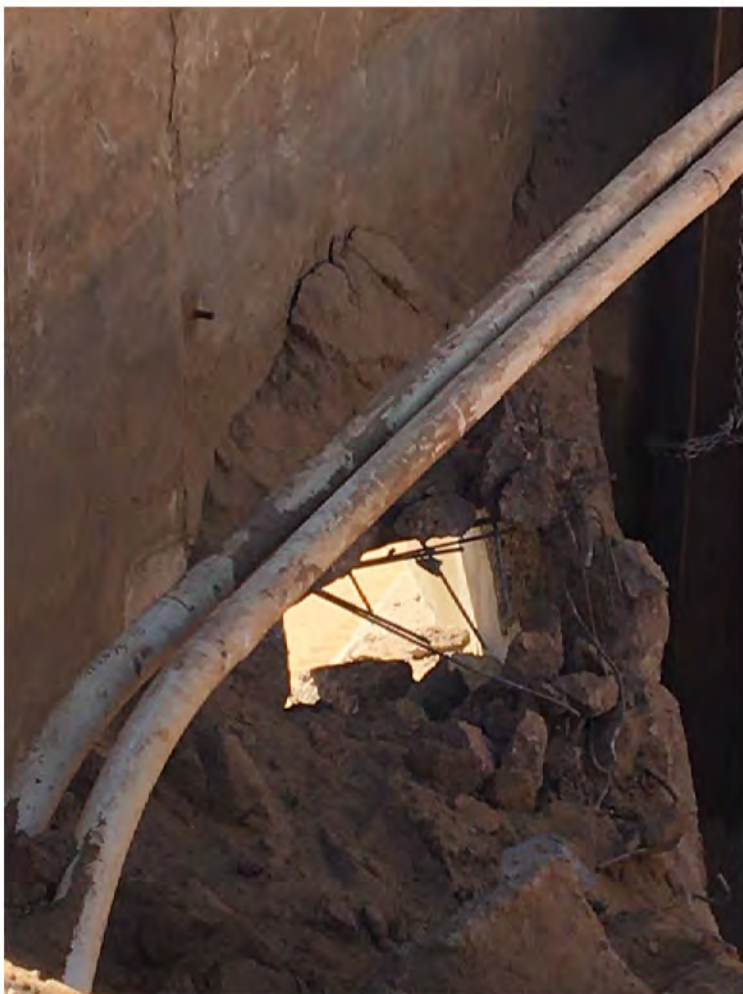
Outfall ID: 1512544

Construction in progress at this outfall at time of inspection

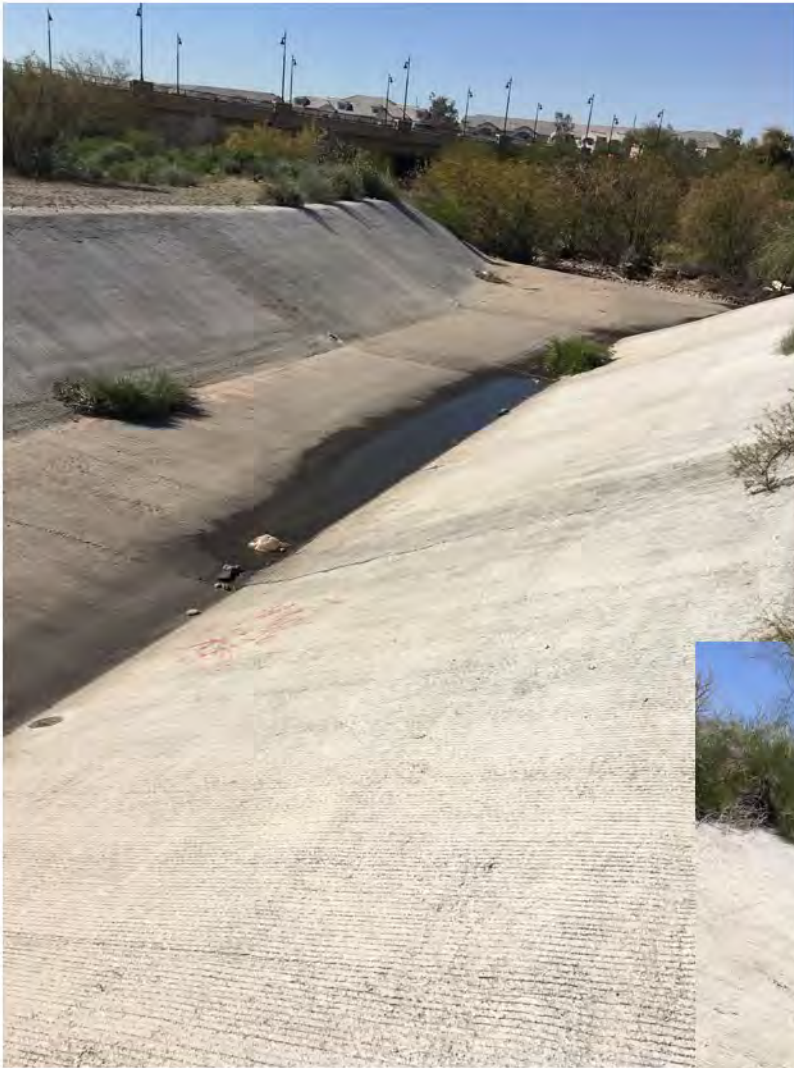
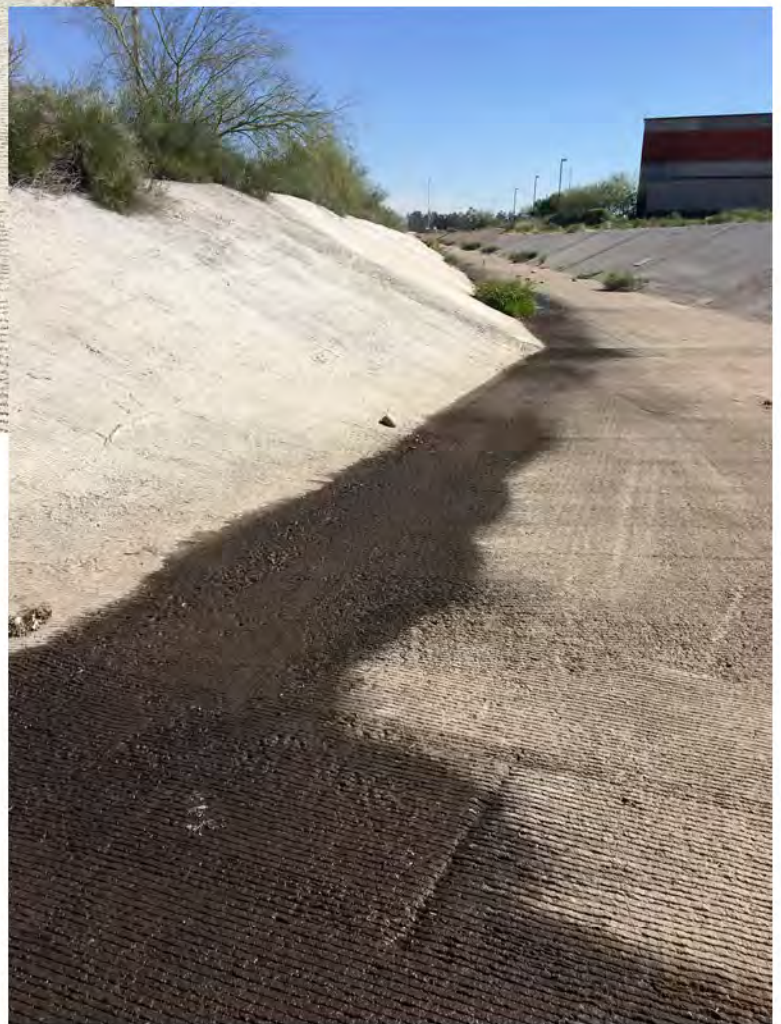
Outfall ID: 1512552

No obvious source for standing water.

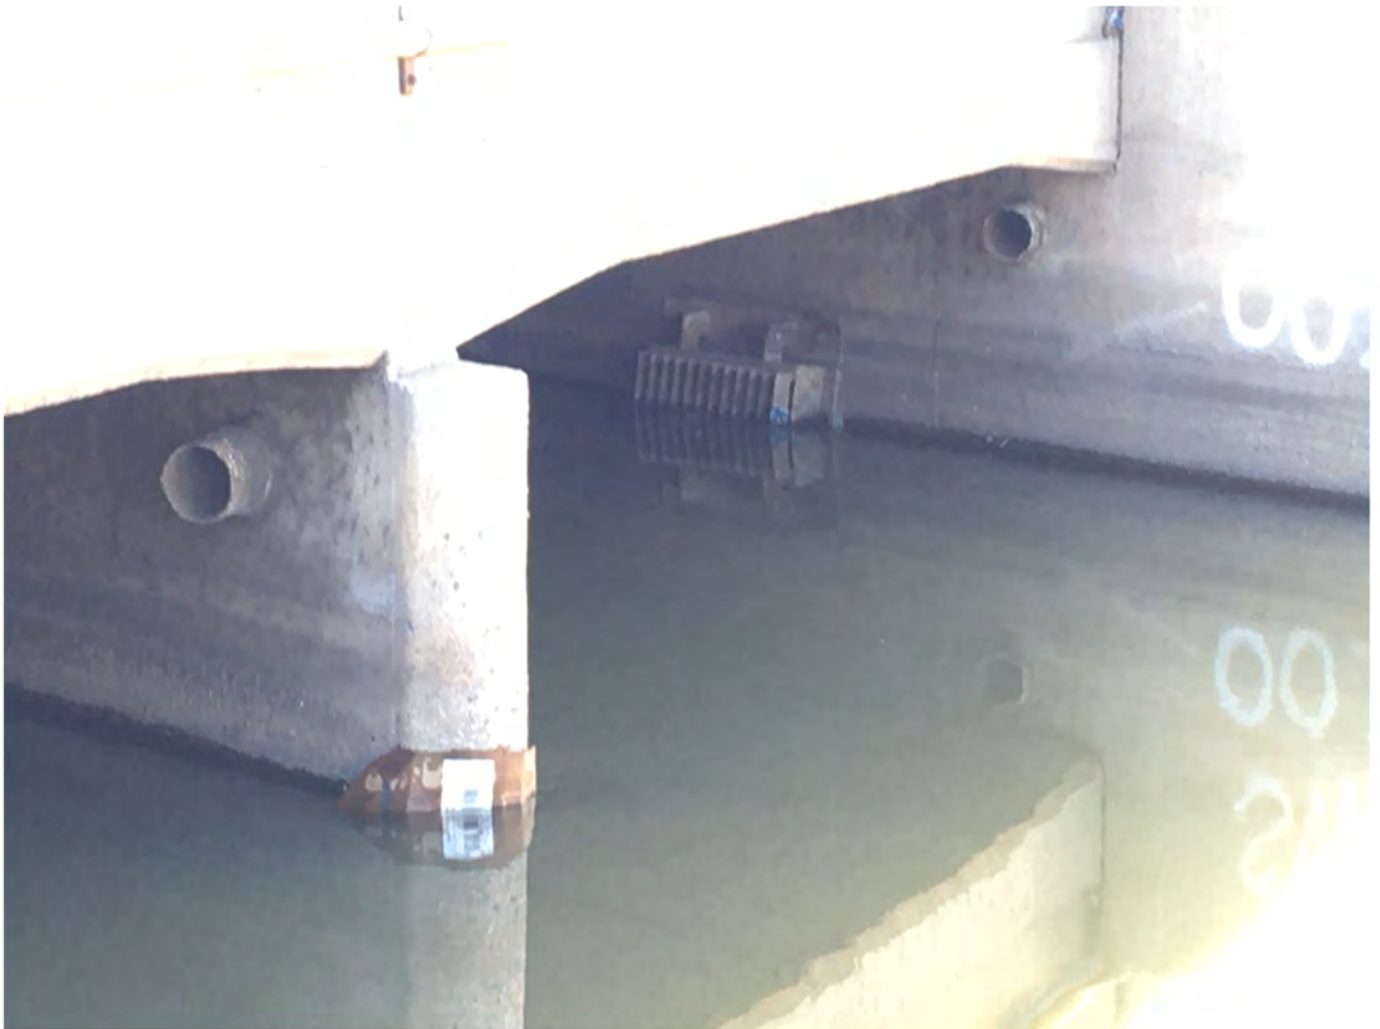
1512558

Pipe opening partially submerged

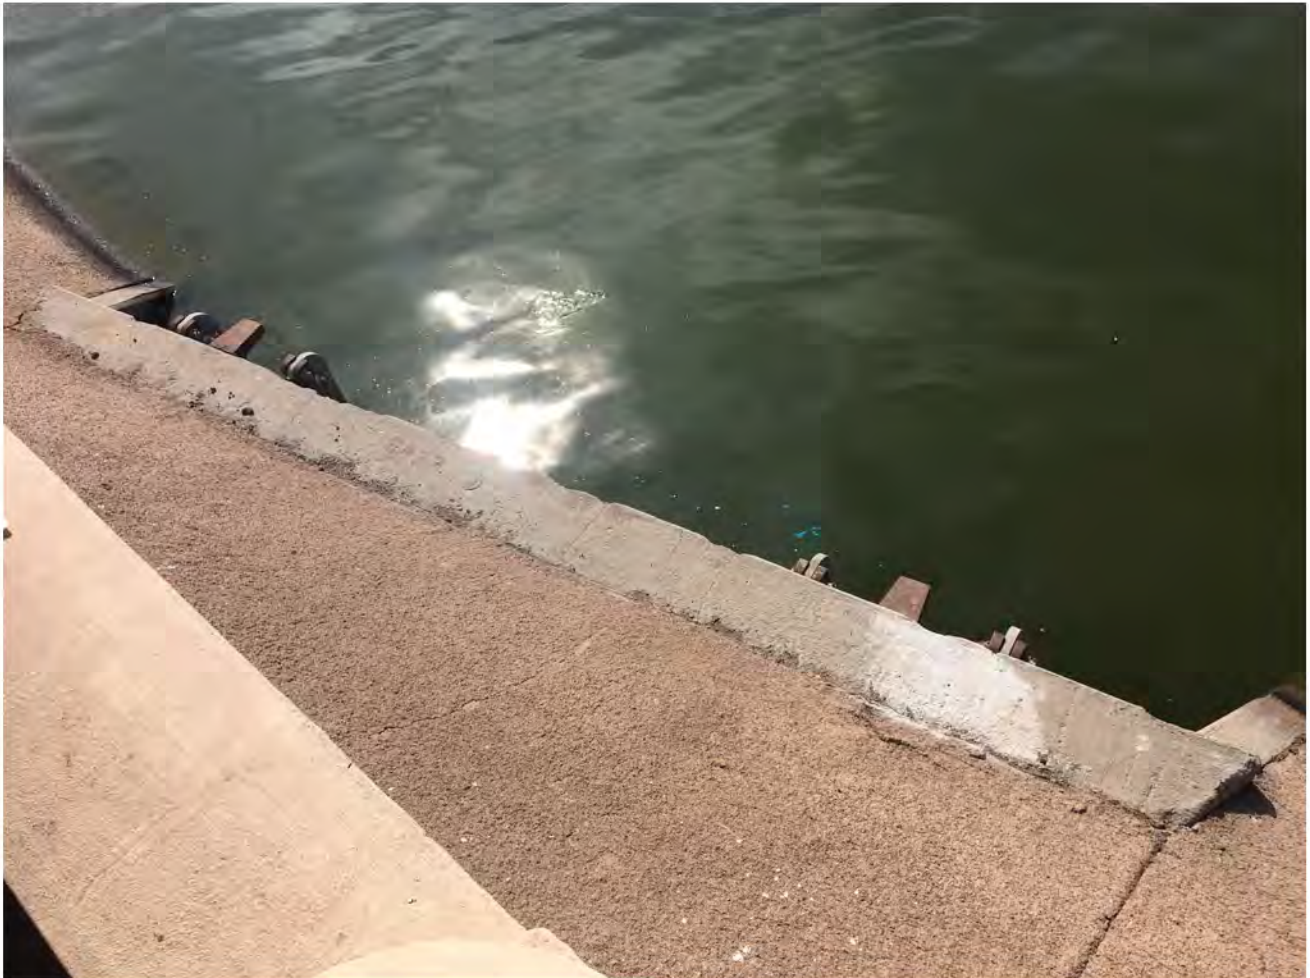
Outfall ID: 2000246

Outfall submerged by Tempe Town Lake
