# **STATEWIDE STORMWATER & EROSION CONTROL STUDY** *Final Report September 2020*

*Prepared For:* Arizona Department of Transportation Multimodal Planning Division

Prepared By: Michael Baker International 2929 N. Central Avenue, Suite 800 Phoenix, Arizona 85012

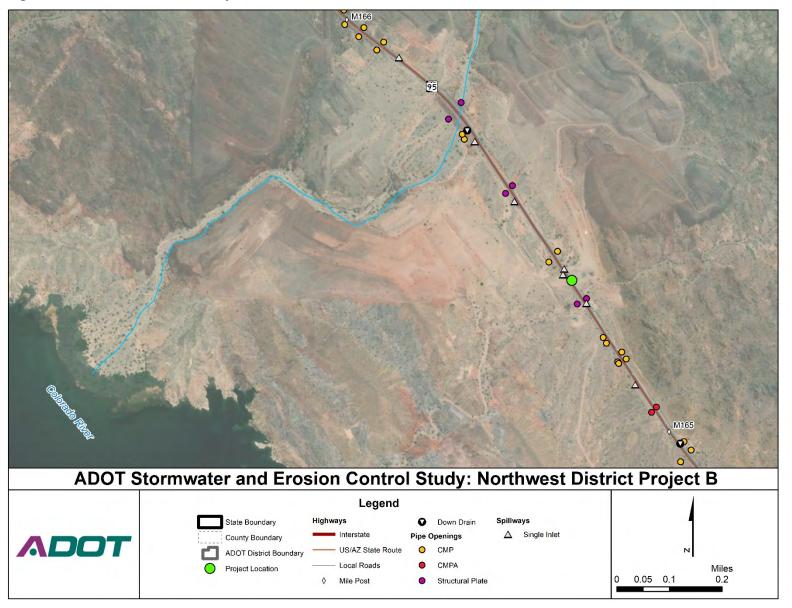
### **Figure 10: Northwest District Project B**

*Project Description:* Water draining from undeveloped RV camping spot on State Land to the east of SR 95 causing severe sedimentation of area around CMP Culverts in this location. Water pooling around culverts is saturating the roadway causing sloughing of the fill above the culverts. The roadway is being compromised from the clogging of the two culverts. Erosion caused by water flowing is undercutting roadway fill and causing sedimentation of the culvert inlets preventing stormwater from flowing through them.

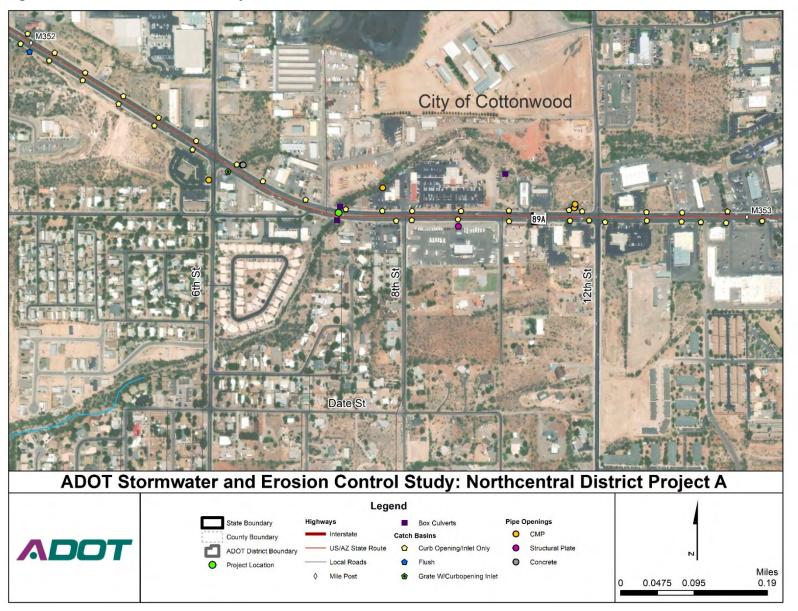
# Figure 23: Northcentral District Project A

*Project Description:* Location consists of built-up sediment, limiting capacity of flow in the wash. Four of the five barrels are 80% clogged, however the box culverts are likely properly sized. The ADOT Drainage Group looked at this location and determined that sediment upstream and downstream needs to be removed to alleviate the condition. Forest vegetation has built up over the years, impacting the sediment deposition at this location. Survey shows approximately 1300 CY of material needs to be removed from upstream, downstream and in the box culvert. This effort is larger than a typical maintenance project and specialized equipment will be needed due to forest, boulders, box height and sediment. Standard maintenance equipment will not fit in the 5-foot high box culverts. 700 CY of sediment is estimated to be inside the box culvert. If not mitigated, there is concern that the box culverts will overtop, and water will flow into the businesses downstream.

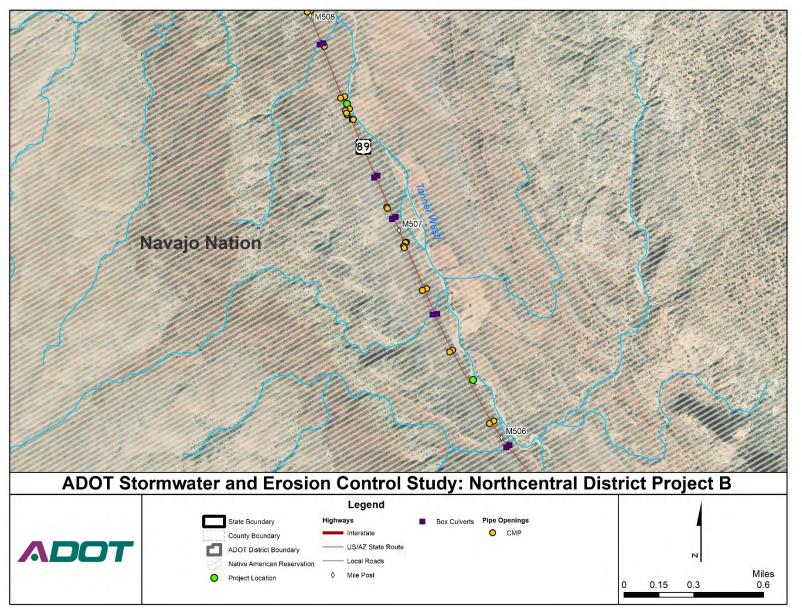
*Project Description:* Tanner Wash adjacent to the highway (south) is continually meandering towards the highway at two locations: MP 506.3 and MP 507.3. Historical google satellite images show the continued trend of the stream getting closer to US 89 and there is a potential for highway failure if it reaches the highway. Each year severe monsoon flows bring Tanner Wash closer to the highway. Wash exhibits large flow and high velocity characteristics. The wash migration seems to be occurring naturally and not the result of any upstream activities. The roadway embankment is continually eroding into the channel, leading to the collapse of the ADOT fence on multiple occasions. Fine sandy soil conditions exacerbate the problem. ADOT maintenance has installed weirs to mitigate, but that did not prove to be effective. ADOT successfully mitigated a similar issue upstream at MP 510-518 in conjunction with a passing lane installation project, and that seemed to be effective. Recommend emulating that solution at these two locations.

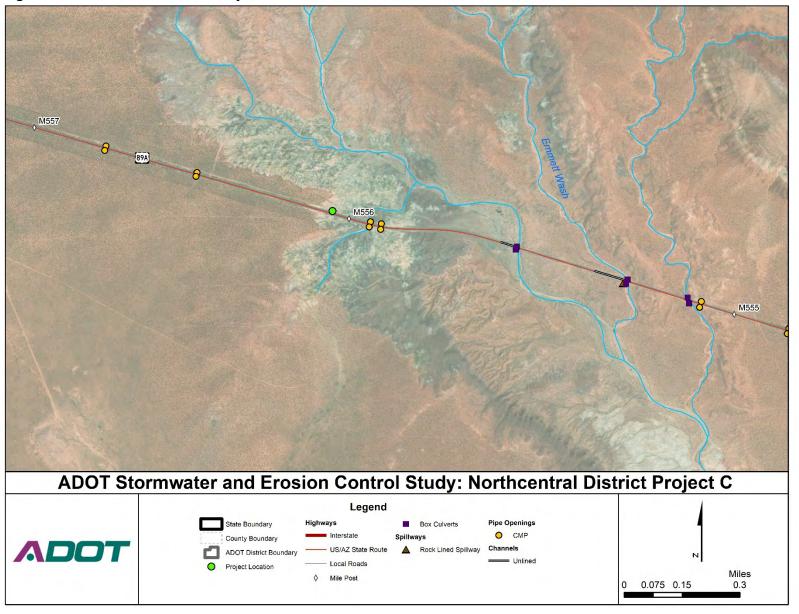
# Figure 31: Northcentral District Project C

*Project Description:* Wash on the north side of US 89A at MP 556 is within 5-feet of highway. Over the years, the flow of the channel has changed (the natural channel bank breached) and now runs parallel to the highway instead of the historic perpendicular flow. Rip rap has been placed on the shoulder, but this is now being undermined. It is preferred that the channel be restored to its historical location approximately 50-yards away, but the existing channel is 5-inches to 10-inches lower than the historical channel location. Fine sandy soil conditions complicate potential mitigation measures.

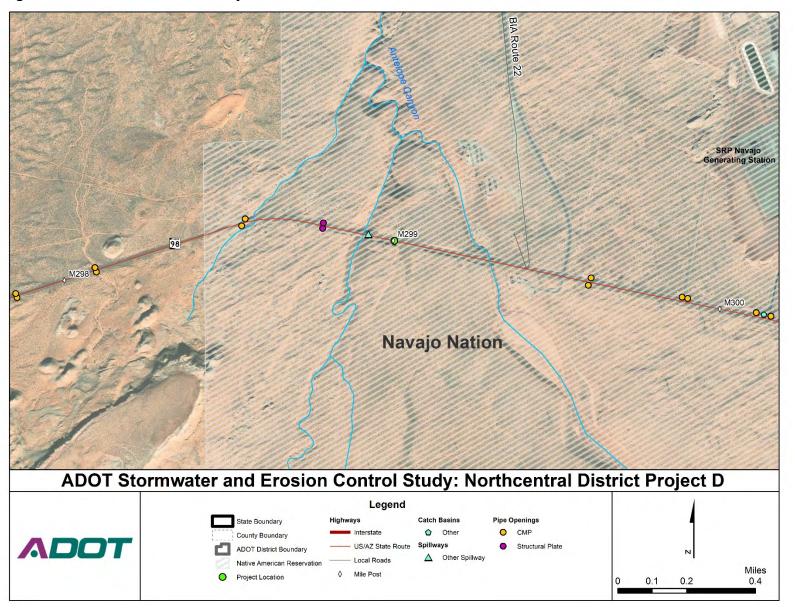
#### Figure 35: Northcentral District Project D

*Project Description:* Pipes were buried when the Lachee Waste Water Treatment Plant (WWTP) failed approximately 10 to 12 years ago. Sediment deposition as a result now has existing CMPs about 15 to 20-feet below grade at the inlet. The highway is acting as a dam, and sediment now is approximately 10-feet from the highway.

*How long has this been a concern?* Since the WWTP failed 10 to 12 years ago. No ADOT maintenance activities have been conducted.

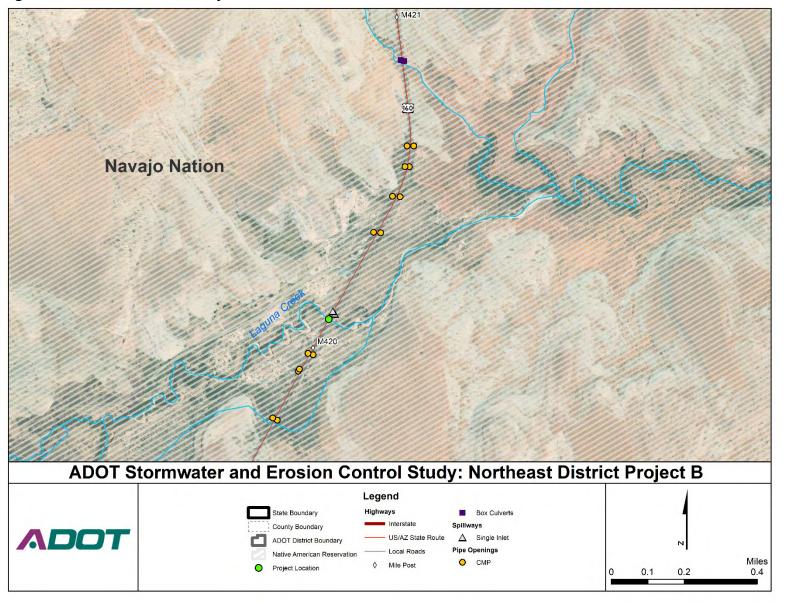
#### Figure 56: Northeast District Project B

*Project Description:* There are three (3), 48-inch, 96-foot long CMPS that are experiencing significant scour and erosion on the downstream side. Poor soil conditions in the area (sandy) make it difficult to stabilize the embankment. This condition is not threatening to the roadway. This project had a Project Assessment (PA) prepared in 2007 (H-69101C) which estimated \$1.5 million in new construction to mitigate the existing condition. Please refer to PA for additional details.

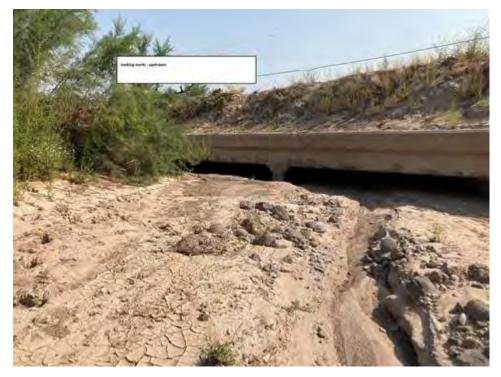
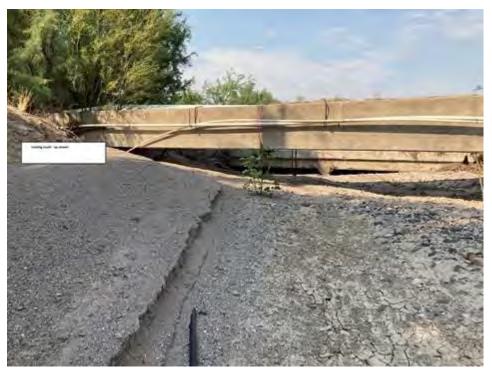
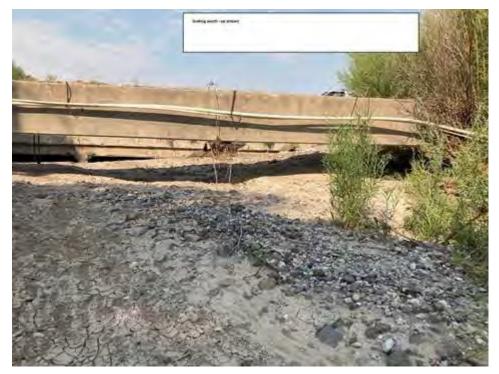
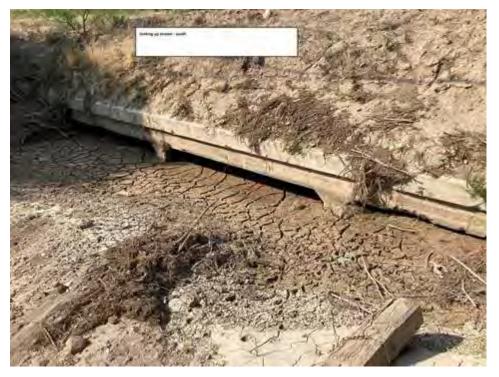
Figure 200: Existing Conditions of Box Culverts

Figure 201: Existing Conditions of Box Culverts

Figure 202: Existing Conditions of Box Culverts

Figure 203: Existing Conditions of Box Culverts
