Tech Brief

November 2017

Maintenance of Guardrail Systems

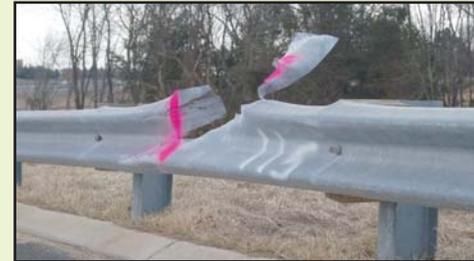
A

- Vertical tears in the W-beam (Photograph A) that extend to the top or bottom of the rail greatly reduce the capacity of the rail and create areas of high stress concentrations, both of which can cause the rail to tear completely through and allow vehicular penetration upon impact. Non-manufactured holes (e.g., those caused by crash damage, lug nut damage, or corrosion) in the rail element that intersect the top or bottom edges of the W-beam should also be considered a priority repair condition. Photograph B.
- Rail flattening with or without post deflection, increases the chances that an impacting vehicle will overturn upon contact and may increase the deflection distance. Any flattened panel that increases the W-beam section width to more than 18 inches (normal height is 12 inches) should be replaced.

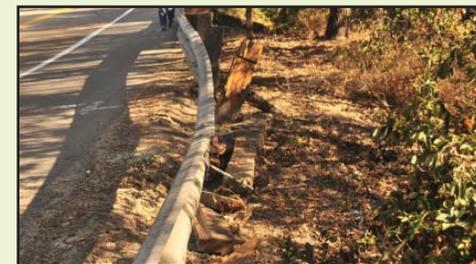
C

- If the barrier has been deflected more than 9 inches over a 25-foot length, its height has been reduced by 2 inches or more from its original height, or if any posts are missing or detached (Photograph C), prompt repairs should be made. These types of damage can result in greater vehicle instability in a crash, may leading to rollover, barrier rupture, or barrier overrides.

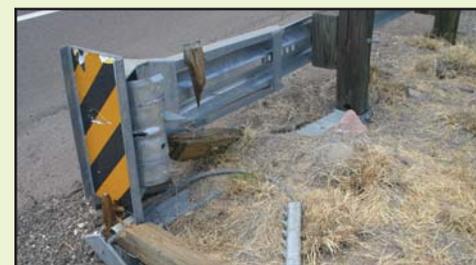
D

- If the end post is broken or if either the cable or steel bearing plate is missing (Photograph D), the anchorage is lost and any motorist striking the rail downstream from the terminal would likely penetrate the system rather than be redirected. Thus, if any of these components are deficient, repair work should be a very high priority.
- For those terminal designs that incorporate an energy-absorbing head, it is critical that this head be properly aligned and in position with the W-beam rail element so the rail will “feed” into it in any head-on crash. If the impact head cannot slide along the W-beam, its energy absorbing capacity is seriously compromised, probably resulting in a more severe crash. In Photograph E, the impact head and post #1 are misaligned, reducing or preventing its intended performance in an end-on impact.
