Town of Miami Trail System Study

Existing and Future Conditions

DRAFT

March 5, 2025

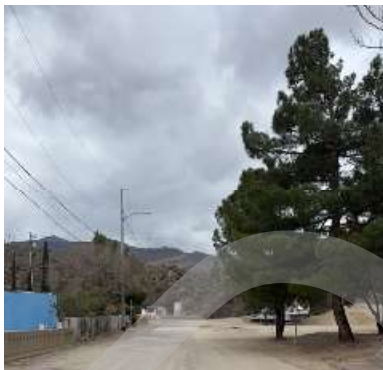
**Turner Street** (looking west)

Turner Street connects between the Bullion Plaza Cultural Center and Museum and US 60 on the west side of town.

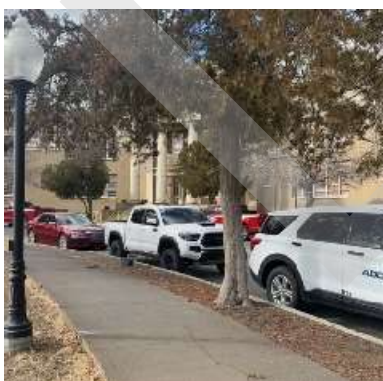
**Plaza Avenue** (looking south)

Plaza Avenue forms a loop around the Bullion Plaza park and includes 6-foot-wide sidewalks and a landscaped strip on the western and northern portions of the plaza, with mature shade trees.

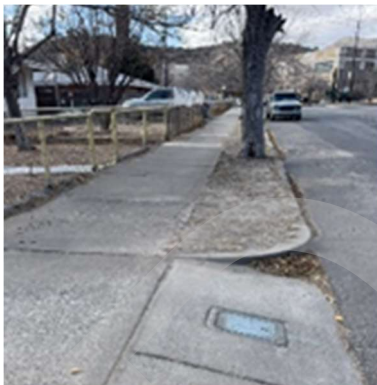
Sullivan Street (looking west)

Sullivan Street connects between the Bullion Plaza Cultural Center and Museum and Miami's historic downtown.

Sidewalks are located exclusively on the southern side of the street along this segment, with a steep slope and few residences located on the northern side.

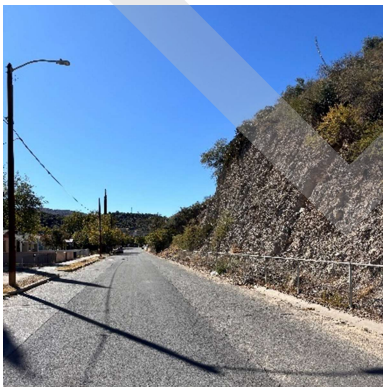
Sullivan Street (looking west, past the hill slope)

Sidewalks are located exclusively on the southern side of the street along this segment, with a steep slope and few residences located near Plaza Avenue and Davis Canyon Road on the northern side.

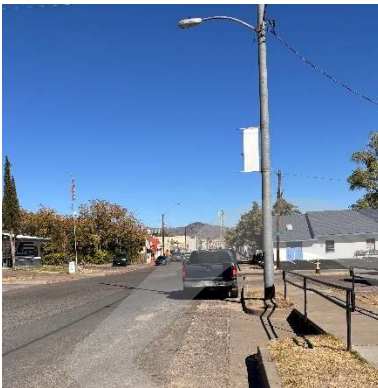
Sullivan Street (looking east)

This area is the center of historic Miami, with commercial and civic uses fronting the street (including the Miami Police and Fire Departments and Hostetler Pool).

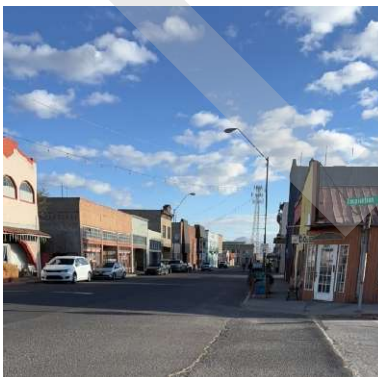
Sullivan Street (looking east from the start of the hill slope)

Beginning just east of Davis Canyon (in front of Our Lady of the Blessed Sacrament Catholic Church), sidewalks are located along the northern and southern sides of Sullivan Street.

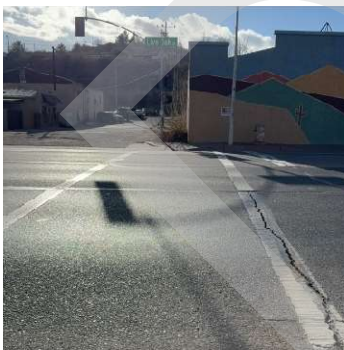
Miami Avenue (looking south)

Miami Avenue provides a connection between Miami's historic downtown and the residential neighborhoods nestled in the hillsides to the south of US 60.

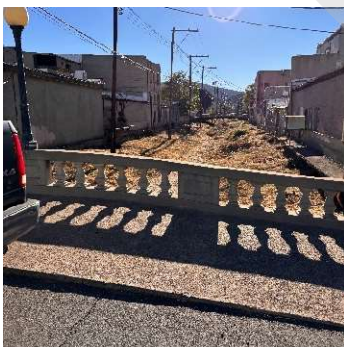
Miami Avenue (looking west)

Looking west along Bloody Basin, a drainage parallel to Sullivan Street drains the historic downtown area (referred to as the Miami Flats). The six bridges that cross the wash include sidewalks on both sides.

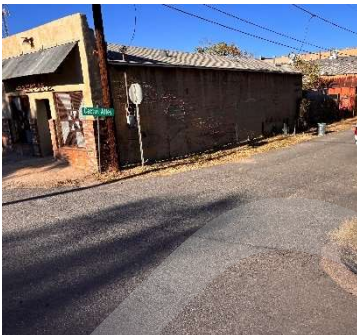
Cactus Alley (looking east from Miami Avenue)

Cactus Alley is a narrow public alley that runs parallel to US 60 between commercial properties built to the ROW.

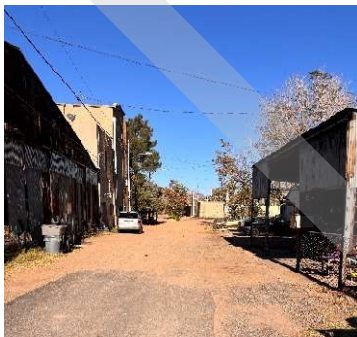
Cactus Alley (looking west)

Cactus Alley includes active commercial businesses, which constrain the ROW.

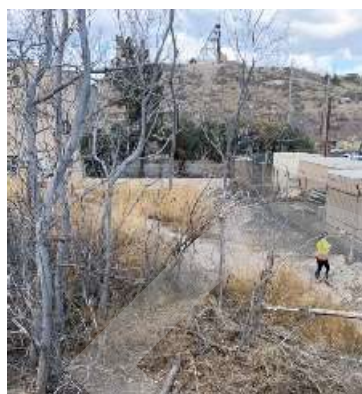
**Cactus Alley (looking west)**

The westernmost portion of Cactus Alley is overgrown with shrubs and trees and was found to be impassable.

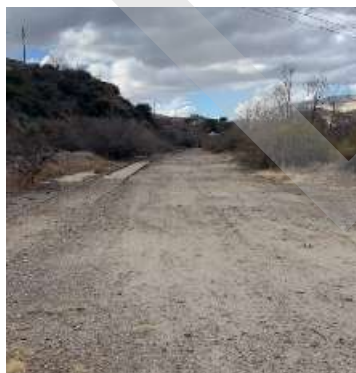
**Cactus Alley (looking east)**

East of the overgrown section (described above), Cactus Alley is a broad path. With little adjacent development, there are few eyes on the alley to provide a safe environment for pedestrians and cyclists.

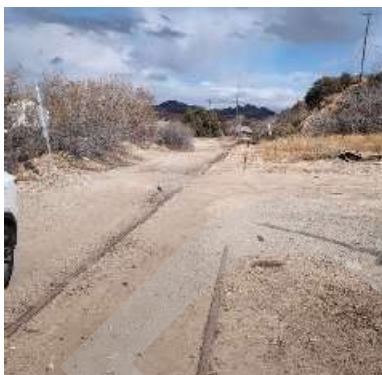
**Cactus Alley** (looking east toward Marion Street)

Abandoned tracks along this segment are obscured by washed-in gravel and dirt.

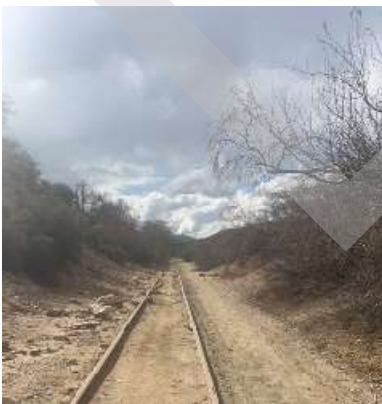
**Cactus Alley** (looking west toward Mill Street)

In this section, the tracks are prominent.

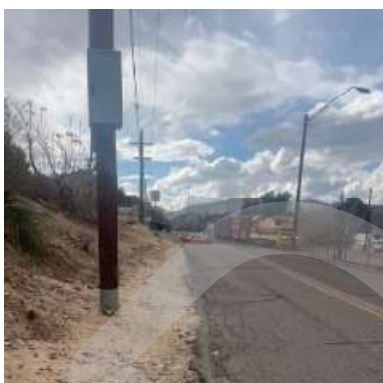
**Railroad Avenue (looking east)**

Railroad Avenue is paved east of Marion Street and travels along an active AZER railroad line. There is no barrier between the tracks and the roadway east of New Street.

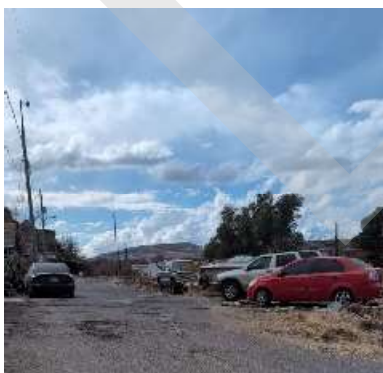
**Railroad Avenue (looking west)**

Some sections of Railroad Avenue are bordered by residential parcels, and vehicles were observed parking on the roadway and adjacent shoulder during the field visit.

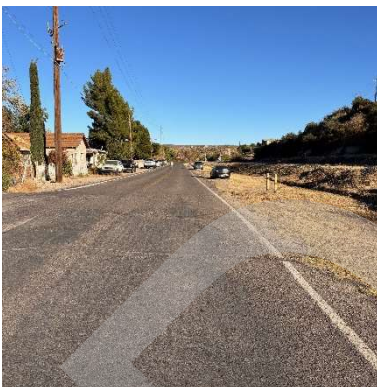
**Locomotive Drive (looking east)**

Locomotive Drive is abutted by a mix of residential and commercial buildings north of the roadway, and AZER railroad tracks south of the roadway. The rail line is elevated, and vehicles were observed parking in the ROW between the roadway and tracks.

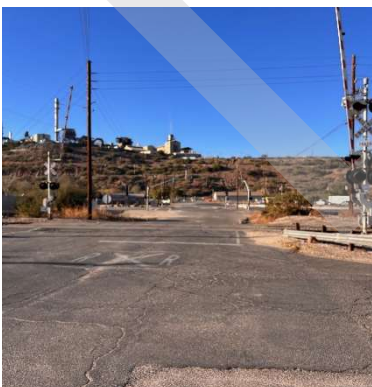
**Locomotive Drive (looking west)**

This section of the alignment crosses the AZER railroad tracks at Pineway Street and Old Oak Street.

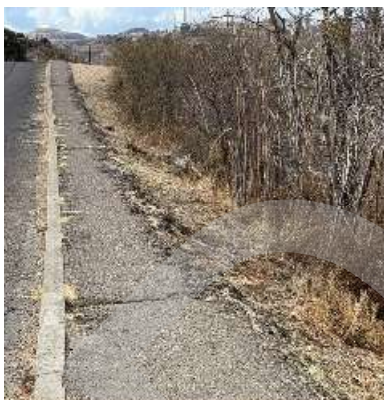
**Railroad Avenue (looking east)**

Railroad Avenue has a 4-foot deteriorating asphalt sidewalk with curb at the road edge on the northern side from Old Oak Street to Maple Leaf Street. At Maple Leaf Street, the northside sidewalk ends and there is a concrete sidewalk on the south side continuing to the MUSD facilities.

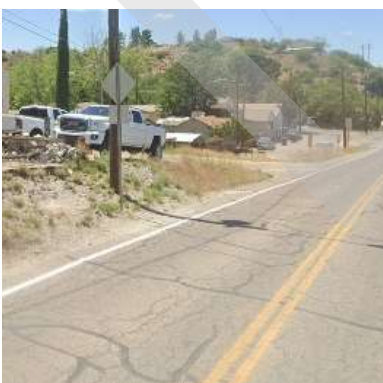
**Railroad Avenue (looking west)**

Railroad Avenue has a narrow shoulder (less than 2 feet) on the southern side.

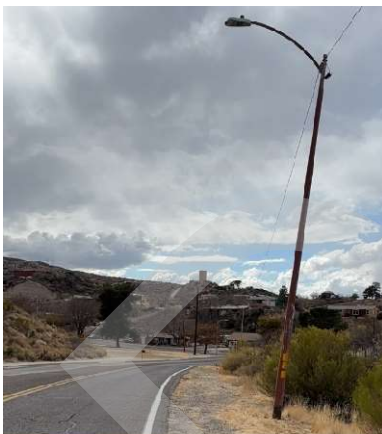
**Railroad Avenue (looking east)**

Railroad Avenue traffic is divided by a double-yellow line, striped 12-foot median for most of its length. There is a narrow shoulder (less than 2 feet) on the northern side, sloping down to the parallel railroad tracks.

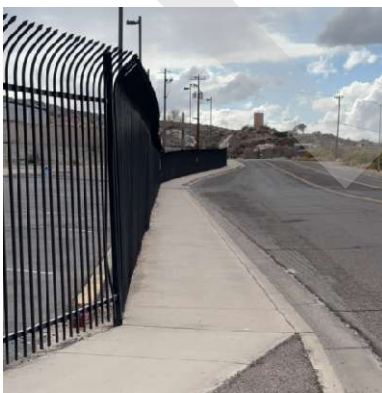
**Railroad Avenue (looking west)**

Railroad Avenue has a continuous concrete sidewalk from Maple Leaf Street to Ragus Road (along which the sidewalk continues to US 60).

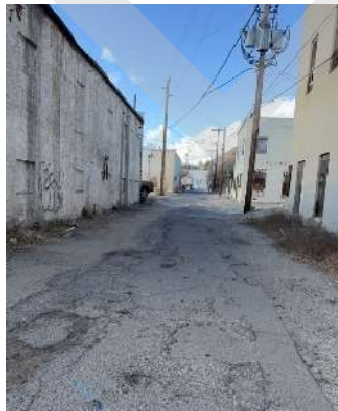
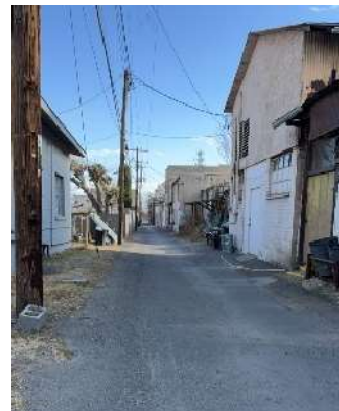
Infrastructure	Observations
ROW	
ROW Surface: Mostly paved	<ul style="list-style-type: none"> ❖ Poor pavement condition; uneven with patchwork, large cracks, and rutting in many places, particularly at intersections (such as Chisholm Avenue). ❖ Some areas covered in dirt, with rocky surfaces.
ROW Width:	<ul style="list-style-type: none"> ❖ Typically 30 feet between Davis Canyon Road and Chisholm Avenue. ❖ Typically 18 feet between Chisholm and Miami Avenues (desktop review).
ROW Obstructions/Constraints:	<ul style="list-style-type: none"> ❖ Utility poles and meters extend into usable path in some areas. ❖ Vacant or abandoned properties dispersed throughout the area, with broken doorways/windows/etc. fronting the alleyway. ❖ Some vehicles travel through the alleyway, which may cause safety concerns for active transportation users. ❖ Lack of striping and signs along Sykes Alley.
Crossings/Lighting
