### **Biological Evaluation**

**Apache Junction to Tortilla Flat**

**Federal Project No. STP-088-A(202)T**

**TRACS No. 088 MA 203 H8112 01C**

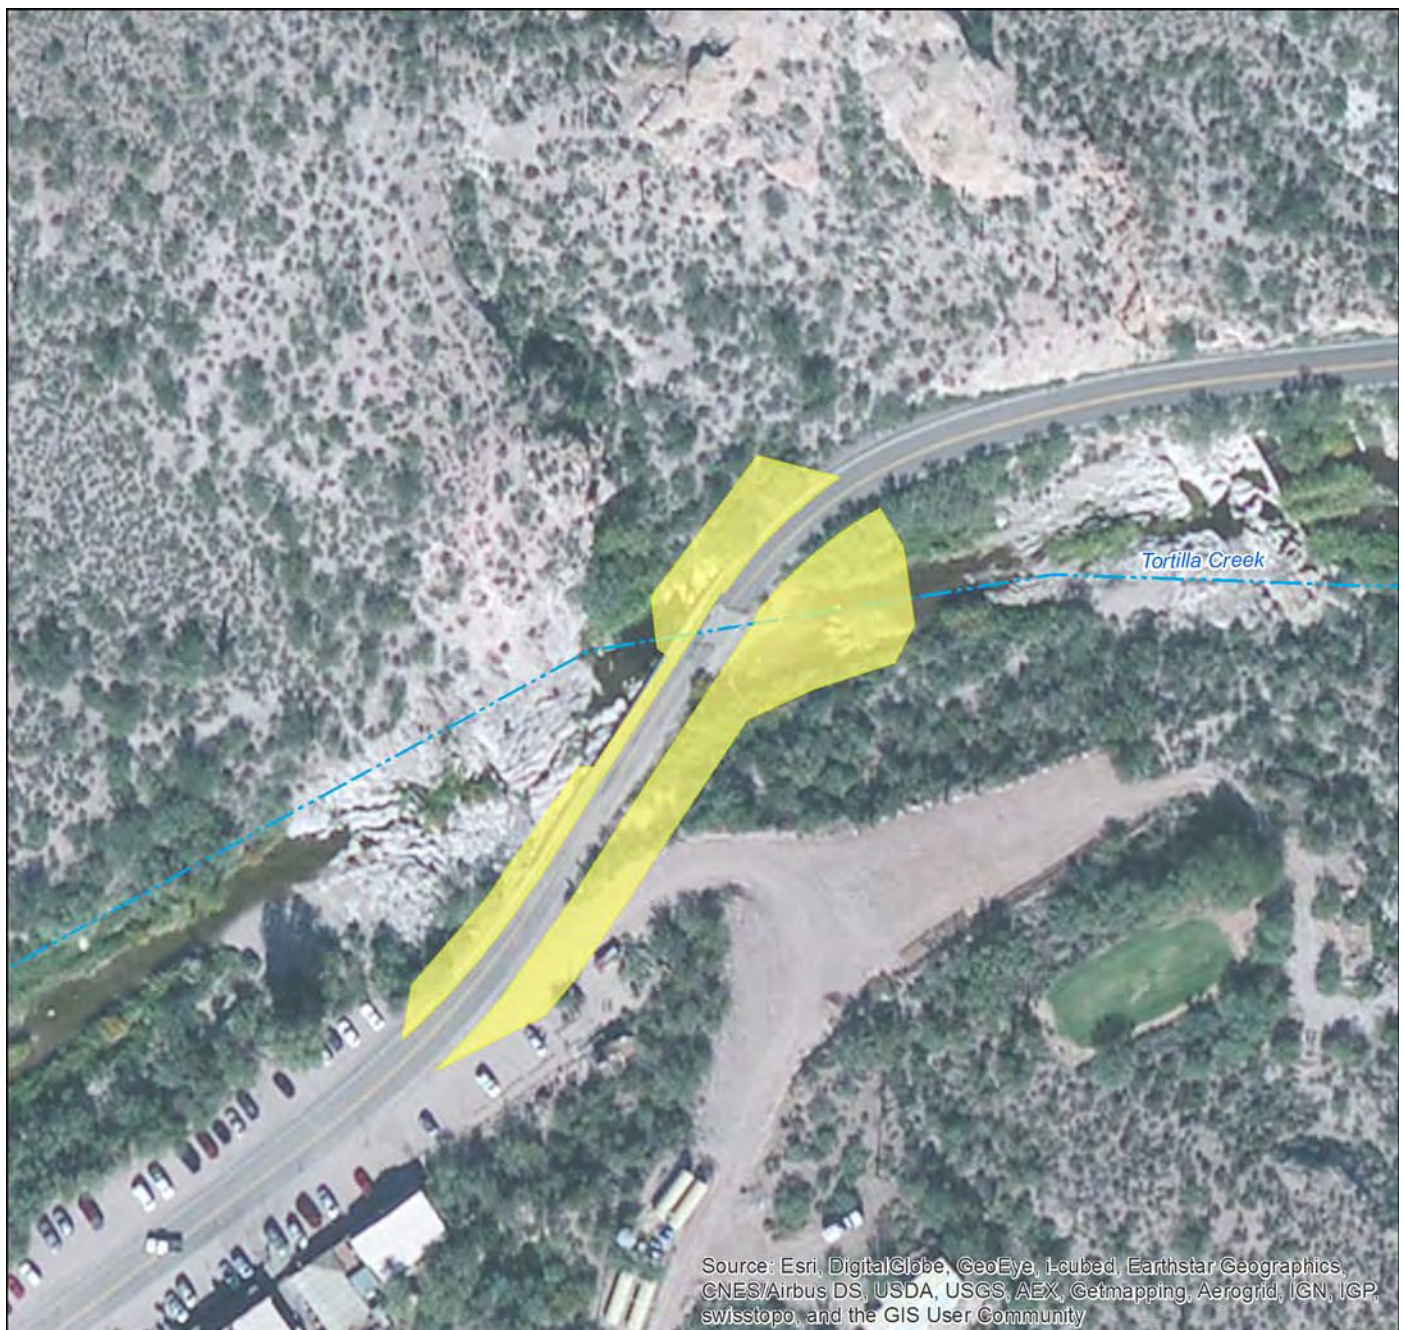
**Figure 4.** Tortilla Creek ford crossing construction area

Heavy equipment would access the work area to remove the exterior concrete of the deteriorating upstream portion of the ford, along with the associated fill material from inside the ford structure. The existing culvert pipe would be cut off even with the remaining ford cutoff wall and the remaining section of pipe would be cleared of any blockages with hydrovac trucks that use a combination of pressurized water and vacuum hoses to remove material. The hydrovac trucks would be parked on top of the concrete ford and/or the access road on the upstream side of the ford; one truck would excavate/vacuum at the upstream end of the culvert pipe and the other truck would vacuum at the downstream end of the pipe at the same time to minimize any discharge of material or water from the pipe during the pipe cleanout. Turbidity socks or other control measures would be temporarily placed on the downstream side of the pipe opening to contain any accidental discharge of water or excavated material. The new culvert pipe would be installed by inserting it inside the existing pipe and pushing it into place with an excavator or similar equipment. The space between the old and new pipes would be grouted with non-shrinking grout to secure the new pipe in place. The contractor would hand-place grout at the downstream pipe opening 24 hours prior to pumping grout into the rest of the space, or use another method approved by the Engineer (e.g., installation of a bulkhead or collar on the downstream end of the pipe) to prevent the discharge of grout to the downstream channel when it is pumped into the space between the two pipes.

The ford crossing work would be restricted to the period from April through June, when flows are typically low and sometimes non-existent. The contractor would have some flexibility in their choice of methods to complete the work; the description below describes a general concept of how the work could be completed. The sequence of construction at the ford crossing would begin with installation of traffic control to limit traffic to one lane on the downstream side of the ford. Fish/frog removal activities would be completed in any surface water before equipment is allowed to enter the channel. Block nets would be installed and monitored to prevent fish and frogs from entering the work area if surface flows are present. If needed, berms, concrete barriers, or other temporary structure(s) may be installed in order to aid in dewatering the work area. These barriers may form a complete or partial barrier across the channel. Figure 4 shows that anticipated area of disturbance at the ford crossing; project plan excerpts are also included in Appendix D.

Equipment access to the work area would require grading within the construction area adjacent to and within the channel on the upstream side of the ford using an excavator or similar earth-moving equipment to create an access road. Vegetation including several Goodding's willow trees and small patches of wetland vegetation (e.g., buttonbush, giant reed) would be impacted by vegetation clearing on the upstream side of the ford crossing. The work area directly adjacent to the upstream side of the ford would be dewatered to allow concrete work to occur; this may be accomplished by excavating a sump for the purpose of pumping water from the upstream side of the ford to the downstream side. One or more pumps with associated hoses would likely be used to dewater the work area. Pump intakes would be screened to avoid intake of fish. If only groundwater is present within the work area and there are no surface flows, block nets and monitoring would not be required, but if surface flows enter the project area, work would stop until block nets have been installed and any fish/frogs removed from the work area. Measures to prevent erosion and discharge of sediment-laden water (e.g., settling basins, turbidity socks) would be installed on the downstream end of the hose(s). Only foot traffic would be allowed within the low flow channel on the downstream side of the ford; vehicles may access the area for limited use to place equipment such as water tanks or settling basins above the Ordinary High Water Mark defined in the Jurisdictional Determination and approved by the US Army Corps of Engineers (US Army Corps of Engineers 2015).

The sequence of construction at the ford crossing would consist of: (1) mobilization – delivering equipment and setting up contractor use areas; (2) site preparation – milling asphalt from the top of the ford, dewatering the work area, excavating and removing the southern half of the ford crossing, clearing rubble from the existing 18-inch steel culvert; (3) construction – installing a 15-inch steel liner in the existing culvert and grouting the annulus with non-shrinking grout, repairing cracks and spalls, installing formwork and steel reinforcement, placing wet concrete, removing formwork, sealing concrete surfaces with methacrylate, placing backfill; and (4) demobilization – removing excess/unused construction material, restoring the site, and removing equipment. The work at the ford crossing would be planned to occur during dry conditions (to the extent practicable), and would take approximately 6 weeks to complete. Figure 4 shows the anticipated area of disturbance required for reconstruction of the Tortilla Creek ford crossing.

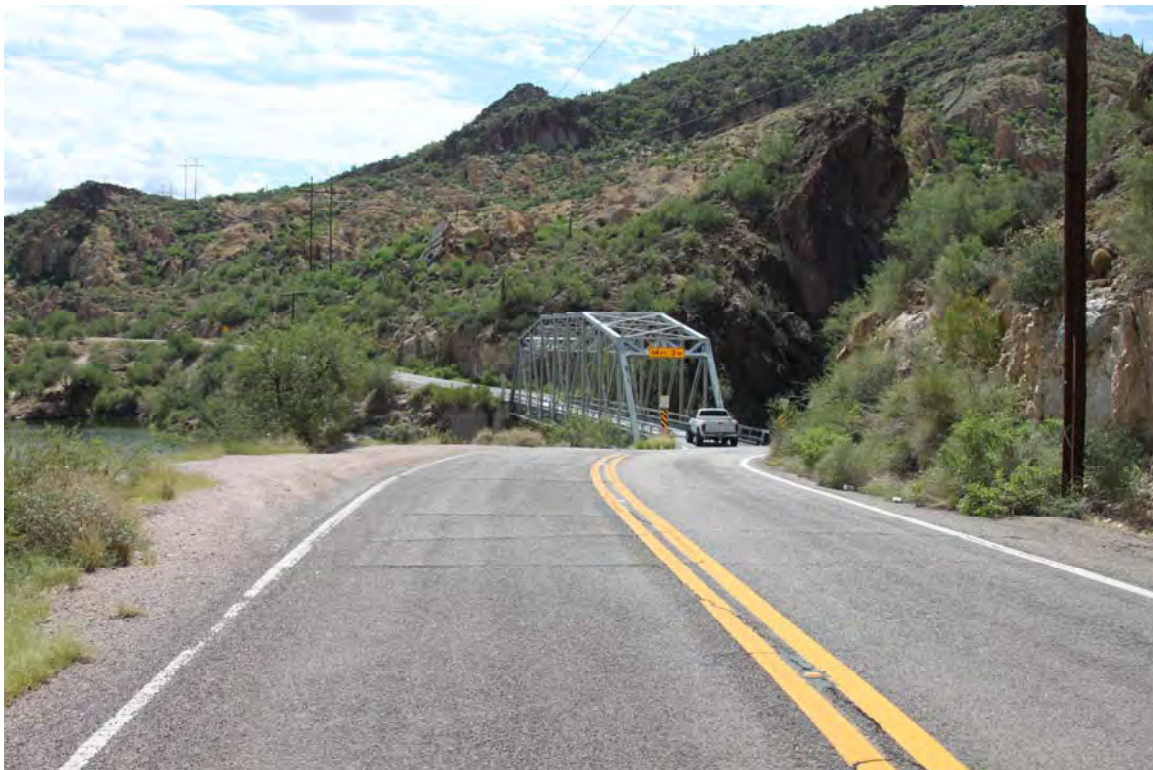
Photo 20. View to the east of the First Water Creek Bridge (Structure No. 26) at MP 209.6.

The First Water Creek Bridge (Structure No. 26) and the Boulder Canyon Bridge (Structure No. 193) were inspected for the presence of bats and nesting birds during a site visit on August 26, 2014. They are both steel truss-type bridges with open beam structures that generally do not provide any day-roosting habitat for bats (see Photos 21 and 28 in Appendix B). Several cliff swallow nests were observed on the underside of the Boulder Canyon Bridge, while no bird nests were observed at the First Water Creek Bridge.

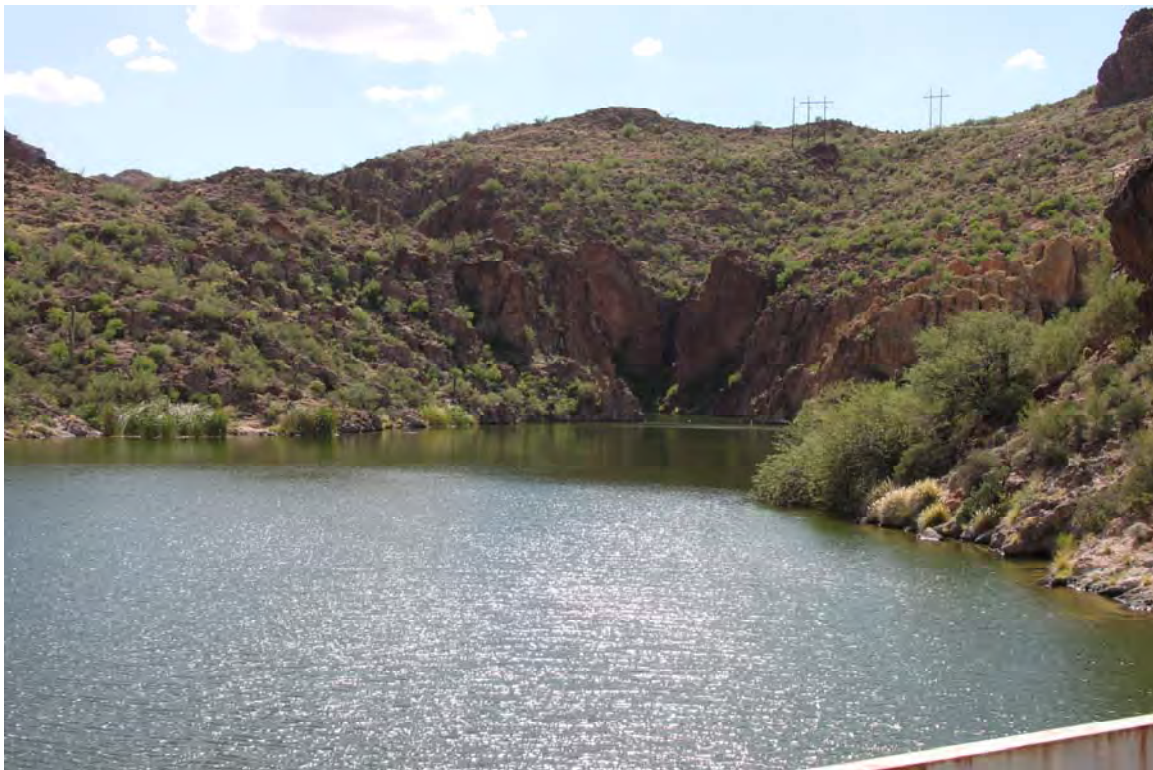
Photo 21. Close-up view of the First Water Creek Bridge.

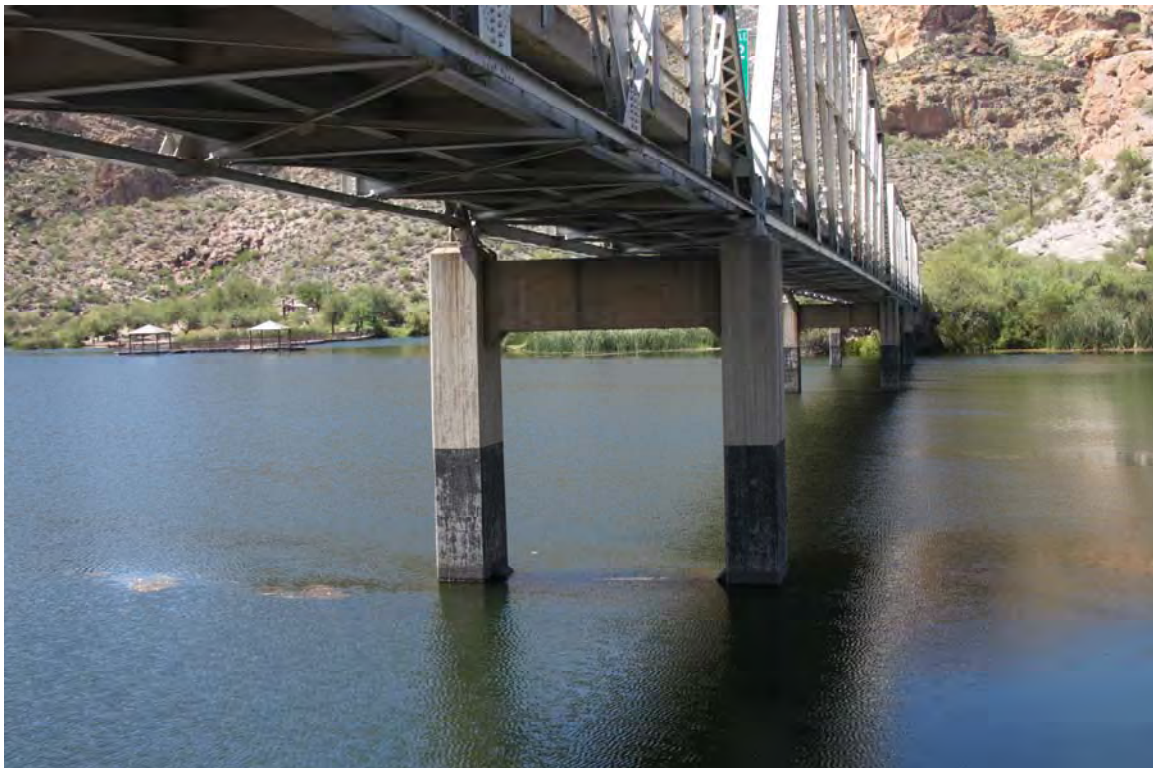
Photo 28. View of the Boulder Canyon Bridge from the eastern bridge abutment.

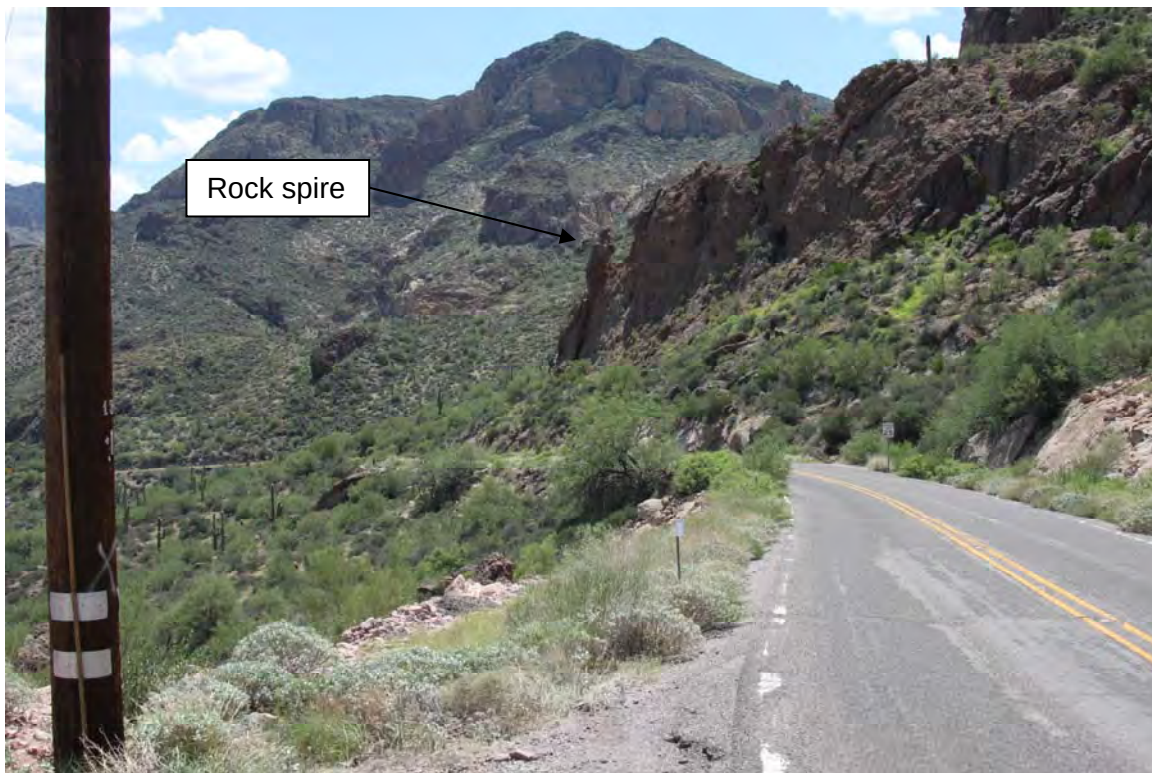
Photo 31. View to the southeast of the rock spire from near MP 212.6.

travel lane more difficult. At MP 212.70, a large rock spire approximately 100 feet above the roadway exhibits signs of a decomposing foundation and cracking where the rock adheres to the cliff face, creating a rockfall hazard. Safety improvements are needed to correct these identified issues.

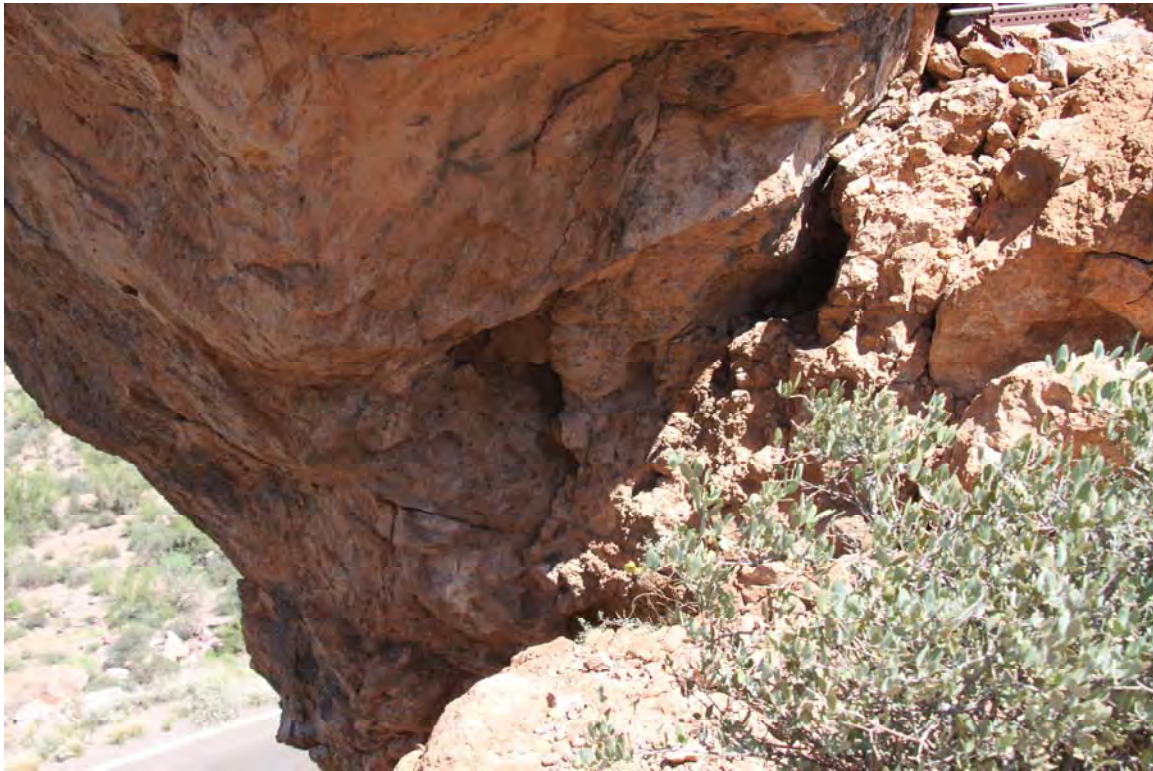
Photo 35. View of the base of the rock spire.

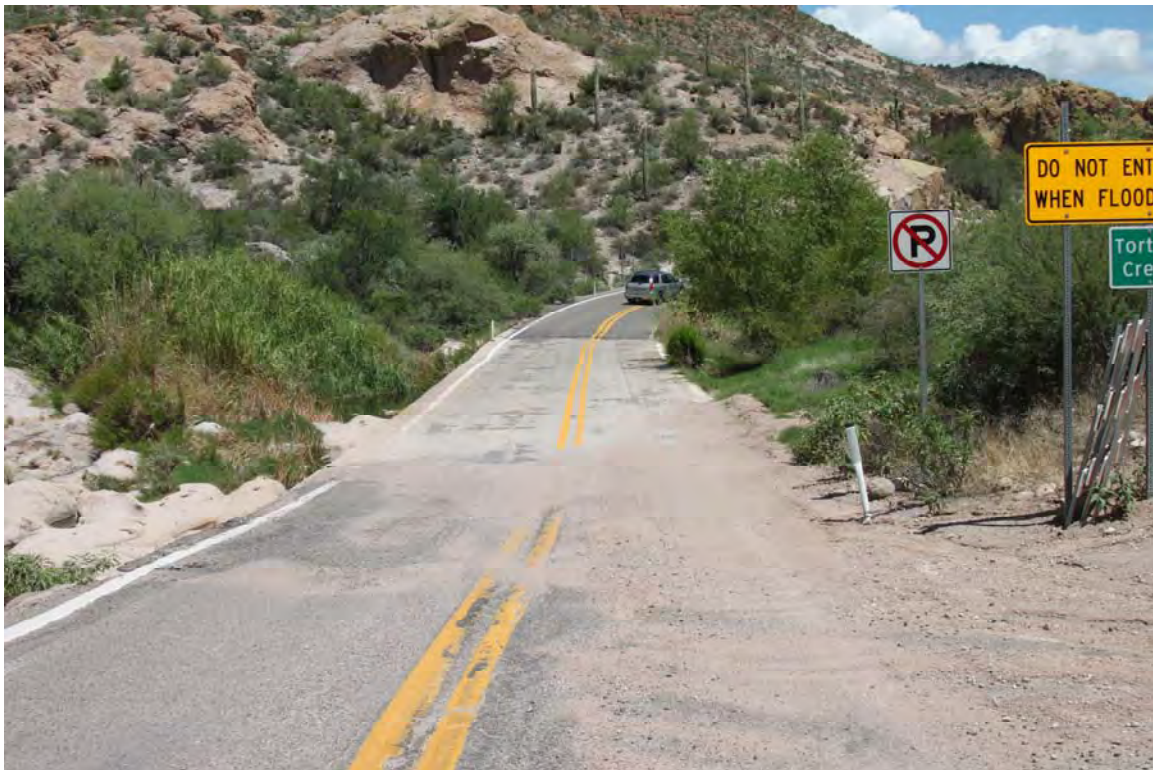
Photo 36. View to the northeast of the ford crossing of Tortilla Creek.

The existing ford crossing is 23.5 feet wide and consists of a 17.5-foot-wide section that was constructed as part of the original ford crossing, and a 6-foot-wide section that was added on later to provide a wider crossing (see Photo 36 in Appendix B). Reconstruction of the concrete ford crossing of Tortilla Creek would require excavation and the removal of the 6-foot-wide southern (upstream) portion of the ford; the 17.5-foot-wide northern (downstream) portion of the ford would remain in place, but would be repaired to improve its condition. Work at the ford crossing is expected to take approximately 6 weeks. Dewatering is expected to be necessary to complete the repairs.

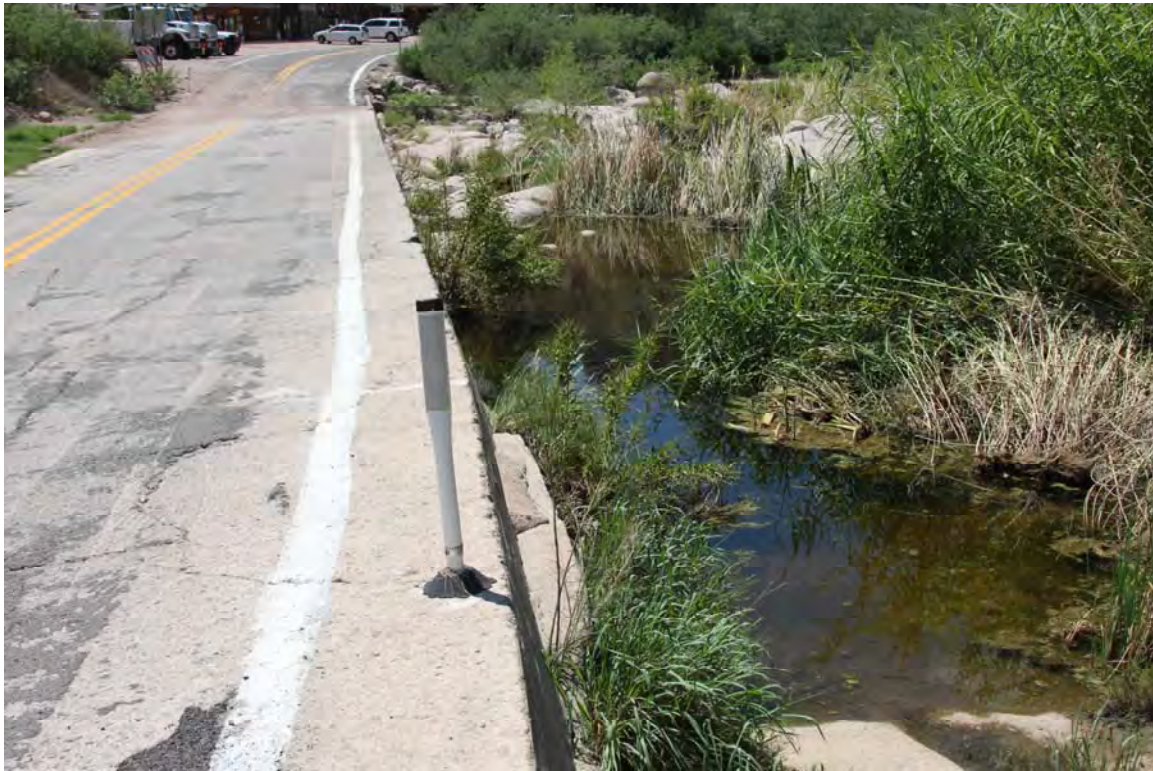
Photo 37. View to the west along the downstream (north) side of the ford crossing of Tortilla Creek.

- Both Sides of the Ford: There is some asphalt remaining on top of the concrete ford that would be milled off prior to reconstruction of the ford.
- Downstream Side of the Ford: Repair the existing cracks and spalls. The cracks would be vee-notched along their length with a concrete saw and filled with a suitable material. The spalls would be repaired using a structural concrete patching material.

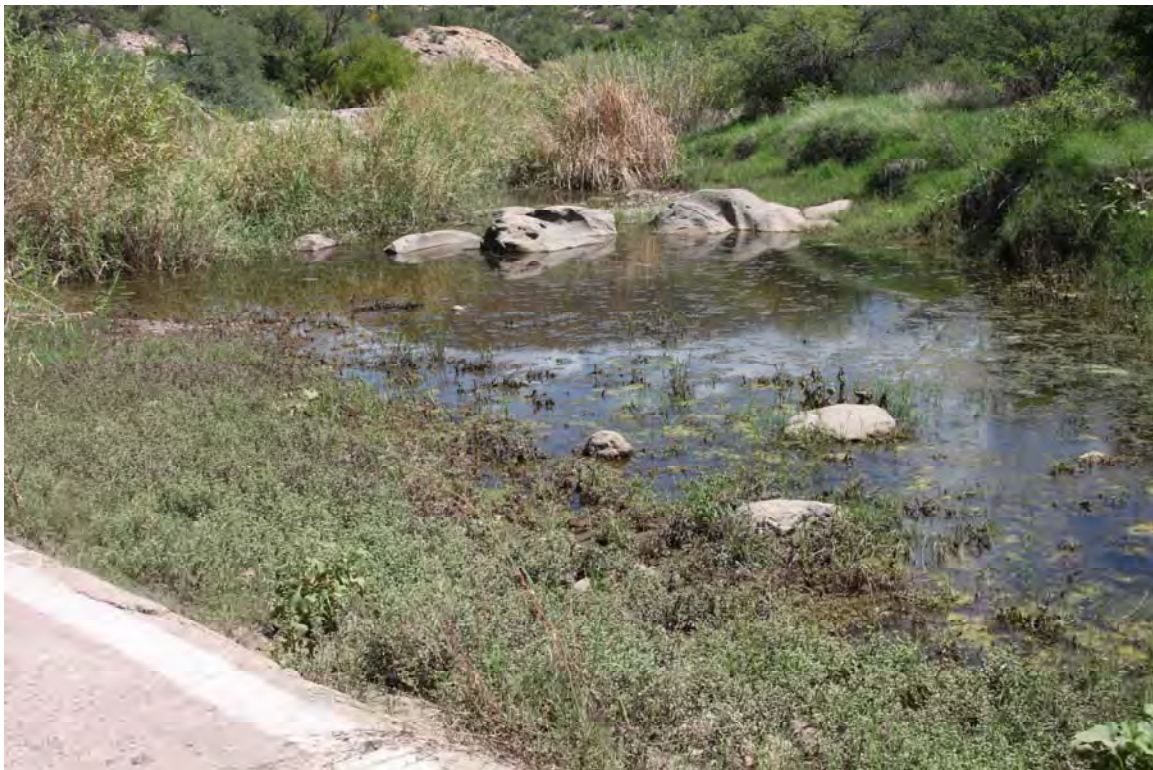
Photo 38. View to the east of the upstream (south) side of the ford crossing of Tortilla Creek.

- Upstream Side of the Ford: Remove the entire 6-foot-wide section added to the length of the ford in the 1940s and replace with a new reinforced concrete roadway with cut-off walls (refer to the excerpted plan sheets in Appendix D). The new portion would be tied to the existing downstream side of the ford with dowels. The new portion would have transverse joints constructed to match the locations of the existing joints in the downstream side.

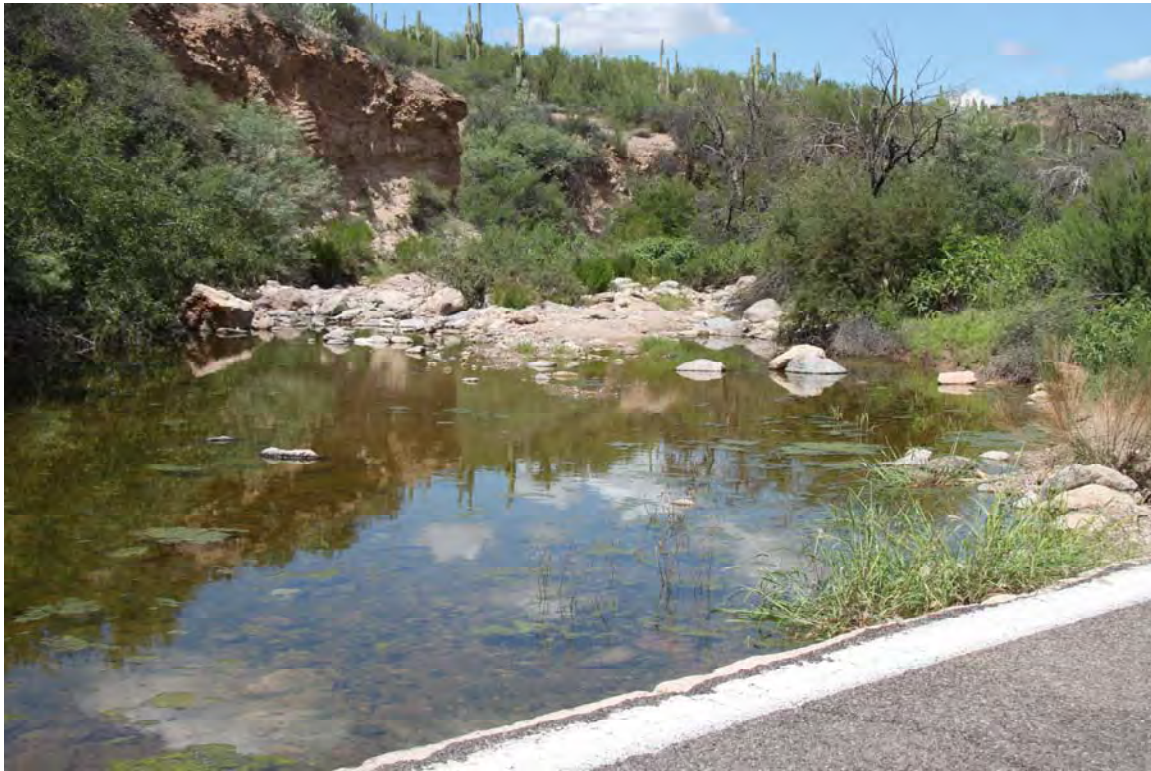
Photo 41. View to the northwest (upstream) at the SR 88 low-water crossing of Mesquite Creek.

There are numerous culverted crossings of ephemeral drainages in the project area, and two bridges that traverse inlets to Canyon Lake: the First Water Creek Bridge (Structure No. 26) at MP 209.62 and the Boulder Canyon Bridge (Structure No. 193) at MP 211.05. Two notable drainages are also crossed via at-grade, low-water crossings: Tortilla Creek (MP 213.3) and Mesquite Creek (MP 214.37; refer to Figures 2 and 3). Tortilla Creek is intermittent in the project area, and nearly perennial below the ford crossing at SR 88; base flows at the crossing get down to less than 1 gallon per minute and no flow has been recorded at times, though water is typically still present in small pools below the crossing (K. Kessler, TNF, pers. comm. 2014; see Photos 37 and 38 in Appendix B). Flow measurements taken just below the ford crossing were provided by the TNF (Table 2). Mesquite Creek is also intermittent in the project area; standing water and scant flows across the roadway were observed at the SR 88 low-water crossing of Mesquite Creek during a site visit on August 26, 2014 (see Photos 41 and 42 in Appendix B).

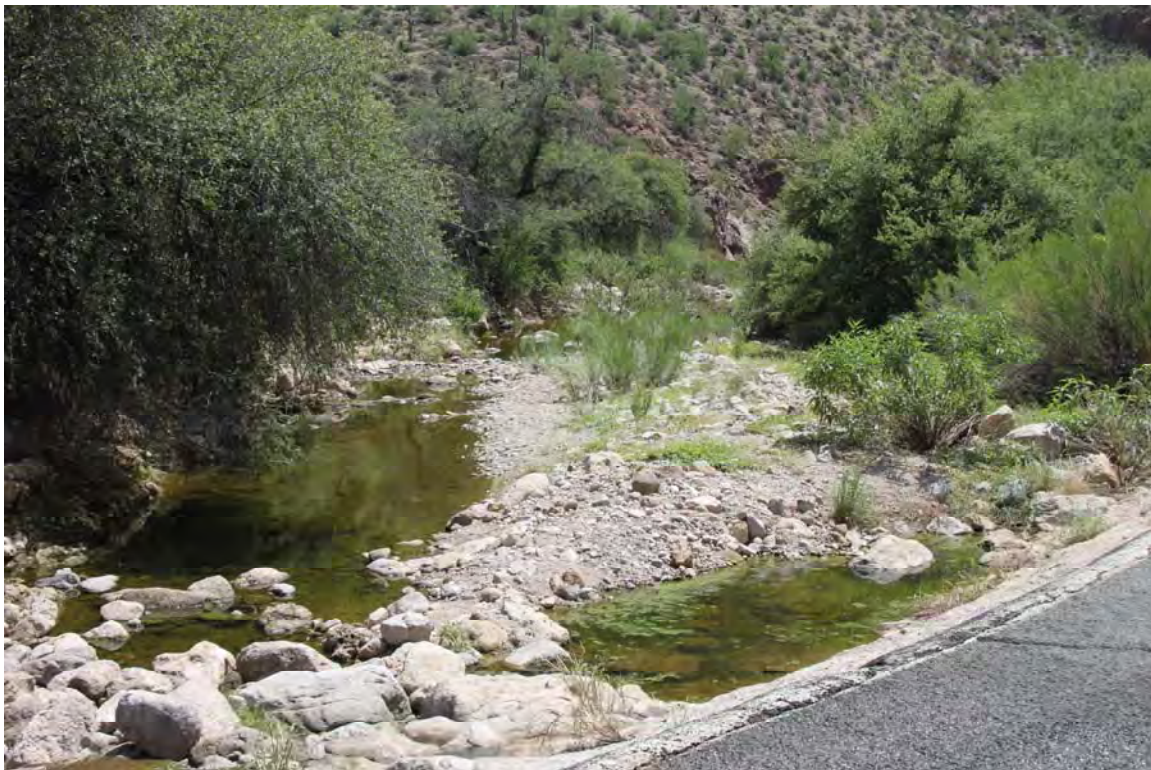
Photo 42. View to the southeast (downstream) at the SR 88 low-water crossing of Mesquite Creek.
