ADOT

US 60X Sossaman Road
to Meridian Road

Comprehensive Transportation Study

Final Report
February 2018

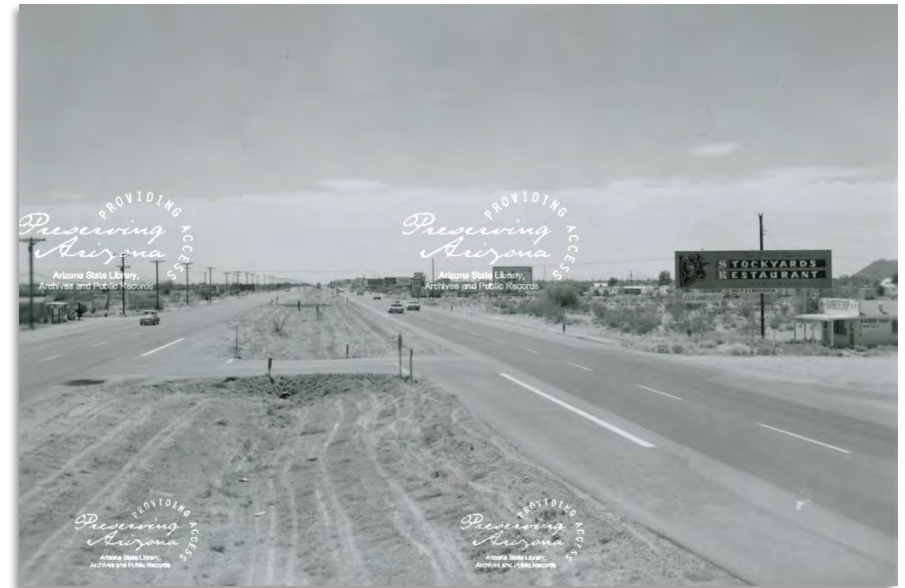
Figure 1.1: Study Corridor

As illustrated in Figure 1.1, the study corridor consists of US 60X from Sossaman Road to Meridian Road.

Photograph taken of the US 60X corridor west of Apache Junction in 1966.
Photo courtesy of the Arizona State Library History and Archives Division

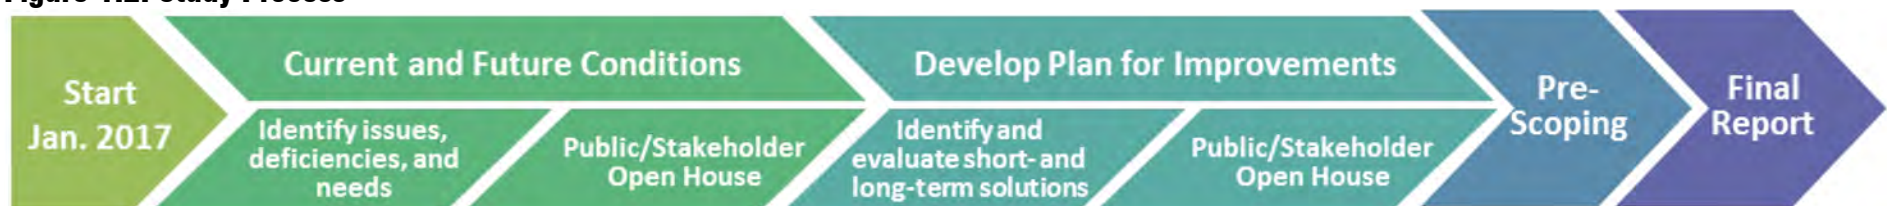
Figure 1.2: Study Process

The development of a comprehensive transportation plan is a technical, collaborative process that involves affected parties along the US 60X corridor, including local jurisdictions, regional agencies, stakeholders, and the public. For this study, five key stages were followed to ultimately develop a regionally cohesive, fiscally constrained improvement plan. *Working Paper 1: Existing and Future Conditions* inventoried and analyzed the existing and future conditions in the study area, including existing transportation system deficiencies, issues, and needs. *Working Paper 2: Draft Plan for Improvements* identified and evaluated improvement projects to address the needs and deficiencies identified in Working Paper 1. Figure 1.2 illustrates the process that is utilized for this study.

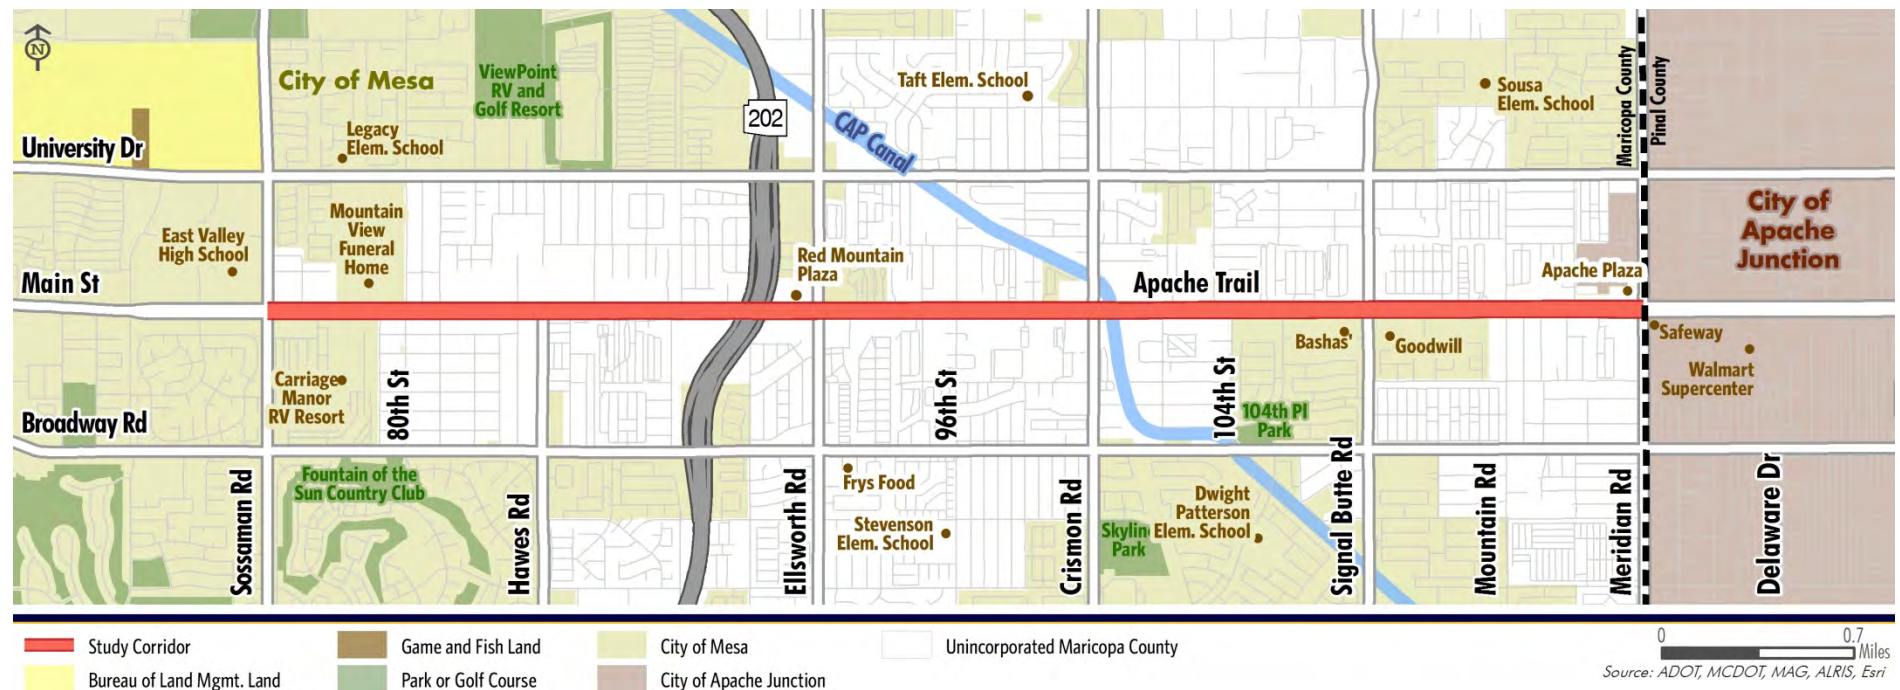
Figure 2.1: Land Ownership

The US 60X corridor lies completely within Maricopa County; however, Pinal County is adjacent to the eastern boundary of the study area. The corridor is also completely within the Maricopa Association of Governments (MAG) planning area. Figure 2.1 illustrates land ownership within the general vicinity of the study corridor. Northwest of the study area, the Bureau of Land Management (BLM), and the Arizona Game and Fish Department (AGFD) own land along University Drive.

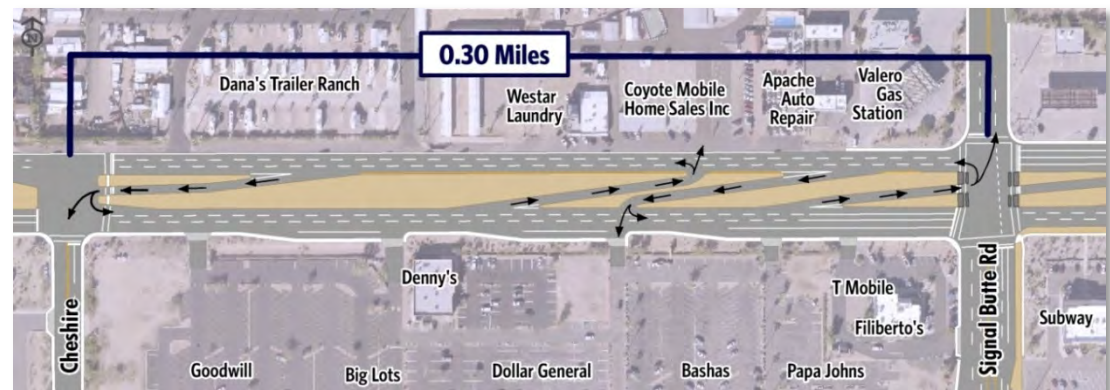
Between Cheshire and Signal Butte Road, the corridor has a unique configuration of three lanes in each direction with curb, gutter, and a sidewalk in the eastbound direction. In addition, this section of the US 60X corridor has two median crossover left-turn lanes; one for eastbound and one for westbound traffic. These turn lanes are only 160-feet west of the signalized Signal Butte Road intersection and may be confusing for motorists

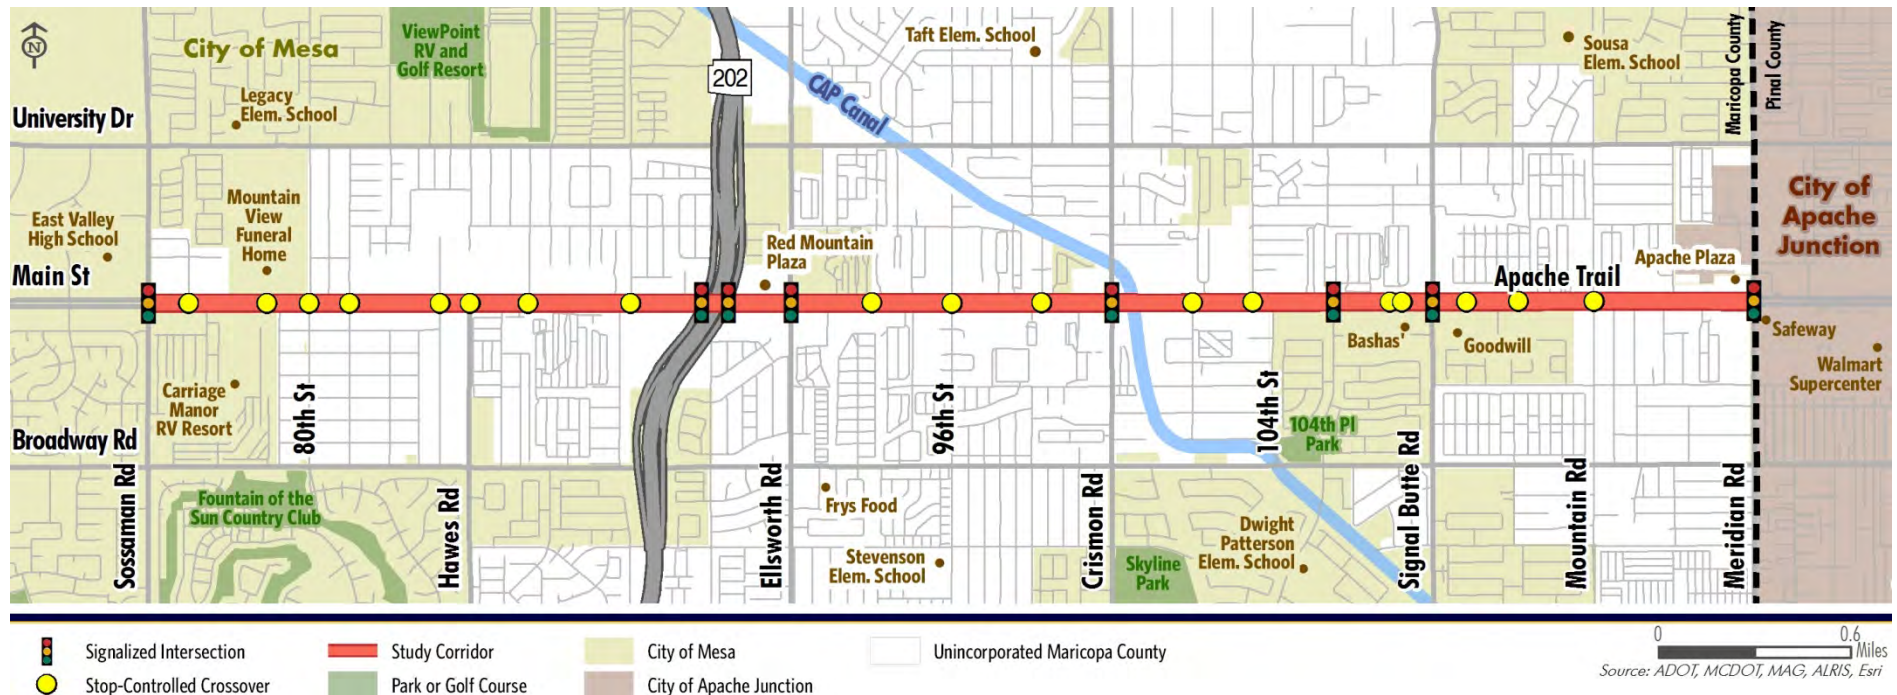
Figure 3.2: Traffic Control

Figure 3.2 illustrates the location of the eight traffic signals located along the study corridor. Several of the traffic signals operate with a Quad-Sequential phasing that allows the inside of the intersection to clear prior to signaling for the northbound and southbound turning lanes to move. In addition to the traffic signals, there are 18 stop-controlled crossovers located approximately every 1/8 to 1/4 mile along the corridor. As shown on right, many left-turn storage lanes are short causing backups on US 60X. Crashes that have occurred at the crossovers are typically angle (front to side); many of these crashes are from motorists trying to cross US 60X and pulling out in front of traffic in attempt to enter the crossover.

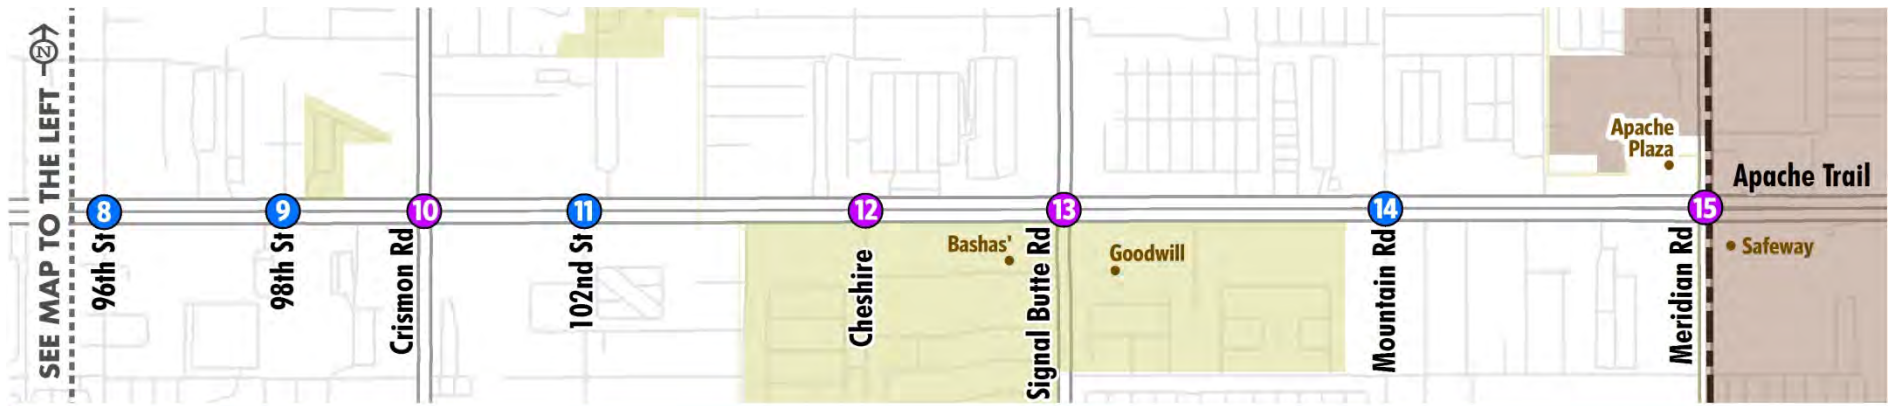
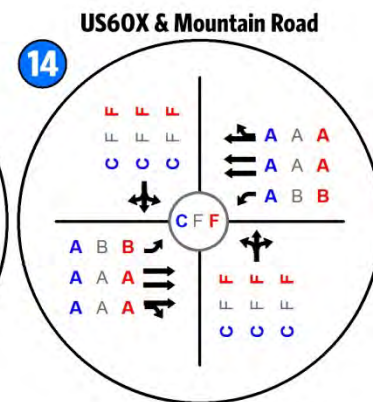
Figure 3.6: Existing Intersection Level of Service

The existing traffic signal timings were obtained from the operating agencies and used in the model to best represent existing conditions. Figure 3.6 displays the results of the operational analysis with LOS for the AM, Midday, and PM peak hours for each intersection movement and the intersection as a whole. All signalized intersections currently operate at LOS C or better except:

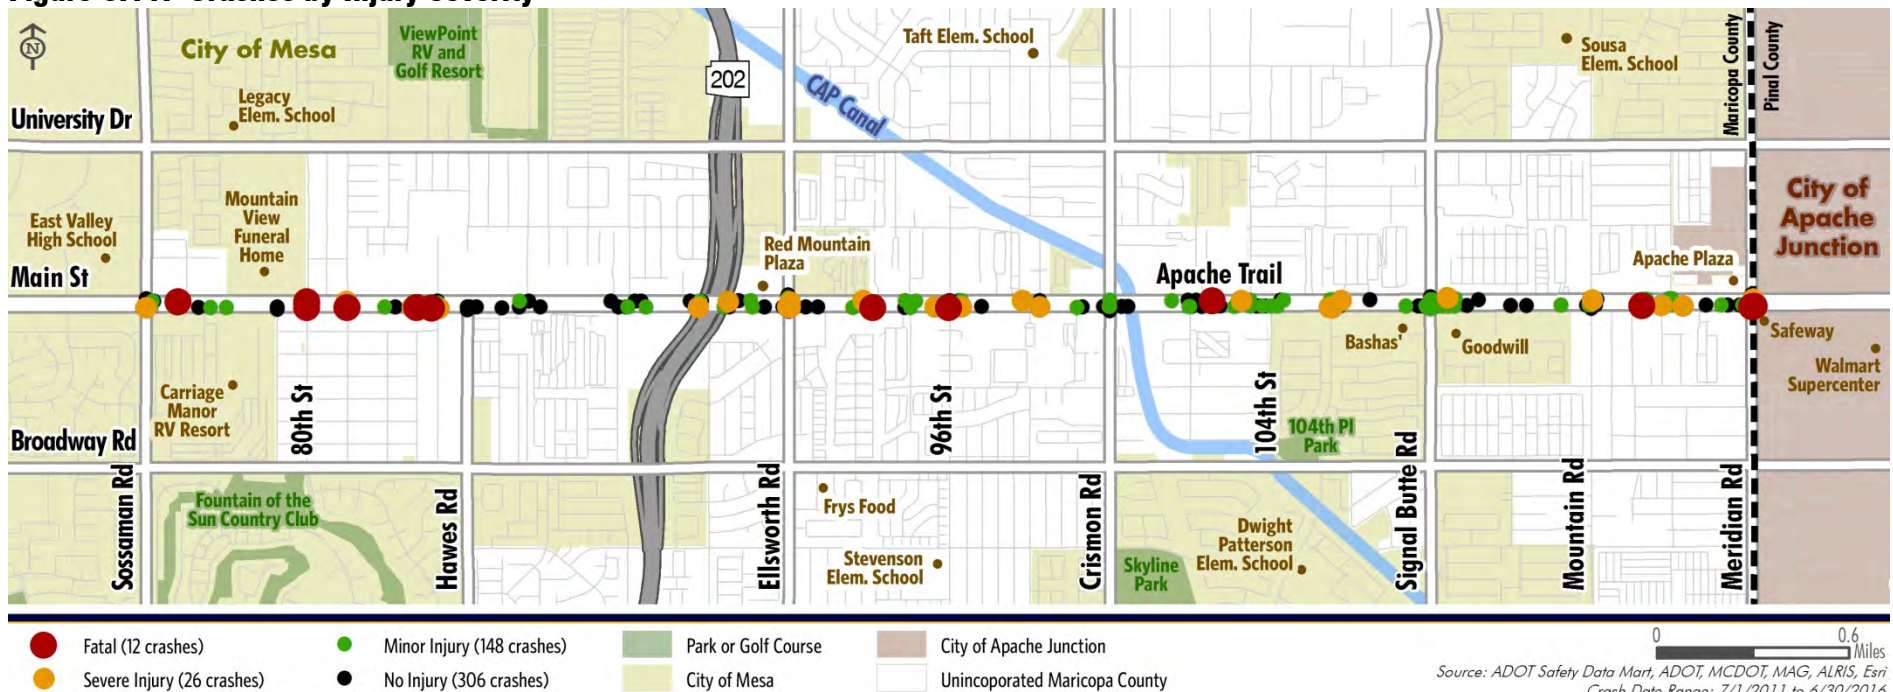
Figure 3.11: Crashes by Injury Severity

The ADOT Safety Data Mart characterizes crash severity by the following categories: no injury, possible injury, non-incapacitating injury, incapacitating injury, fatal, and unknown. For this study, incapacitating injury crashes represent “severe injury” crashes and possible injury and non-incapacitating injury crashes represent “minor injury” crashes. Figure 3.11 provides an illustration of the locations of crashes by injury severity. During the analysis period, there were 12 fatal crashes and 26 severe injury crashes along the corridor. It is important to note that numerous non-roadway safety issues, such as not wearing a seatbelt or vehicle condition, may result in a crash fatality.

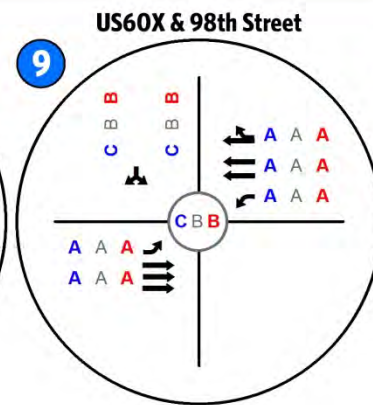
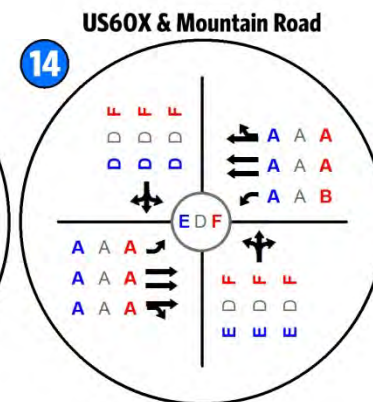
Figure 3.18: Projected Long-Term (Year 2040) Level of Service

Figure 3.17 displays the projected AM, Midday, and PM peak hour turning movement volumes for the long-term planning horizon. Figure 3.18 illustrates the overall intersection LOS, and LOS at each turn movement for each leg/approach at each intersection. Table 3.5 lists the overall intersection LOS for the AM, Midday, and PM peak hours. As illustrated in the Figures and Table, all unsignalized intersections (except for 88th and 98th Street) operate at LOS D or worse during at least one peak period. The unsignalized intersections of 80th Street and 96th Street have the worst overall operations with LOS E or F for all periods. The signalized intersections of Sossaman Road, Ellsworth Road, and Crismon Road operate at a LOS D during the AM and PM periods, and Meridian Road operates at a LOS D in the PM period.

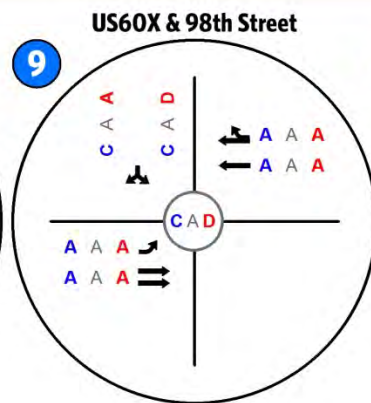
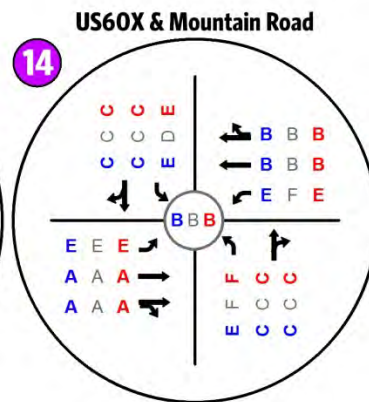
Figure 4.10: Ultimate Configuration Alternative 2 - Projected Short-Term (Year 2025) Intersection Level of Service

Figure 4.10 illustrates the current overall intersection LOS, and LOS for each turn movement for each leg/approach at each intersection. Table 4.8 lists the overall intersection LOS for the AM, Midday, and PM peak hours.

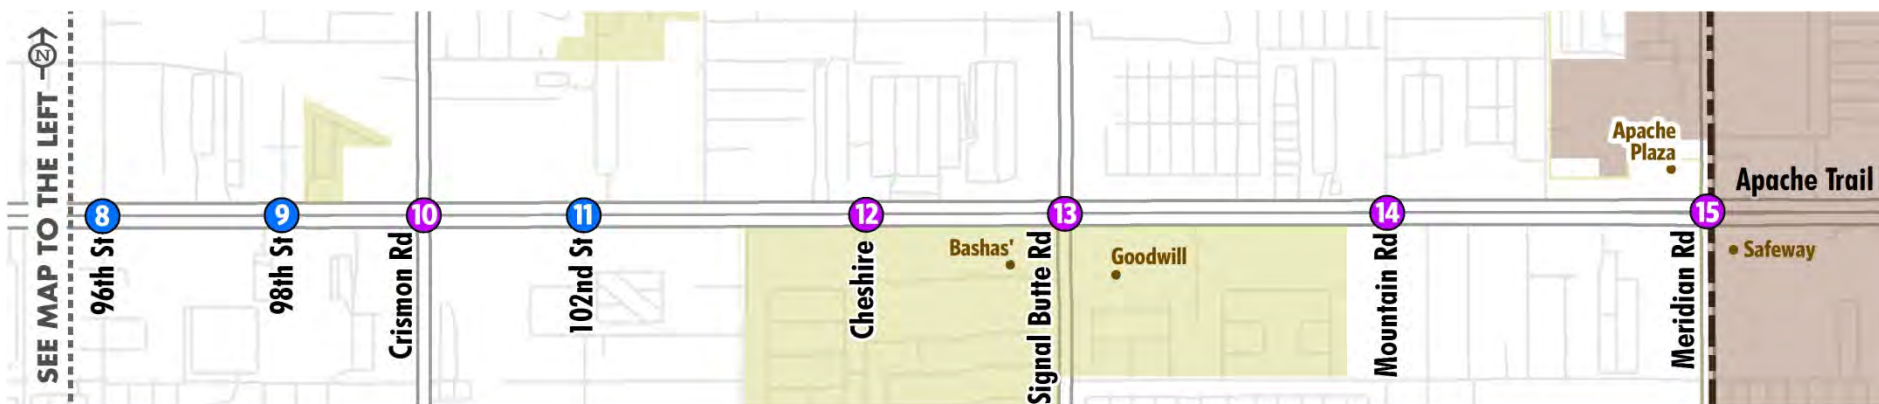
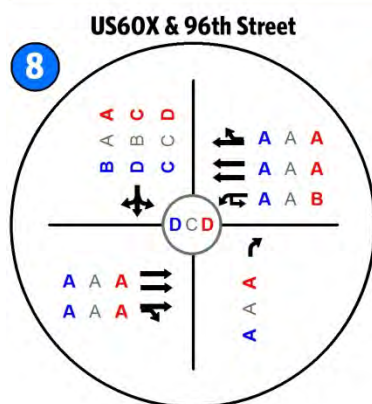
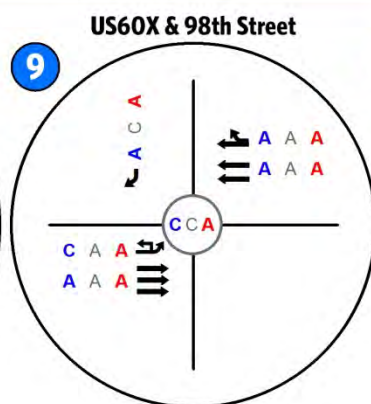
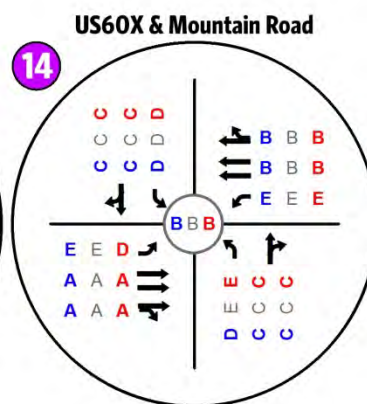
Figure 4.11: Ultimate Configuration Alternative 2 - Projected Long-Term (Year 2040) Intersection Level of Service

Figure 4.11 illustrates the current overall intersection LOS, and LOS for each turn movement for each leg/approach at each intersection. Table 4.9 lists the overall intersection LOS for the AM, Midday, and PM peak hours.

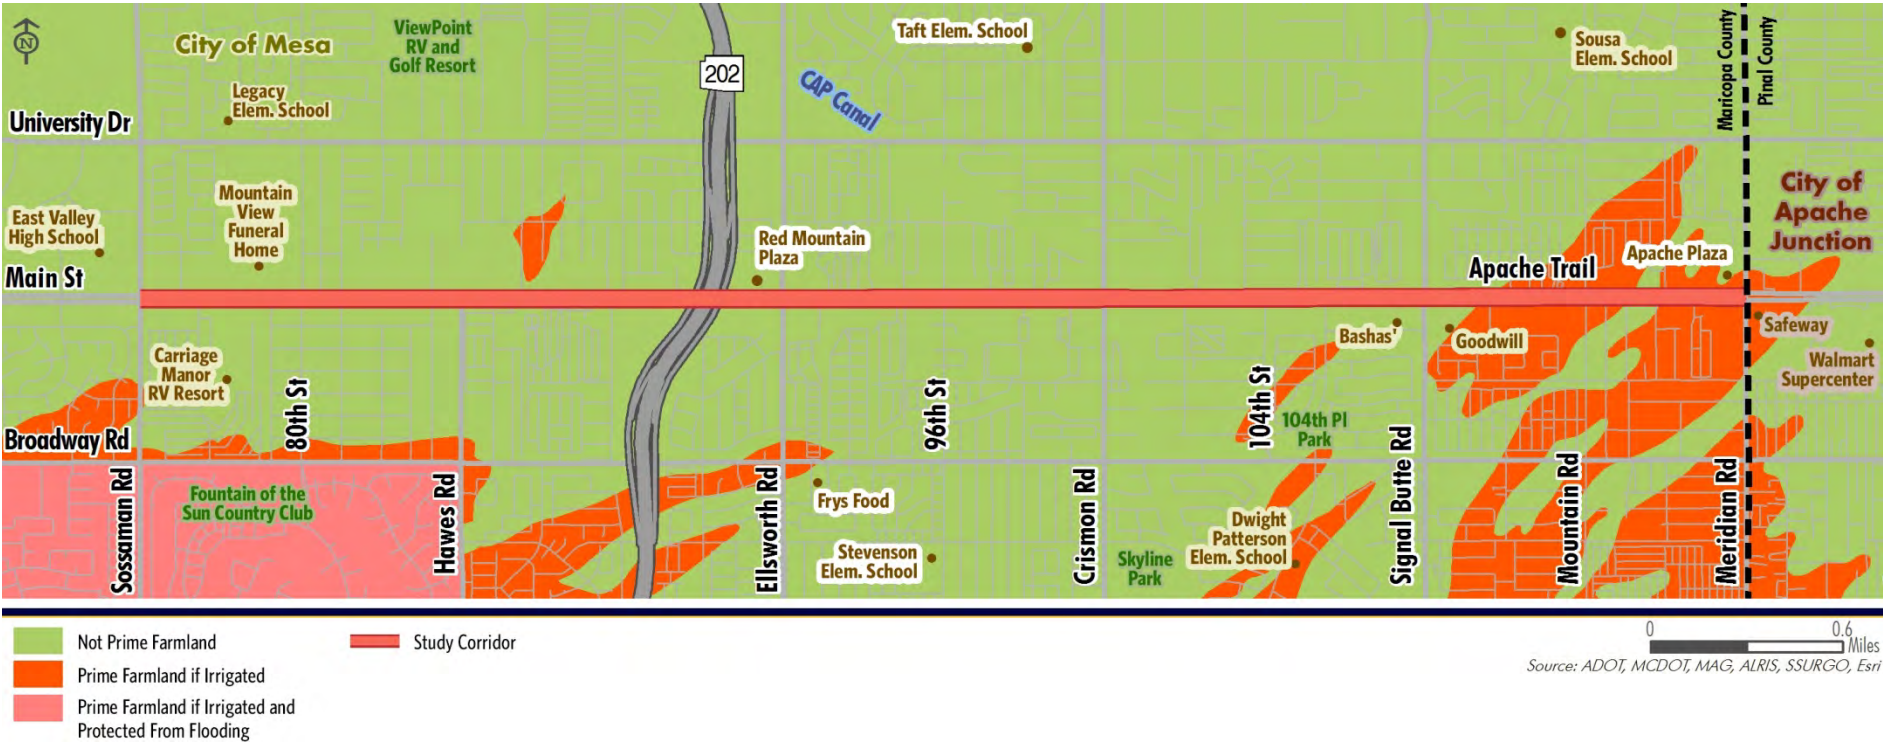
Figure 5.2: Prime and Unique Farmlands

The study area is located in the Natural Resources Conservation Service's (NRCS) Soil Survey Geographic (SSURGO) Database soil survey area AZ 645. According to the Soil Survey and based on soil characteristics, there are areas designated as 'Prime farmland if irrigated' within the survey AZ 645 that cross over the eastern end of the study corridor. However, since the area is identified as "urban" within the 2010 census¹ and no active agriculture is occurring, the areas adjacent to US 60X would not be considered prime or unique farmland. Figure 5.2 illustrates the location of prime and unique farmland.
