1.0 Introduction

The Arizona Department of Transportation (ADOT), in partnership with the Federal Highway Administration (FHWA), has initiated a design concept study and environmental studies to evaluate the proposed improvements to I-40 in Coconino County, Arizona. The study area begins west of the I-40/Bellemont Traffic Interchange (TI) at milepost (MP) 183.0 and extends east to MP 214.0, east of the Winona TI. The study area is located within ADOT's Flagstaff District.

The purpose of this project is to improve operations and reduce congestion by adding capacity to I-40 from west of the Bellemont TI to east of the Winona TI. The study will develop and evaluate feasible alternatives to meet the capacity needs for the design year 2040, as well as interim (short-term) improvements. This study will identify a range of improvements, such as the widening of I-40, redesigned interchanges, and proposed new interchanges, based on the results of preliminary engineering and environmental technical studies. The results of the engineering analysis are documented in this Design Concept Report (DCR), and the results of the

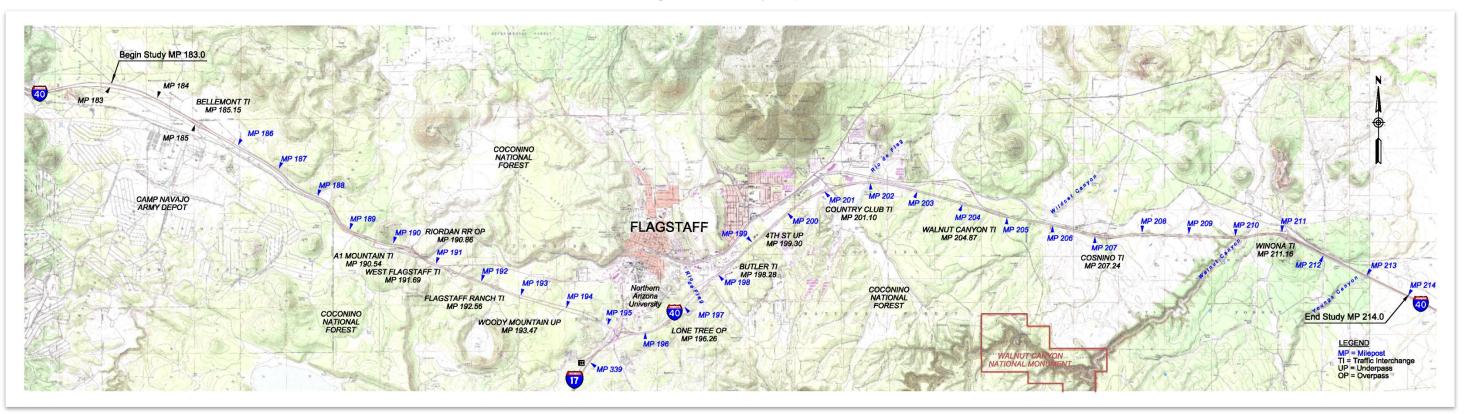
Figure 1 – Location Map

The study area begins on I-40 at approximately MP 183.0, west of the existing Bellemont TI, and extends east to approximately MP 214.0, east of the Winona TI. The project limits also include the northern terminus of I-17 at the I-40 system interchange and all of the ramps associated with the system interchange. A location map detailing the study limits and the surrounding area is shown on Figure 1. A vicinity map is shown on Figure 2.

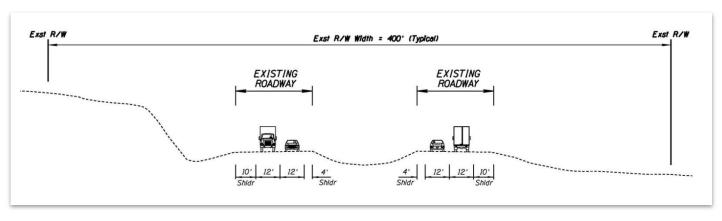
Figure 3 – Existing Typical Section

Mainline lanes average twelve feet in width, with ten-foot outside shoulders and four-foot inside shoulders. The existing highway cross slope is 1.5% in tangent sections except in the westbound direction from approximately MP 205.5 to MP 208.5 the cross slope is 2.0%. Some segments of the westbound roadway were originally a two-way highway (US 66) and were constructed with a parabolic crown rather than a straight left-to-right cross slope. Figure 3 shows the existing typical section of the highway.

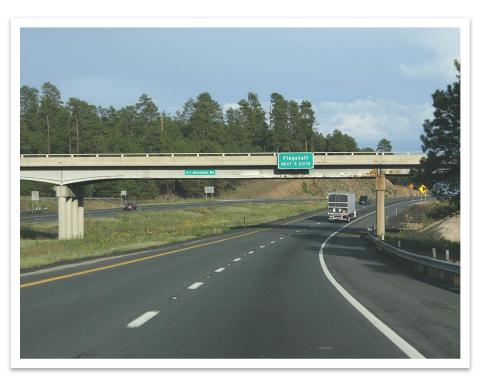
Photograph 1-1. I-40 at A-1 Mountain Road, looking east.

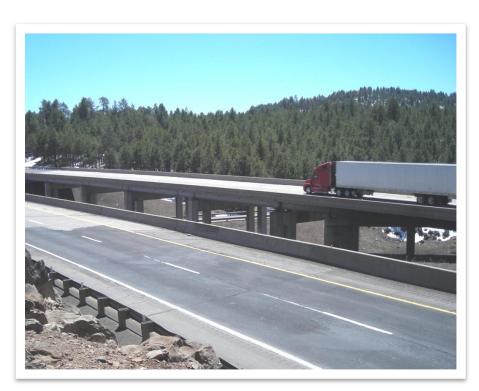
Photograph 1-2. I-40 Riordan railroad overpass, looking south.

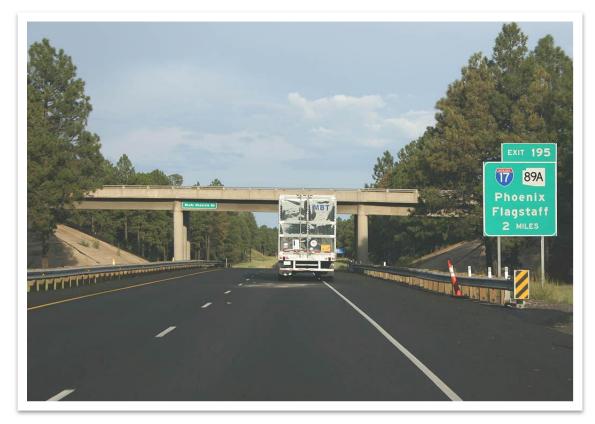
Woody Mountain Road is a local road which crosses over I-40 at milepost 193.47. There is no existing access to the interstate at this location.

Photograph 1-3. I-40 at Woody Mountain Road, looking east.

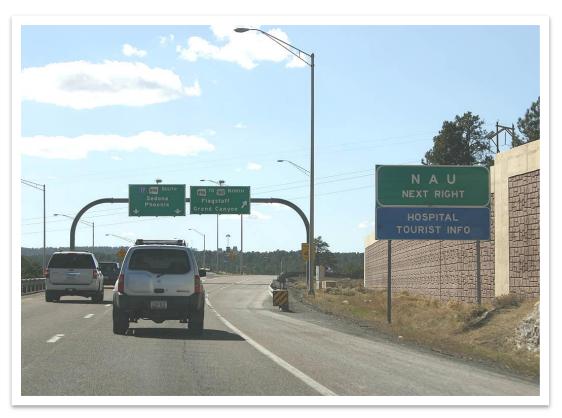
Photograph 1-4. I-40 at system TI, looking west.

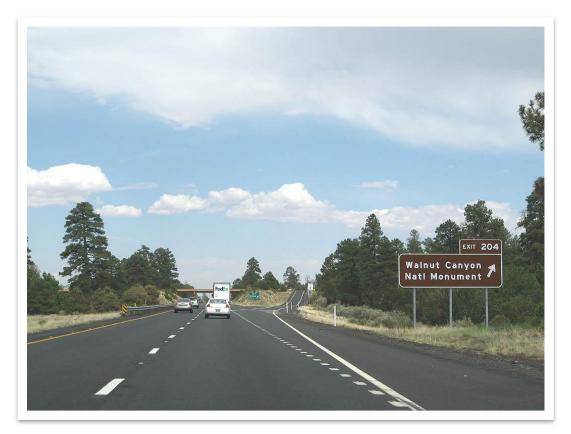
There are three service interchanges within this segment. The Walnut Canyon TI (MP 204.87) is a diamond interchange. This interchange provides access to the Walnut Canyon National Monument to the south and Old US 66 to the north. The short westbound entrance ramp connects to the two-way cross road approximately 2000 feet west of the other three ramps.

Photograph 1-5. I-40 at Walnut Canyon TI, looking east.
