CLIFTON – ZORILLA STREET BRIDGE PRE-SCOPING

MPD 009-16

PRE-SCOPING DOCUMENT

OCTOBER 2015

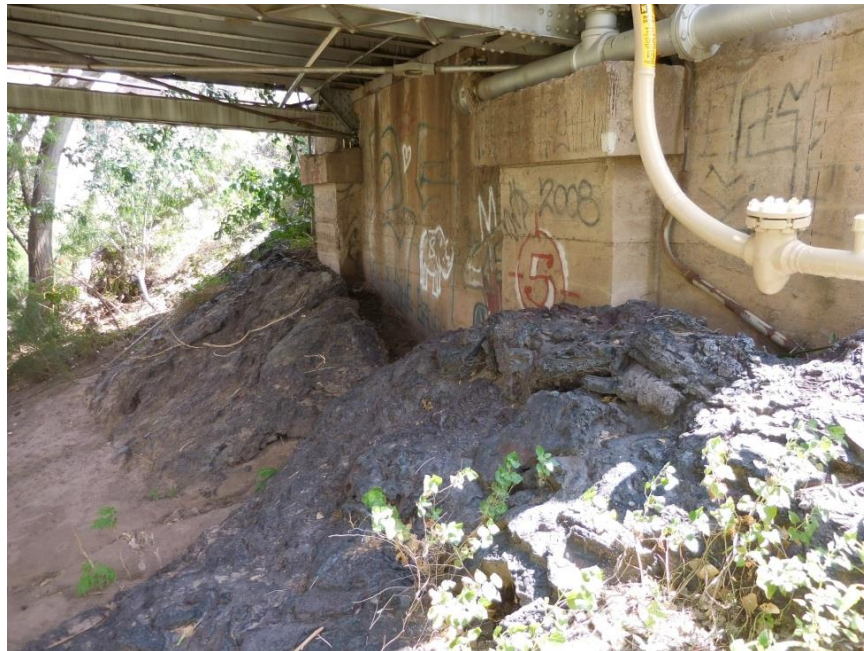
Two different efforts at providing scour protection are present at the bridge abutments. One is a large masonry/rock wall running along the east bridge abutment (see included photo) and the other is dumped slag (molten rock refuse from mining operations) in and around the west abutment. The depth and sufficiency of these two ad-hoc scour protection features is unknown. However, there are no visible signs or known history of erosion around the bridge abutments, despite the occurrence of several extreme flow events during its nearly 100-year life.

West Abutment – Poured mine slag used as scour protection (Gas main shown)

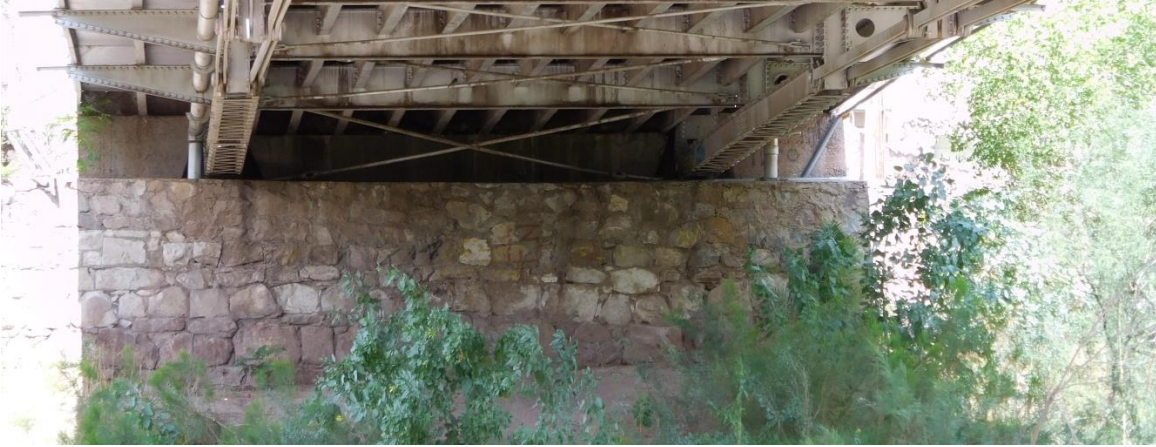
East Abutment – Rock wall built in front of abutment

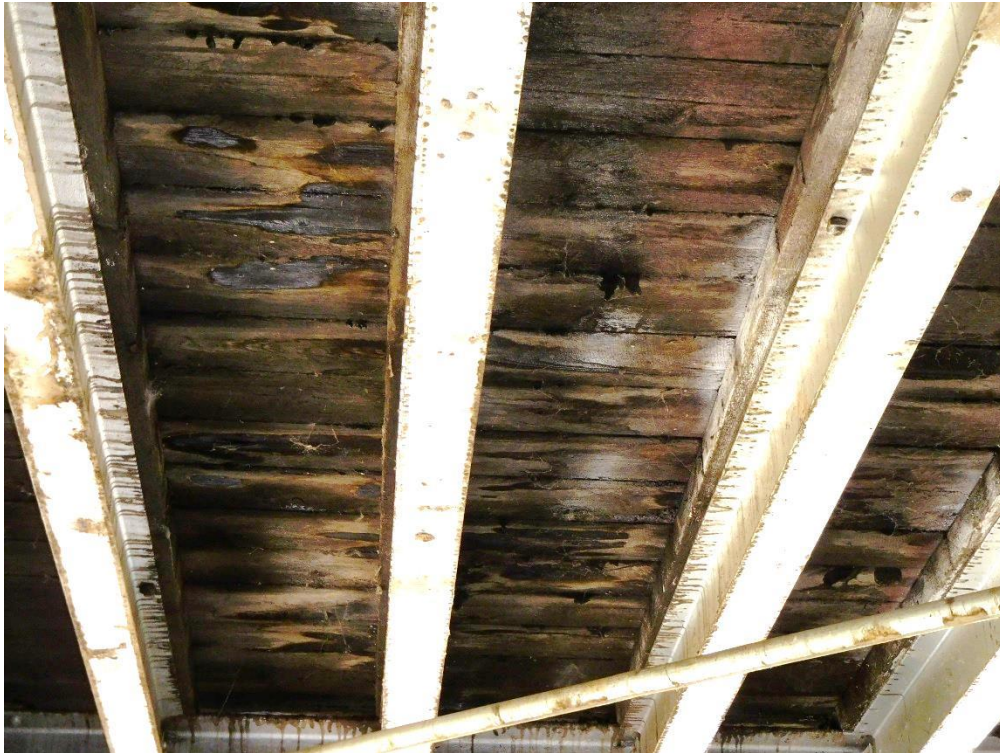
Wood Bridge Deck – Looking up from below

- Sampling/testing of the wood deck to determine adequacy
- Replacement of damaged wood deck members

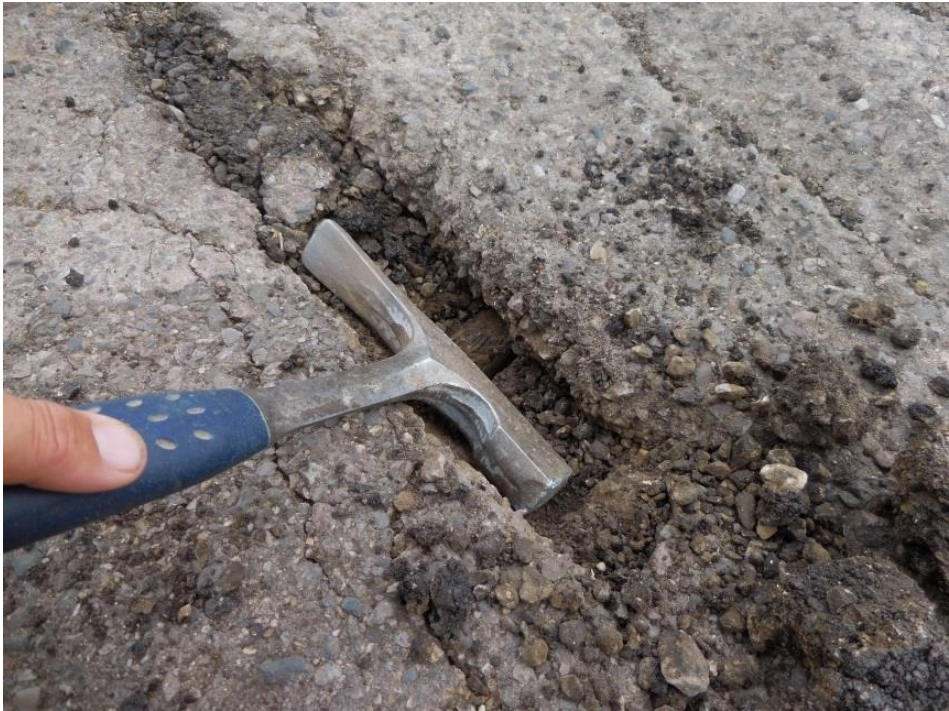
The existing asphalt surface is cracked and potholed. The asphalt depth is approximately 2” thick (see attached photo). Cracked nuts on the truss pins were observed in the superstructure.

Asphalt Pavement Deck - ~2" Thickness

- Rehabilitation of the bridge deck wearing surface
- Replacement of cracked and broken pin nuts
- Removal of rust/repainting
- Installation of an inside bridge railing to protect the steel trusses
- Changing of the vertical clearance sign to 10’-3” from 10’-4”

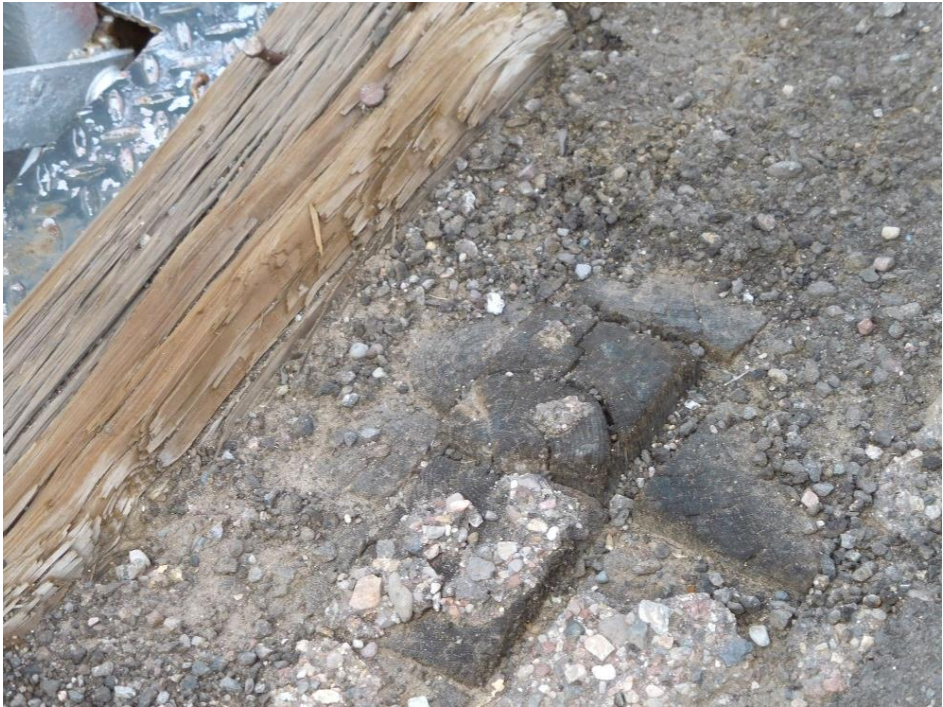
Severed wood posts cut flush with the asphalt surface are present at each vertical steel truss member (see attached photo). These posts may once have served to support bridge railing inside of the steel super structure.

Severed Wood Post Next to Wooden Pavement Edge

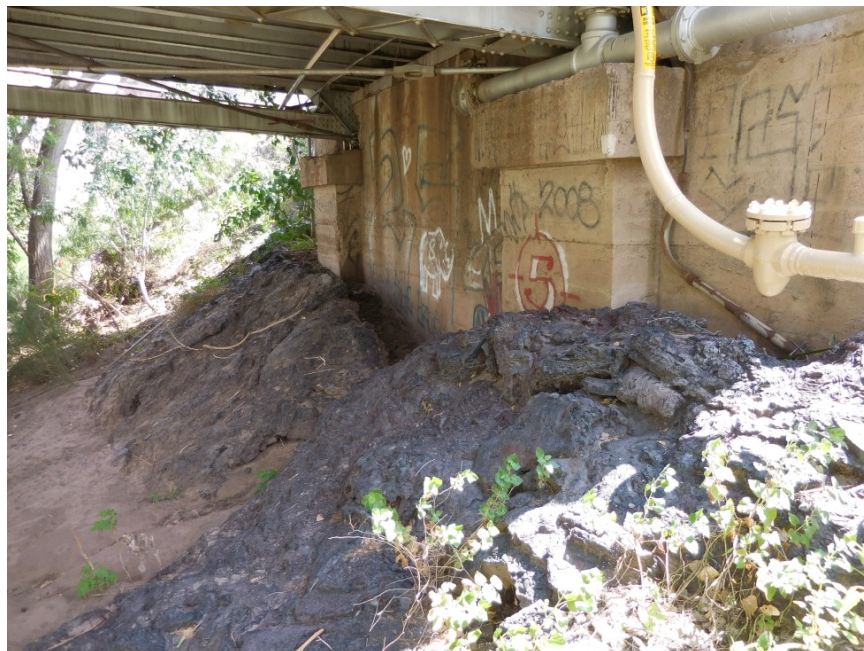
Town different types of scour protection were observed at the bridge abutments. This protection included a large masonry/rock wall running along the east bridge abutment (see included photo and dumped slag (molten rock refuse from mining operations) in and around the east abutment. The depth of these two scour protection features is unknown. No visible signs of erosion around the bridge abutments were noted.

West Abutment – Poured mine slag used as scour protection (Gas main shown)

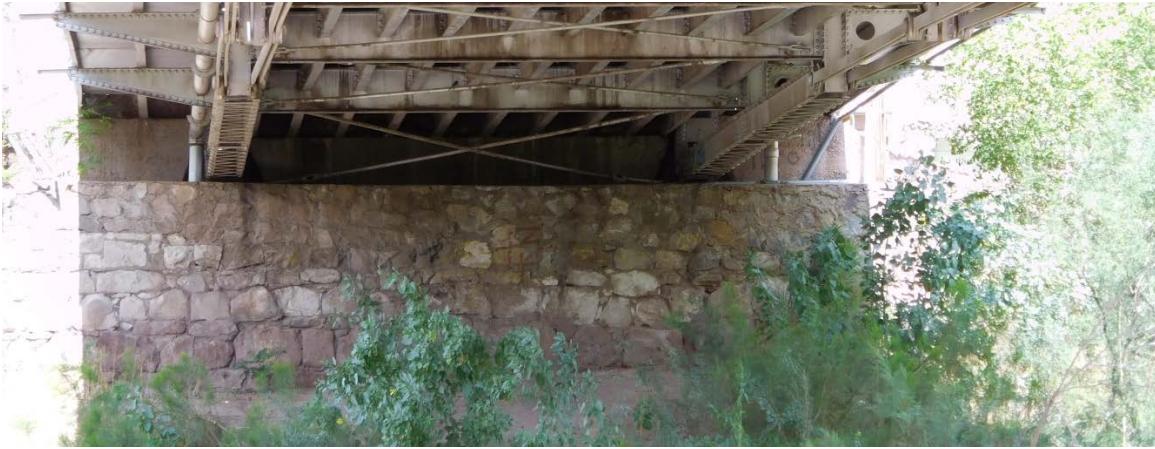
East Abutment – Rock wall built in front of abutment

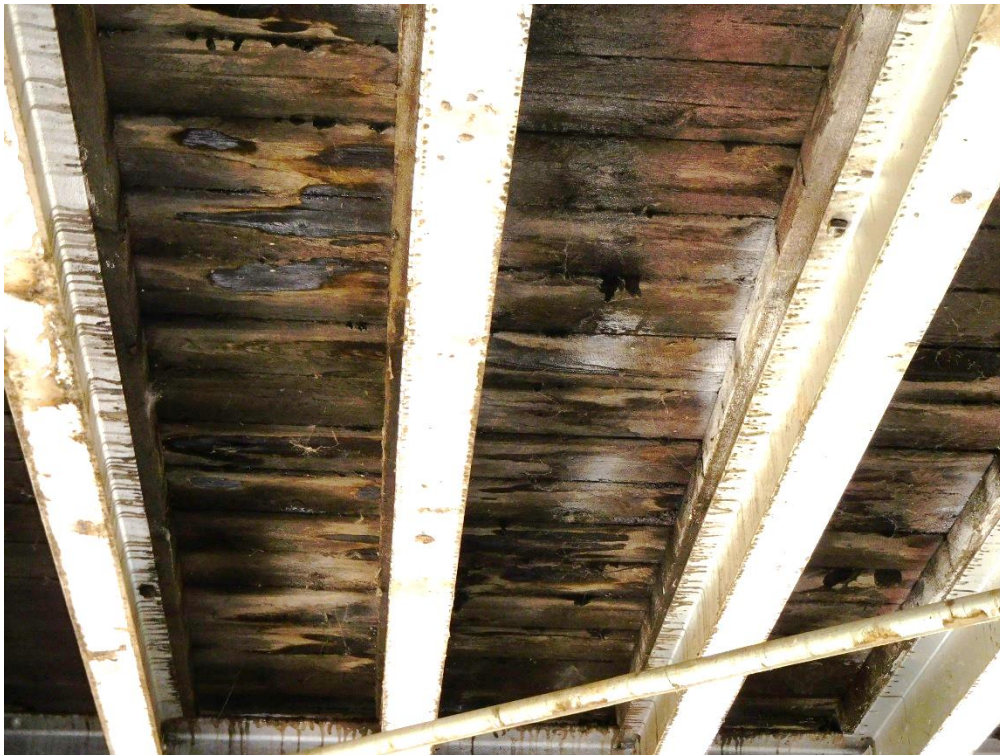
Wood Bridge Deck – Looking up from below

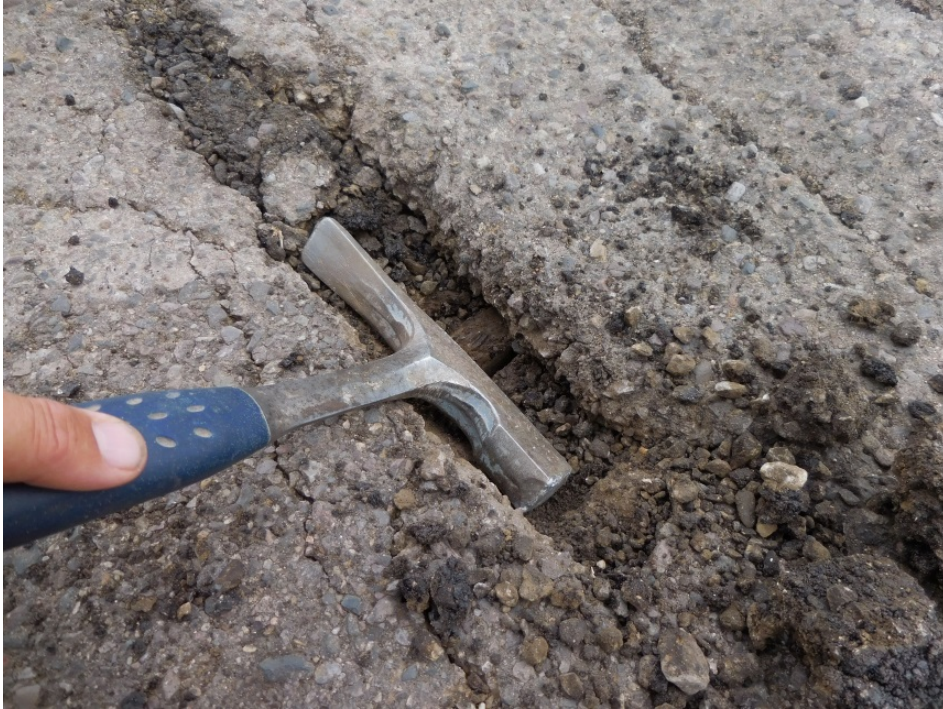
The existing asphalt surface is cracked and potholed. The asphalt depth was observed to be about 2” thick (see attached photo).

Asphalt Pavement Deck - ~2" Thickness

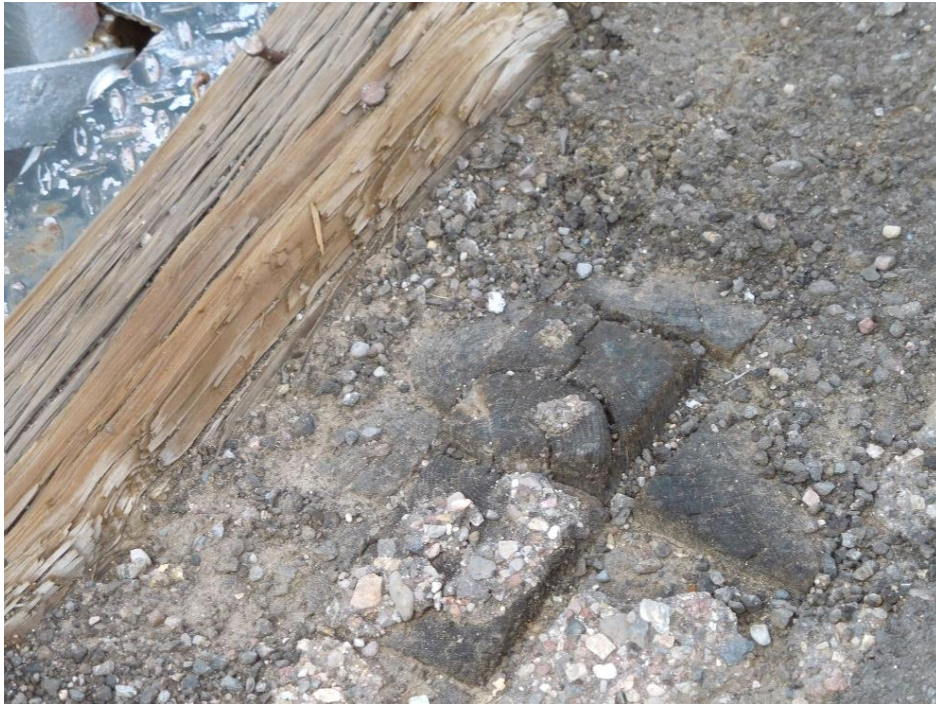
Severed wood posts cut flush with the asphalt surface were noted at each vertical steel truss member (see attached photo). It appeared that these posts may once have served to support bridge railing inside of the steel super structure.

Severed Wood Post Next to Wooden Pavement Edge
