# Chinle to Many Farms Safety Improvement Study

## Final Report

Prepared for Arizona Department of Transportation

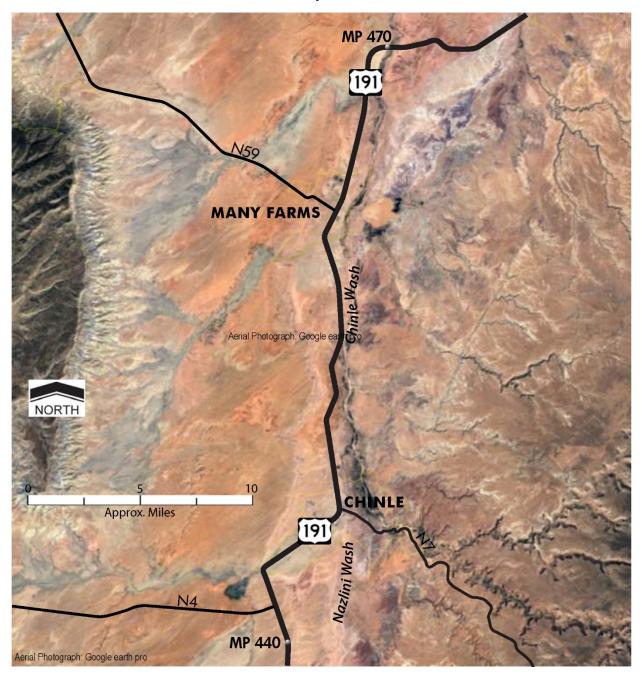
Figure 1.1 Study Area

This report describes existing conditions and anticipated future conditions within a study area along US-191 from Milepost (MP) 440, near Navajo Route (N) 4/Pinon Road, and MP 470, north of Many Farms at Chinle Wash. This study area, shown in **Figure 1.1**, includes the communities of Chinle and Many Farms, which are recognized Chapters within the Chinle Agency of the Navajo Nation Tribal Government. These two Chapters are both Census-Designated Places (CDPs). US-191 serves as the primary route of social and economic activity for the Navajo Nation.

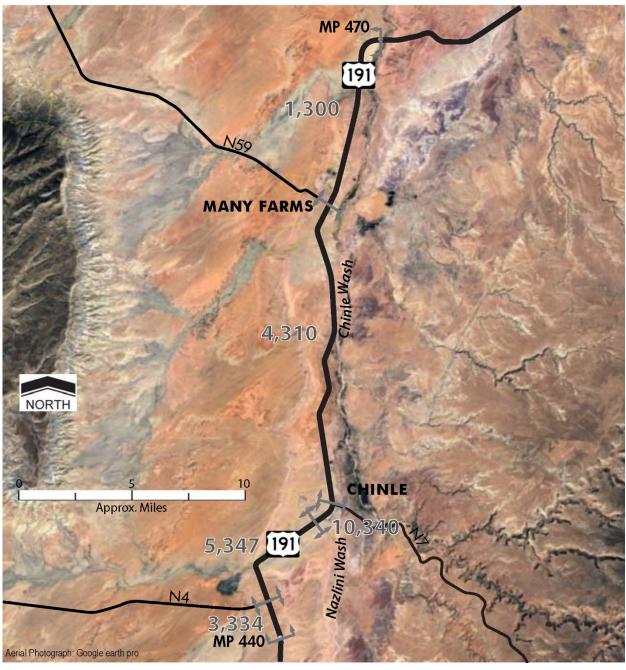
Figure 2.3 Segment Traffic Volumes

Source: Data Source: Highway Performance Monitoring System (HPMS) Location Report for Year – 2015, Multimodal Planning Division, Arizona Department of Transportation (ADOT).

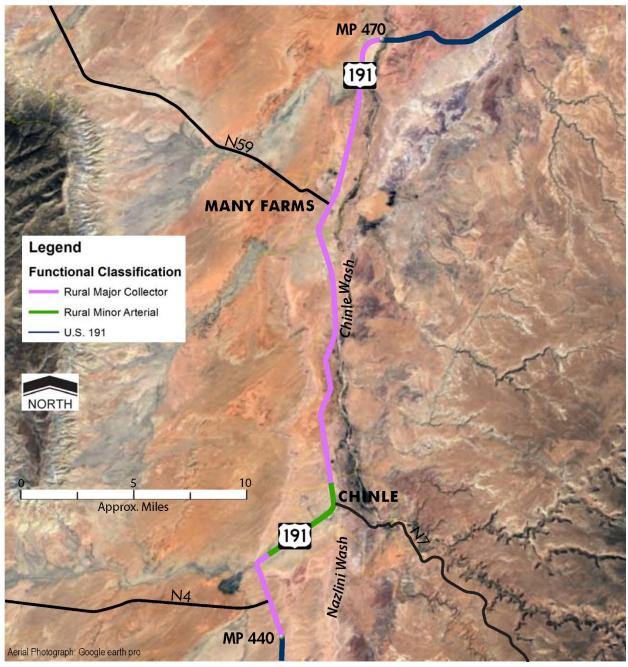
Figure 2.4 Functional Classification of US-191: MP 440 to MP 470

Source: Highway Performance Monitoring System (HPMS) Location Report for Year – 2015, Multimodal Planning Division (MPD), Arizona Department of Transportation (ADOT).

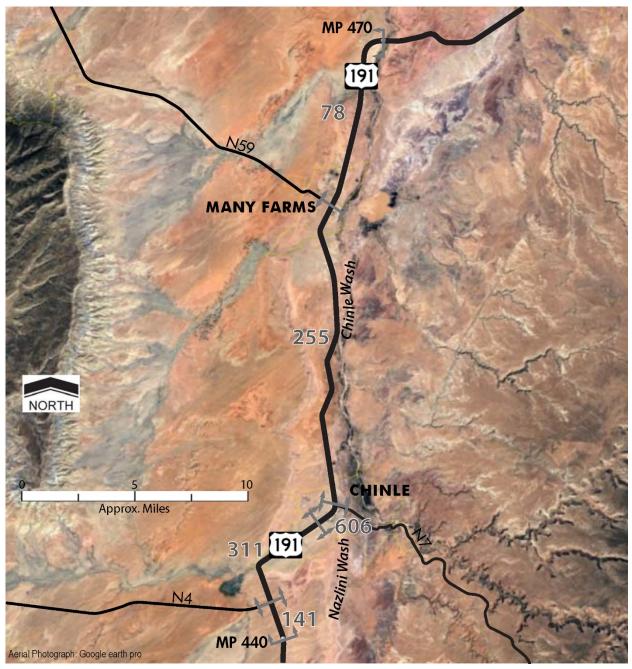
Figure 2.5
Average Daily Truck Traffic by Segment

Source: Data Source: Highway Performance Monitoring System (HPMS) Location Report for Year – 2015, Multimodal Planning Division, Arizona Department of Transportation (ADOT).

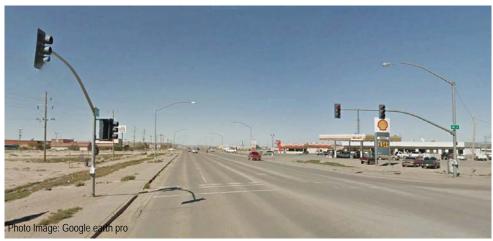
Figure 2.12
Faded Crosswalk Northbound Approach

What appears to have been crosswalk stripping between the west side of US-191 and the sidewalk at the southeast corner of the intersection is all but obliterated (Figure 2.12). Similarly, extremely faded crosswalk stripping is present for the crossing between the southeast and northeast corners of this intersection (Figure 2.13).

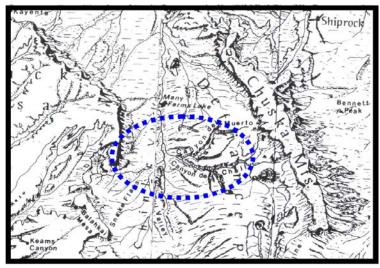
Figure 3.1
General Topographic Features of the Study Area

The southern end of the study area is dominated by the deep canyons of Canyon de Chelly complex the to east (Figure 3.1). The rim of Canyon de Chelly National Monument at the edge of the Fort Defiance Plateau is a prominent feature. The study area extends north and west to the Lohali Mesa and Bitter Water Basin at the foot of Black Mesa. The rugged eastern boundary gives way relatively flat and gently sloping plateau in the middle section

Note: Chinle Chapter is highlighted with blue dashed line; Many Farms Chapter area is directly north.

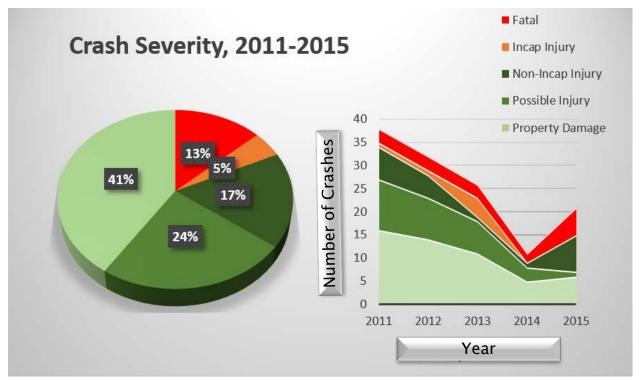
Figure 4.7 US-191 Crash Severity and Trends: 2011 – 2015

Almost two-thirds of crashes resulted in property damage only (PDO) or in "possible" injuries. The remaining third involved an injury of some nature (refer to **Figure 4.7**). Thirteen percent of crashes resulted in one or more fatalities, which is extraordinarily high, as less than one percent of crashes statewide involved fatalities. Apache County fatalities also were considerably lower, although notably higher than the State as a whole; there were only 38 fatal crashes (resulting in 46 fatalities) associated with 398 crashes in 2015 or 9.5 percent. The higher incidence of fatalities in Apache County, as well as the study area, can be attributed to a number of factors largely associated with operating vehicles in rural areas, including: speed, poor lighting, two-lane roadways, and inability to effect rapid emergency responses to the crash scenes.

The number and severity of crashes declined steadily from 2011 to 2014 in each category (**Figure 4.7**). Then, every category increased in 2015, except Possible Injury, which continued to decline. Property Damage increased, but only slightly. **Figure 4.7** reveals 35% of crashes resulted in a certain injury of some severity (13% Fatal + 5% Incapacitating Injury + 17% Non-Incapacitating Injury). Twelve of the 23 crashes resulting in either fatal or incapacitating injuries occurred in the focus areas. They were proportionally distributed through Zones 1, 2, and 3, where the speed limit is higher. No fatal or incapacitating injury crashes occurred in Zone 4, which is much smaller and the volume of traffic is higher, but vehicle speeds are lower and more lanes create better traffic flow.

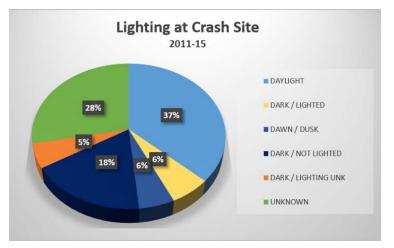
# Figure 4.8 Crash Light Conditions, 2011-15

**Figure 4.8** shows the proportion of crashes occurring during the 2011–2015 reporting period that were associated with varying light conditions. The location of these crashes in the corridor was depicted previously in **Figure 4.6**.

US-191 within the study area has artificial lighting covering only the most developed part of Chinle (Zone 4). Outside this segment of the highway, crash data revealed 53 percent of crashes occurred in Zones 1-3, where there is no street lighting. The data indicated 29 percent of crashes in these zones happened either "Dawn/Dusk," "Dark/Not Lighted," "Dark/Lighting Unknown" conditions. Additionally,

occurred in "Unknown Light" conditions. So, it is potentially possible that the actual proportion of crashes that occurred under no or low-light conditions falls between 29 and 57 percent.

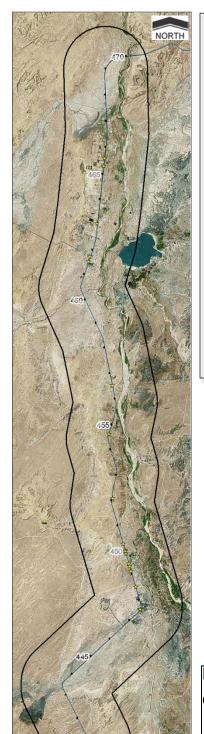
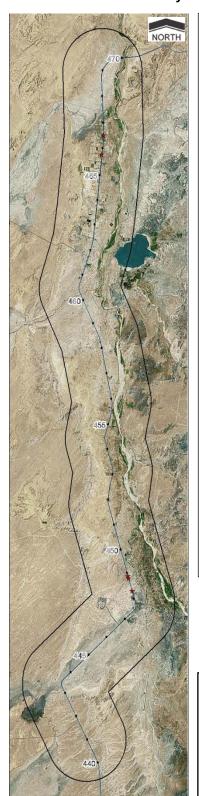
# Figure 4.11 Analyses of Three Crash Types

potentially can improve vehicle and pedestrian safety at specific locations. Selected crash types are mapped in **Figure 4.11**, identifying the general location of crashes, providing focused analyses and descriptions of existing conditions that may contribute to the prevalence of each crash type.

Twenty crashes classified as "sideswipe" "head-on" or occurred during 2011-2015 reporting period (Figure A). Thirteen occurred in the focus areas, with eleven clustered in the three zones associated with Chinle community. Nine crashes occurred in relation to vehicles entering or exiting the highway where three was no access control, i.e., driveways, access roads to fields, parking lots. The occurrence of this type of crash

Although crashes involving pedestrians do not necessarily result in serious injury to the pedestrian, vehicle/pedestrian conflicts favor the vehicle. All such crashes in the study area during the 2011-2015 reporting period resulted in a fatality. In both the ADOT and Nation data, Navajo presence of a pedestrian was listed as a cause of the crash. Unfortunately, the data do not specify how the pedestrian was involved.

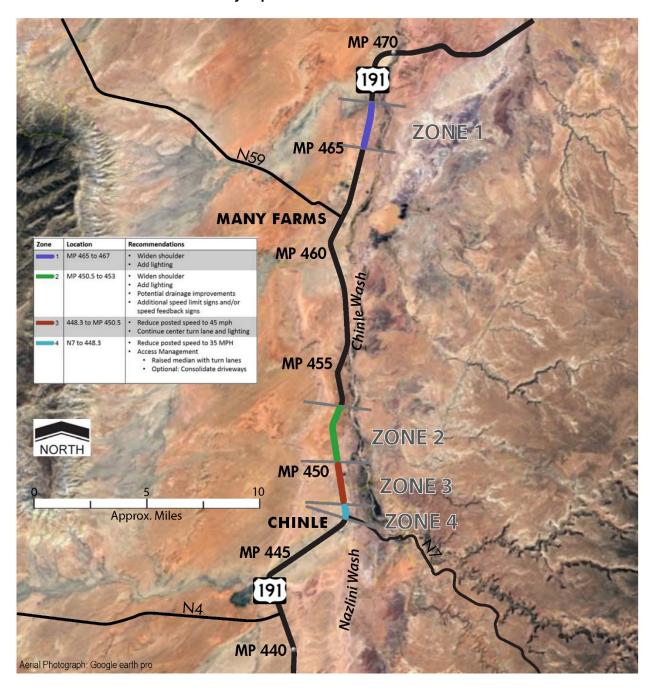
Figure 5.1 Safety Improvement Recommendations

The second category of improvement recommendations concentrates on the central portion of the Chinle community and highlights crash types that suggest the need for Access Control.

The third category identifies areas where road widening would improve safety. It also includes improvement recommendations focused on slow moving traffic situations that contribute to unsafe conditions by creating concentrations of vehicles in bottlenecks.

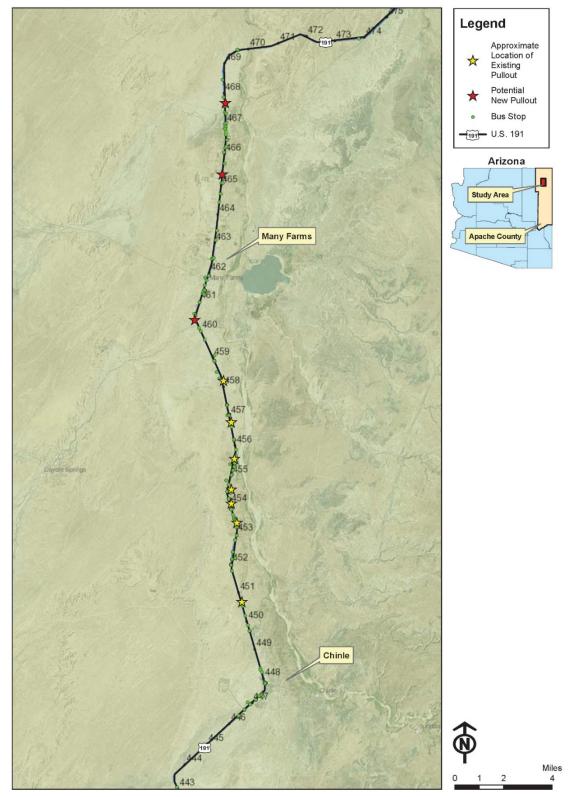
Figure 5.4 Existing and Proposed Bus Stops and Slow Vehicle Pullouts

There are three types of roadway improvement recommendations for the US-191 travel corridor through the study area: widening for a continuous left-turn lane, widening of shoulders, and pullouts for slow moving vehicles.
