Arizona Statewide Rest Area Study

Final Draft Working Paper 1

Existing Conditions and Data
Collection

Prepared For:
Arizona Department of Transportation

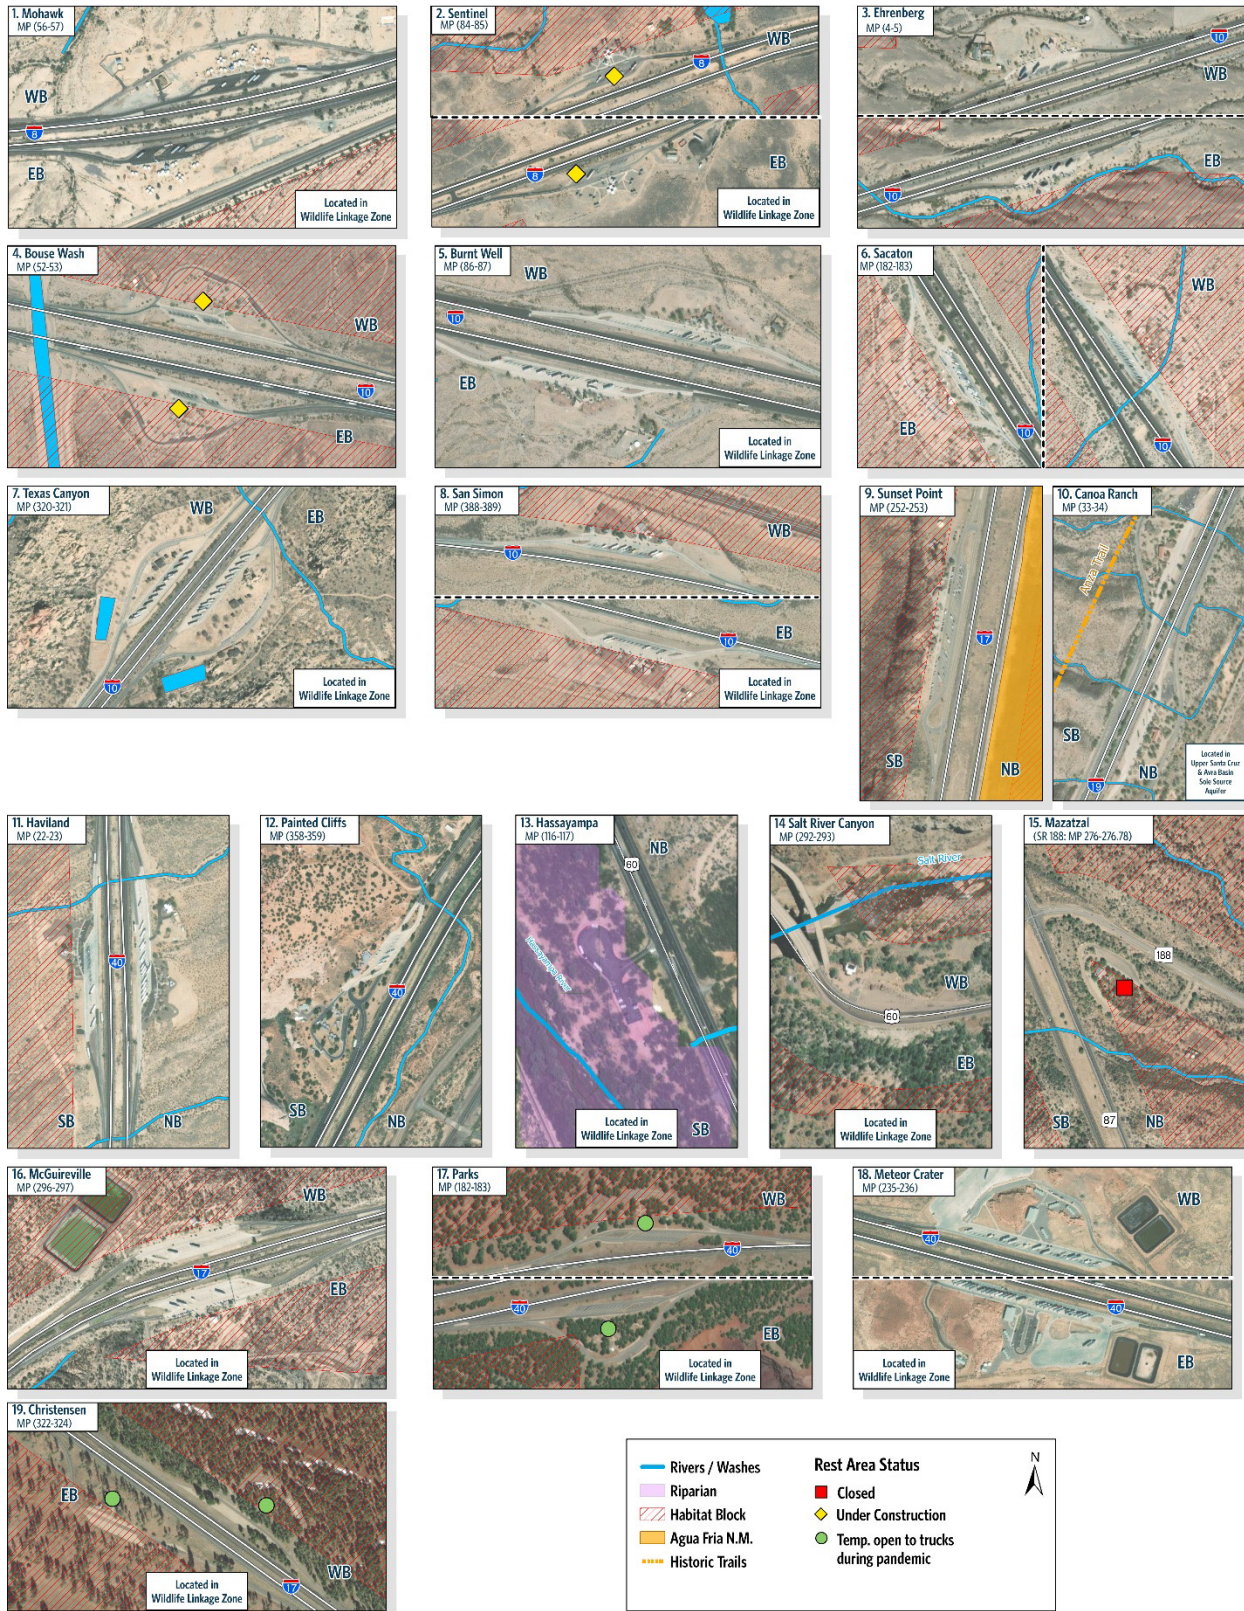
Figure 2-4. Preliminary Environmental Features

As presented in **Figure 2-4**, 13 rest areas are located adjacent to a habitat block and 11 are in a wildlife linkage zone. As defined by AGFD, a habitat block consists of important wildlife habitat that can reasonable expected to remain wild for at least 50 years, and a wildlife linkage zone is an area critical to wildlife movement. Coordination with AGFD is recommended during the rest area study and design processes.

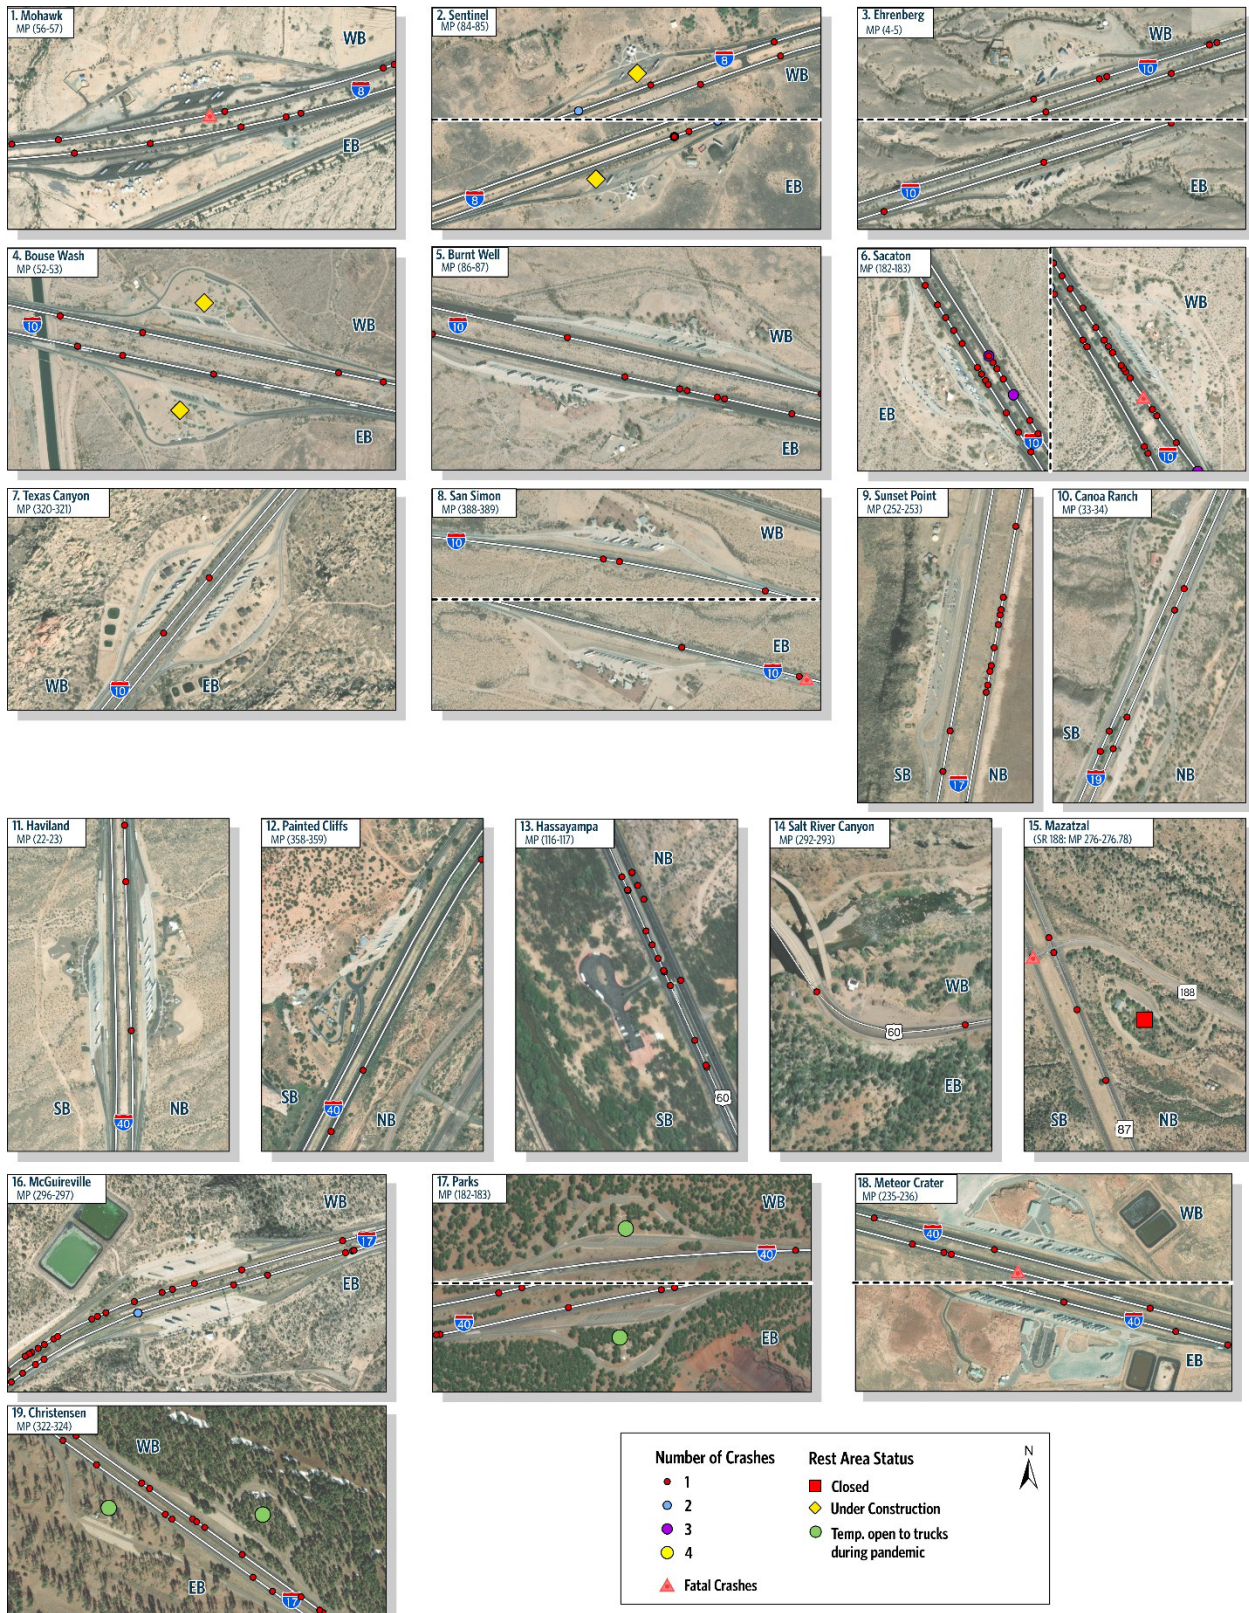
Figure 3-1. Crashes Near Rest Areas from 2017 to 2021

Figure 3-1 illustrates the crashes per location at each of the rest areas over the five-year analysis period. An analysis and brief discussion for each rest area including summaries of the various types of crash patterns is provided in **Appendix B**.

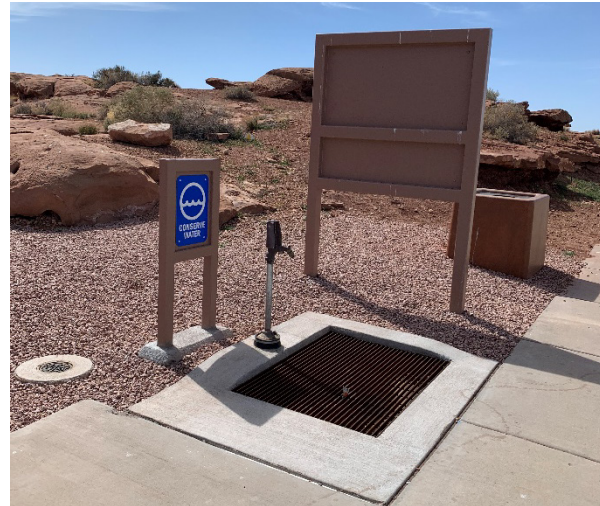
Water Conservation Pump – Meteor Crater Rest Area (EB)

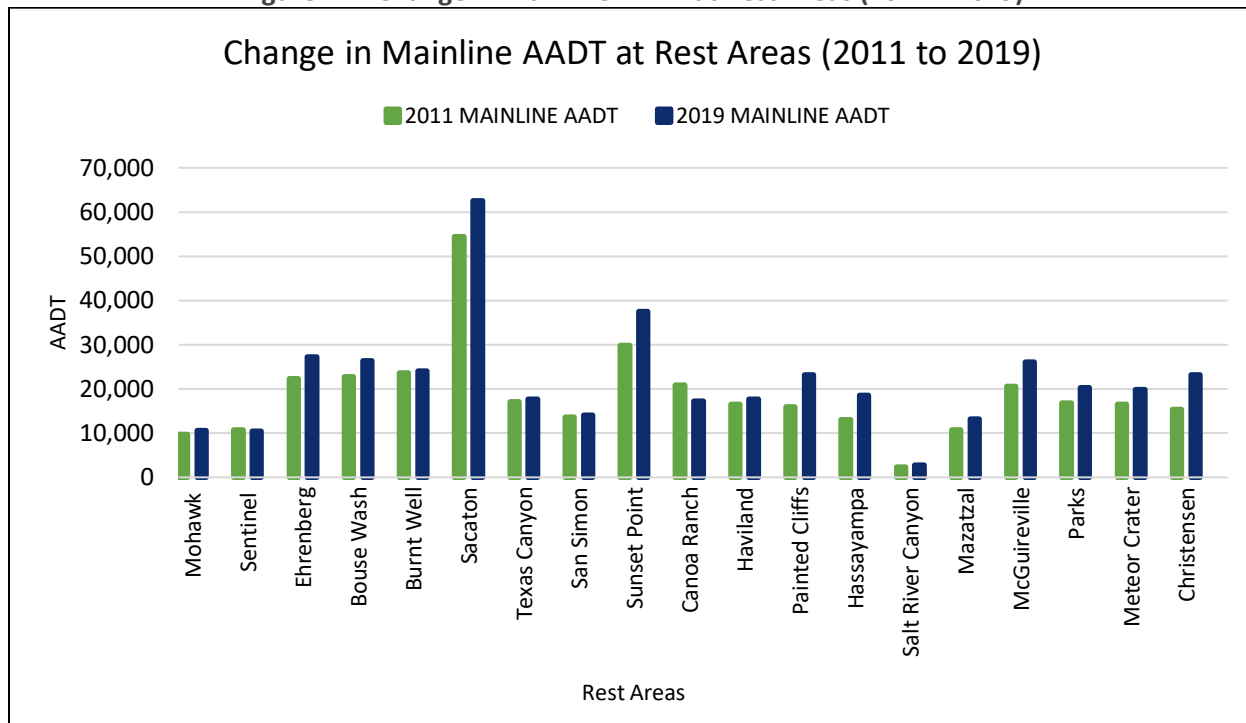
Figure 4-2. Change in Mainline AADT at Rest Areas (2011 – 2019)

rest areas saw the smallest percentage increase (2.2 percent, 3.4 percent, and 3.8 percent, respectively) during this timeframe. **Figure 4-2** presents the changes in AADT volumes from 2011 to 2019 at each of ADOT’s managed rest areas.

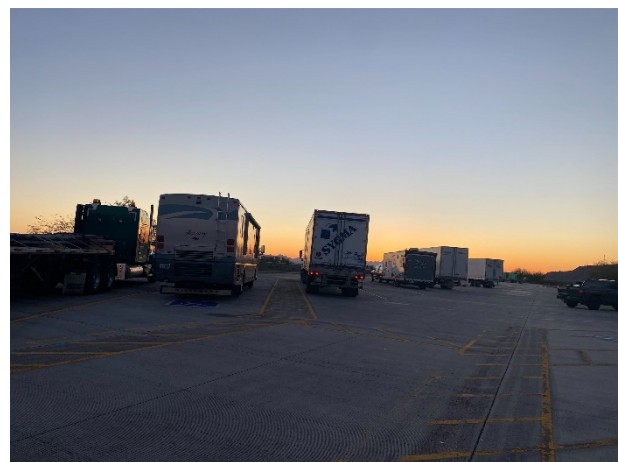
Trucks Parked at the Ehrenberg Rest Area (WB)

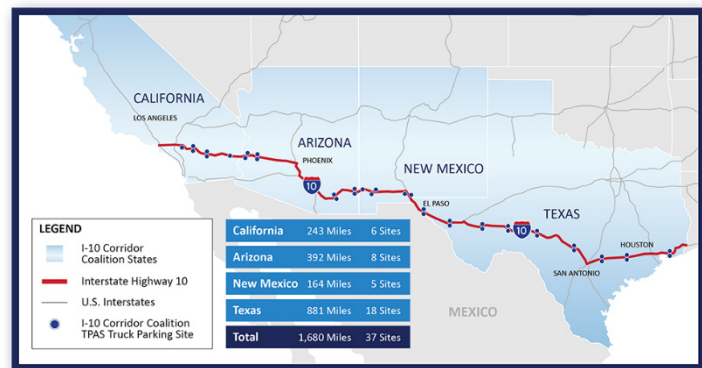
The most recent initiatives include the newly established I-10 Corridor Coalition, which is a joint effort among departments of transportation for California, Arizona, New Mexico, and Texas. This coalition was awarded a grant by the U.S. Department of Transportation to implement a Truck Parking Availability System (TPAS) along the I-10 corridor between California and Texas. The TPAS

project is being designed to detect truck parking availability at rest areas and to disseminate this information in real-time to commercial drivers. One goal of this project is to reduce the amount of time drivers spend looking for available parking, thereby reducing driver fatigue, as well as reducing the chance that drivers will park in undesignated locations. Therefore, the result of this project is expected to provide benefits such as improved mobility and safety, reduction of infrastructure damage and emissions, and reducing lost earnings for commercial drivers through increased efficiency and productivity.¹⁰ The TPAS system is being implemented at 4 ADOT rest areas (8 sites) along the I-10 corridor in Arizona, which include the Ehrenberg, Bouse Wash, Texas Canyon, and San Simon rest areas. Once completed, truck parking availability at those rest areas will be disseminated to drivers through use of dynamic messaging signs located before each rest area exit, as well as on the ADOT 511 website. According to ADOT, construction of TPAS at these 4 rest areas is expected to begin in the fall of 2022. In addition, ADOT plans to evaluate the potential for standardizing the TPAS system at the remaining rest areas following a period of operation and evaluation.

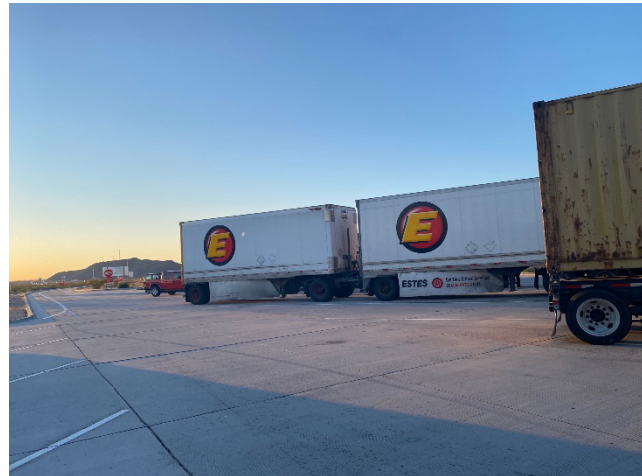
Truck Parking at Ehrenberg Rest Area (EB)

As part of the field visit data collection, the number of truck parking spaces being utilized during the time of each field was collected. The number of spaces used, as well as the calculated utilization rates are provided in **Table 4-10**. Although the amount truck parking spaces being used during the field visits is not a reliable indicator of each rest area’s overall truck parking utilization, it does provide some insight for truck parking at ADOT rest areas. It should be noted that the truck parking utilization was collected during peak truck parking hours (5:00pm to 5:00am), as suggested by ADOT. Among the rest areas studied, only the eastbound Texas Canyon and eastbound Ehrenberg rest areas were observed as having a truck parking utilization above 75 percent. Also, the Hassayampa rest area does not have designated truck parking spaces, which is why the utilization is above 100 percent.

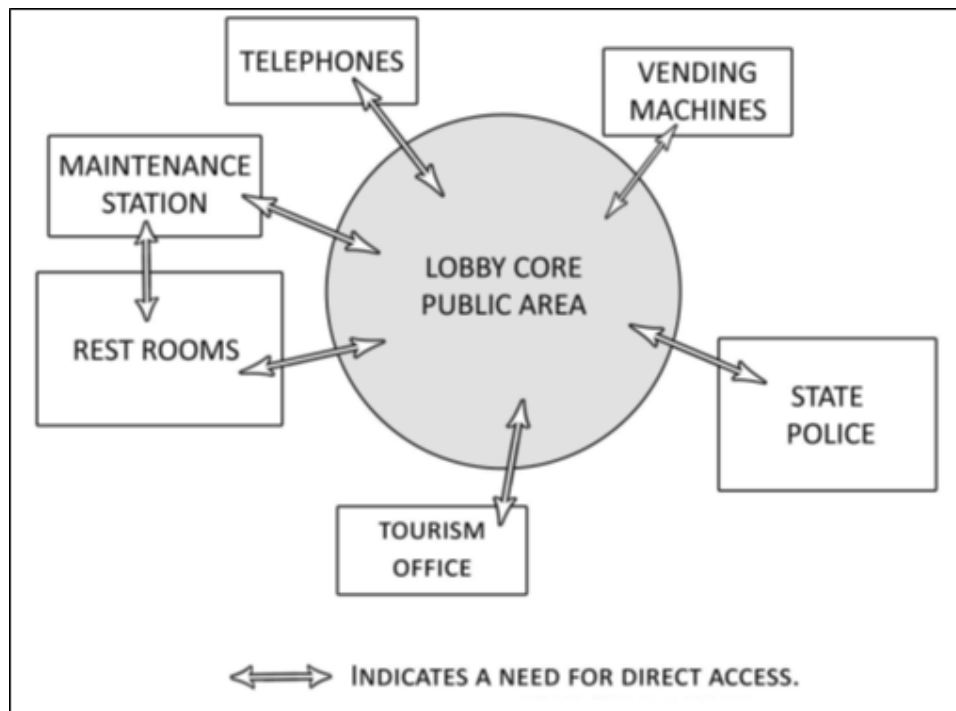
Figure 5-4. Rest Area Main Building: Features to be Accessed Through Lobby (NYDOT)

Figure 5-4 presents appropriate access requirements for the core lobby area of the main rest area building.

In Figure 1.15, the “Tourism Office” cell might also be substituted with areas with information displays and computer kiosks or Wi-Fi internet access points.
