INITIAL DESIGN CONCEPT REPORT

SR 88, MP 222 – MP 229

ADOT Project No. 88 MA 222 F0494 01L
Federal Project No. x

Apache Trail Hwy

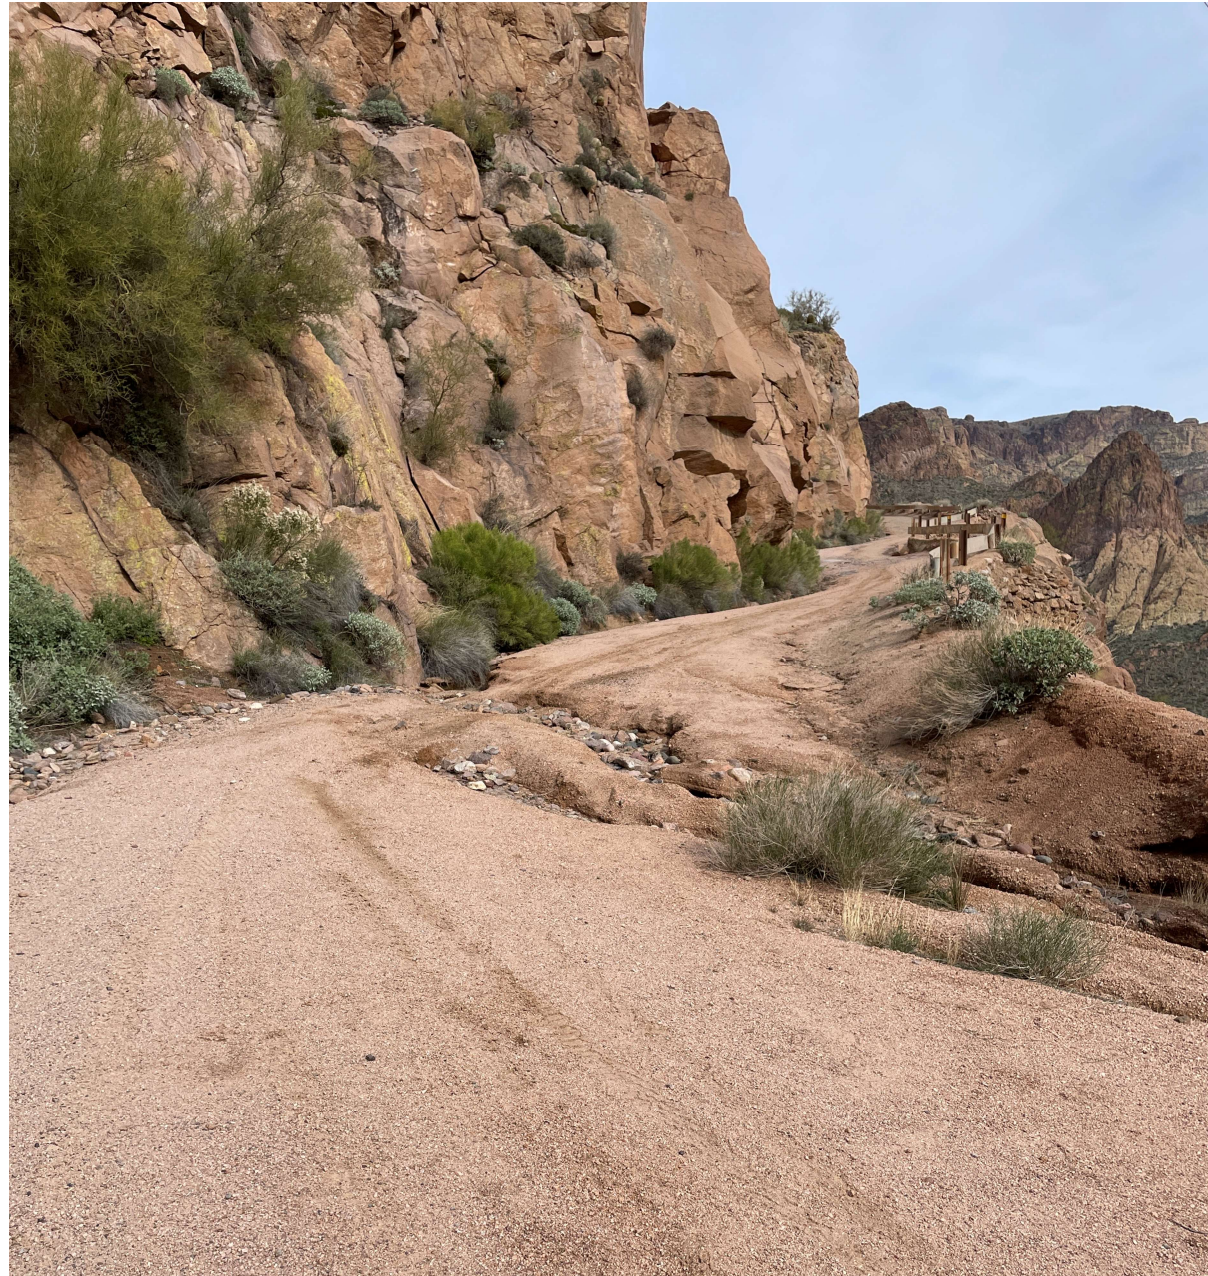
Figure 3 – Existing SR 88 Profile

The SR 88 vertical alignment consists of vertical grades that vary from 0% to approximately 10%; the elevation drops from west to east, with an average project elevation of 2500 feet. The existing SR 88 profile is shown on Figure 3.

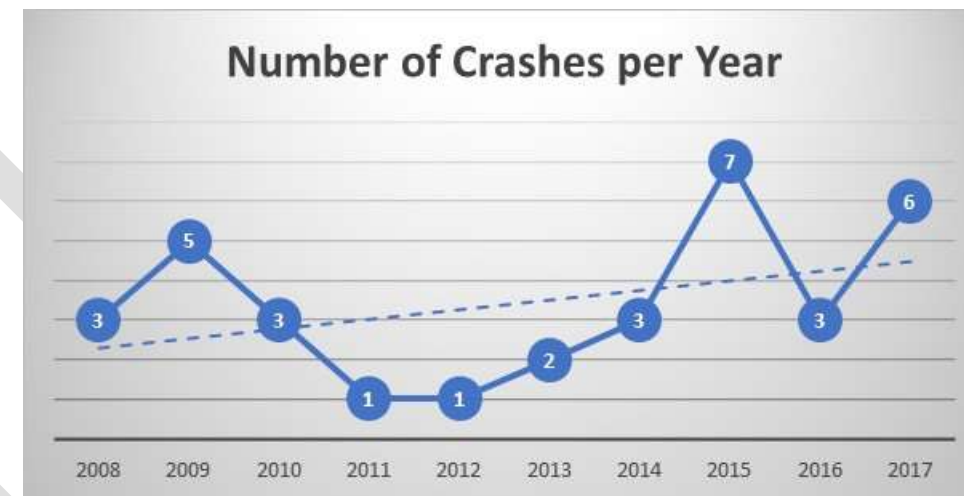
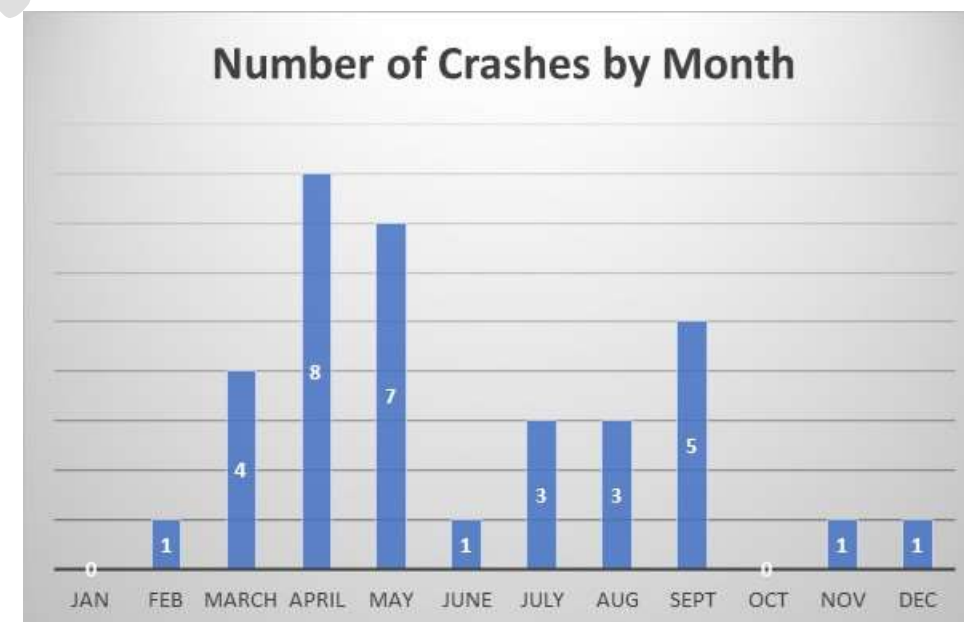
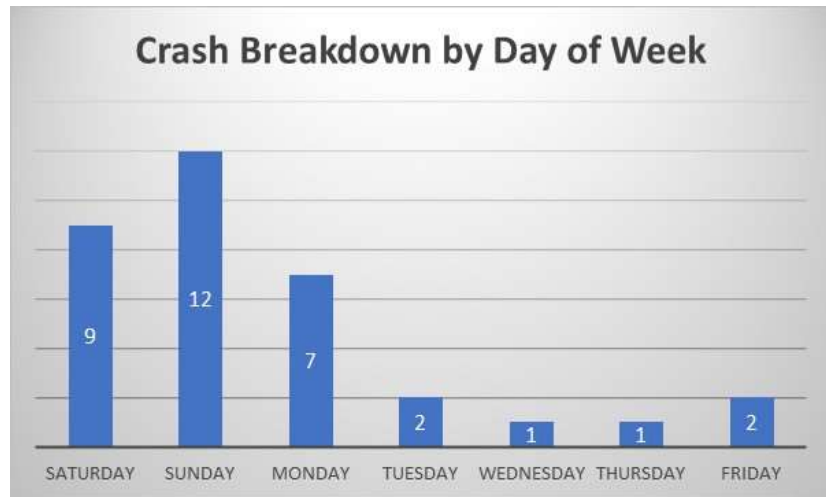
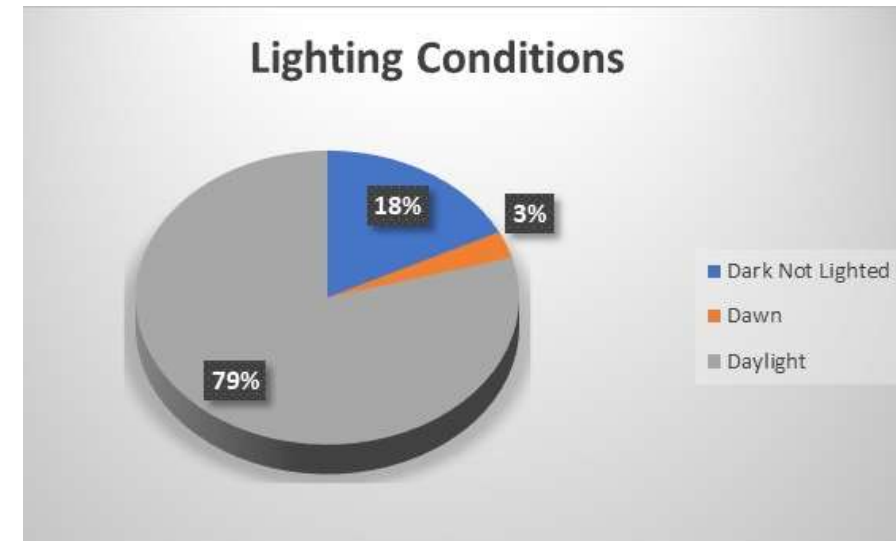
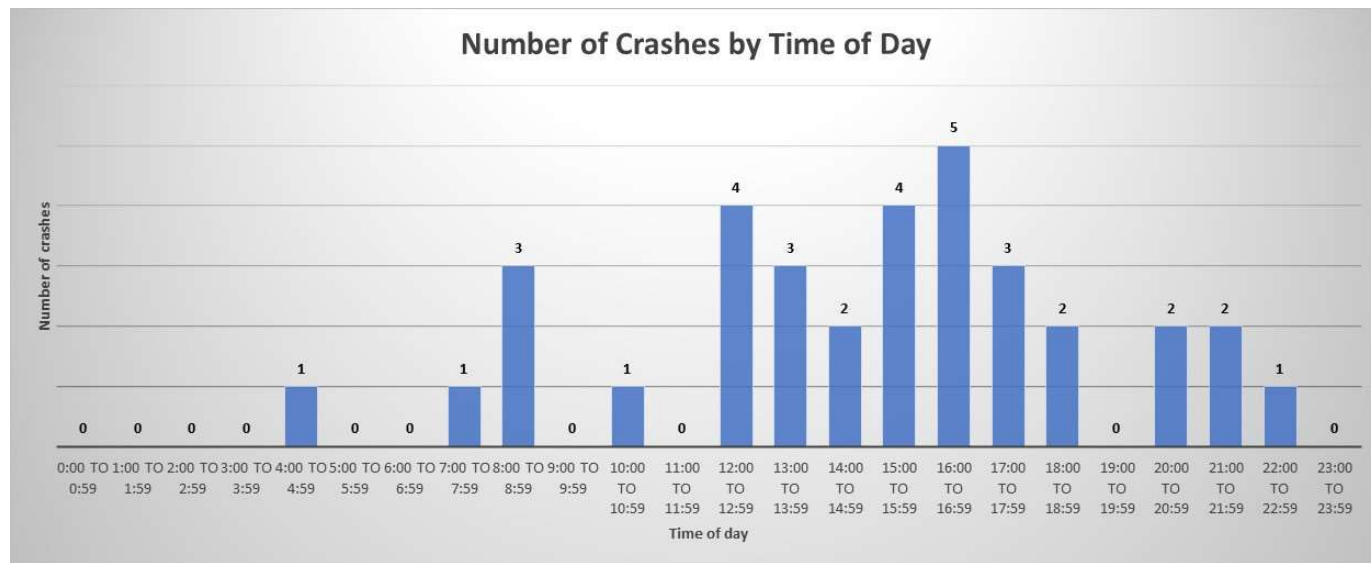
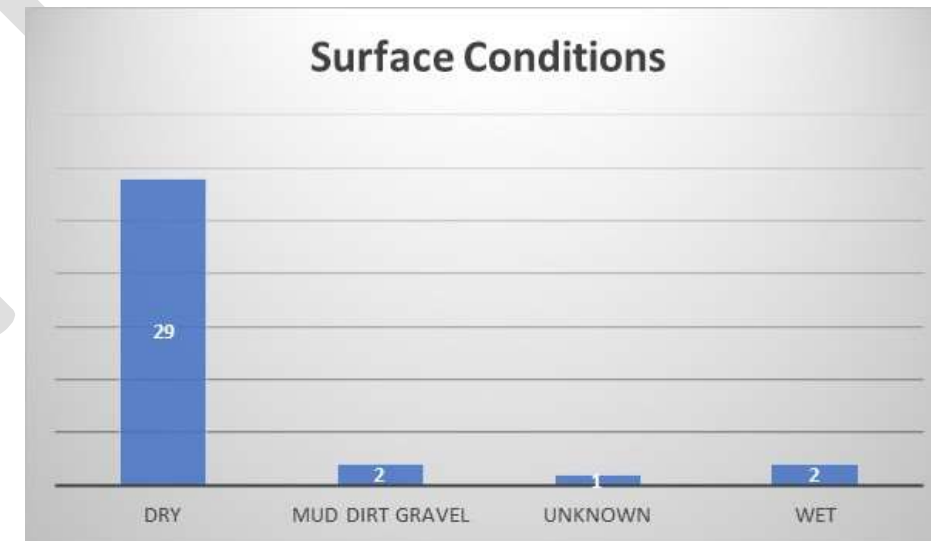
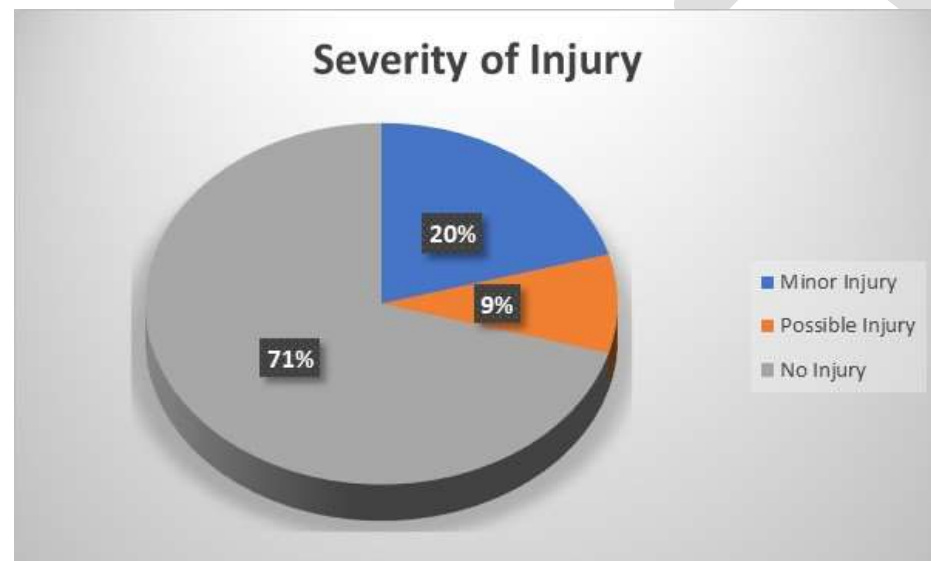
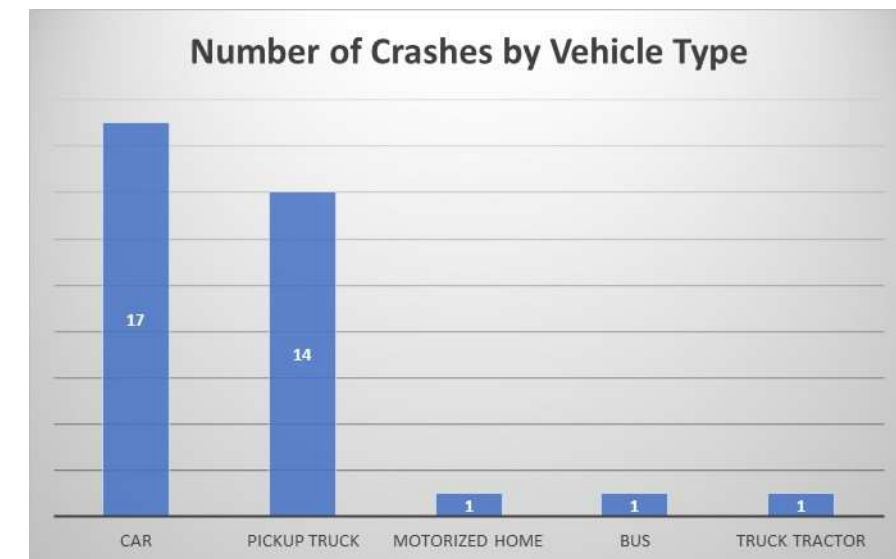
Figure 4 - Crash Diagrams

Figure 4 depicts the crash analysis data, sorted by various criteria. The year with the highest number of crashes is 2015, with seven crashes. Overall, the trend for crashes per year is increasing. During the record period, the month with the highest number of crashes is April with eight crashes, with May following close behind with seven crashes. Saturday and Sunday have the highest number of crashes compared to other days of the week with nine and twelve crashes, respectively. For time of day, the highest number of crashes occurred around the PM peak hour with five crashes occurring during the 4 PM hour.

The majority of crashes occurred during daylight lighting conditions (79 percent) while 18 percent occurred under dark not lighted conditions. The surface conditions for 29 of the 34 crashes were dry. The vehicle types most often seen in the crashes were cars or pickup trucks.

Table 6 shows the number of crashes by severity along SR 88. The data indicates that approximately 71 percent of total crashes along SR 88 were property damage only (no injury) crashes. The data also shows that during the 10-year period, no fatal crashes occurred along SR 88 in the study area. The single vehicle crashes included run off the road crashes, hitting an animal/wild game, equipment failure (tires/brakes), fire/explosion, hitting other fixed object, and overturn rollover.

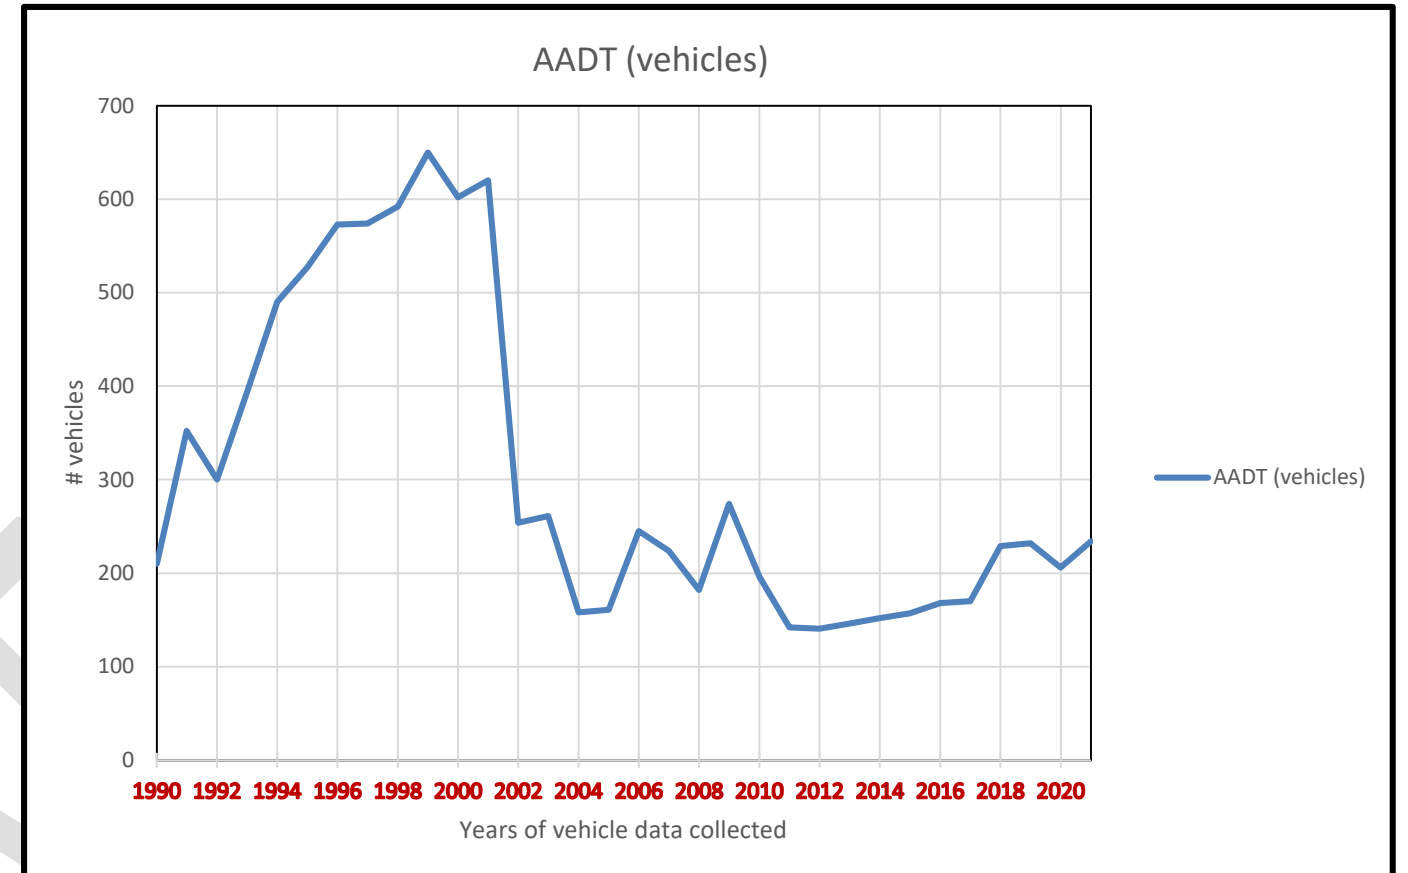
Figure 5 – AADT Volumes by Year at MP 228

In the most recent collected data set in 2018, the Percent Trucks (T) was 6.3%, the Peak Hour Factor (K) was 16%, and the Distribution Factor (D) was 62%. The traffic volumes fluctuated between 141 and 650 vehicles per day over the past 30 years. Traffic volumes in this corridor did not increase or decrease on a straight trajectory. Many environmental, infrastructure, and economic conditions influence the traffic volumes.

The SR 88 corridor between MP 203.4 and MP 220.2 (the section west of the study segment) experienced poor pavement conditions for many years, which likely contributed to the lower traffic volumes in the early 2000s and resulted in lower traffic volumes through 2018 compared to the early 1990s. In 2018, SR 88 was reconstructed and repaved from MP 203.4 to MP 220.2.

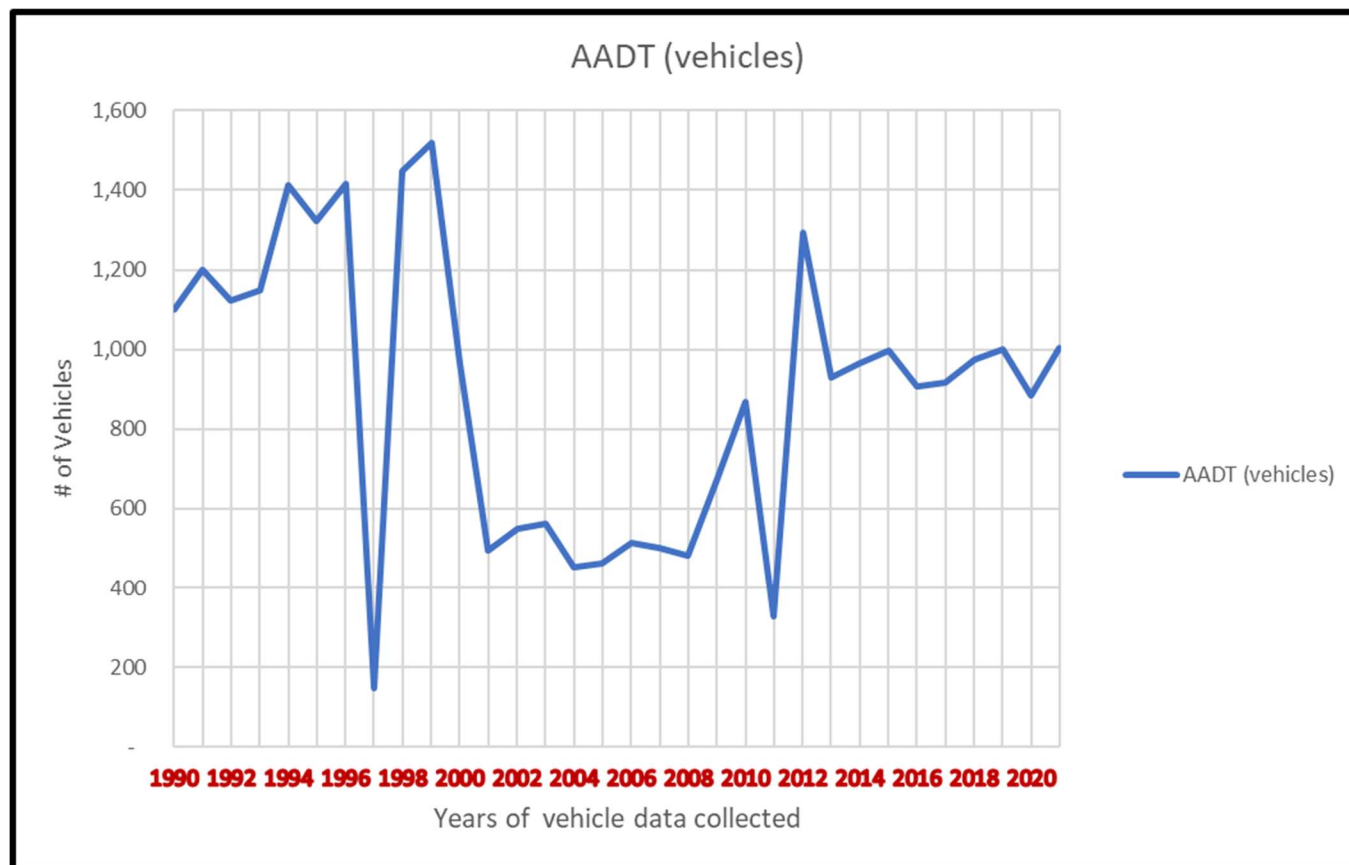
Figure 6 – AADT Volumes at MP 212 Shown Graphically

The traffic volumes fluctuated between 148 and 1,447 vpd in the past 30 years. Traffic volumes in this western section of the corridor did not increase or decrease on a straight trajectory either. Many environmental, infrastructure, and economic conditions influence the traffic volumes. In the most recent
