PROJECT 347 MA 184 F0476 01C
NFA
MARICOPA ROAD
STATE ROUTE 347: RIGGS ROAD TRAFFIC INTERCHANGE
CONSTRUCT TRAFFIC INTERCHANGE

ADA COMPLIANCE AND FEASIBILITY REPORT

January 20, 2023

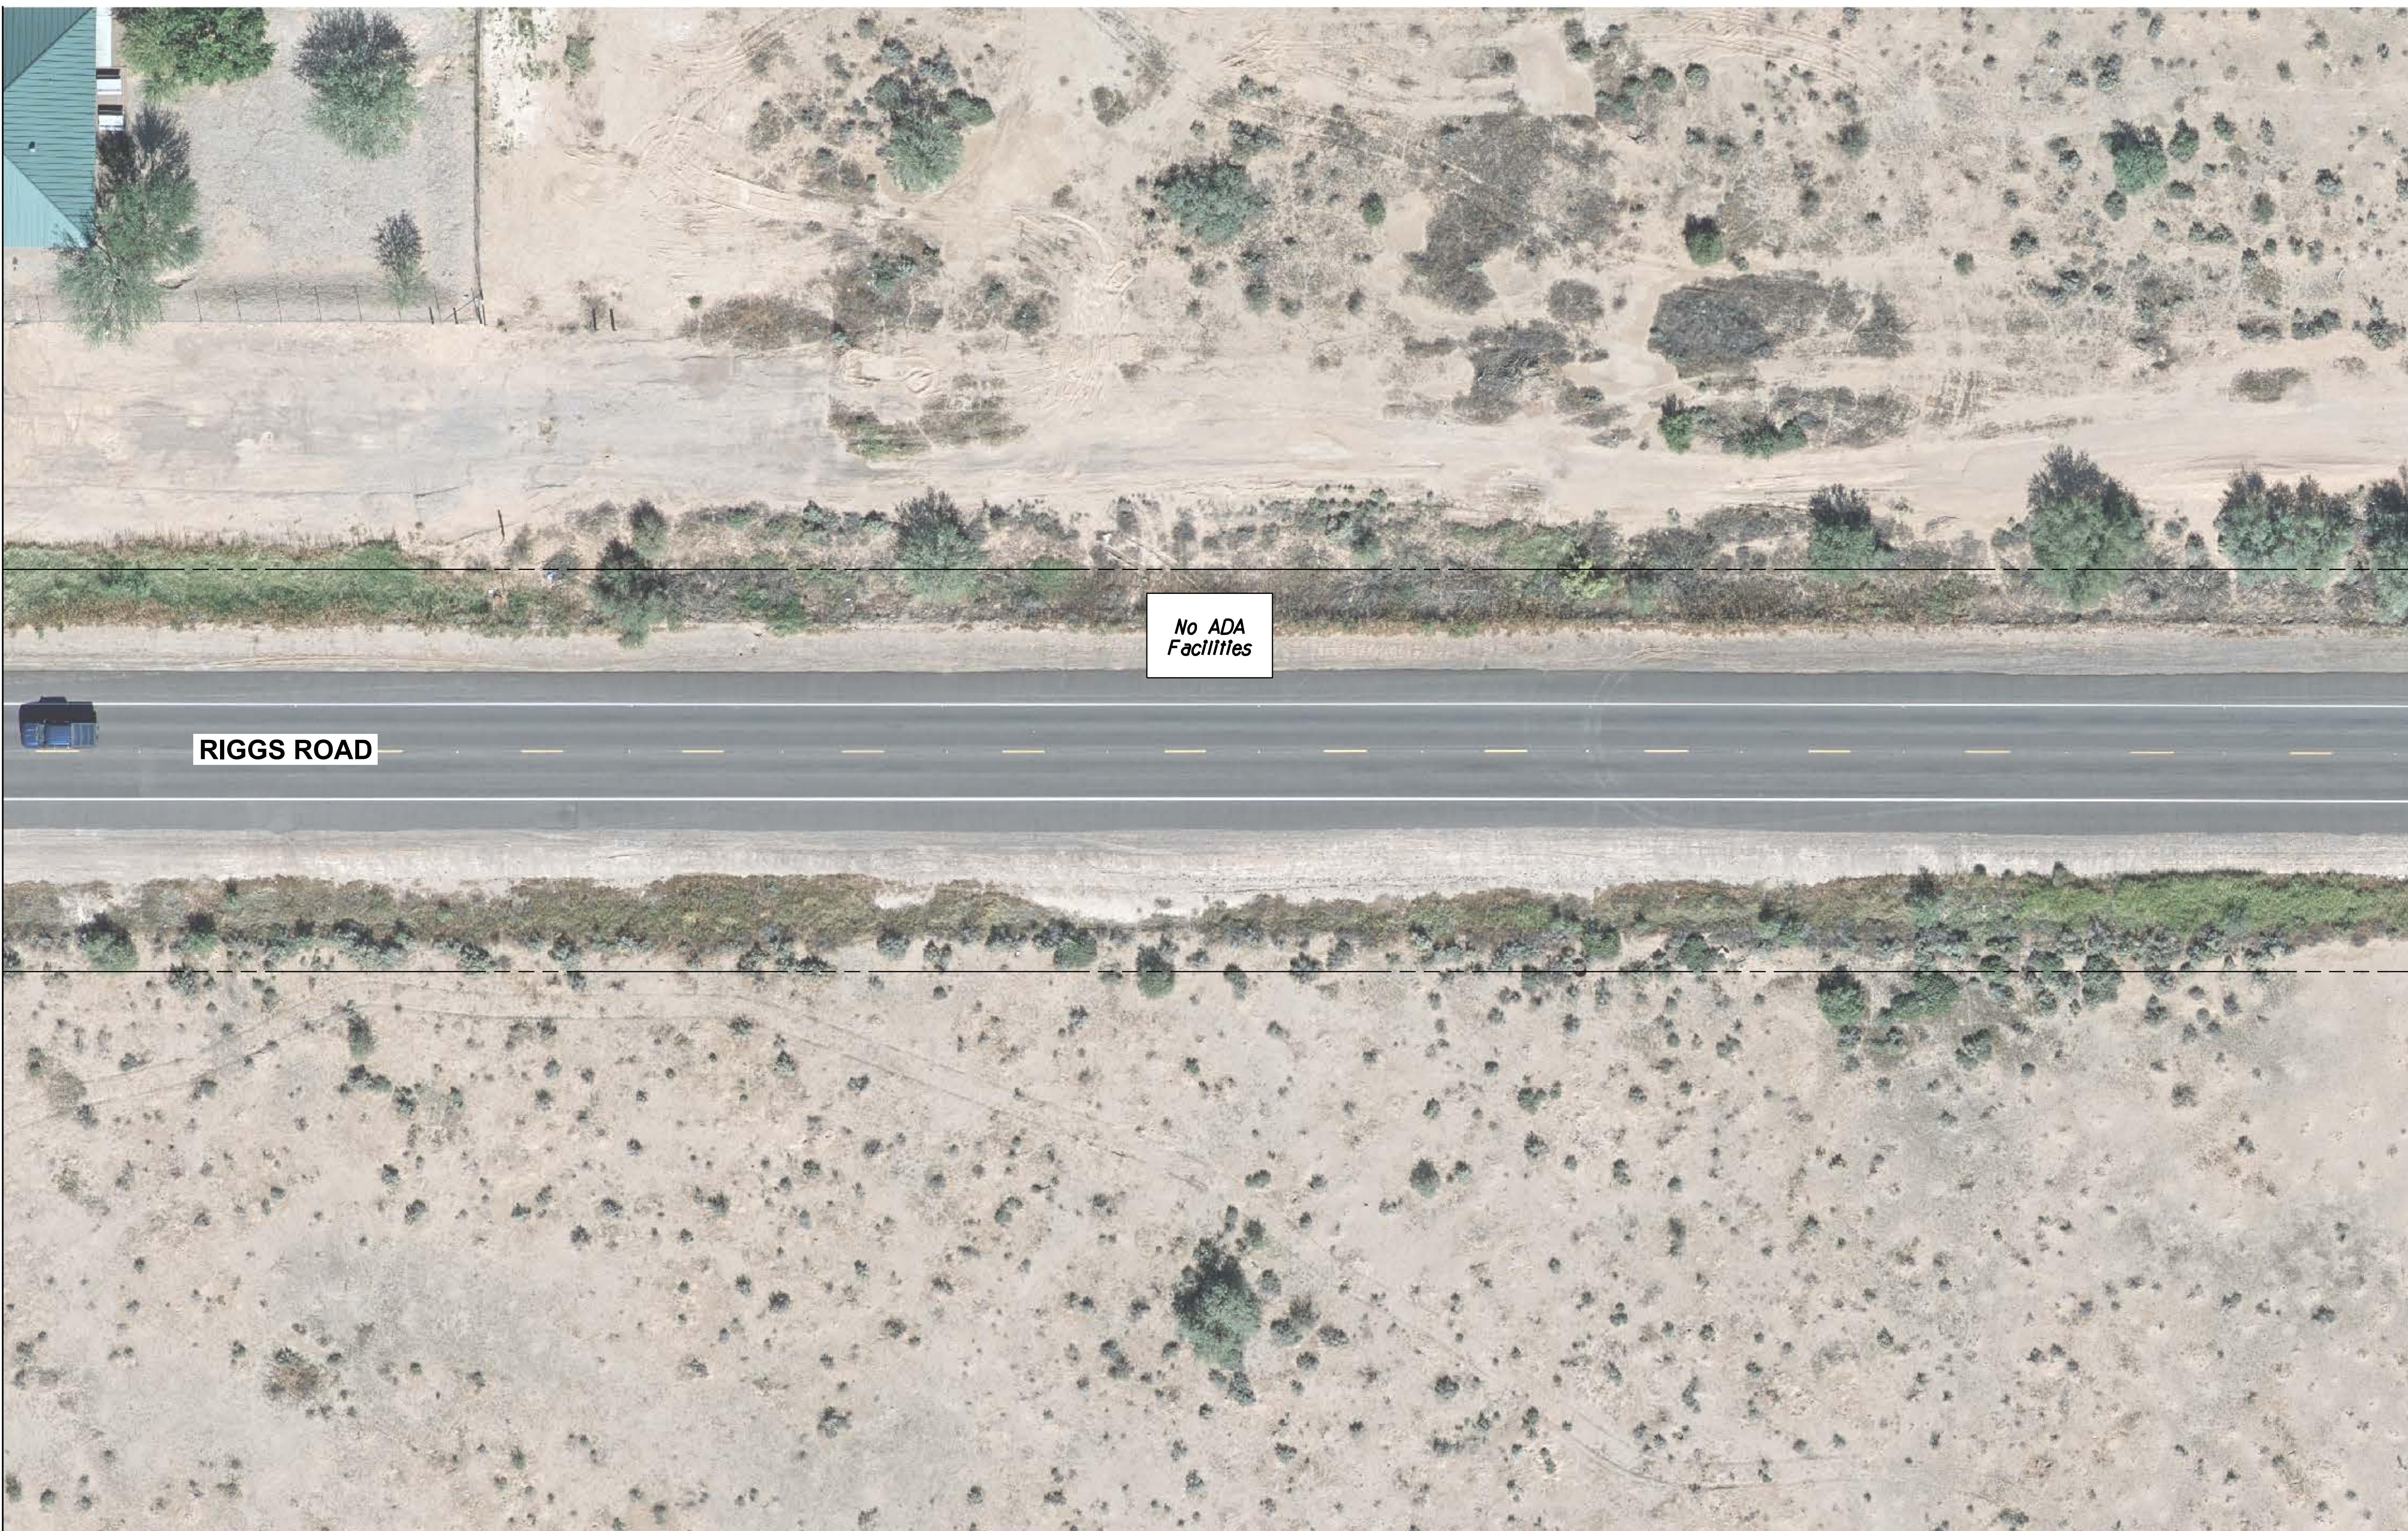
MATCHLINE PAGE 2

#XXDW01
Crosswalk
Cross Slope > 2%

#XXDW02
Crosswalk
Compliant

#XXDW03
Crosswalk
Cross Slope > 2%

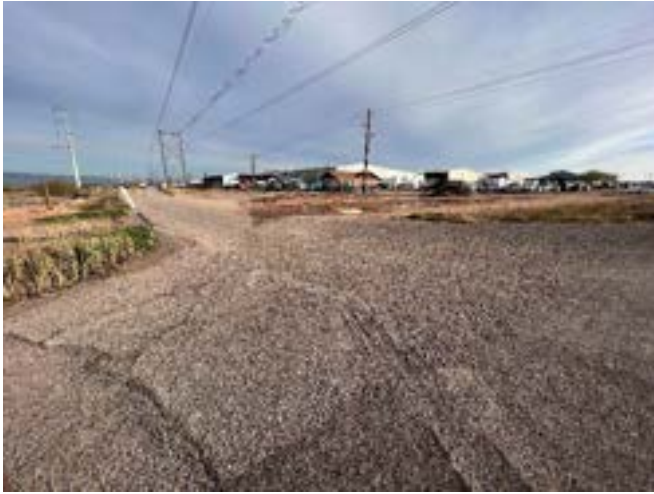
Asset ID	Location	Beginning MP	Compliance Evaluation		DCR Proposed Action	Final Proposed Action	Construction Action
			From FIS Report	From Field Survey			
XXXDW01	Revolution Industrial Driveway	185.19 (Lt)	Not in FIS Database	Cross Slope > 2%	Driveway will be reconstructed with this Project		
XXXDW02	Revolution Industrial Driveway	185.20 (Lt)	Not in FIS Database	Compliant	Driveway will be reconstructed with this Project		
XXXDW03	Revolution Industrial Driveway	185.21 (Lt)	Not in FIS Database	Cross Slope > 2%	Driveway will be reconstructed with this Project		
XXXDW04	Gila River Indian Community Utility Authority Maricopa Substation Driveway	185.29 (Lt)	Not in FIS Database	Compliant	Driveway will be removed with this Project

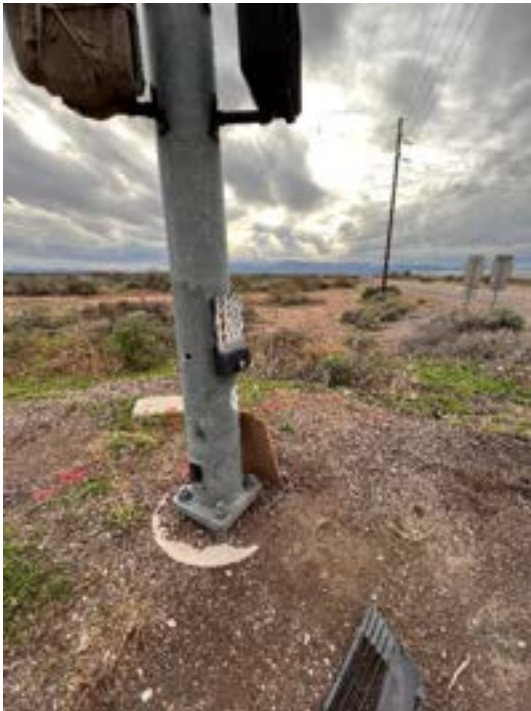
Asset ID	Location	Beginning MP	Compliance Evaluation		DCR Proposed Action	Final Proposed Action	Construction Action
			From FIS Report	From Field Survey			
XXAPS01	SR 347 and Riggs Rd, Southwest Corner	185.27 (Lt)	Not in FIS Database	Not aligned with crosswalk & no ADA accessible route	Pedestrian signal will be removed with this project		
XXAPS02	SR 347 and Riggs Rd, Southeast Corner	185.29 (Rt)	Not in FIS Database	Not aligned with crosswalk & no ADA accessible route	Pedestrian signal will be removed with this project		
XXAPS03	SR 347 and Riggs Rd, Southeast Corner	185.29 (Rt)	Not in FIS Database	Not aligned with crosswalk & no ADA accessible route	Pedestrian signal will be removed with this project		
XXAPS04	SR 347 and Riggs Rd, Northwest Corner	185.29 (Lt)	Not in FIS Database	Not aligned with crosswalk & no ADA accessible route	Pedestrian signal will be removed with this project		
XXAPS05	SR 347 and Riggs Rd, Northwest Corner	185.29 (Lt)	Not in FIS Database	Not aligned with crosswalk & no ADA accessible route	Pedestrian signal will be removed with this project
