Town of Miami Trail System Study

Needs and Gap Analysis

June 19, 2025

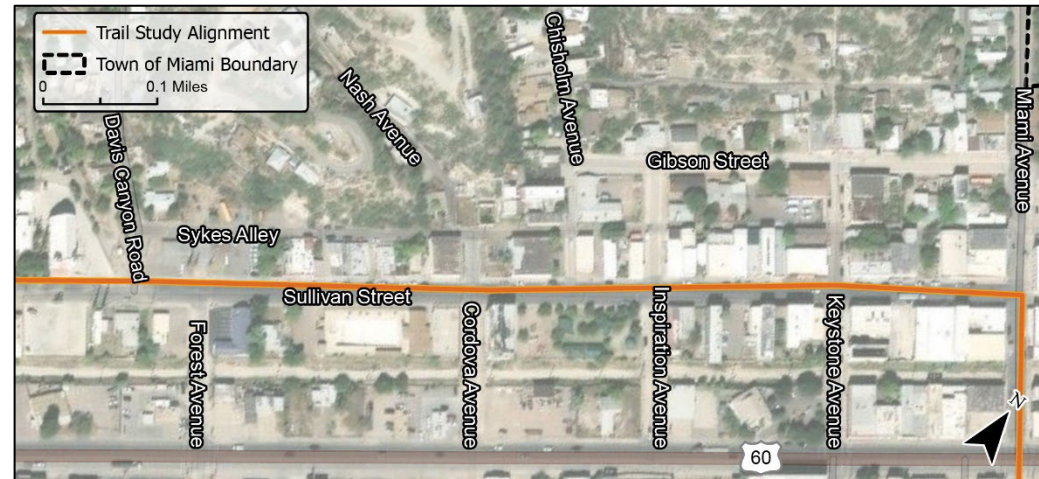
3. Sullivan Street – Davis Canyon Road to Miami Avenue

This segment provides access to historic downtown Miami, a key community destination. The area is largely commercial, with residential neighborhoods located north and west of the segment.

Topics	Need	Comments
Existing Ped/Bike Infrastructure	■	<ul style="list-style-type: none"> • Sidewalks present on both sides of roadway. • No bicycle infrastructure. • Diagonal ADA ramps at intersections. • Some pedestrian amenities/street furniture such as benches.
Lighting	■	<ul style="list-style-type: none"> • Streetlights on both sides of roadway, with decorative string lighting throughout the area.
Drainage	■	<ul style="list-style-type: none"> • Drainage addressed through street curbs.
Shade	■ ■	<ul style="list-style-type: none"> • Trees present near the park. Some business façades have awnings that provide limited shade.
Crossings	■ ■ ■ ■	<ul style="list-style-type: none"> • Unmarked street crossings at Forest Avenue, Cordova Avenue, Inspiration Avenue, and Keystone Avenue. • While this segment has the most crossings, there are no marked crosswalks.
Neighborhood Access	■	<ul style="list-style-type: none"> • Generally good access to neighborhoods and businesses throughout segment.

Additional Comments		<ul style="list-style-type: none"> • On-street parking for most of this segment. • Markings or signs would be needed to create a safe route if bicycles share the road along this segment. • Occasional commercial driveways disrupt the sidewalk and create conflict points. • Street furniture and utility poles restrict useable sidewalk space in some areas, which may negatively impact accessibility.

Pedestrian infrastructure, streetscape enhancements and bicycle amenities would improve user safety and comfort in this segment.

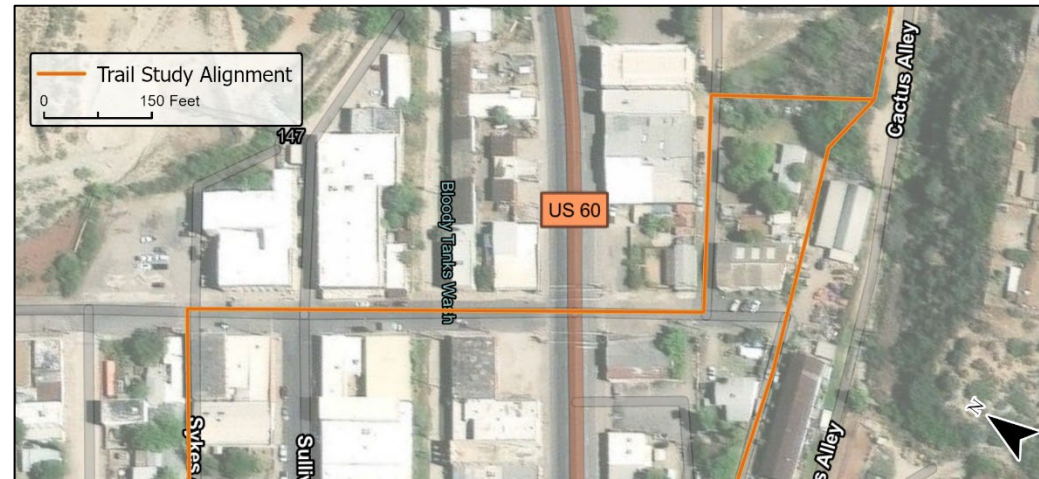
4. Miami Avenue

This segment includes a signalized crossing of US 60, providing a critical connection between community destinations and neighborhoods north and south of US 60.

Topics	Need	Comments
Existing Ped/Bike Infrastructure	■ ■	<ul style="list-style-type: none"> • Sidewalks present on both sides of roadway north of US 60, with varying widths along this segment. No sidewalk south of US 60. • Wide but uneven sidewalks on both sides of the bridge, with poor surfacing where the bridge meets flat sidewalk near the US 60 intersection. • Some pedestrian amenities/street furniture such as benches. • ADA ramps present, but there are accessibility issues such as tall curbs/sidewalks with no guardrail.
Lighting	■	<ul style="list-style-type: none"> • Streetlights on both sides of roadway, with historic lights at the bridge.
Drainage	■	<ul style="list-style-type: none"> • Drainage addressed through street curbs.
Shade	■ ■	<ul style="list-style-type: none"> • Limited shade provided by buildings and business façade awnings.
Crossings	■	<ul style="list-style-type: none"> • Marked crosswalks at US 60 intersection, with pedestrian push buttons at each corner.

Neighborhood Access	■	<ul style="list-style-type: none"> • Generally good access to neighborhoods and businesses throughout segment.
Additional Comments		<ul style="list-style-type: none"> • Vehicles parked on both sides of the roadway. • Sidewalk improvements to the bridge crossing Bloody Tanks Wash may warrant additional design consideration to maintain the safety and structural integrity of the bridge. • Street furniture and utility poles restrict useable sidewalk space in some areas, which impact accessibility. • Utility box and poles restrict sidewalk on the northwest corner of the US 60 intersection, which makes it more difficult for path users (particularly those who may use mobility devices) to comfortably cross.

Crossing improvements and enhanced pedestrian/bicycle infrastructure would increase safety along this segment.

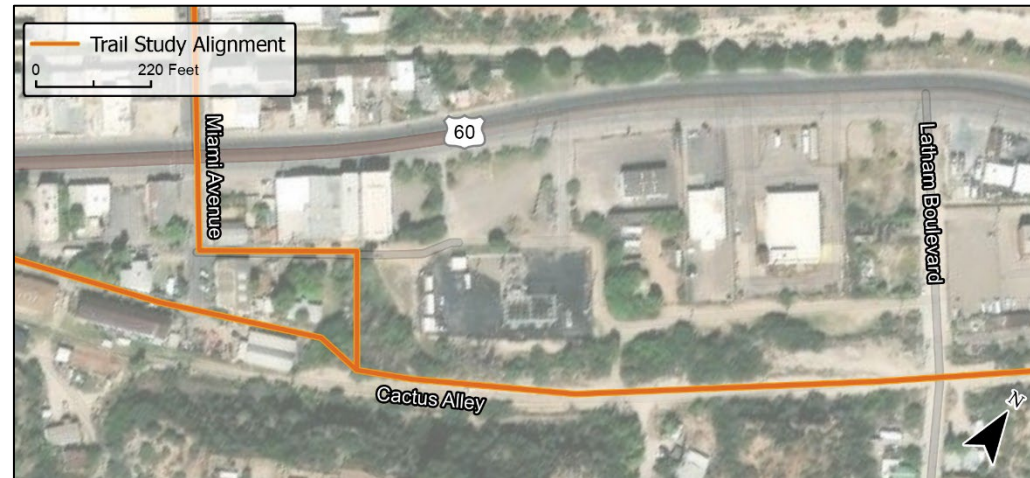
6. Cactus Alley/Railroad Avenue – Miami Avenue to Latham Boulevard

This segment provides a defined route through an area of Miami with no existing pedestrian/bicycle infrastructure. There are residential properties to the south and commercial uses to the north of the alignment.

Topics	Need	Comments
Existing Ped/Bike Infrastructure	■■■	<ul style="list-style-type: none"> No pedestrian or bicycle infrastructure along this segment. Some sections of this segment are impassable. It is largely unpaved, with large rocks, debris, vegetation and other overgrown natural features on both sides of the unused AZER tracks.
Lighting	■■■	<ul style="list-style-type: none"> Limited lighting near industrial businesses and the substation on Cactus Alley. Limited visibility in alleyway.
Drainage	■■■	<ul style="list-style-type: none"> Some drainage ditches are present along this segment (with some of those ditches substantially eroded).
Shade	■■■	<ul style="list-style-type: none"> While there are some sparse trees in this segment, most vegetation consists of shrubs and does not provide adequate shade cover.
Crossings	■■■	<ul style="list-style-type: none"> No marked crosswalks present.
Neighborhood Access	■■■	<ul style="list-style-type: none"> The majority of this segment is largely impassable and would be difficult to access from hillside neighborhoods.

Additional Comments		<ul style="list-style-type: none"> AZER tracks run along most of this segment but appear to be inactive. Railroad coordination would be needed for any path. Right-of-way to the north and south of the tracks is largely inaccessible. Coordination with property owners may be needed for the section of Cactus Alley near Miami Avenue. Some structures are vacant, and outside storage of abandoned vehicles, equipment and materials creates an unsafe environment for path users. Consider how to navigate the area of overgrown vegetation near the substation. Steep hillsides adjacent to the AZER tracks may complicate any path improvements in the segment.

Major improvements would be needed to create a safe, useable pathway through this segment.

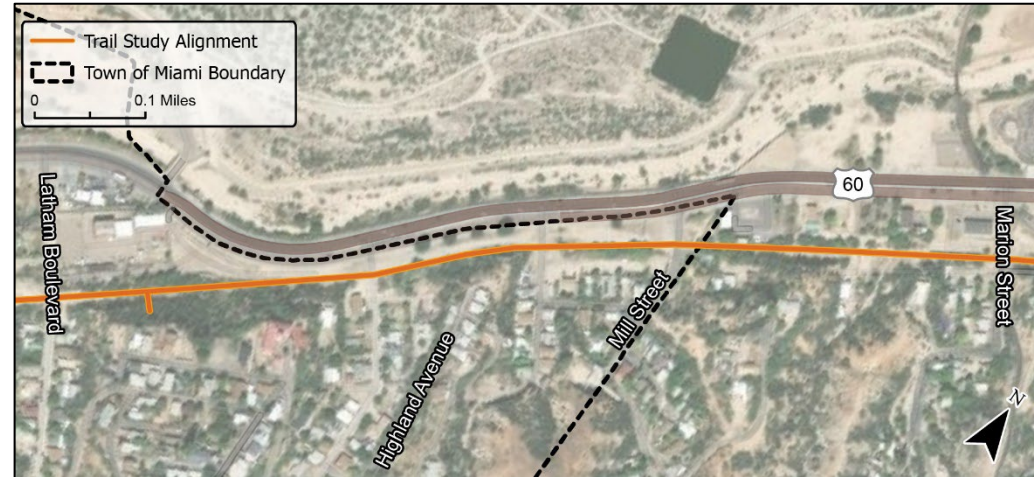
7. Cactus Alley/Railroad Avenue – Latham Boulevard to Marion Street

This segment provides an alternate pedestrian/bicycle route off of US 60, connecting neighborhoods and key destinations in the Town of Miami with those east in unincorporated Gila County. The area is largely residential south of the alignment, with limited commercial parcels north of US 60.

Topics	Need	Comments
Existing Ped/Bike Infrastructure	■■■	<ul style="list-style-type: none"> No pedestrian or bicycle infrastructure along this segment. Segment is unpaved. Large rocks, vegetation and other overgrown natural features obstruct the right-of-way.
Lighting	■■■	<ul style="list-style-type: none"> Streetlighting is limited or nonexistent in most parts of the segment.
Drainage	■■■	<ul style="list-style-type: none"> Drainage crossings and channels are located near Mill Street and Michaels Way, and near Kent Street.
Shade	■■■	<ul style="list-style-type: none"> Several large shade trees between Kent Street and Loomis Avenue. Shade is otherwise sparse or nonexistent.
Crossings	■■■	<ul style="list-style-type: none"> No marked crosswalks at the street crossings at Latham Boulevard, Highland Avenue, Mill Street and Marion Street.
Neighborhood Access	■	<ul style="list-style-type: none"> Neighborhood access facilitated with the cross streets.

Additional Comments		<ul style="list-style-type: none"> Wide right-of-way in most of this segment provides space for a path.

Major improvements would be needed to provide a safe and attractive alternative route to US 60 along this segment.

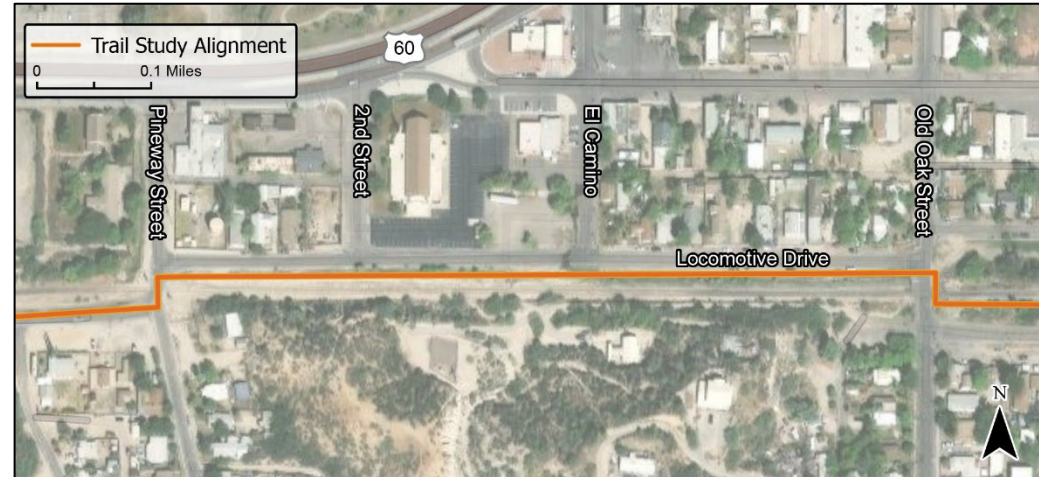
9. Locomotive Drive – Pineway Street to Old Oak Street

This segment provides unincorporated Gila County neighborhoods with access to key destinations in Miami and the surrounding areas, including MUSD. The area has a mix of residential and commercial development.

Topics	Need	Comments
Existing Ped/Bike Infrastructure	■■■	<ul style="list-style-type: none"> No existing pedestrian or bicycle infrastructure along segment. Roadway encompasses existing pavement (no shoulder). There is no barrier between railroad and street.
Lighting	■■	<ul style="list-style-type: none"> Limited streetlights on north side of street. Residences on north side of street provide a secure route that is visible to the community.
Drainage	■■■	<ul style="list-style-type: none"> Storm runoff is channeled under the railroad tracks and drains between the street and railroad to the east.
Shade	■■■	<ul style="list-style-type: none"> No shade on south side of roadway, several mature trees adjacent to north edge of roadway.
Crossings	■■■	<ul style="list-style-type: none"> Crossings at both Pineway and Old Oak Streets of street and railroad. No marked crosswalks.
Neighborhood Access	■■	<ul style="list-style-type: none"> Railroad parallel to Locomotive Drive limits access from the south.

Additional Comments		<ul style="list-style-type: none"> A path on either the north or south side of the street, if feasible, would impact existing on-street parallel parking. Numerous residential driveways intersecting the street create conflict points for any facility on the north side. Existing drainage on the south side of the street may impact any path. A safety barrier would be required between any pedestrian/bicycle facilities and the railroad. Right-of-way is constrained west of El Camino.

Minor pedestrian/bicycle improvements in this segment would increase safety and comfort for users.

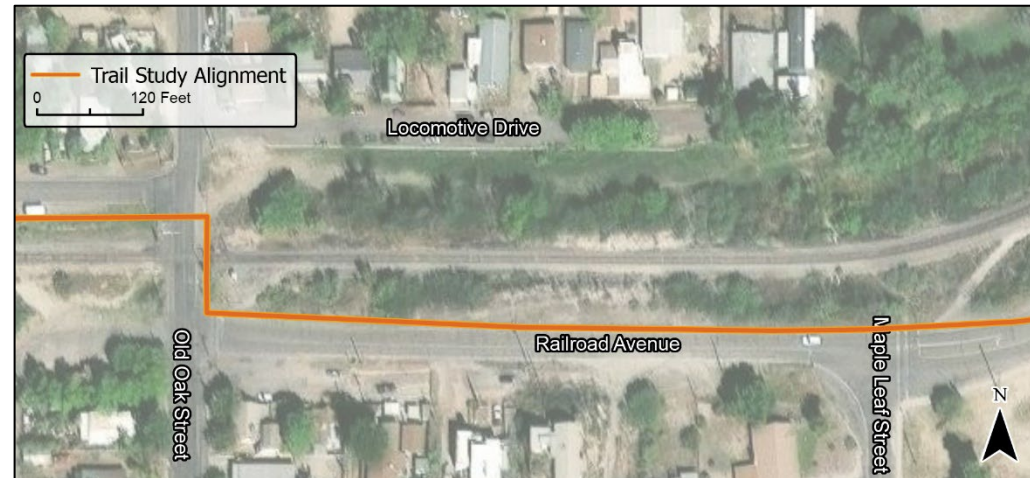
10. Railroad Avenue – Old Oak Street to Maple Leaf Street

This segment provides unincorporated Gila County neighborhoods with access to key destinations in Miami and the surrounding areas, including MUSD. The area is largely residential.

Topics	Need	Comments
Existing Ped/Bike Infrastructure	■■■	<ul style="list-style-type: none"> Narrow asphalt sidewalk north of roadway in poor condition, crumbling in some sections. No sidewalk south of roadway. North of sidewalk, the ground is uneven and slopes downward to the AZER tracks, with heavy vegetation. No bicycle infrastructure. Lack of ADA-compliant paths. ADA ramps at the southeast and southwest corners of Maple Leaf Street/Railroad Avenue. Utility poles and guardrail restrict useable right-of-way space near Maple Leaf Street.
Lighting	■■	<ul style="list-style-type: none"> Streetlights south of roadway, but limited lighting near Maple Leaf Street/Railroad Avenue intersection.
Drainage	■■■	<ul style="list-style-type: none"> Drainage addressed through street curbs.
Shade	■■■	<ul style="list-style-type: none"> Vegetation provides little to no shade in this segment.
Crossings	■■	<ul style="list-style-type: none"> Crossings at Old Oak Street and Maple Leaf Street, with marked crosswalks present at both intersections. Crosswalk markings fading.

Neighborhood Access	■	<ul style="list-style-type: none"> Cross streets provide alignment access for hillside neighborhoods. Properties south of roadway provide visibility and safety for pedestrians/bicyclists along this segment.
Additional Comments		<ul style="list-style-type: none"> Downward slopes and AZER tracks north of the roadway may present challenges to any path improvements to increase segment safety. No barrier between roadway and AZER tracks in this segment. Residential driveways may create conflict points for any potential path improvements south of the roadway.

Minor pedestrian/bicycle improvements in this segment would increase safety and comfort for users.

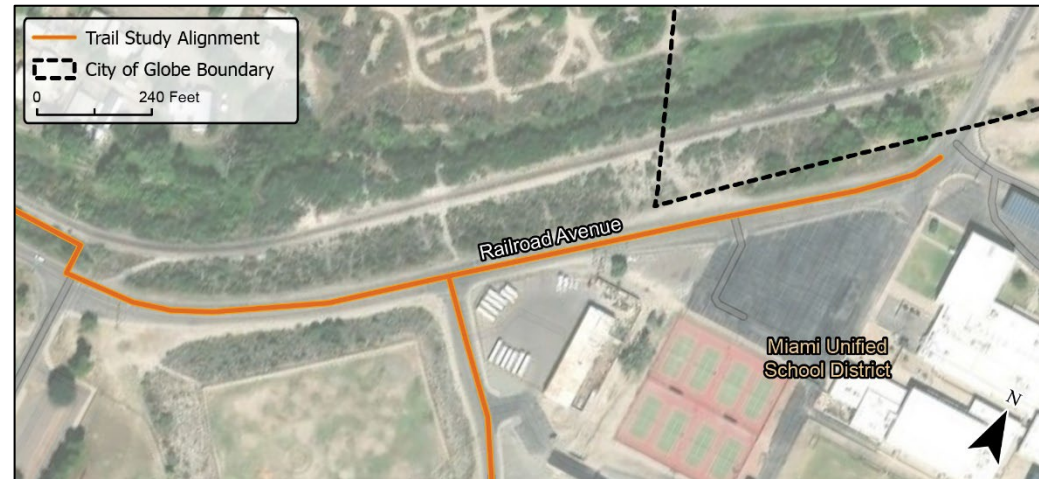
11. Railroad Avenue – Maple Leaf Street to Ragus Road

This segment provides connectivity to a key community destination, MUSD.

Topics	Need	Comments
Existing Ped/Bike Infrastructure	■ ■	<ul style="list-style-type: none"> • Concrete sidewalk south of roadway, no sidewalk north of roadway. • No bicycle infrastructure along this segment. • ADA ramps at MUSD entrances.
Lighting	■ ■	<ul style="list-style-type: none"> • Streetlights present on both sides of roadway. • Lights for MUSD are oriented towards the campus. • Lighting appears inadequate at Maple Leaf Steet intersection.
Drainage	■	<ul style="list-style-type: none"> • Drainage addressed through street curbs.
Shade	■ ■ ■	<ul style="list-style-type: none"> • There is no shade along this segment.
Crossings	■ ■	<ul style="list-style-type: none"> • Marked crosswalks present at MUSD entrances.
Neighborhood Access	■	<ul style="list-style-type: none"> • Good neighborhood access.
Additional Comments		<ul style="list-style-type: none"> • No barrier between roadway and AZER tracks, but heavy vegetation and wide right-of-way provide a buffer.

Minor improvements to existing pedestrian infrastructure would create a safer walking/biking environment for students and other users.
