SR 264 Corridor Planning Study

Working Paper 1: Identify Current and Future Conditions

JUNE 2025

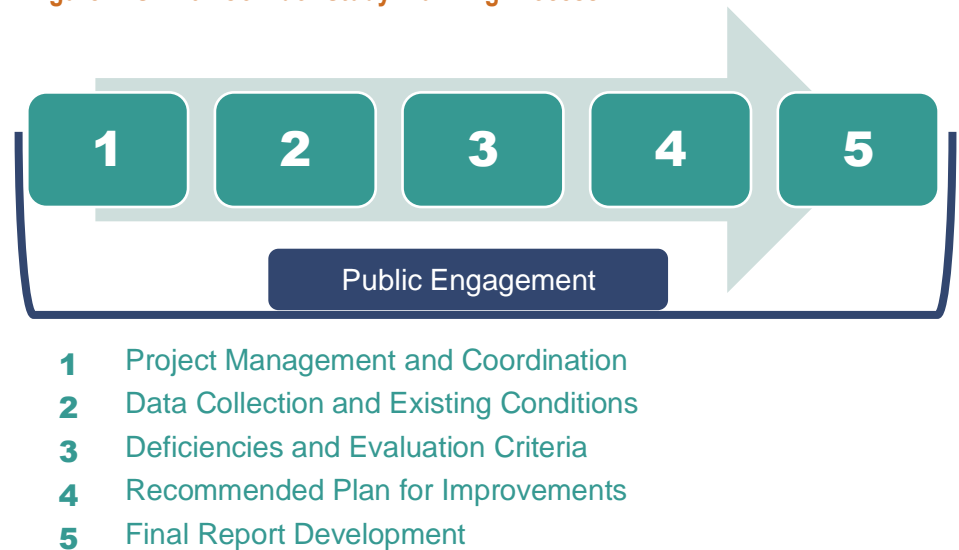
Figure 1. SR 264 Corridor Study Planning Process

Working Paper 2: Identify Deficiencies and Establish Evaluation Criteria (WP2) will identify anticipated traffic needs on the corridor, establish an alternative prioritization framework, and develop potential improvement alternatives. *Working Paper 3: Develop Recommended Plan for Improvements* (WP3) will prioritize the improvement recommendations to determine the Study's recommended projects. The three working papers will be compiled into a final plan for the recommended improvements. Recommendations resulting from the study will inform future transportation planning efforts for stakeholders in the region. **Figure 1** shows the planning process for the SR 264 Corridor Planning Study.

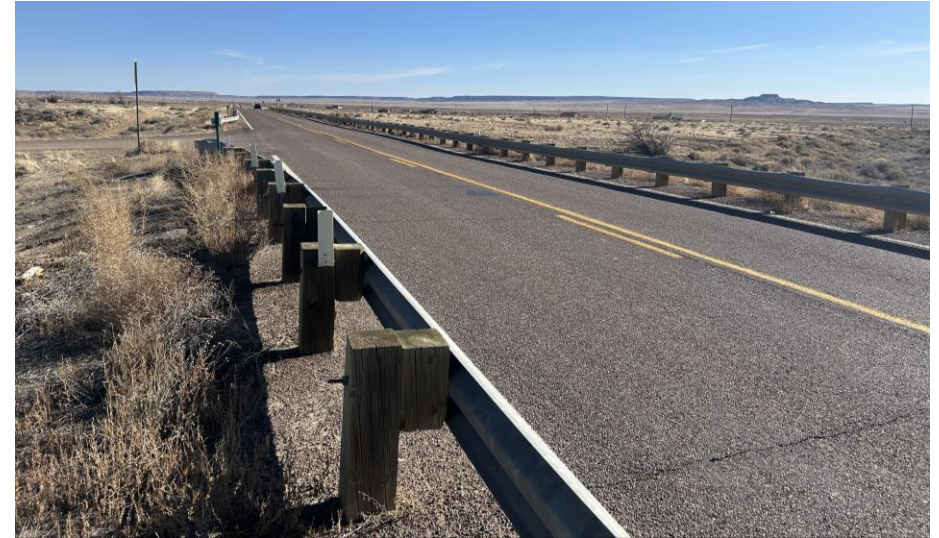
Figure 4. Rumble Strips & Safety Pullout Locations

Bus and Vehicle Safety Pullouts. There are 44 locations on the corridor that can be used as bus and vehicle safety pullouts. The average pullout length is 195 feet in length and 45 feet in width. Pullouts along the corridor are primarily constructed of dirt and gravel, although paved pullouts are present at MP 334.1, 334.9, and 344.3. Most pullout locations can be found between MP 360 and MP 400. Bus and vehicle safety pullout locations are shown in **Figure 4**.

Rumble Strips. Rumble strips are not common along the corridor, with edge-line rumble strips only present in Jeddito, from MP 408 to MP 409 on both sides of the road, and just west of First Mesa, between MP 390 and MP 392 on the south side of the corridor. There were no centerline rumble strips found along the corridor. Rumble strip locations on the study corridor are shown in **Figure 4**.

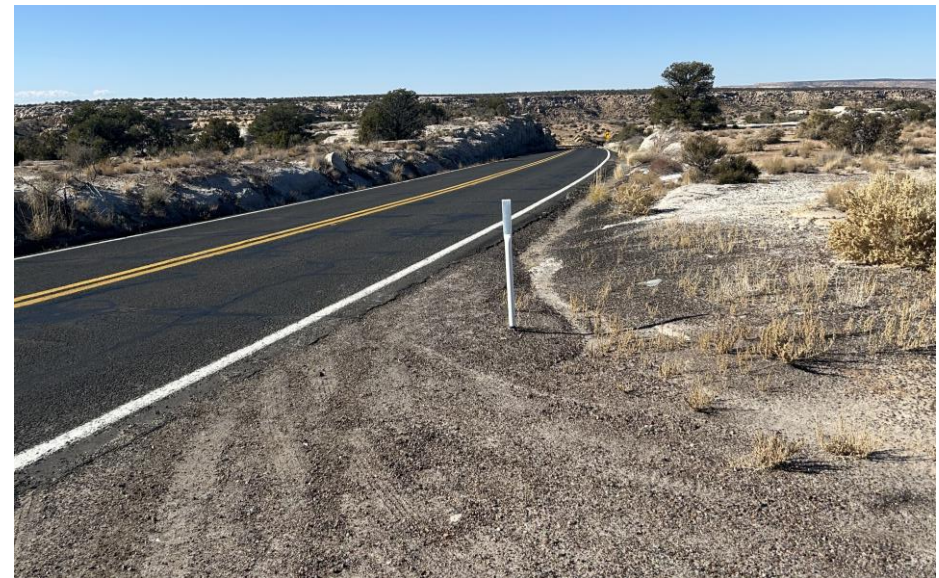
Figure 5. Guardrail Presence

Guardrails. There are 15.75 miles of guardrail present along the corridor, as shown in **Figure 5**. The guardrail inventory identified the presence of guardrail rather than its conformity. Throughout the corridor, there are curves and elevation changes that are accompanied by the presence of guardrails to improve safety for vehicles and active transportation users. The continuous length of guardrail segments are

typically short and are present where there is significant change in topography. Guardrail is most concentrated between MP 365 and MP 390.

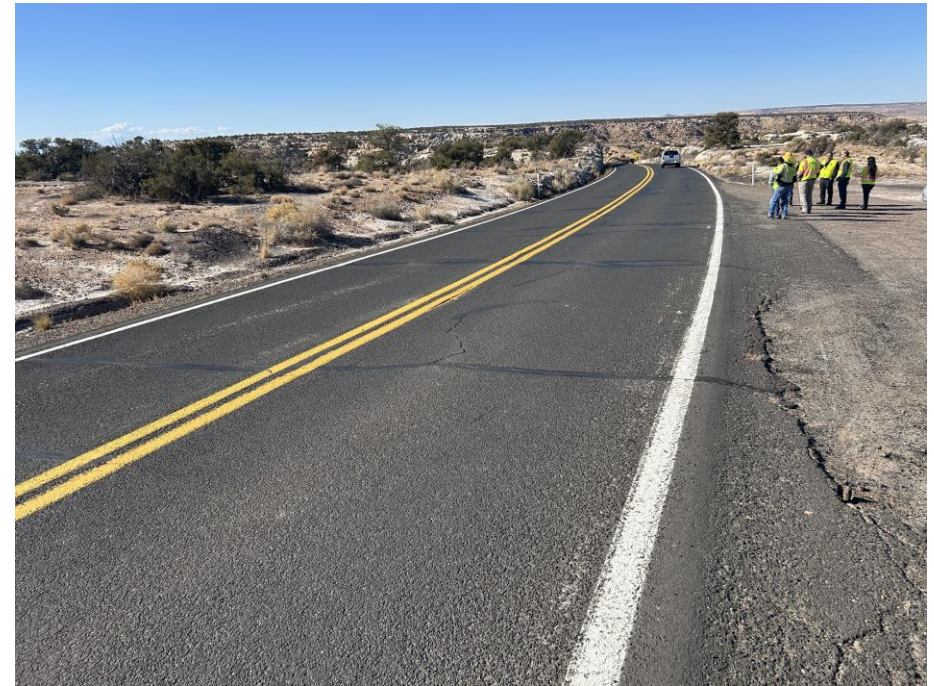
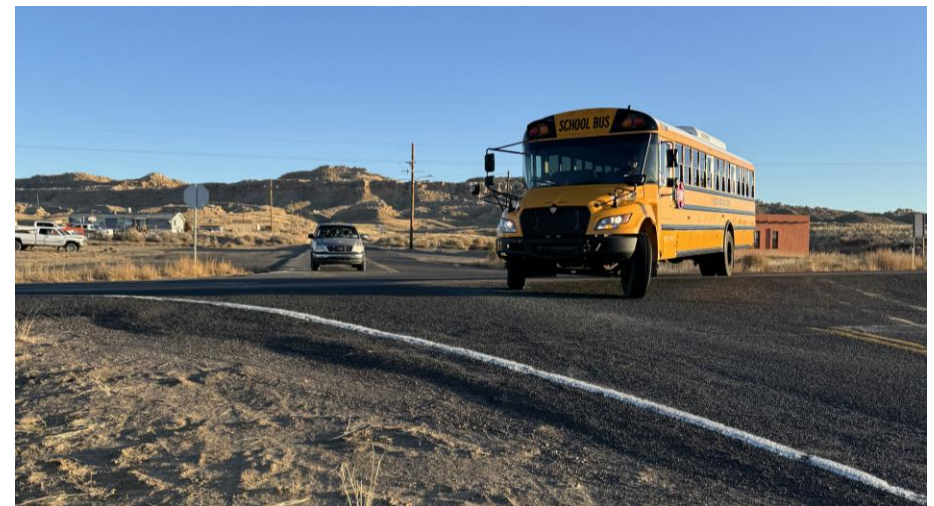
Figure 19. Safety Snapshot
Crashes by Year

A total of 114 crashes were reported from 2020 to 2024 along the SR 264 corridor. It is important to note that there are likely additional crashes not captured in this dataset due to lack of crash data sharing. Some crash data reports had limited details regarding the crash characteristics; crashes with limited information are shown as 'unknown' in the safety snapshot (**Figure 19**) if the data was not available. **Figure 20** shows crash density along the corridor.

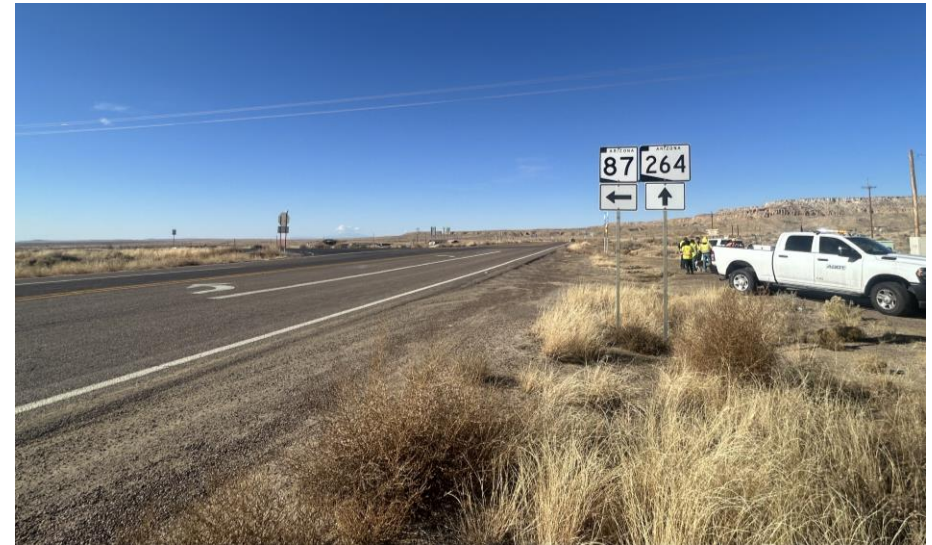
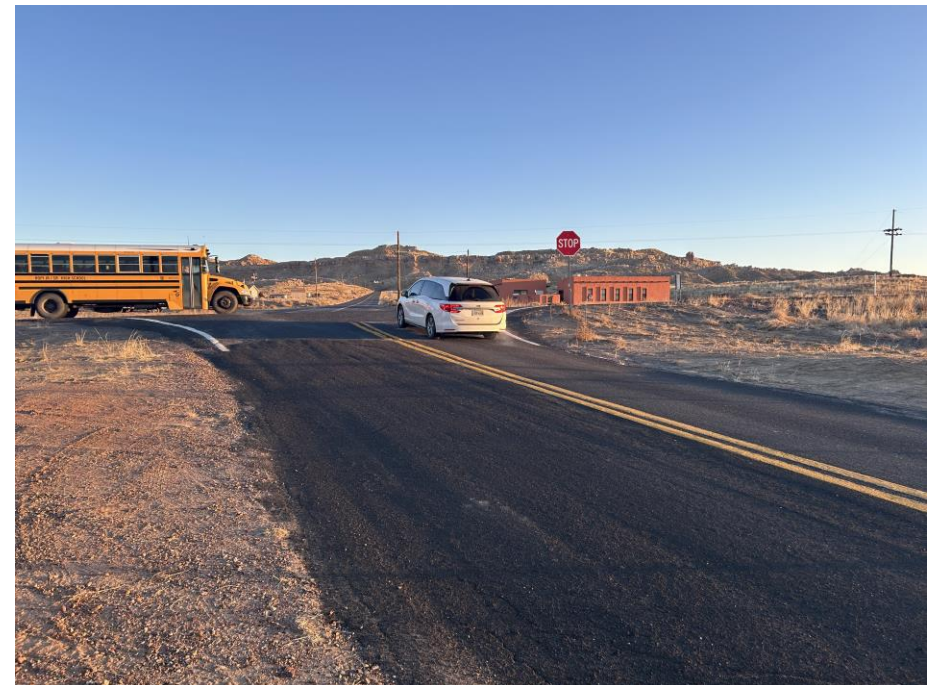
Figure 25. Areas of General Need

The analyses included in this working paper have identified deficiencies that the recommended projects will aim to address. These deficiencies are described below and **Figure 25** shows locations on the study corridor that are hot spots for transportation deficiencies and corridor constraints.

- There are several sections of the corridor that have a physical drop offs along the edge, restricting widening opportunities.
- Many of the roadways that intersect with the corridor are not paved and do not have signed traffic control.
- The areas with active transportation are isolated and disconnected. Even if accessibility is improved along SR 264, additional neighborhood connections will likely be needed to make active transportation trips feasible.
- The SR 264 corridor is the primary and only road in northern Navajo County that stretches from US 160 to US 191, any disruption along the route will have significant travel impacts as there are no alternate routes.
