ADOT SR 264 Corridor Planning Study

Working Paper 2: Identify Deficiencies and Establish Evaluation Criteria

SEPTEMBER 2025

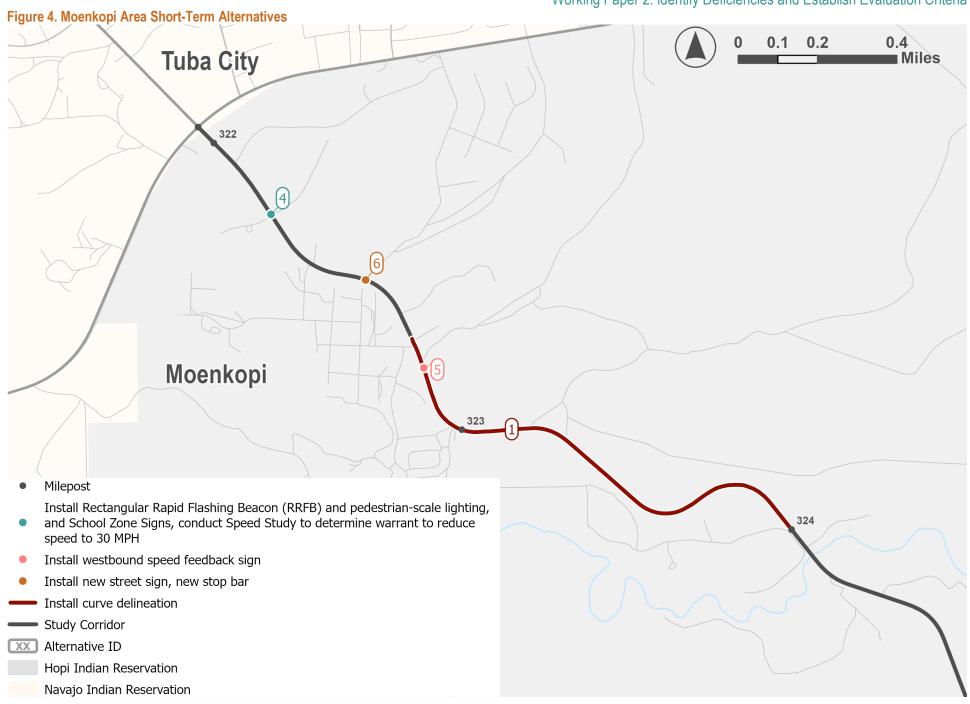
The Moenkopi Area of Need stretches from MP 321.97 to 324.00. The short- and long-term alternatives are outlined below. Short- and long-term alternatives are shown in **Figure 4** and **Figure 5**, respectively.

Alternative 1. East Moenkopi Area (MP 322.75 – 324.00)

Install curve delineation

Install centerline rumble strip

Alternative 3. West Moenkopi Area (MP 321.97 – 322.75)

- Install corridor lighting
- Install shared-use path on the south side of roadway
- Install sidewalk on north side of roadway

Alternative 4. Moencopi Day School (MP 322.22)

- Install Rectangular Rapid Flashing Beacon (RRFB)
- Install pedestrian-scale lighting
- Install School Zone Signs
- Conduct Speed Study to determine warrant to reduce speed to 30 MPH

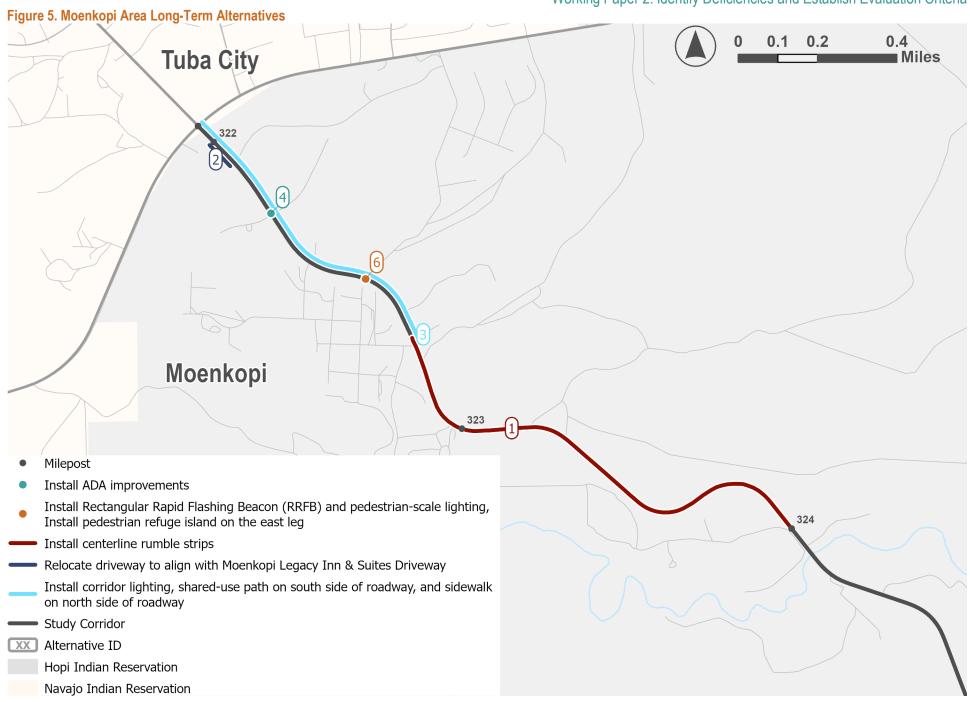
Alternative 2. Tuuvi Travel Center Driveway (MP 321.99 – 322.07)

Relocate driveway to align with Moenkopi Legacy Inn & Suites Driveway

Alternative 6. Hopi Drive Intersection (MP 322.53)

- Install new high-visibility pedestrian crossing with RRFB
- Install lighting, and pedestrian refuge island on the east leg

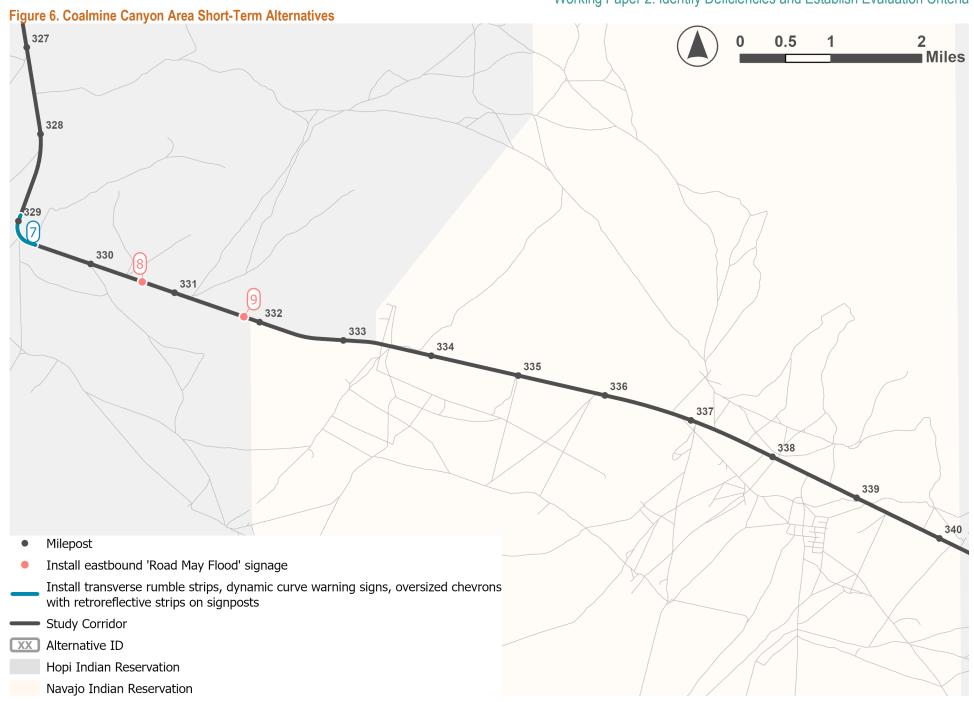
The Coalmine Canyon Area of Need stretches from MP 328.98 to 340.20. Short- and long-term alternatives are shown in **Figure 6** and **Figure 7**.

Alternative 7. Curve at MP 329 (MP 328.98 – 329.31)

- Install transverse rumble strips
- Install dynamic curve warning signs
- Install oversized chevrons with retroreflective strips on signposts

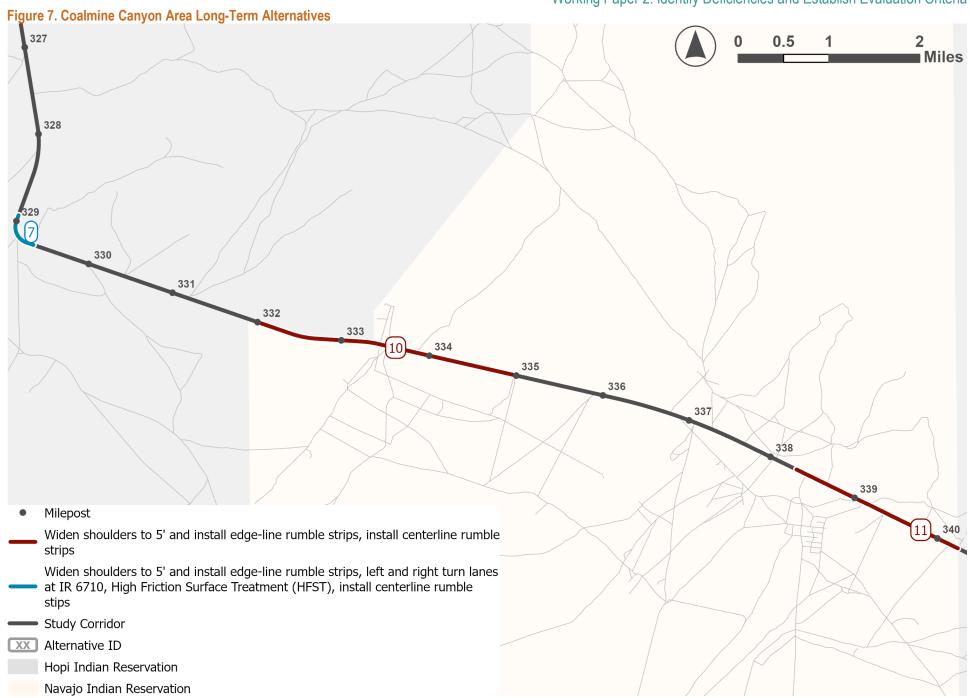
- Widen shoulders to 5'
- Install edge-line rumble strips
- Install left and right turn lanes at IR 6710
- Utilize High Friction Surface Treatment (HFST)
- Install centerline rumble strips

- Widen shoulders to 5'
- Install centerline rumble strips
- Install edge-line rumble strips

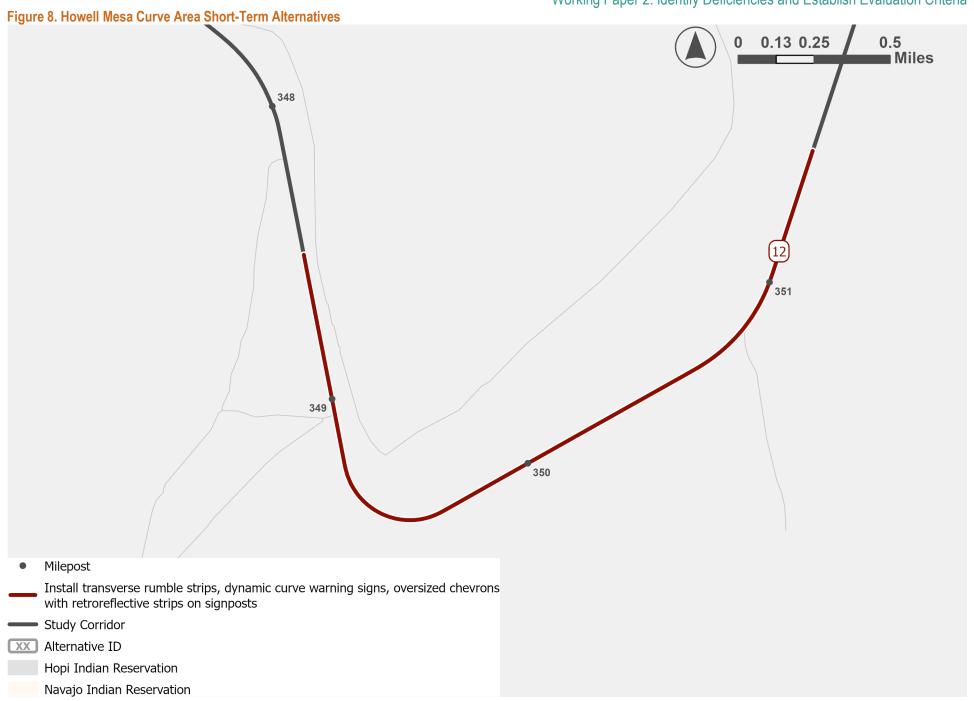
The Howell Mesa Curve Area of Need stretches from MP 348.58 to 351.50. Short- and long-term alternatives are shown in **Figure 8** and **Figure 9**, respectively.

- Install transverse and centerline rumble strips
- Install dynamic curve warning signs
- Install oversized chevrons with retroreflective strips on signposts

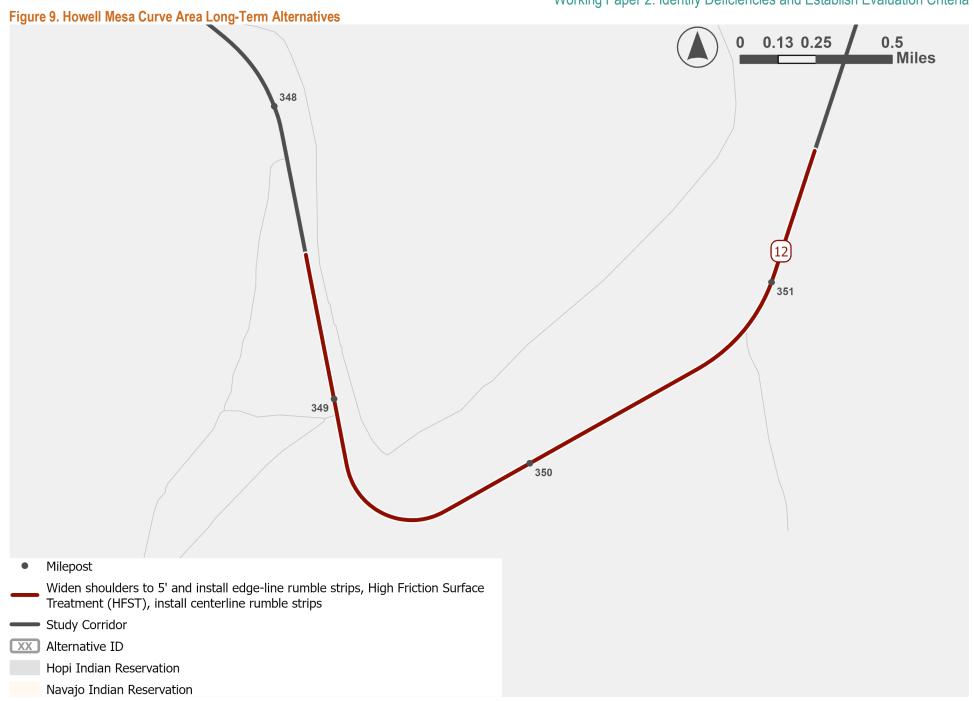
- Widen shoulders to 5' and install edge-line rumble strips
- Utilize High Friction Surface Treatment (HFST)
- Install centerline rumble strips

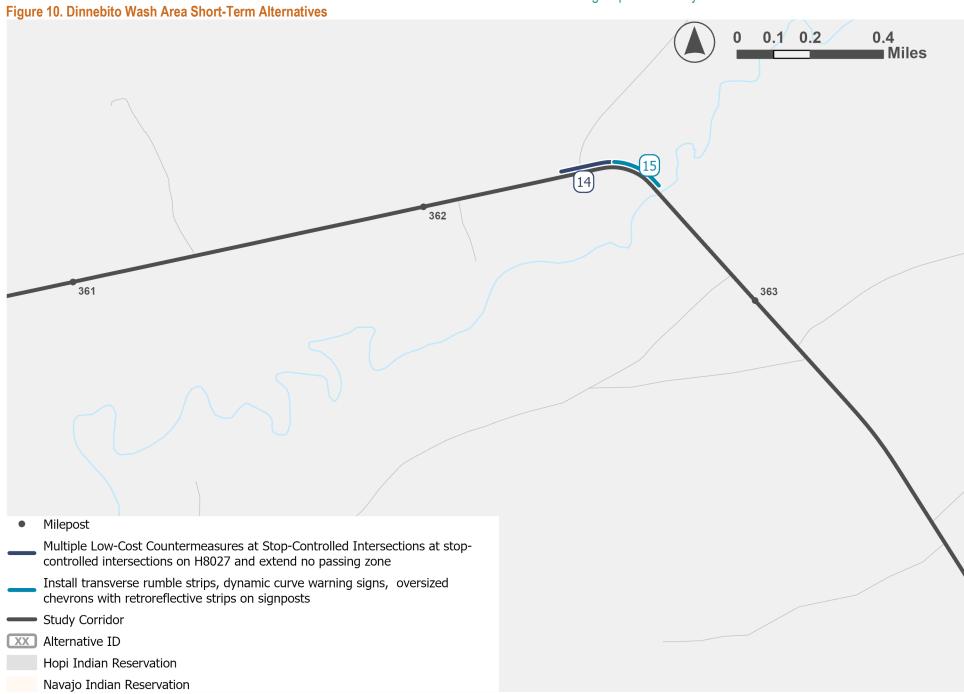
The Dinnebito Wash Area of Need stretches from MP 361.00 to 363.50. Short- and long-term alternatives are shown in **Figure 10** and **Figure 11**.

- Multiple low-cost countermeasures at stop-controlled intersections
- · Extend no passing zone

- Install transverse rumble strips
- Install dynamic curve warning signs
- Install oversized chevrons with retroreflective strips on signposts

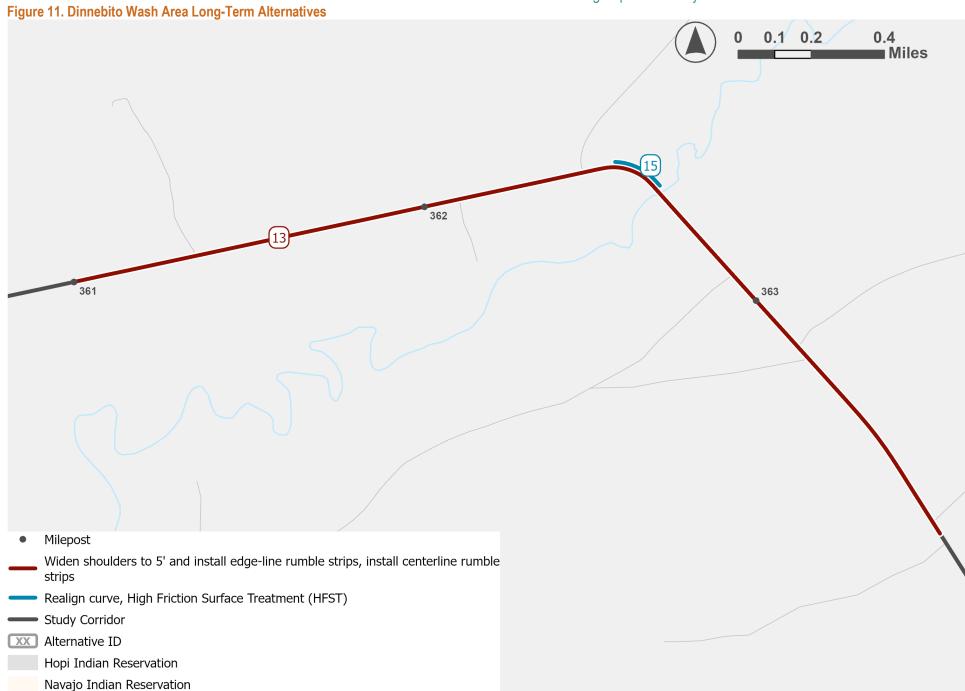
- Widen shoulders to 5' and install edge-line rumble strips
- Install centerline rumble strips

- Realign curve
- Utilize High Friction Surface Treatment (HFST)

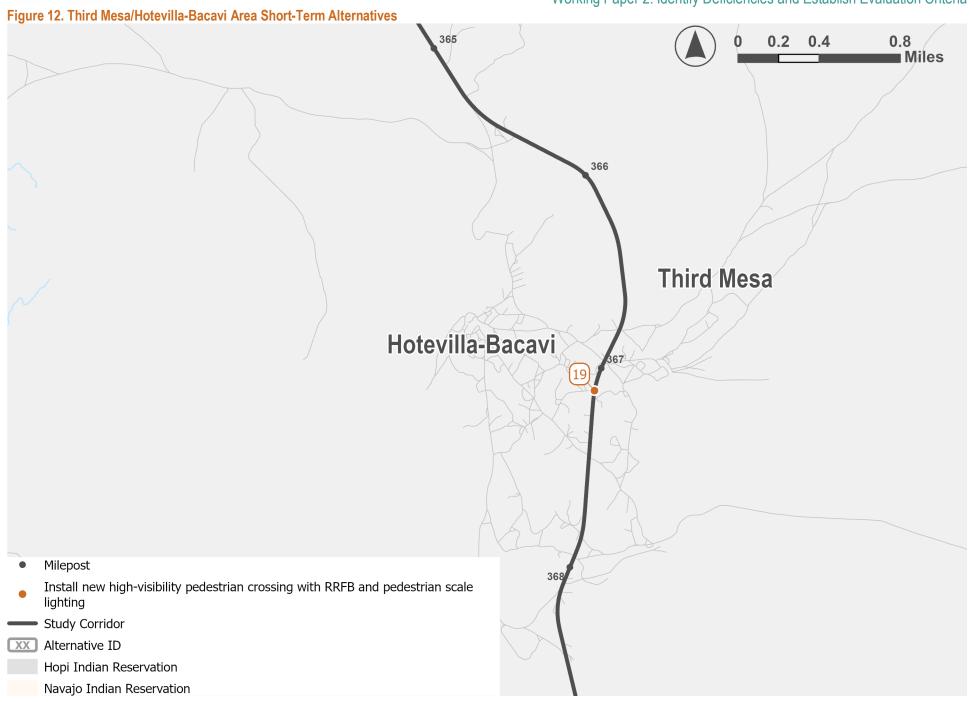
The Third Mesa/Hotevilla-Bacavi Area of Need stretches from MP 365.00 to 368.50. Short- and long-term alternatives are shown in **Figure 12** and **Figure 13**, respectively.

Install new high-visibility pedestrian crossing with RRFB and pedestrian scale lighting

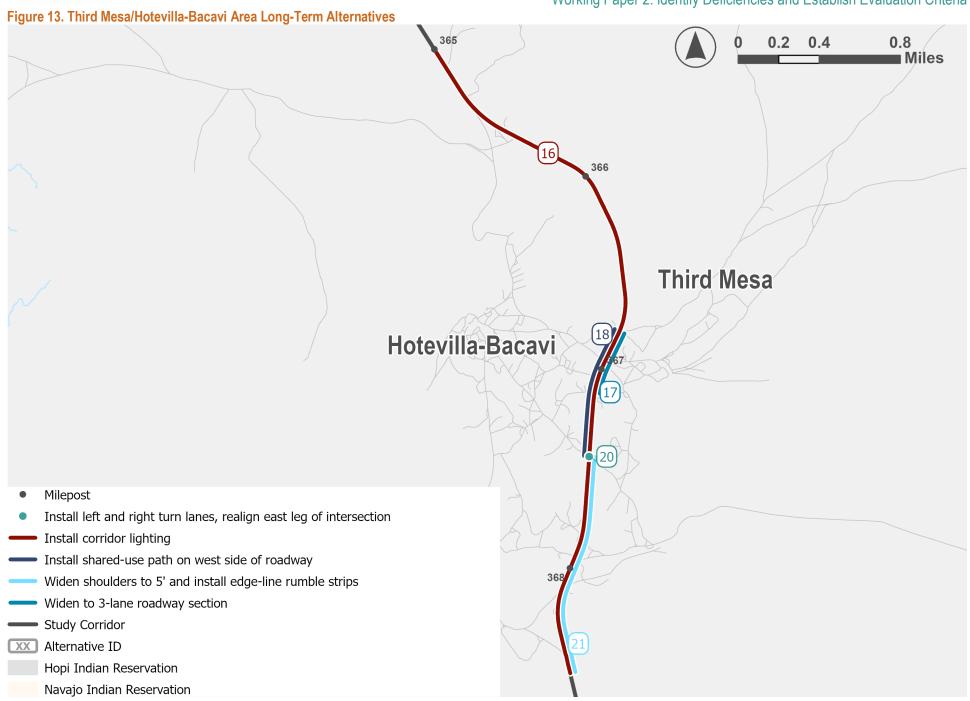
Install corridor lighting

· Widen corridor to 3-lane roadway section

Install shared-use path on west side of roadway

Install left and right turn lanes, realign east leg of intersection

Widen shoulders to 5' and install edge-line rumble strips

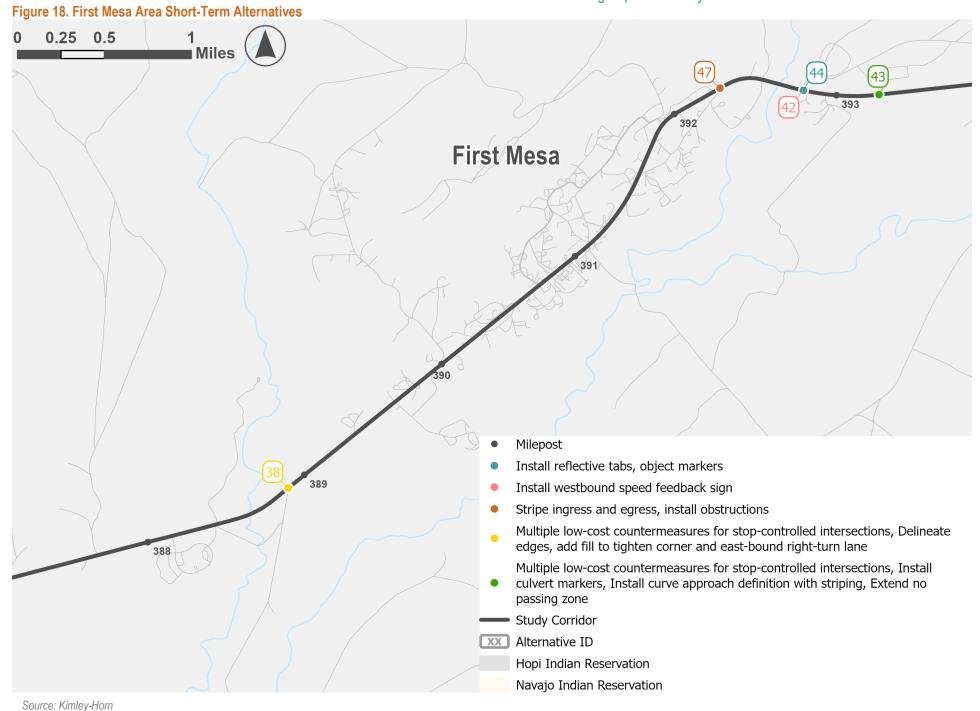
The First Mesa Area of Need stretches from MP 388.00 to 393.20. Shortand long-term alternatives are shown in **Figure 18** and **Figure 19**, respectively.

- Multiple low-cost countermeasures for stop-controlled intersections
- Delineate edges, add fill to tighten corner and east-bound right-turn lane

- Multiple low-cost countermeasures for stop-controlled intersections
- Install culvert markers
- · Install curve approach definition with striping
- Extend no passing zone

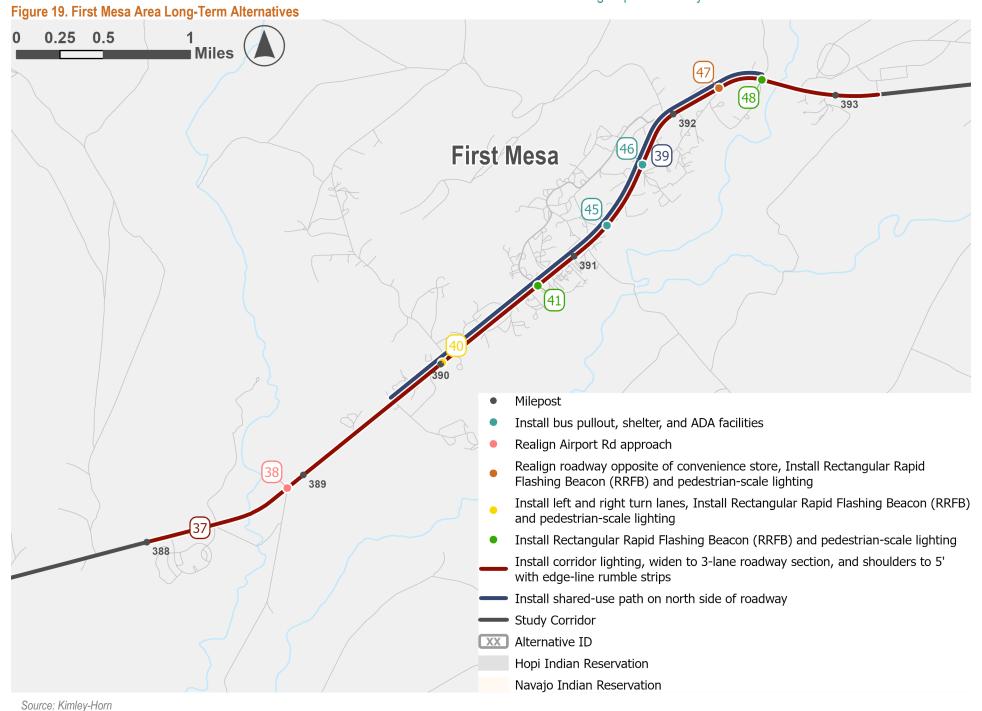
- Install corridor lighting
- Widen to 3-lane roadway section
- Widen shoulders to 5'
- Install edge-line rumble strips

Install shared-use path on north side of roadway

- Install left and right turn lanes
- Install new high-visibility pedestrian crossing with RRFB and pedestrian-scale lighting
