FEBRUARY 2017 // FINAL REPORT

# Low Volume State Routes Study

ADOT WORK TASK NO. MPD 0049-16

Arizona Department of Transportation

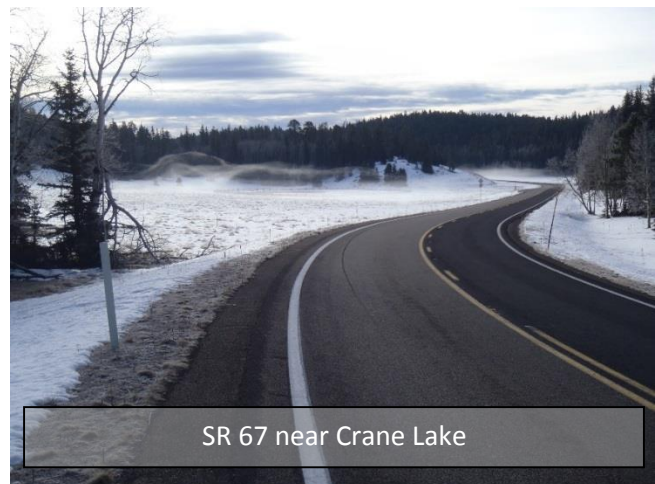
Figure 9: SR 67 From Jacob Lake to North Rim Route Characteristics

This section of SR 67, depicted in Figure 9, is located in Coconino County, beginning at Jacob Lake. It provides a connection to the North Rim of the Grand Canyon. The entire length of the SR 67 segment, which is designated as a Scenic Byway, is located within the northern section of the Kaibab National Forest. Access to the North Rim of the Grand Canyon is closed in the winter months due to snow. Several formal camping and hiking trails are accessible along the route. Several formal pull-offs and rest areas, which include historic and ecological information posts, are also located along the route. There is an average of 1.2 access points per mile. There are no recommendations or programmed projects associated with the segment. Route characteristics are summarized in Table 16.

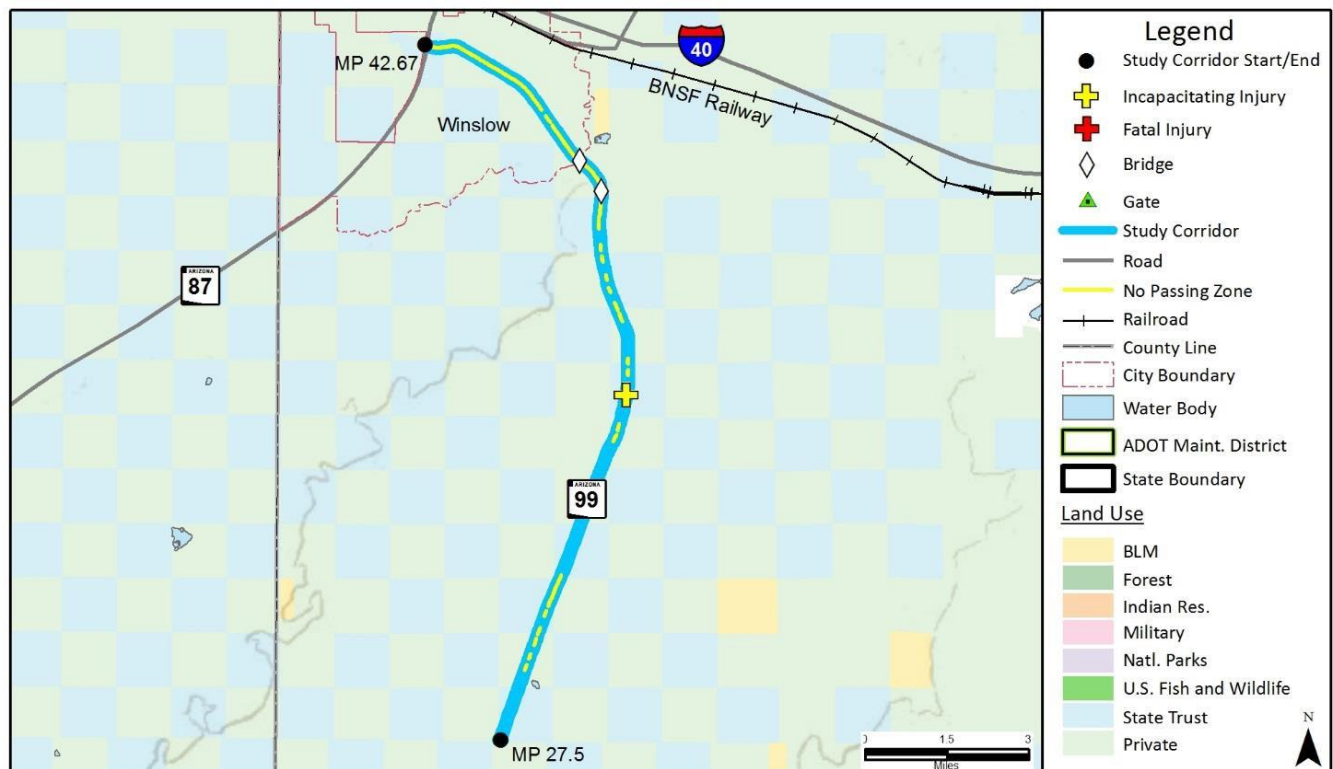
**Figure 10: SR 99 From 15 Miles South of Winslow to SR 87/Winslow Route Characteristics**

This segment has two bridge structures. The Clear Creek Arch Bridge is in Fair condition, with the deck, substructure and superstructure also rated as Fair, although the sufficiency rating was good. The Jacks Canyon bridge is in good condition overall.

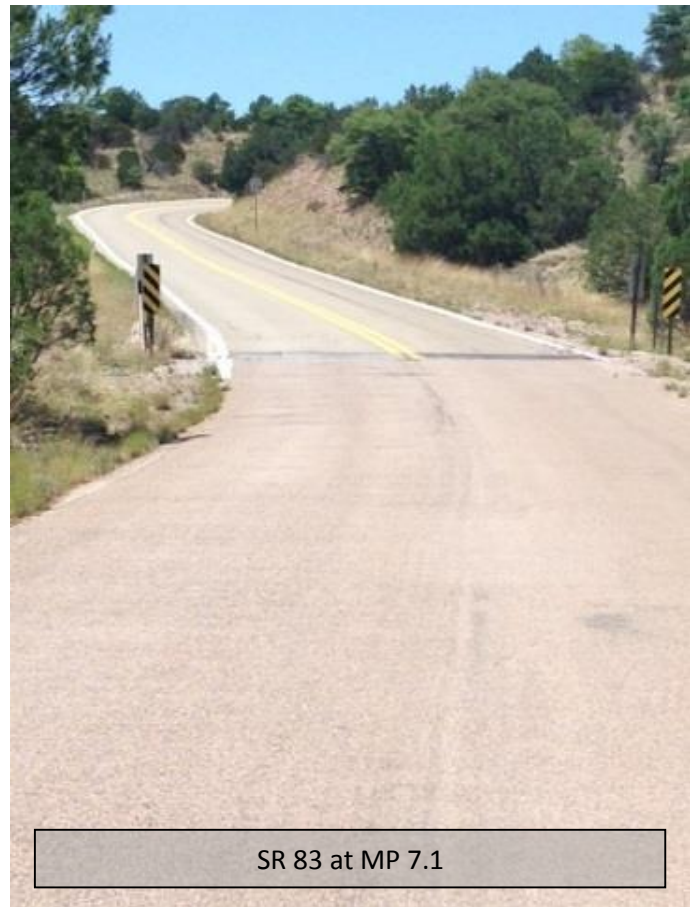
Figure 12: SR 83 From Parker Canyon Lake to SR 82 Route Characteristics

This section of SR 83, depicted in Figure 12, travels through Santa Cruz and Cochise counties. SR 83 connects SR 82 and Sonoita in the north to Parker Canyon Lake and various outdoor amenities in the south, bisecting the Huachuca Ecosystem Management Area of the Coronado National Forest. A portion of the segment is located along Las Cienegas National Conservation Area (NCA), managed by the Bureau of Land Management (BLM). Parker Canyon Lake is located at the southern boundary of the route; several cabins and permanent residences are located near the lake.

The primary purpose of this route is to connect communities in the north and west to the Coronado National Forest and surrounding natural amenities. Shoulders are generally one foot wide along the segment. There are also a number of informal pull-offs located sporadically throughout the route. The *2013 Santa Cruz Comprehensive Plan* identified SR 83 as a state highway that needs to be improved or maintained in order to accommodate traffic increases. The statewide travel demand model reflects a negative growth rate due to changes in population and employment, such as closures of wineries in the region, as well as alternative routes in the future. No recommended or programmed projects were identified. The route characteristics are summarized in Table 22.

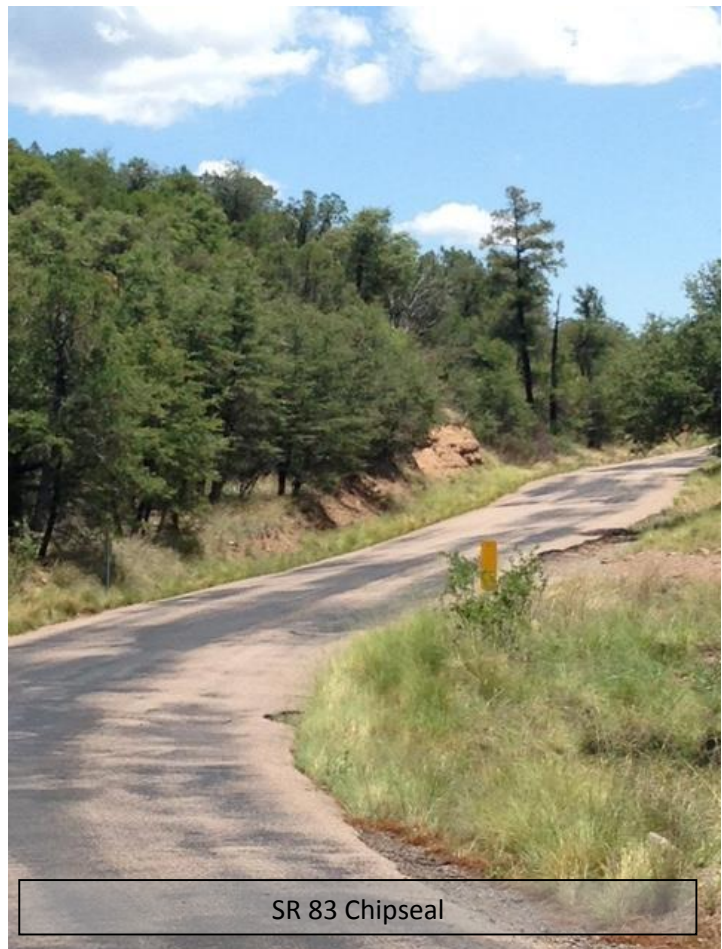
**Table 23: SR 83 From Parker Canyon Lake to SR 82 Recommendations**

This segment is a candidate for route transfer. If it remains in the state system, reduced maintenance costs with minimum maintenance signage is recommended for this segment. Additionally, there is opportunity to perform data analysis to identify crash patterns to determine if conducting a Road Safety Assessment would be beneficial. Since this segment is within the Coronado National Forest and Huachuca Ecosystem Management Area, there is potential to partner with the Forest Service or Central Federal Lands for shared maintenance costs. This segment may be eligible for up to five funding sources: the STBG, HSIP, FLAP, and FLTP. Recommendations are summarized in Table 23.

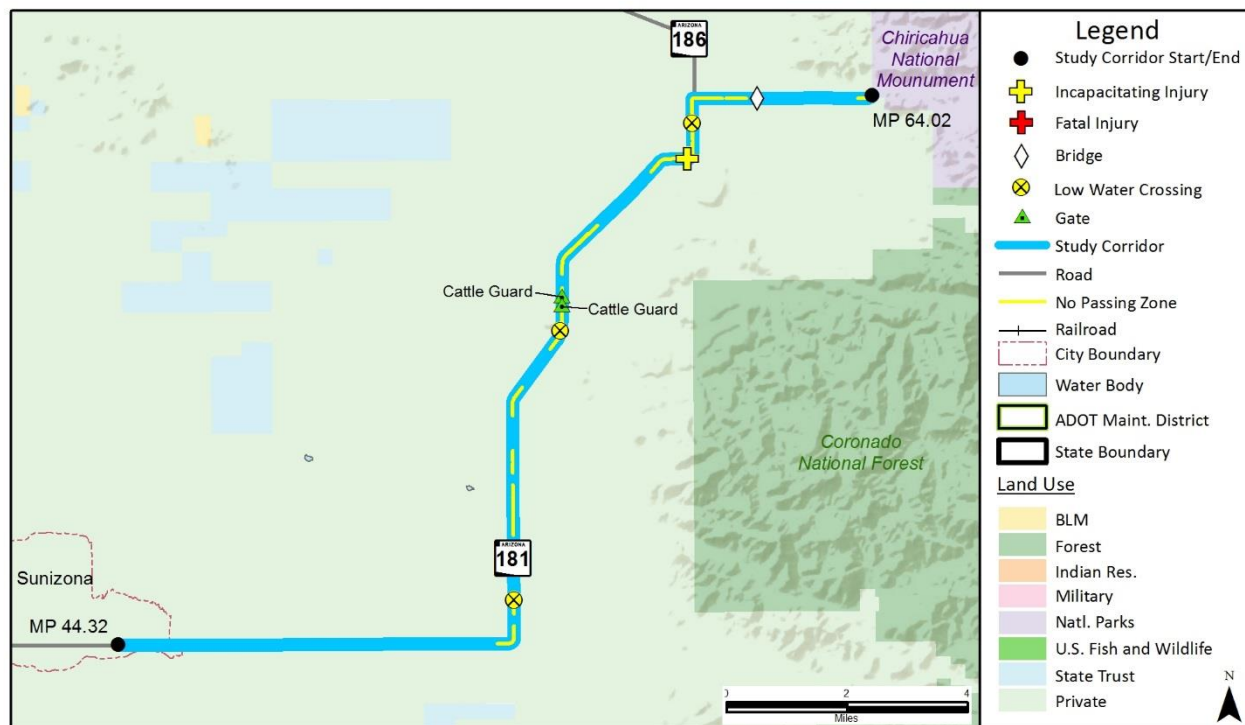
**Figure 17: SR 181 From Feather Pine Road to Chiricahua National Monument Route Characteristics**

This segment has one bridge which is in Fair condition overall. The deck, substructure and sufficiency all have a Fair rating, while the superstructure is rated as Good. One incapacitating crash was recorded in the last five years in this segment. This crash involved a motorcycle negotiating a curve where the driver fell asleep at a 90 degree turn.

The paved portions of this segment have elevated IRI values, concentrated from MP 50 to MP 64, and much of the segment also has slightly elevated cracking. MP 63 to MP 64 has extremely high cracking. This segment has an irregular maintenance history and generally in this area the pavement is oxidized as evidenced by a significant number of crack seals. Only two short segments were paved in the last 20 years.

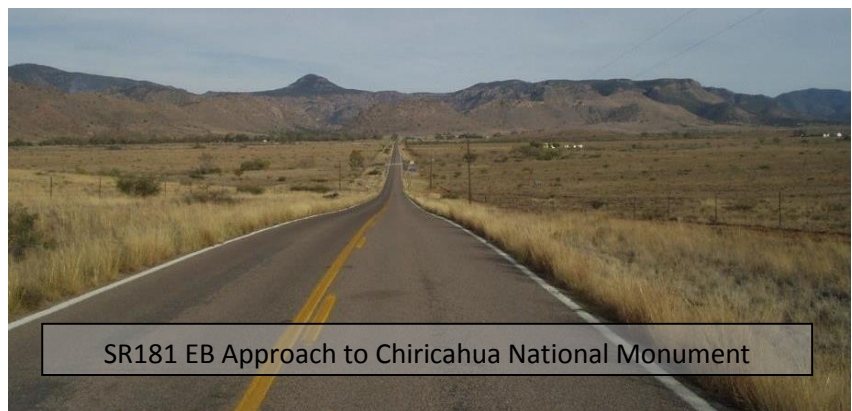
**Table 33: SR 181 From Feather Pine Road to Chiricahua National Monument Recommendations**

For this route, as noted in Table 33, permanent drainage improvements are recommended for the low flow crossings to reduce high reoccurring drainage costs, which will reduce overall maintenance costs. As this route provides access to the Chiricahua National Monument, it is recommended to partner with the National Park Service to share in maintenance costs. SR 181 from the intersection with SR 186 East to the Chiricahua National Monument Boundary was selected for FLAP funds for rehabilitation and paving, and includes drainage and safety improvements. This project is anticipated in the next five years but is not programmed.

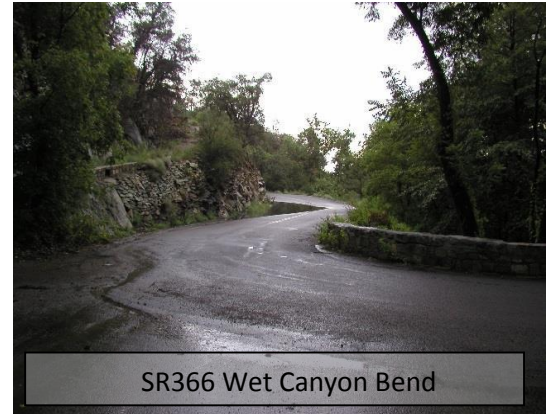
**Figure 20: SR 366 From SR 191 to Columbine Ranger Station Route Characteristics**

This section of SR 366, shown in Figure 20, is located in Graham County, south of Safford, and traverses State Trust Land and the Coronado National Forest, providing access to Mount Graham, including the Mount Graham International Observatory. Mount Graham is also home to many unique animal species. From MP 117, the route is considered mountainous and includes numerous hairpin turns and steep cliffs. Most of the route has no effective shoulder although there are numerous informal pull-offs. The speed limit ranges from 55 mph along the eastern section between MP 115.8 and MP 117.75, is reduced to 40 mph through MP 119, and further reduced to 25 mph for the remainder of the route. The route is only paved between MP 113.69 to MP 136.2. At MP 136.2, a “Road Closed” sign and gate marks the beginning of the unpaved route. The route is closed each year on November 15 for ecosystem management. Additionally, the Coronado National Forest has started working with the University of Arizona and Eastern Arizona College to construct a learning center near their visitor center near Columbine for their National Resources program. There are also discussions with the San Carlos Apache Tribe to allow the construction of a building and facility on Mount Graham for ceremonial use. This route is affected by natural elements such as rock-fall, wildfires and snow/ice in the winter. No recommendations or programmed projects are associated with the segment. Route characteristics are detailed in Table 38.

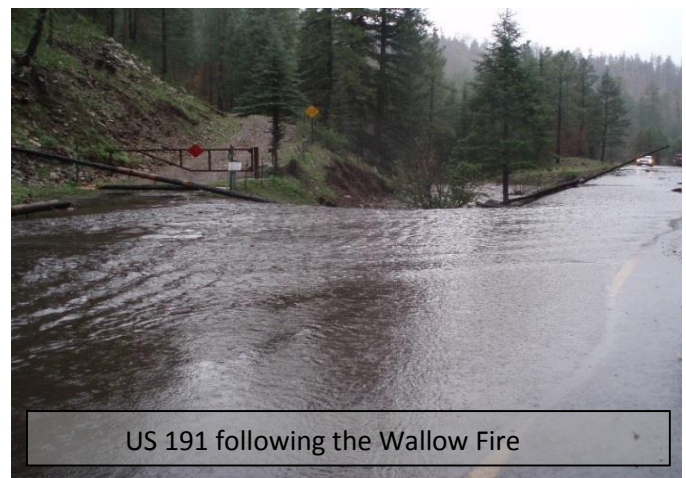
Figure 22: US 191 From US 191x near Granville to SR 180-Alpine Route Characteristics

This section of the US 191 segment, depicted in Figure 22, begins just north of the Morenci mine and is primarily located within the Apache-Sitgreaves National Forest. The route connects the towns of Clifton and Morenci in the south to SR 180 in the north. Legacy ranches, numerous campgrounds and trailheads are located directly off of US 191. The two most popular areas accessed from this segment are the Hannagan Meadow Recreation Area and the Blue Range Primitive Area. The area experiences a spike in traffic during hunting season. This route is affected by natural elements such as rock-fall, wildfires and snow/ice in the winter. US 191 was identified as of major importance for current circulation in the 2004 Apache County Comprehensive Plan. Most of the route includes winding narrow lanes and limited shoulder width. Route Characteristics are presented in Table 42.

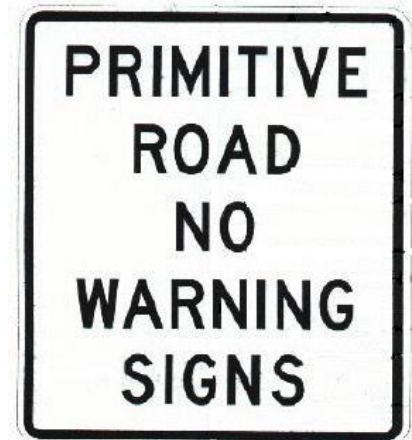
Other states with LVR guidance include New York and Washington State. New York permits the use of a “MINIMUM MAINTENANCE ROAD” sign on an unpaved, low volume road. The *Washington State Modifications to the MUTCD (1996)* includes a provision to use the “PRIMITIVE ROAD” sign on a portion of a county road that:

An accompanying “CAUTION – NO WARNING SIGNS” sign may also be posted with or without a “NEXT XX MILES” plaque.
