## WELLTON BRANCH RAILROAD REHABILITATION STUDY

# FINAL REPORT

April 2014

**Arizona Department of Transportation**

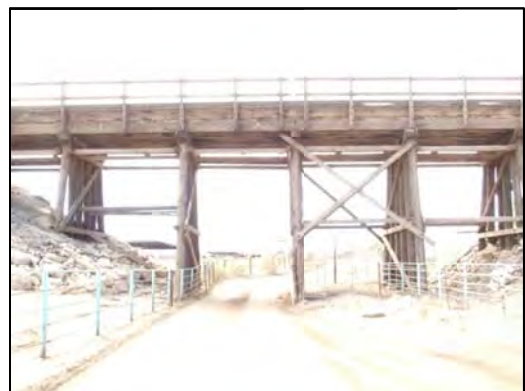
Photo 1 is of the timber trestle bridge at the west end of the JBS Five Rivers Cattle Feeding – McElhaney Feed Yard. There is also a 12 span steel truss bridge that crosses the Gila River and is 1,836 feet in length. Many of the bridges had a considerable amount of vegetation piled against them. There are also 11 culverts ranging from 30-inch to 54-inch diameter along the Roll Industrial Lead. The condition of the culverts is unknown.

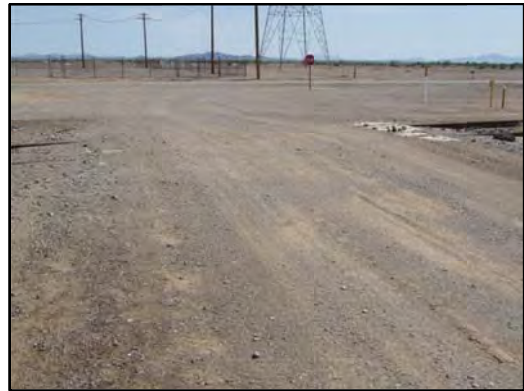
The track on the Wellton Branch was operated as FRA Class 3 track which allows a maximum speed of 40 mph for freight trains and 60 mph for passenger trains. The maximum operating speed for all trains operating along this portion of the Wellton Branch was 40 mph before it was removed from service. At the time of the August 2012 field inspection, most of the ballast was fouled with sand, dirt, and other fines. The observed rail was mostly jointed 113# section rolled between 1942 and 1949. While there was some end batter, the rail head contour was good with very little metal flow. The joint bars appeared to be in good condition and no broken joiners were seen. Based upon the ties that could be seen, most of them were not holding spikes due to splitting and age or were broken at the tie plates or between the rails. There were also clusters of bad and poor ties. Tie plates were double shoulder type with cut spikes and rail anchors used at crossings.

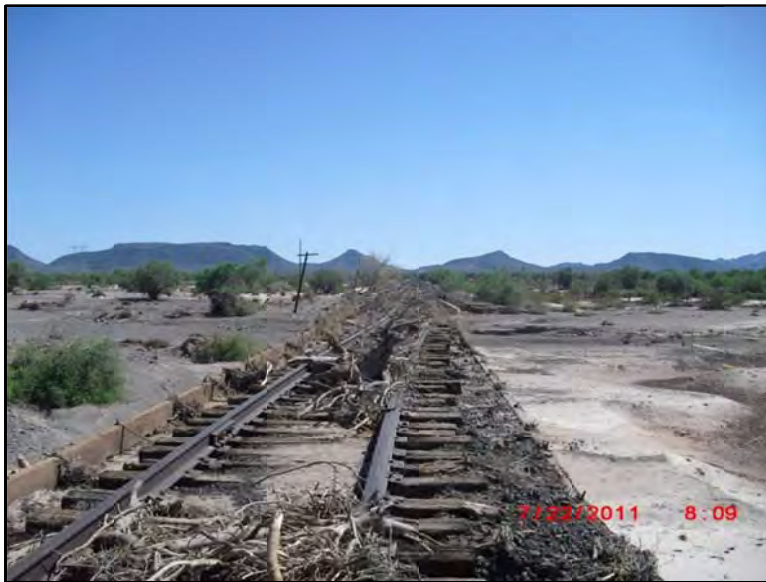
*Photo 3: Washout at Milepost 842.75 (Photo provided by UPRR)*

As shown in Photo 3, one bridge at Milepost 842.75 experienced a washout. There is also one 48-inch corrugated metal pipe culvert on the line. The condition of the culvert is unknown.

- Replace 1 or more bridges totaling 195 feet in length (equivalent to the bridge at Milepost 482.75 where the washout occurred).
- Replace active warning devices at 5 at-grade public crossings including lights, bells, gates, and constant warning predictors.
- Replace passive cross-bucks and railroad crossing signs at 10 public crossings.
- Replace crossing surfaces with concrete panels at 15 public crossings and 7 private crossings.

- Replace 50% of the 42 existing bridges that are 10 feet to 30 feet in length (21 bridges and 360 feet in length total) with concrete box culverts.
- Replace 1 or more bridges totaling 195 feet in length (equivalent to the bridge at Milepost 482.75 where the washout occurred).

- Replace 50% of the 42 existing bridges that are 10 feet to 30 feet in length (21 bridges and 360 feet in length total) with concrete box culverts.
- Replace 2 or more bridges totaling 272 feet in length (equivalent to the bridge at Milepost 482.75 where the washout occurred plus the average of 77 feet per bridge).

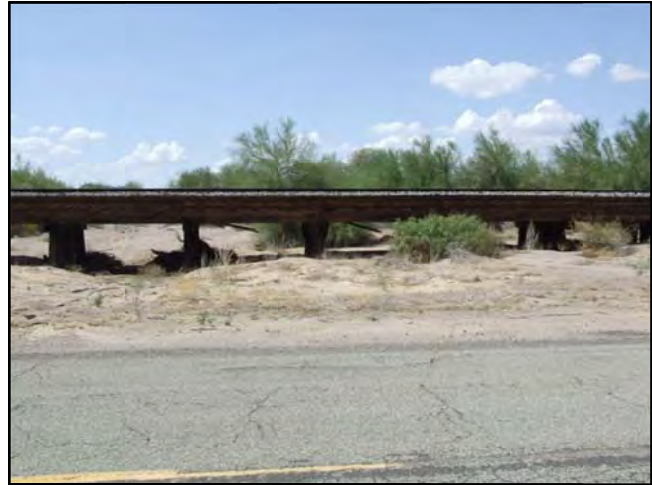
Assuming that no recent bridge inspection reports are available, all of the bridges will need to be inspected in accordance with 49 CFR Part 237, Bridge Safety Standards. Some bridges may only require safety walkways and handrails while others may also require some timber repair or replacement. A few bridges may require more extensive work such as the replacement of some of the piles. Any bridges with vegetation or other debris piled against them should have the vegetation removed. Photo 4 is a typical timber bridge along the Phoenix Line. Some cosmetic repair is required as well as the addition of safety walkways and handrails.

A more thorough field investigation/inspection of the bridges was not completed prior to issuance of this report, but should be conducted at a later date in order to further refine the bridge cost estimates.

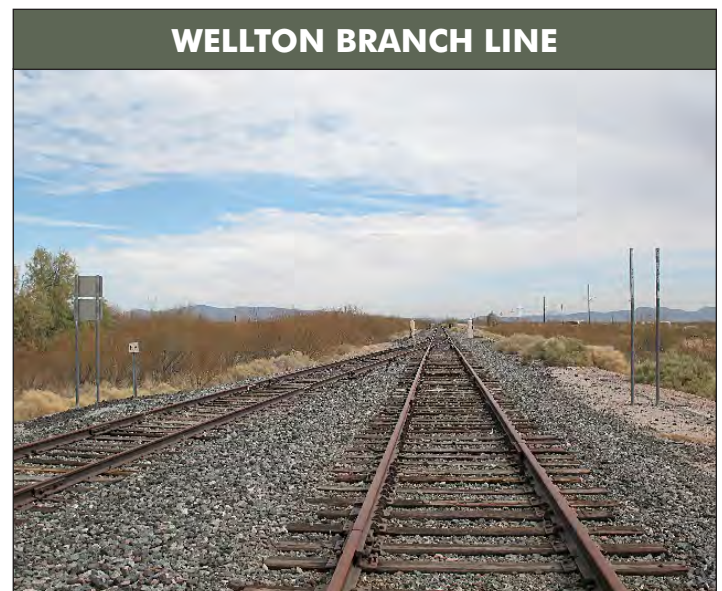
Figure 2: Out of service Wellton Branch near Hyder, Arizona (ADOT/M. Pearsall.)
