**ARIZONA DEPARTMENT OF TRANSPORTATION
BRIDGE GROUP
BRIDGE DESIGN SECTION C**

INITIAL BRIDGE STUDY

**State Route 88 (Apache Trail)
MP 222 - MP 229**

DATE: October 2023

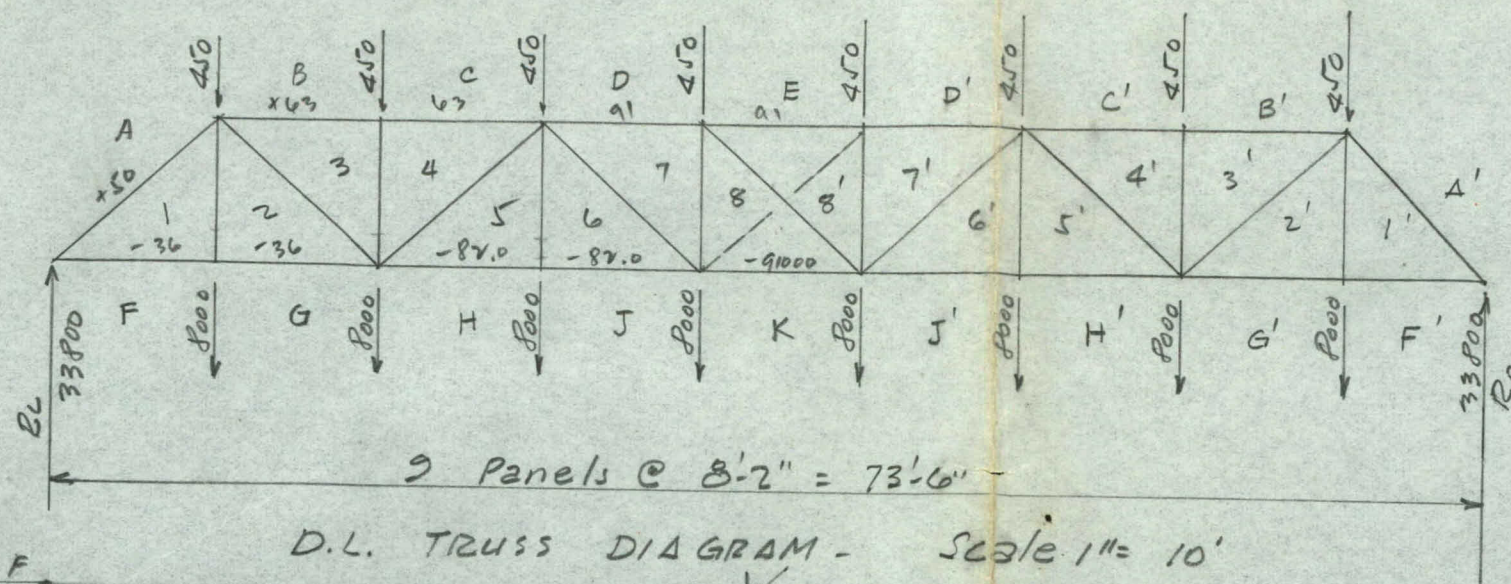
Top chord. $A = 7.760''$
 $\frac{L}{r} = \frac{98}{2.35} = 42$
 use 15000 p.s.i.
 $f_s = \frac{91}{7.76} = 11.7$
 available for LL = 3300 p.s.i.
 $3300 \times 7.76 \times 7.8^2 = 200 \text{ 'K. ea truss}$
 LLM (do not exceed) = 400 'K -
 design evidently contemplated.
 H-10 Loading -
 H-10 = $590.6 \times .667 = 396 \text{ 'K} \checkmark$

Should be posted for.
10-Ton Gross Load - (single vehicle)
18-Ton Tractor & Semi Combination

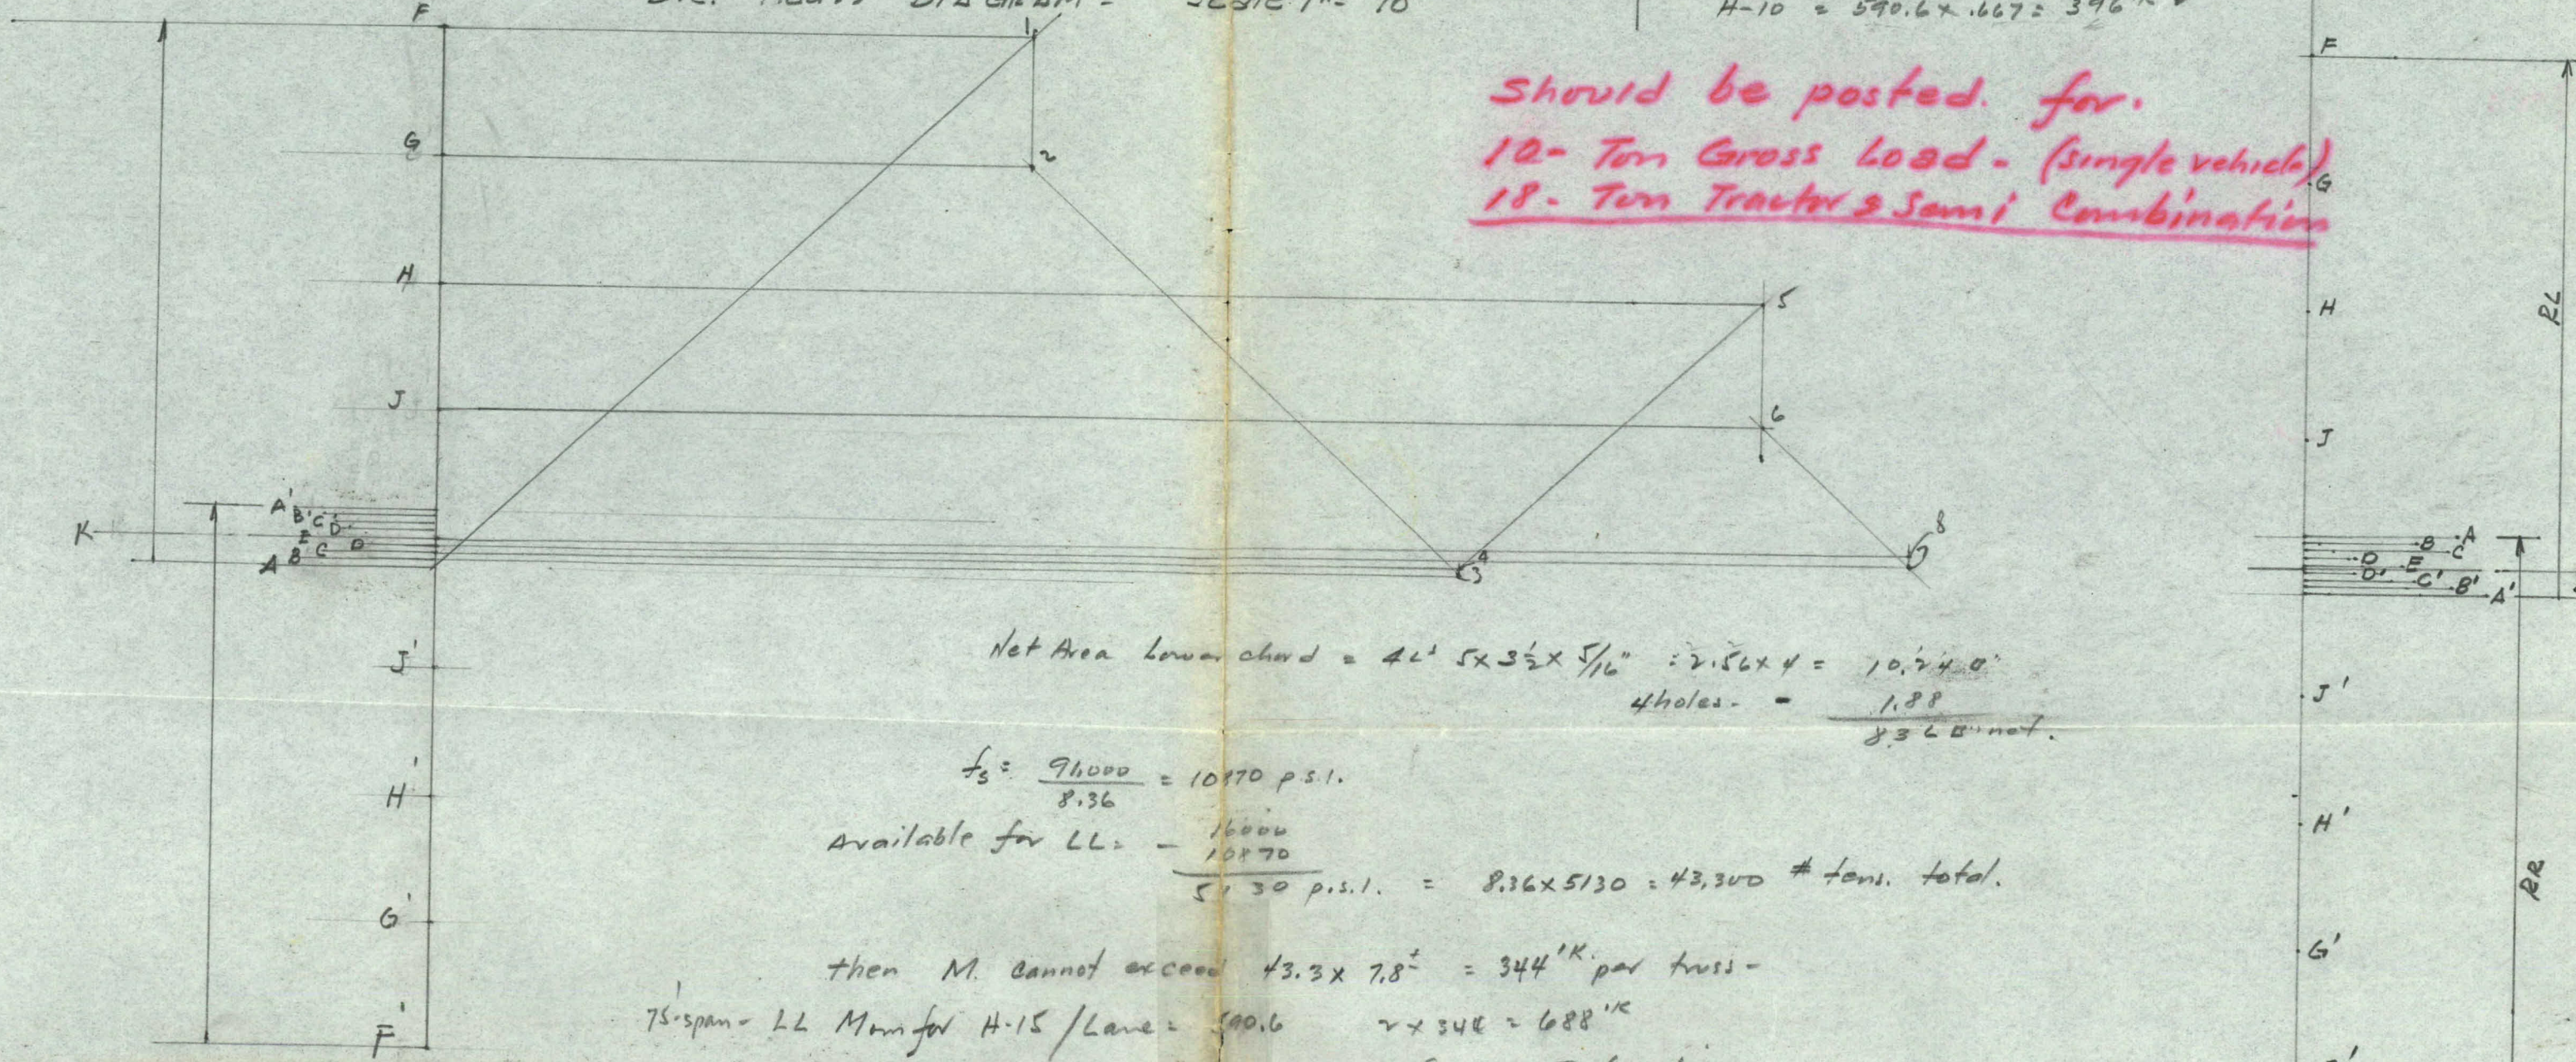
Net Area lower chord = $4L \times 5 \times 3 \frac{1}{2} \times \frac{5}{16} = 21.56 \times 4 = 10.740$
 4 holes = $\frac{1.88}{8.36 \text{ net}}$

$f_s = \frac{91000}{8.36} = 10870 \text{ p.s.i.}$

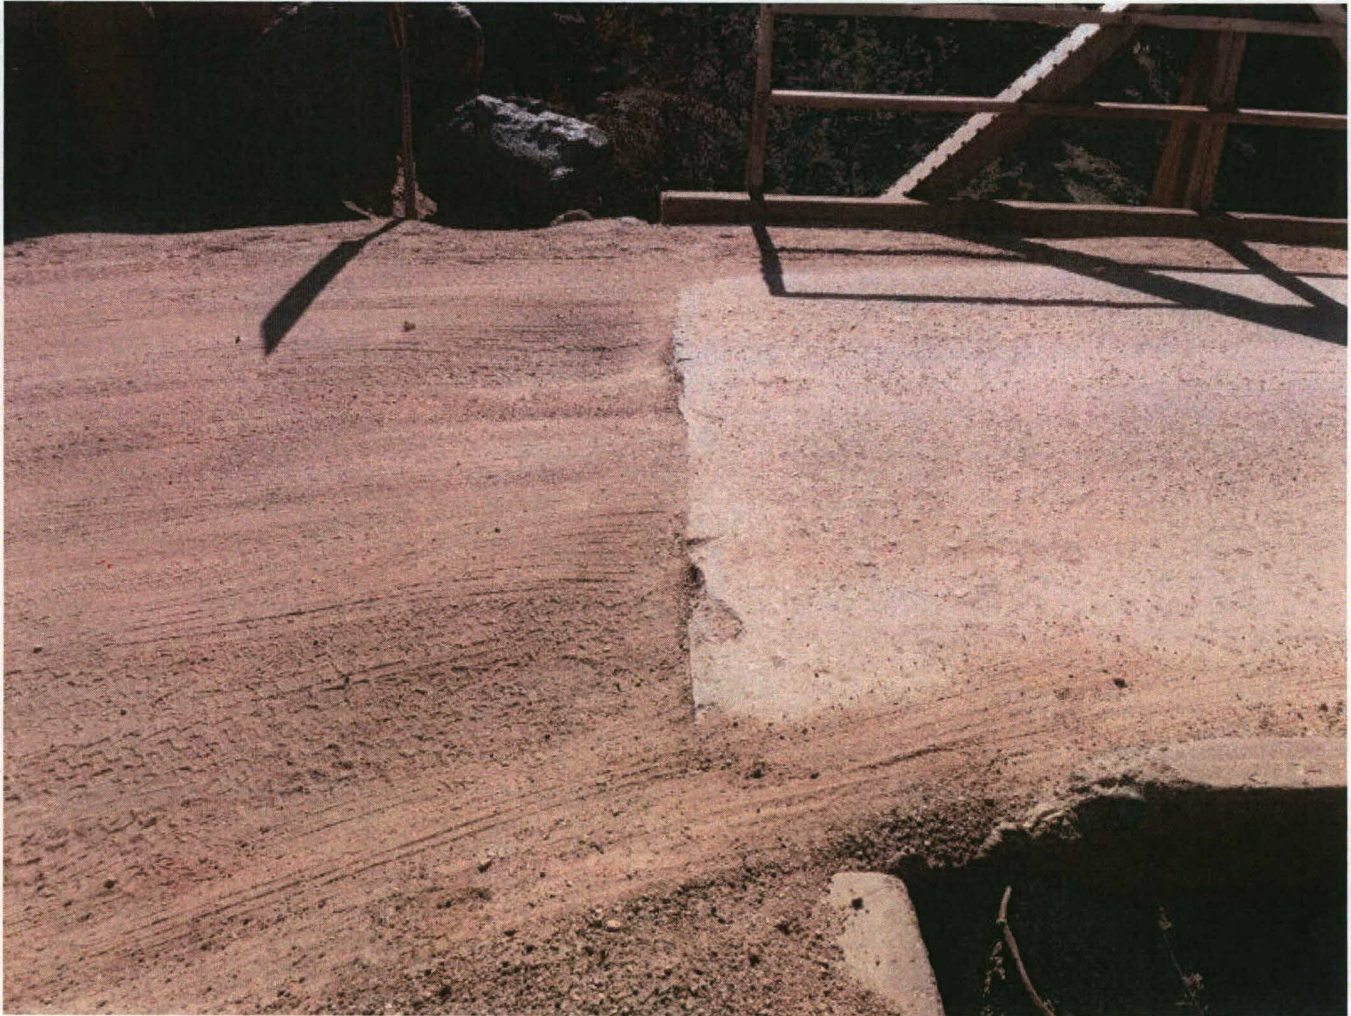
File Name : 00027-2018-09-08-Photo-E.jpg

Description : Photo E. North edge of bridge deck

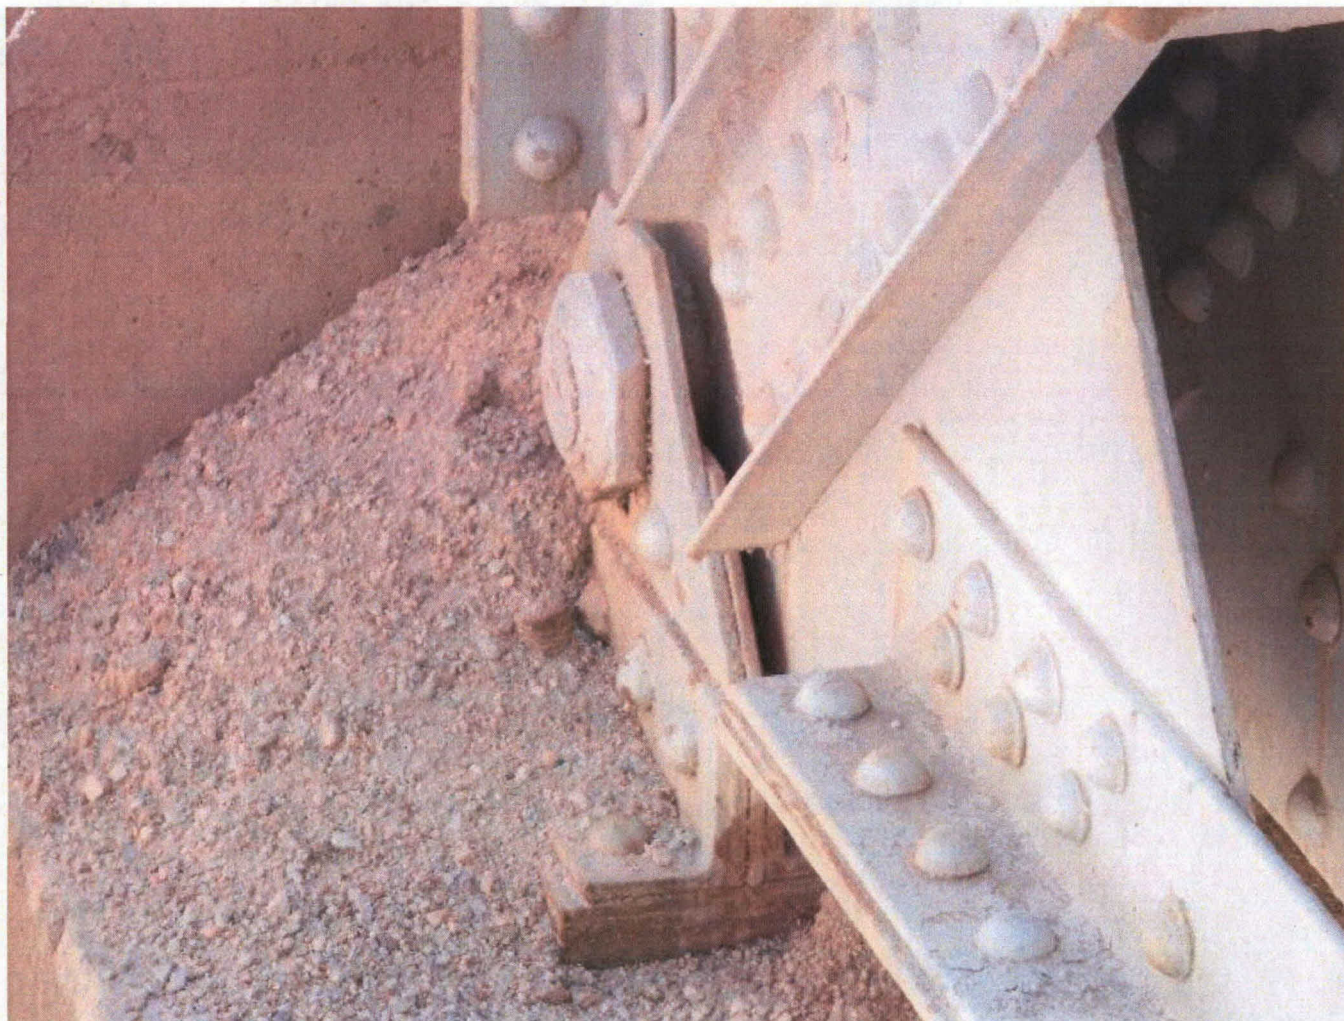
File Name : 00027-2018-09-08-Photo-F.jpg

Description : Photo F. Debris around the northwest bearing

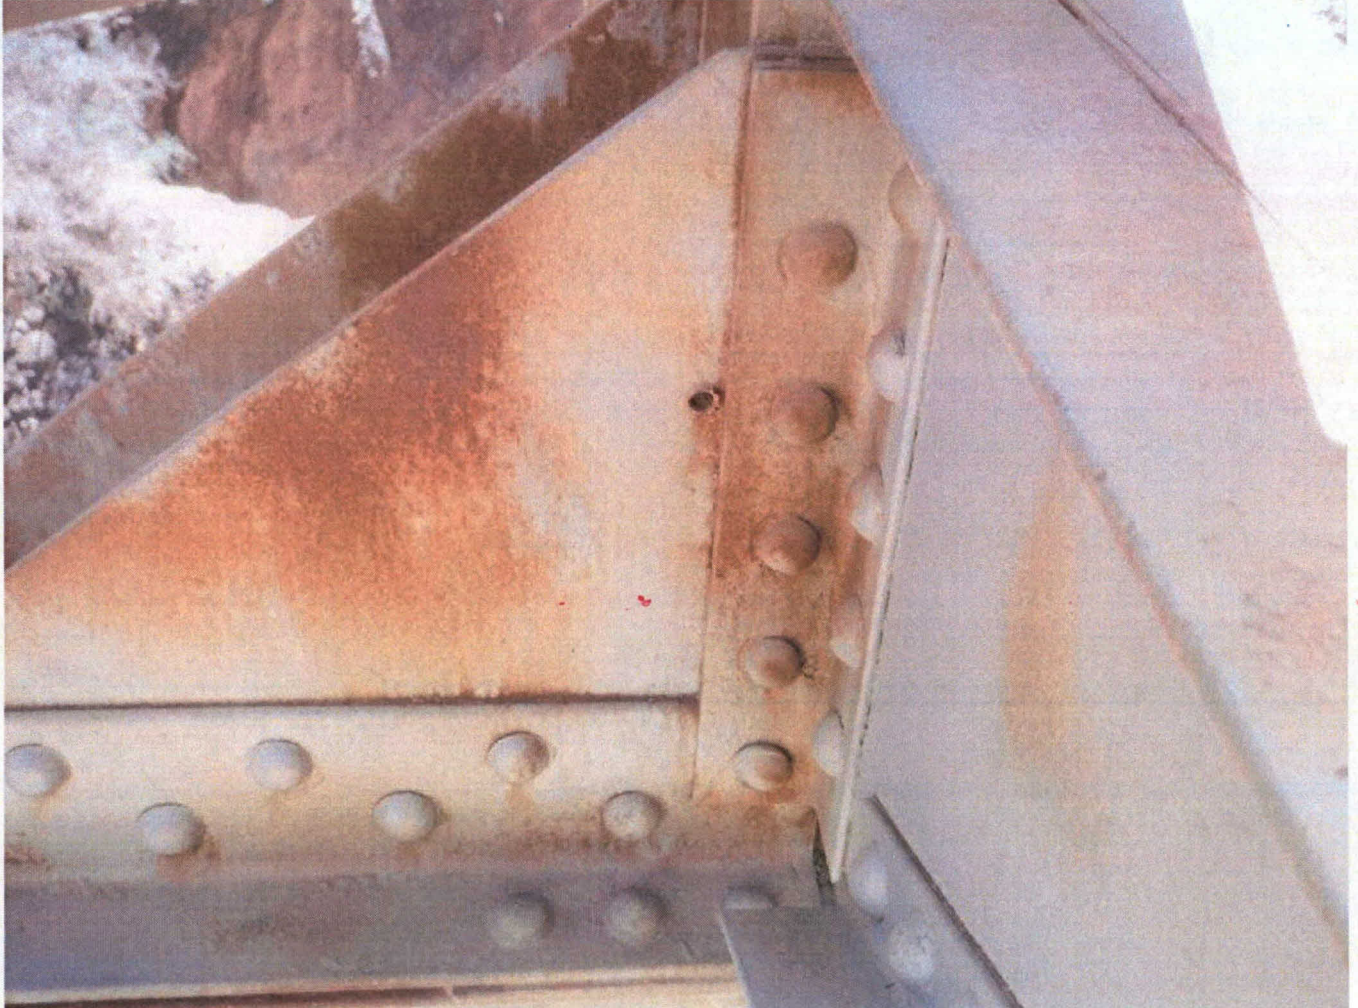
File Name : 00027-2018-09-08-Photo-M.jpg

Description : Photo M. Bullet hole in the L3 exterior gusset plate of the west truss

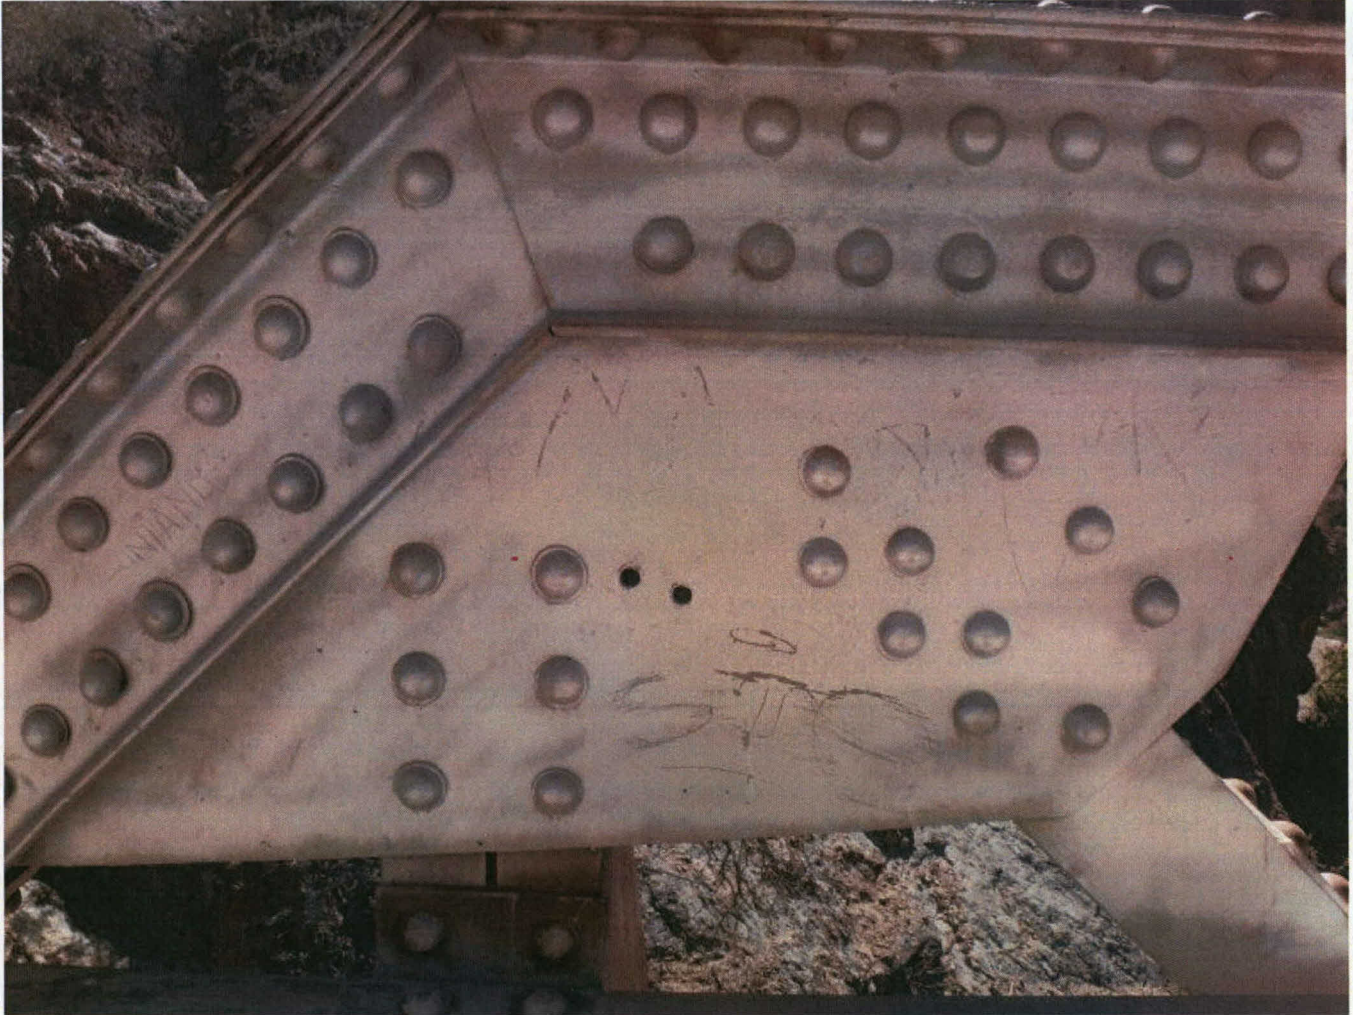
File Name : 00027-2018-09-08-Photo-N.jpg

Description : Photo N. Two bullet holes in the U8 interior gusset plate of the east truss

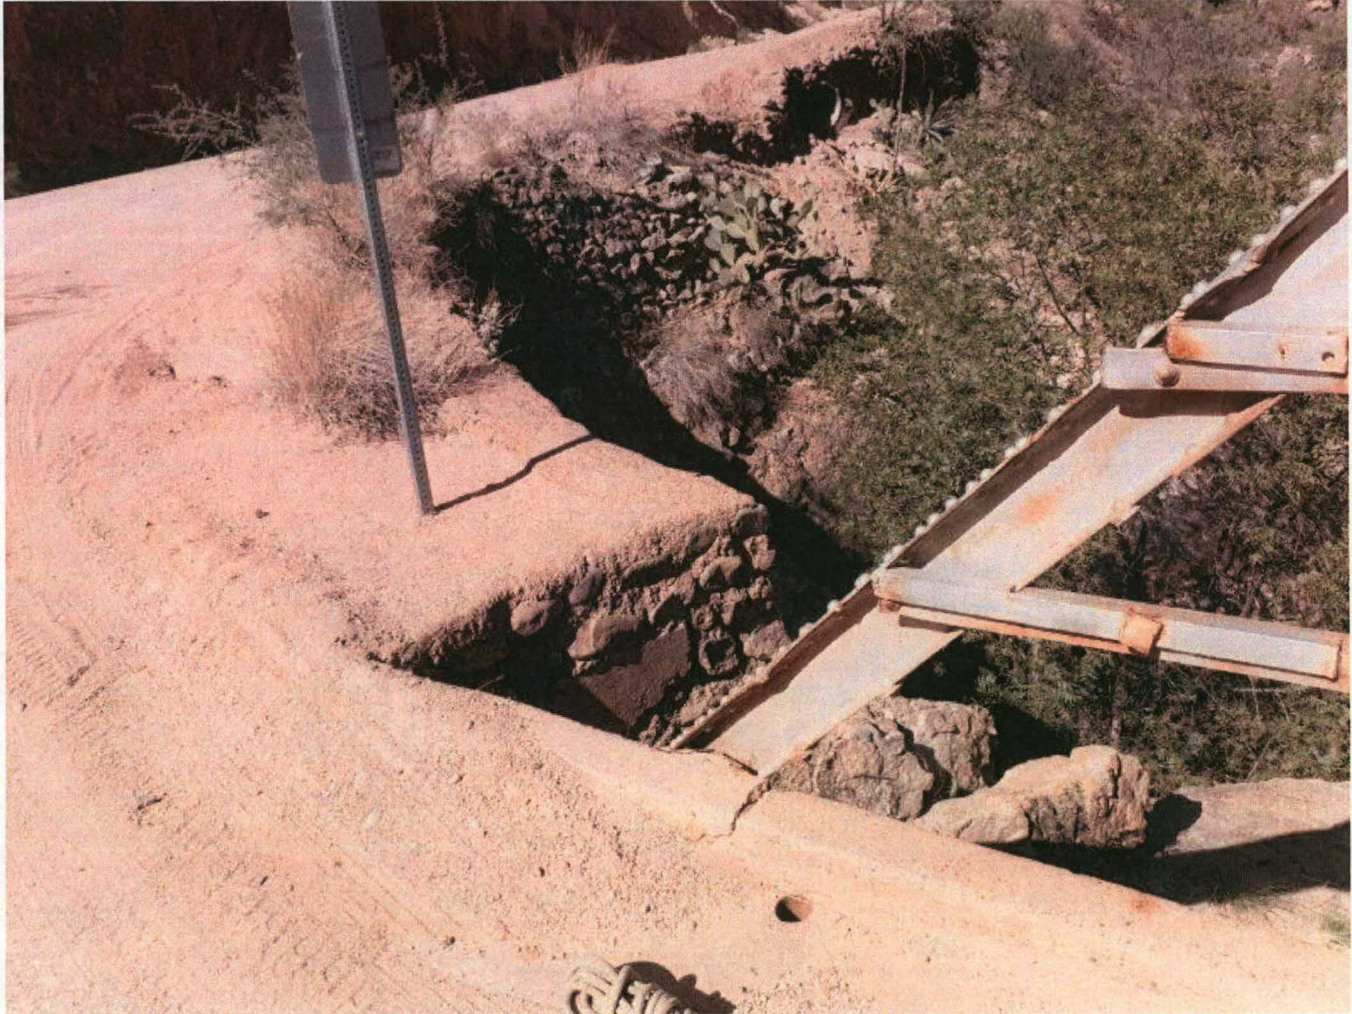
File Name : 00027-2018-09-08-Photo-O.jpg

The railing is composed of two steel angles attached directly to the vertical members of the truss.
 1. The handrail is missing at the southwest and northwest ends. See Photo O.

Description : Photo O. Missing metal bridge railing at the southwest end of the bridge

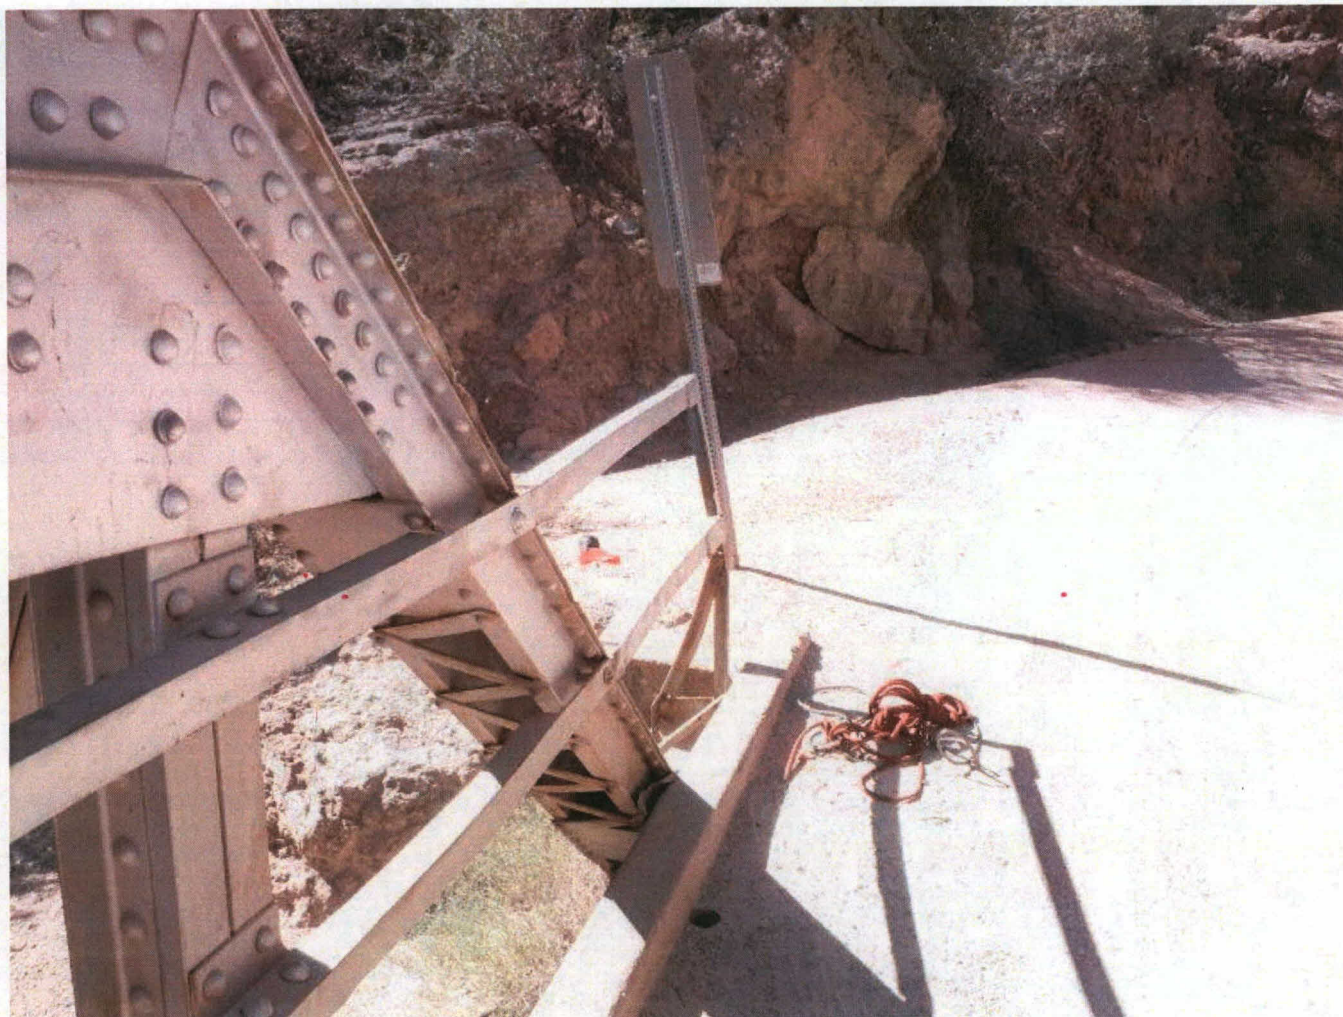
File Name : 00027-2018-09-08-Photo-P.jpg

1. The bridge railing is bent and has impact damage at various locations throughout the bridge.
 2. The handrail is damaged at the southeast corner. See Photo P.
 3. The end of the northeast lower rail has impact damage.

Description : Photo P. Damaged metal bridge railing at the southeast end of the bridge

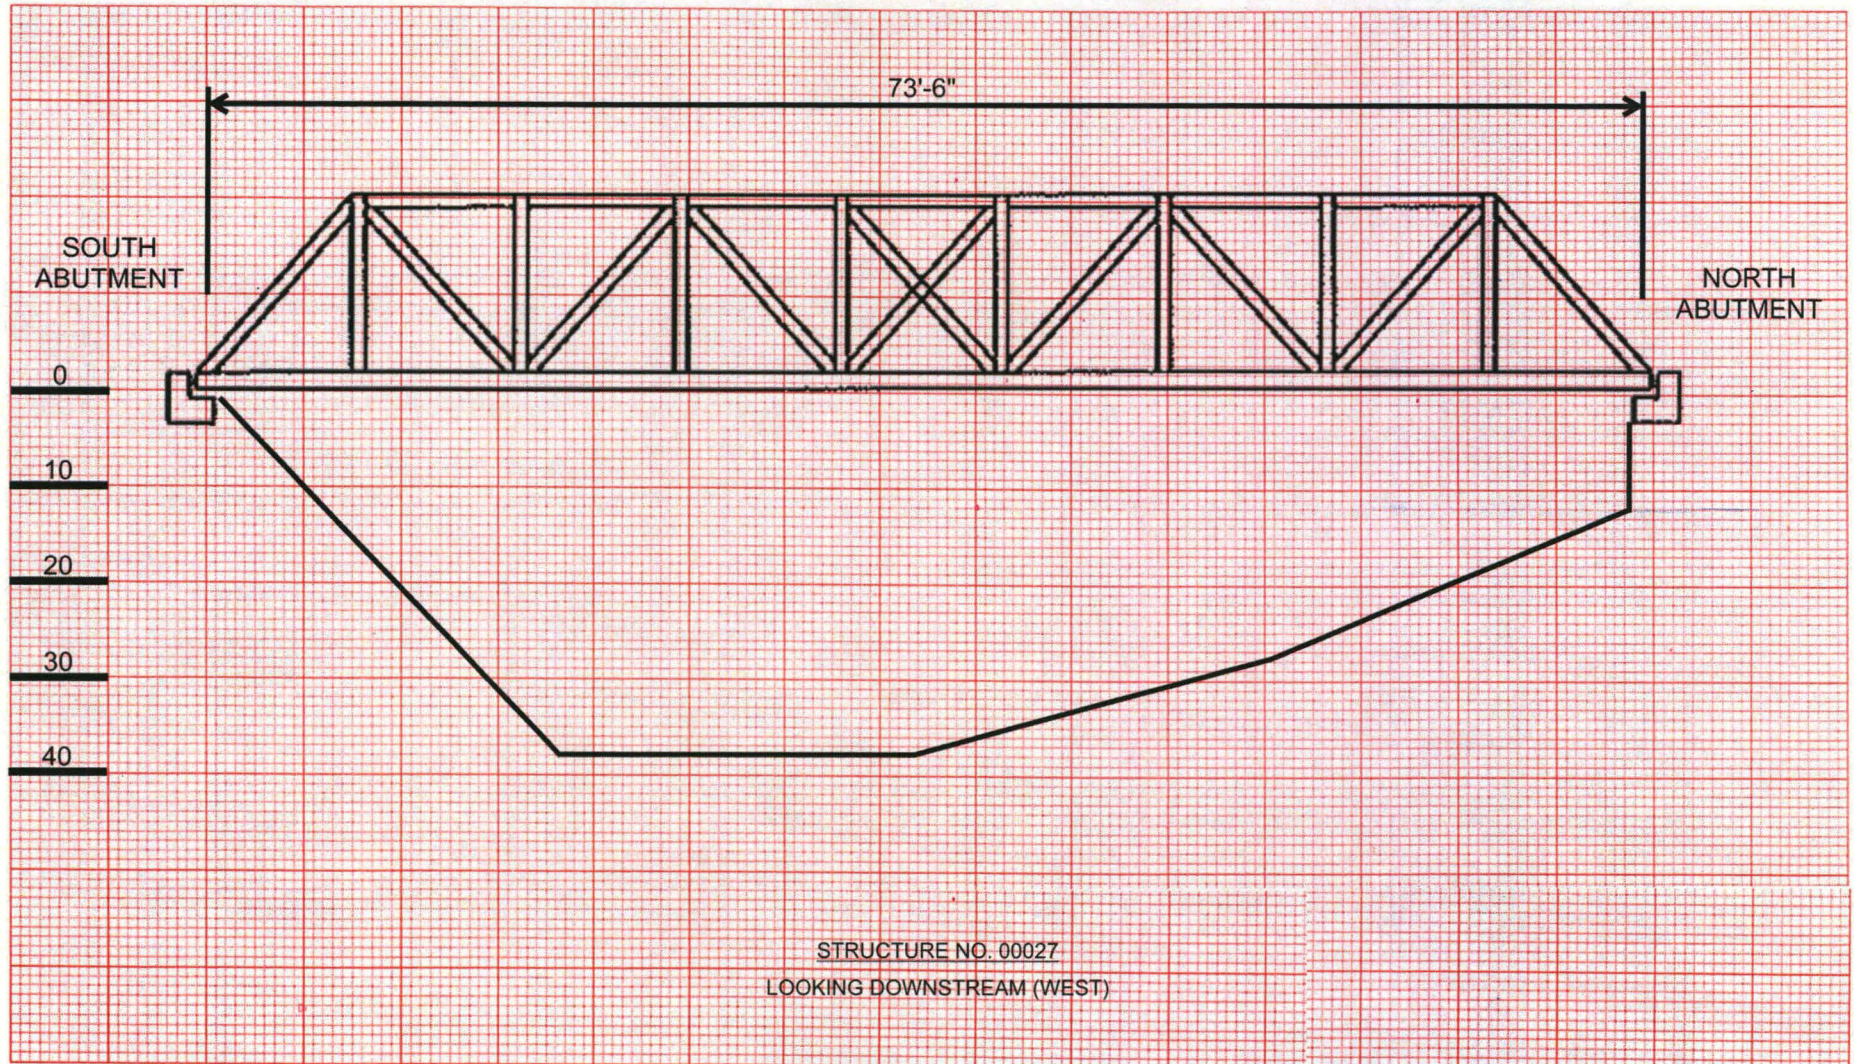
Channel Profile Diagram

Insp. No.	Insp. date	Inspector's Initial	Channel Profile Location (U/S or D/S)	Depth at Abut. 'A1' face or at Support, 'P' (RHS)	Depth at quarter span	Depth at mid span	Depth at 3/4 span	Depth at the left side of Support 'P'	Depth at the right side of Support 'P'	Depth at quarter span	Depth at mid span	Depth at 3/4 span	Depth at the left side of Support 'P'	Depth at the Right side of Support 'P'	Depth at quarter span	Depth at mid span	Depth at 3/4 span	Depth at Abut. 'A2' face or at Support, 'P' (LHS)
	09/08/18	HDR	U/S	0.2'	38.2'	38.2'	28.1'											12.5'

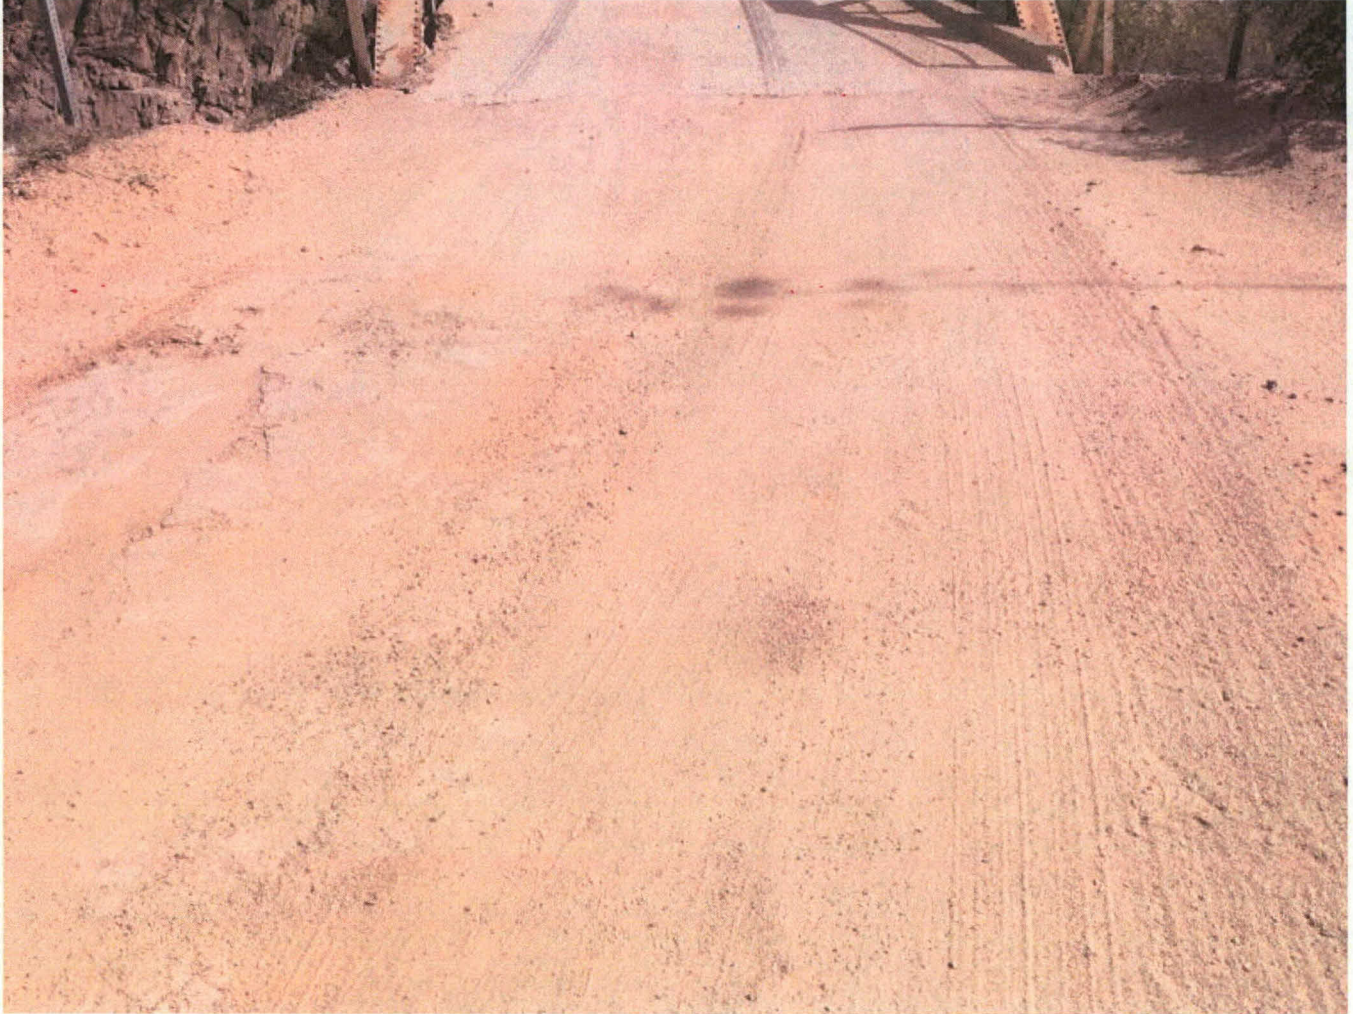
File Name : 00028-2018-08-30-Photo-E.jpg

Description : Photo E – South Approach Condition

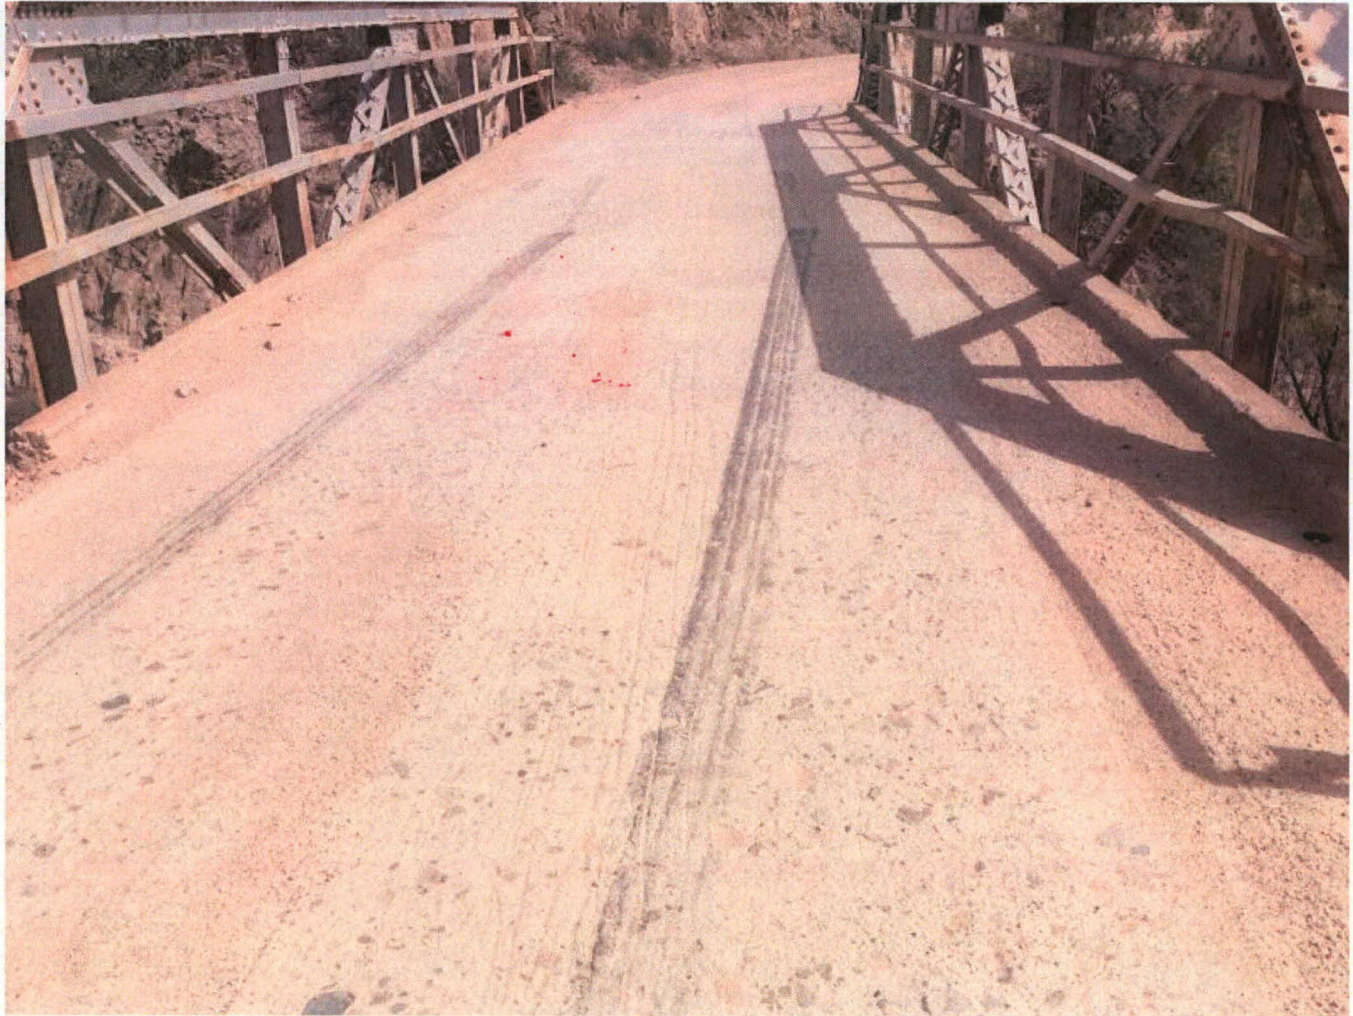
File Name : 00028-2018-08-30-Photo-G.jpg

1) The metal railing paint system has failed with minor to moderate surface corrosion throughout (see photos G, J, K, and R).								
7000	Damage	30	each	0	0	0	30	0

1) The metal railing has moderate impact damage at all four corners (see photos G, J, K, R and list of maintenance items).

Description : Photo G – Typical Top of Deck Condition

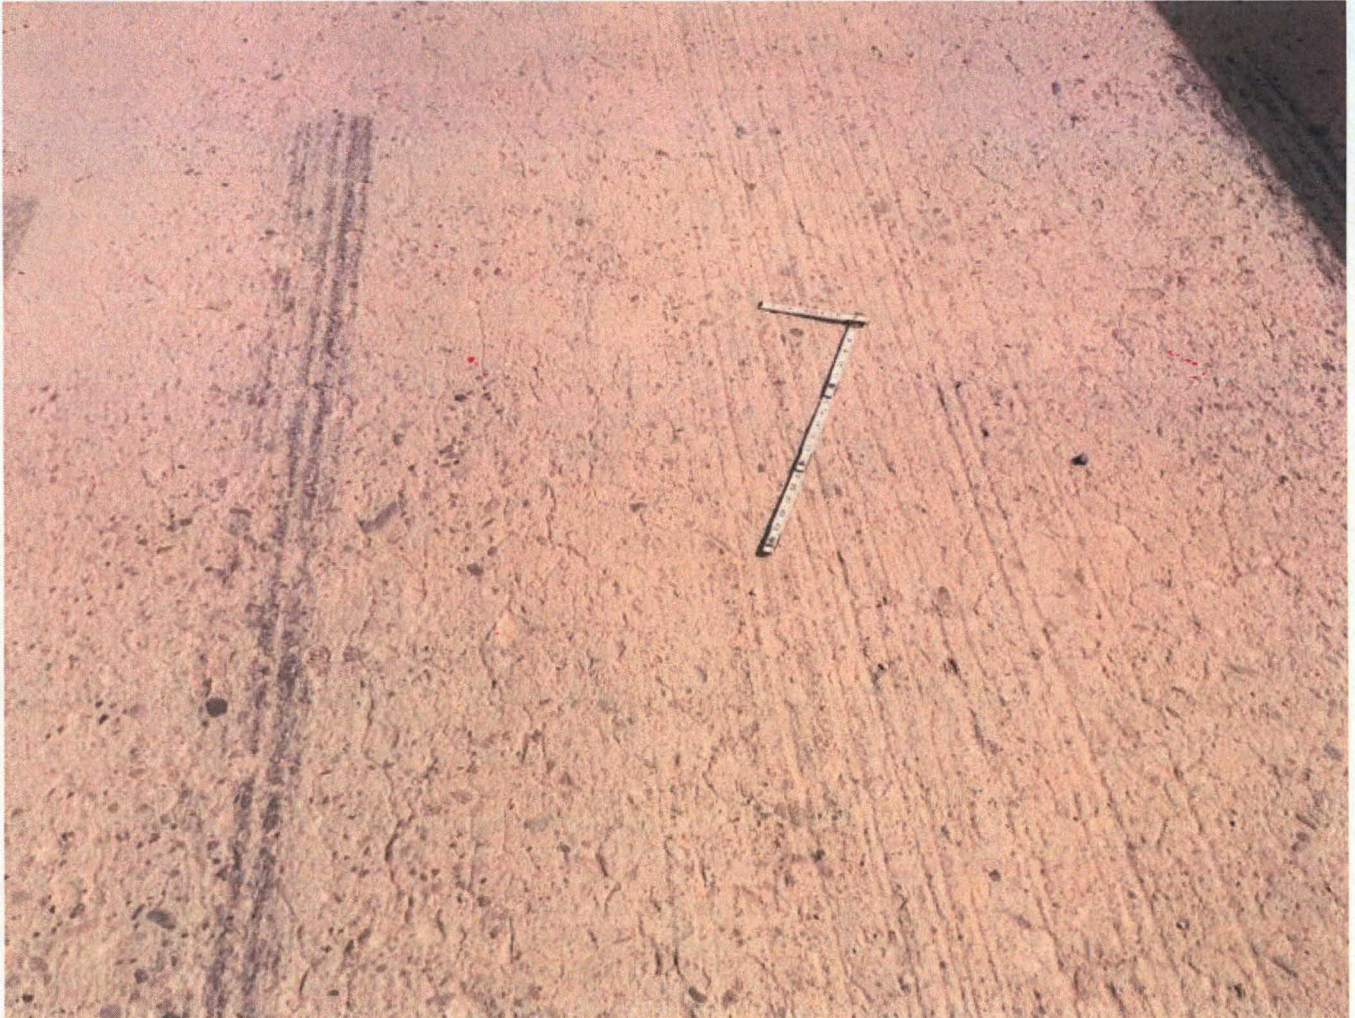
File Name : 00028-2018-08-30-Photo-H.jpg

Description : Photo H – Typical Deck cracking and scaling

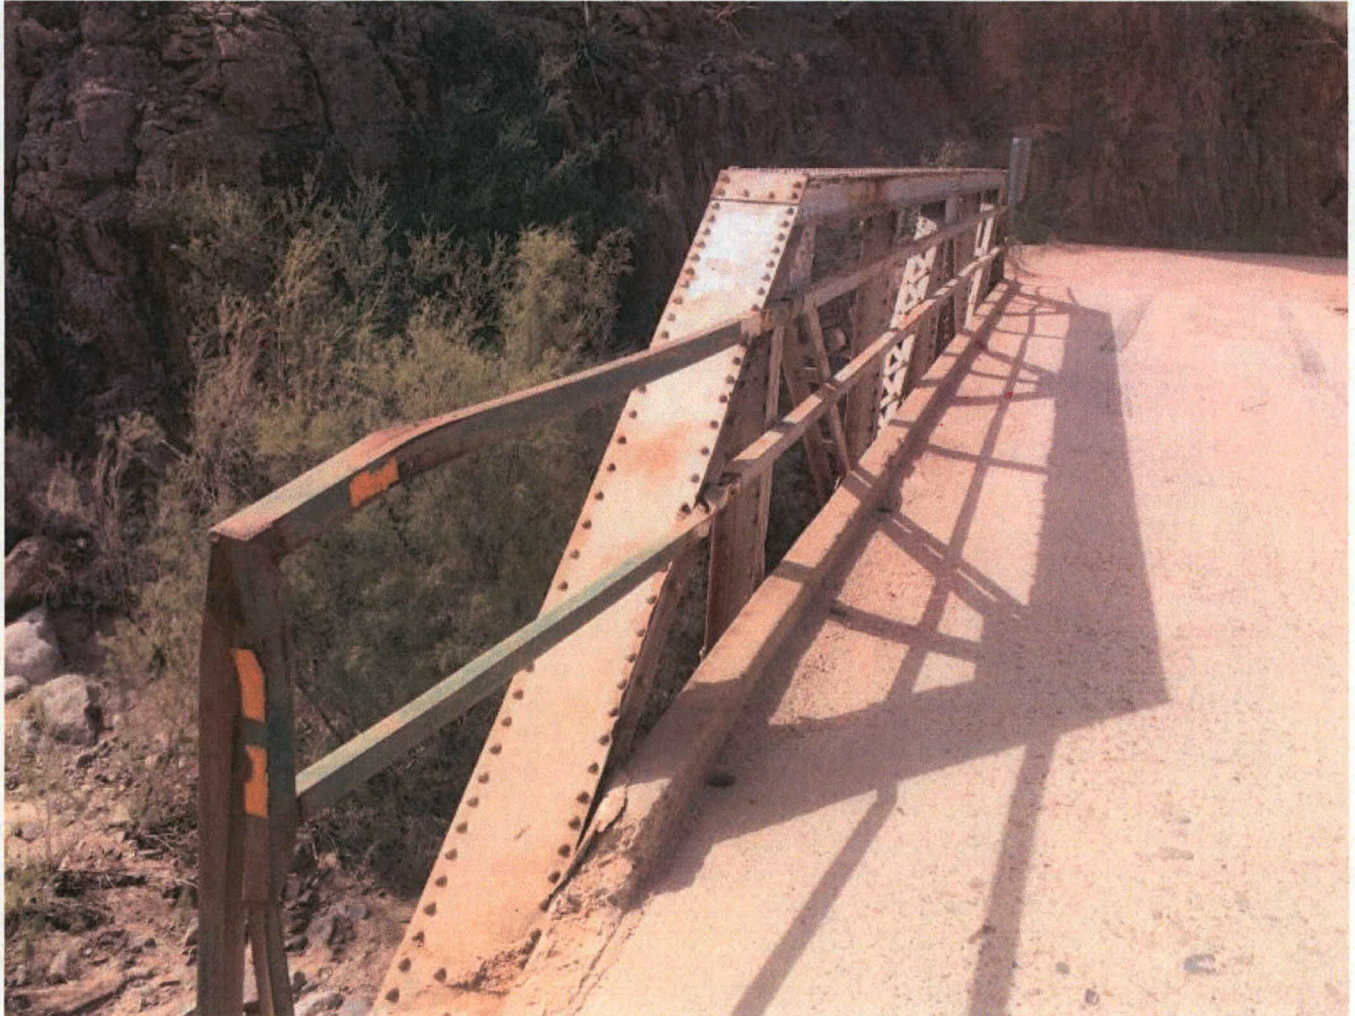
File Name : 00028-2018-08-30-Photo-J.jpg

Description : Photo J – East Truss looking South

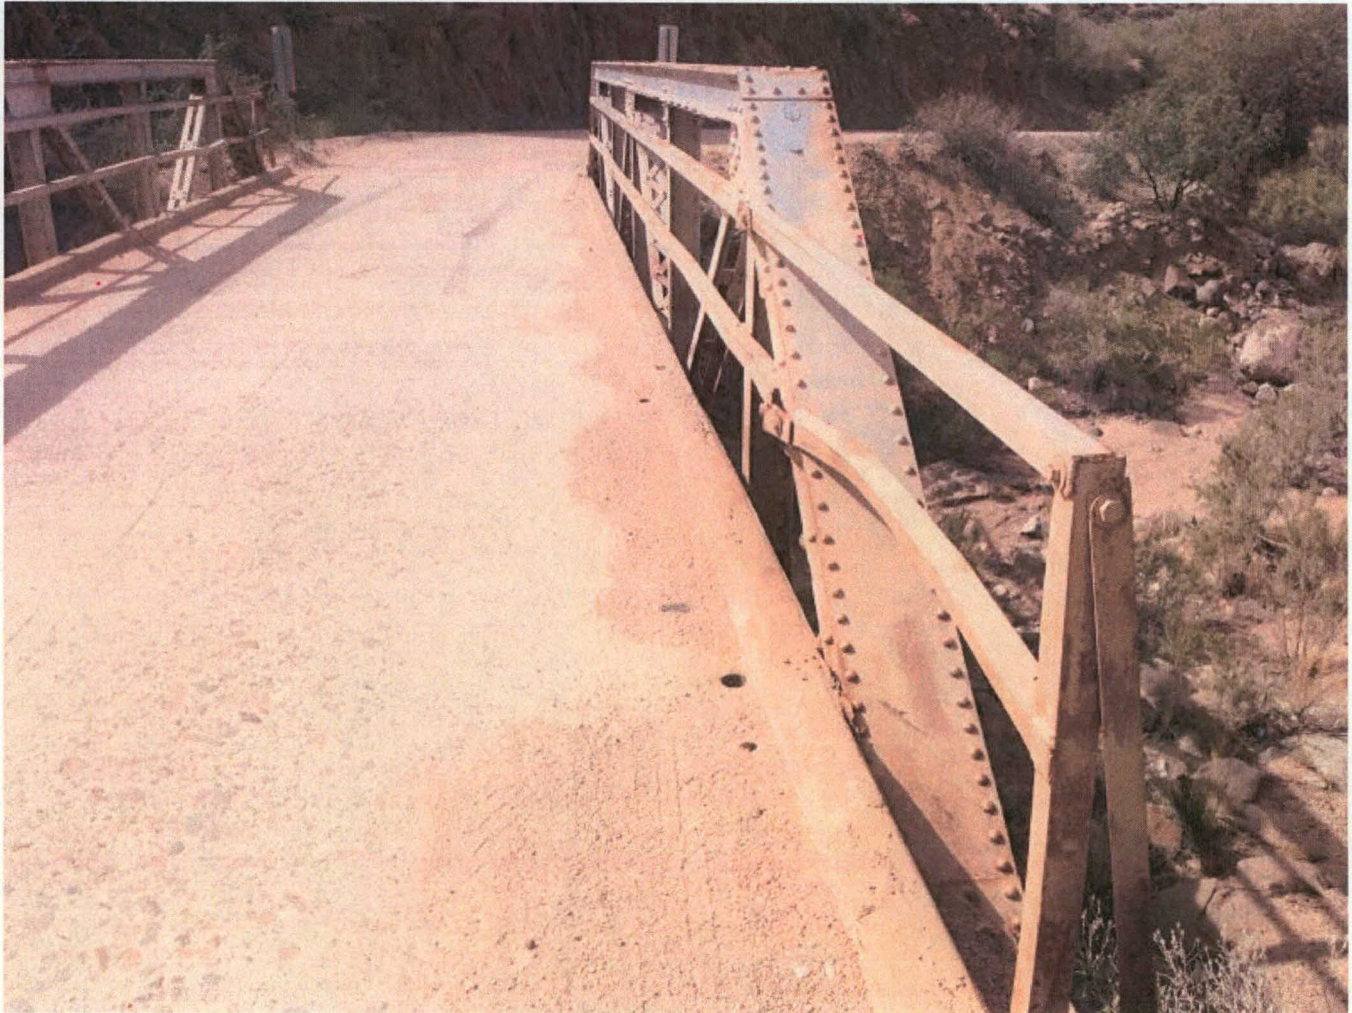
File Name : 00028-2018-08-30-Photo-K.jpg
Description : Photo K – West Truss looking South

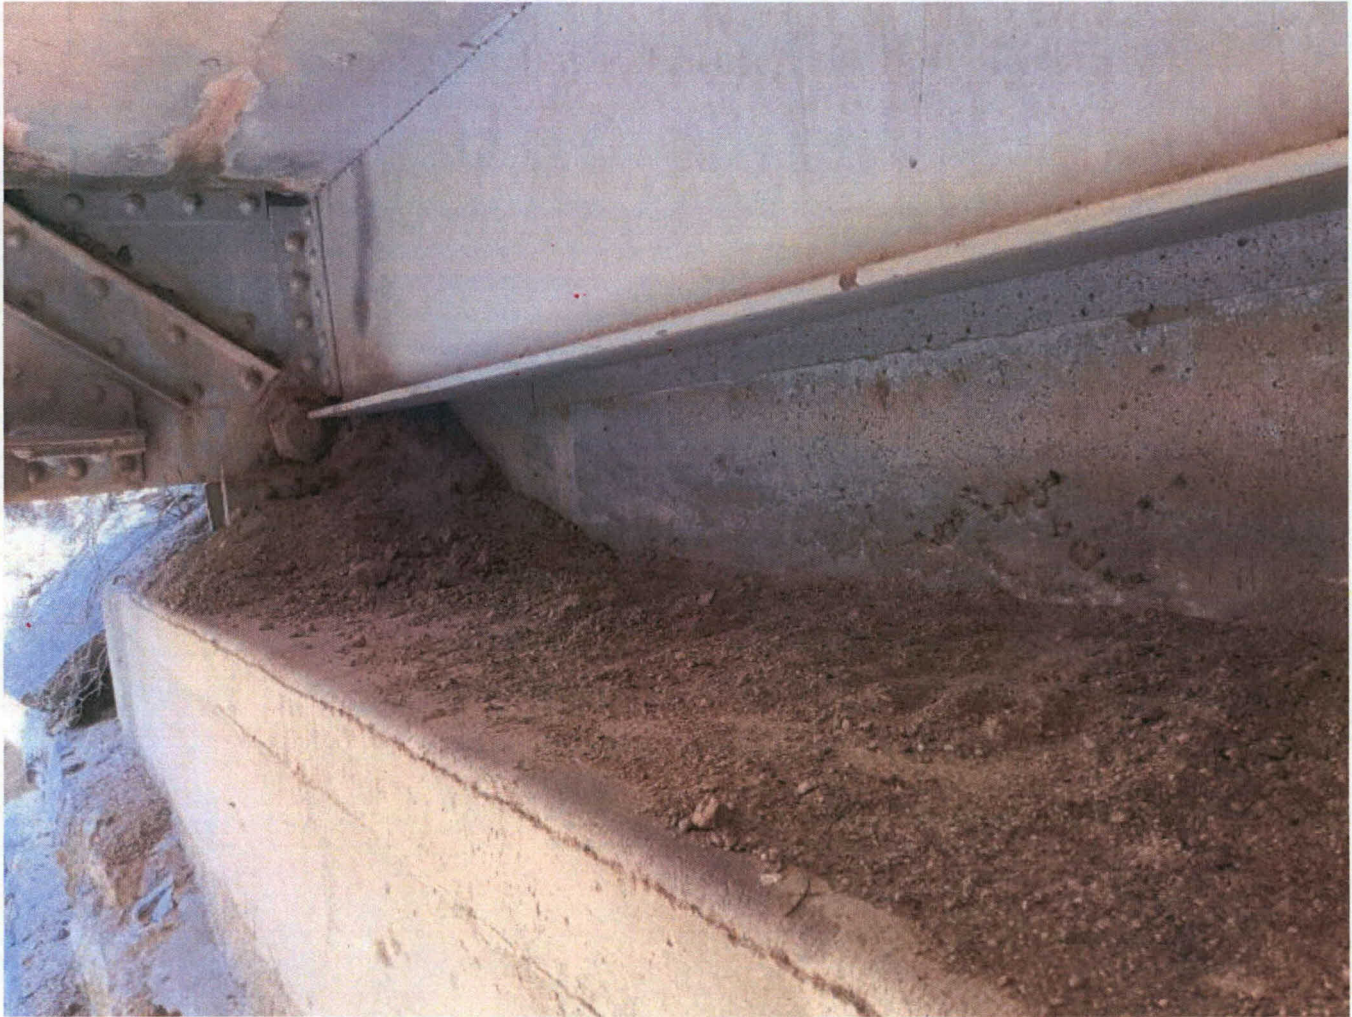
File Name : 00028-2018-08-30-Photo-M.jpg

Description : Photo M – North Abutment Cap with debris around bearings (looking West)
