**ARIZONA DEPARTMENT OF TRANSPORTATION
BRIDGE GROUP
BRIDGE DESIGN SECTION C**

INITIAL BRIDGE STUDY

**State Route 88 (Apache Trail)
MP 222 - MP 229**

DATE: October 2023

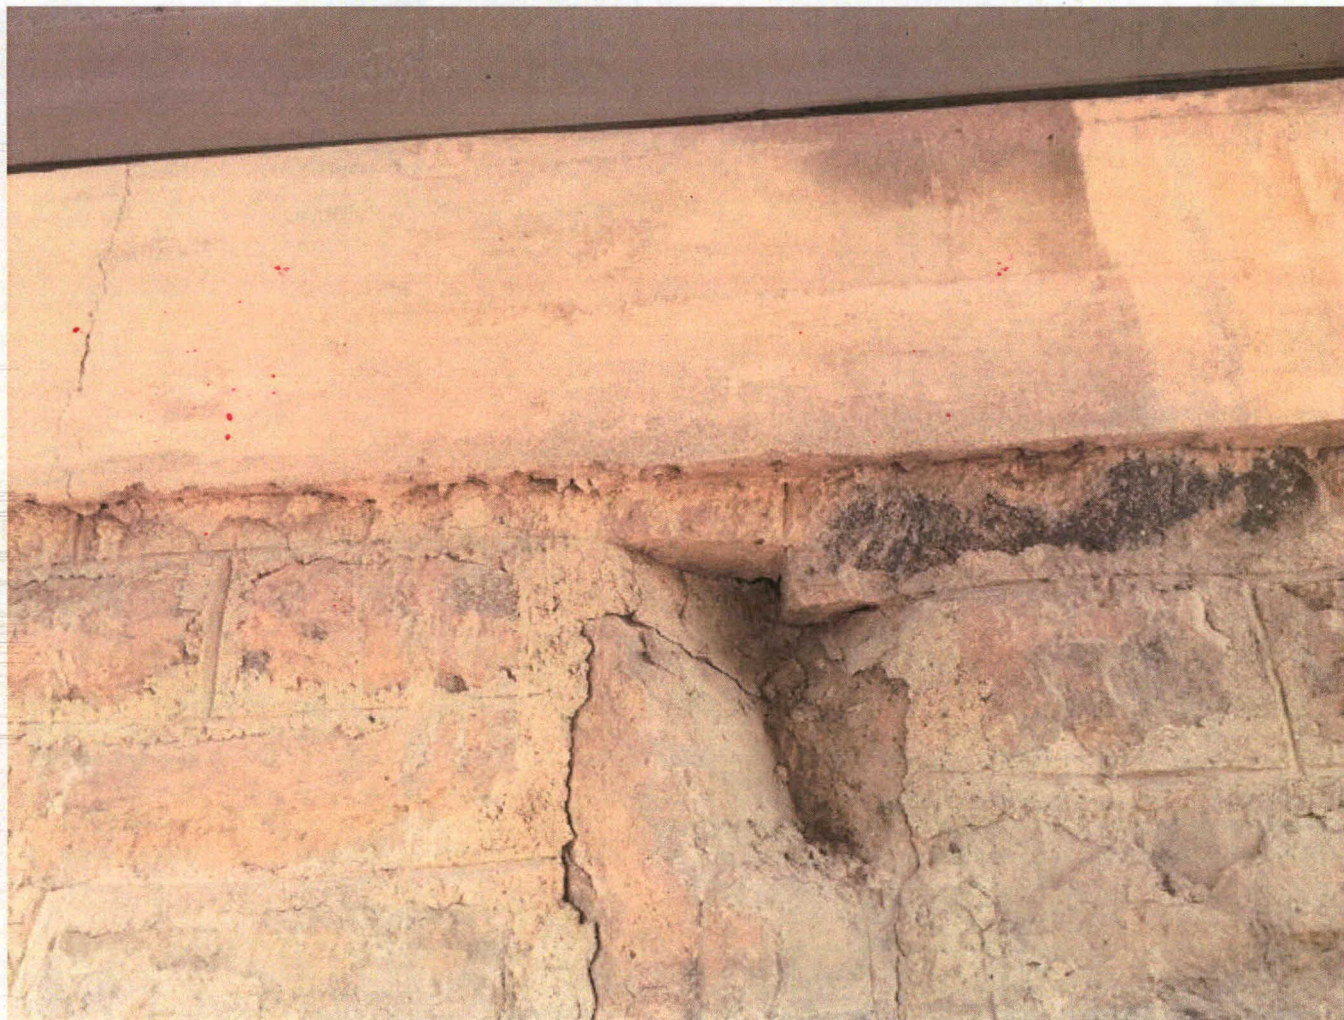
File Name : 00028-2018-08-30-Photo-O.jpg

Description : Photo O - South Abutment broken masonry block

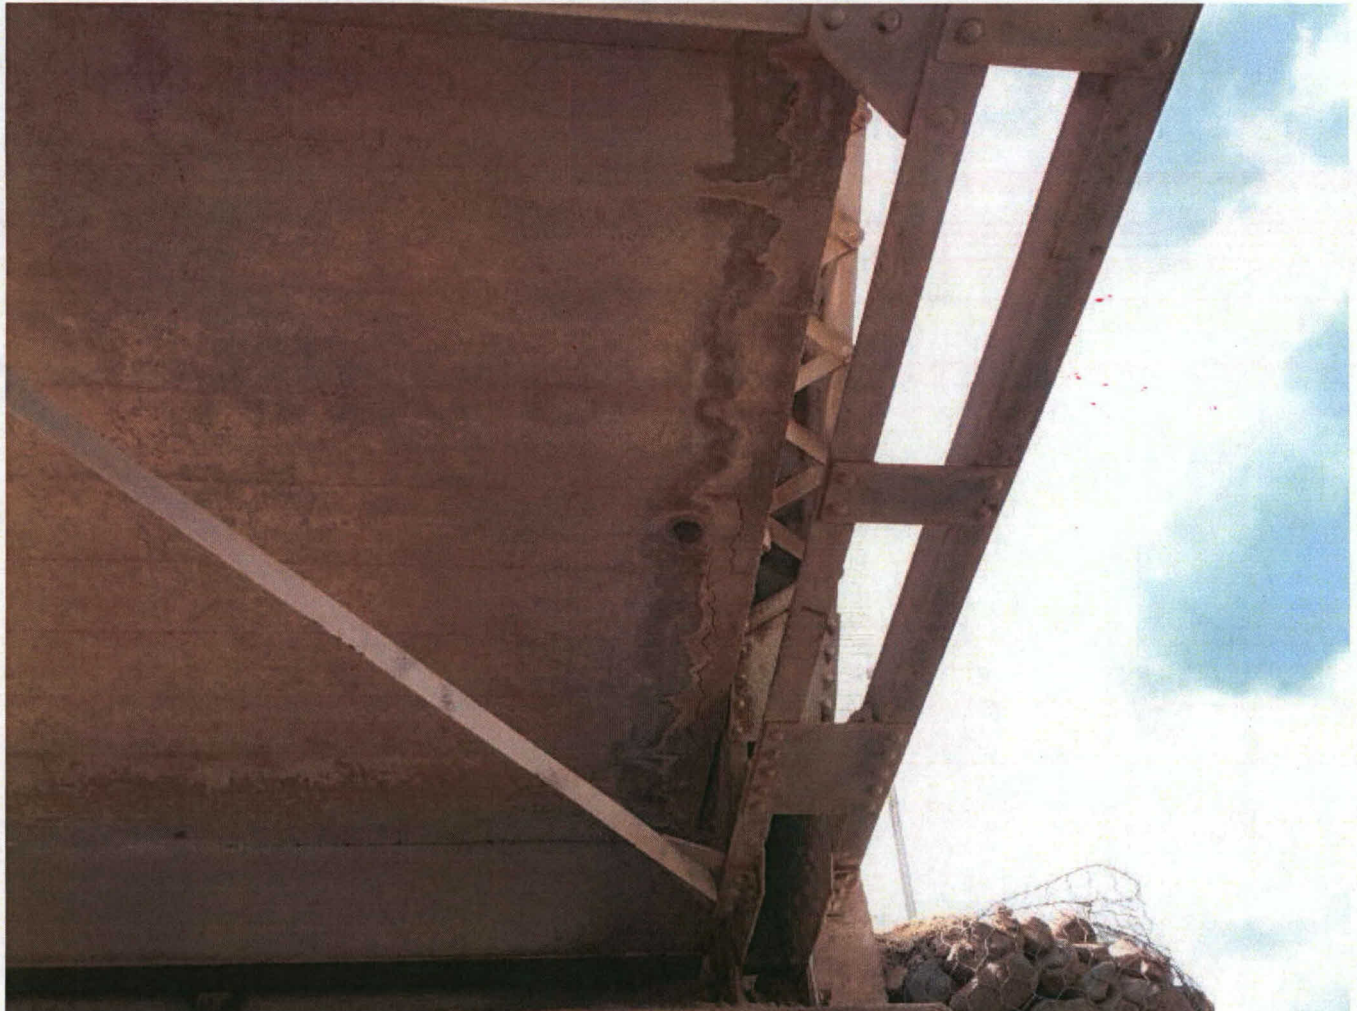
File Name : 00028-2018-08-30-Photo-P.jpg

Description : Photo P - Southwest corner soffit, medium cracks and delamination

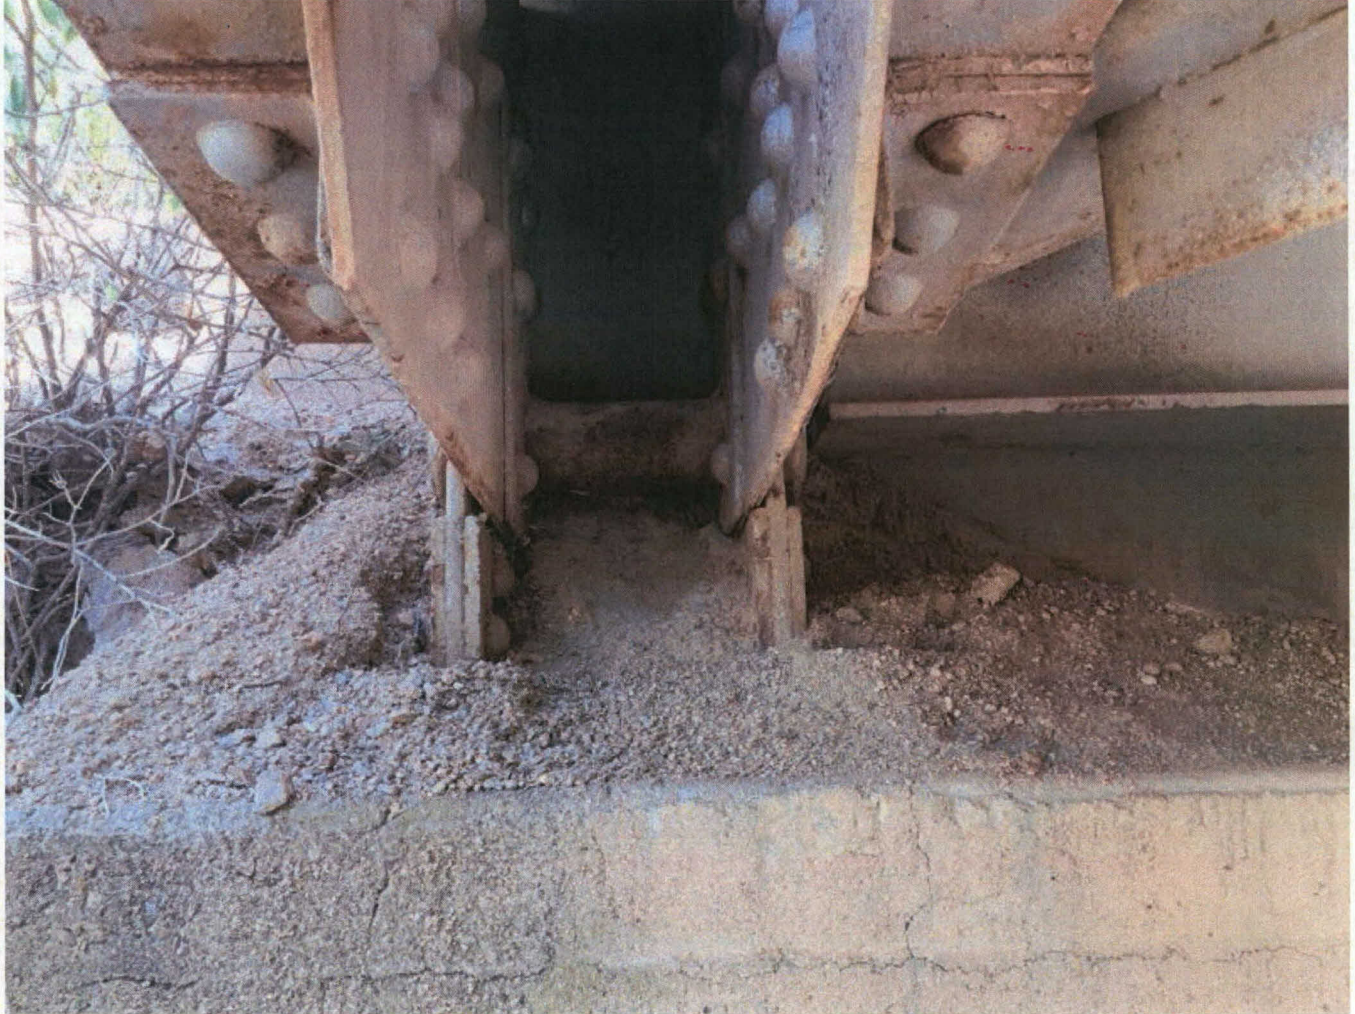
File Name : 00028-2018-08-30-Photo-Q.jpg

Description : Photo Q – West Truss L6 looking North, buildup of debris at bearing

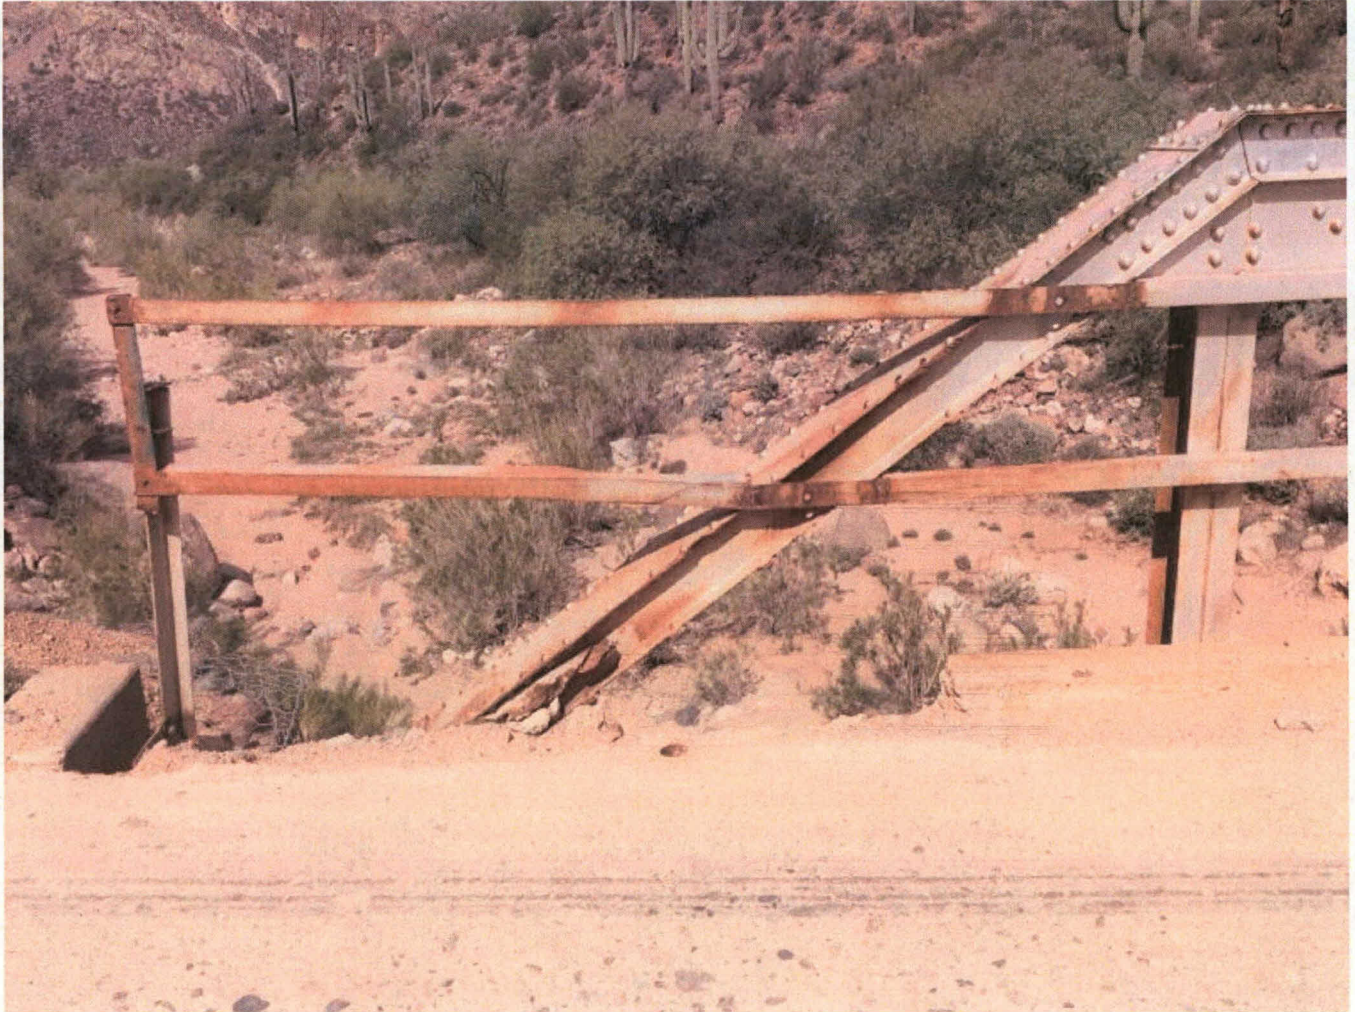
File Name : 00028-2018-08-30-Photo-R.jpg

1) The metal railing paint system has failed with minor to moderate surface corrosion throughout (see photos G, J, K, and R).								
7000	Damage	30	each	0	0	0	30	0

1) The metal railing has moderate impact damage at all four corners (see photos G, J, K, R and list of maintenance items).

Description : Photo R - Southwest corner, missing/damaged curb

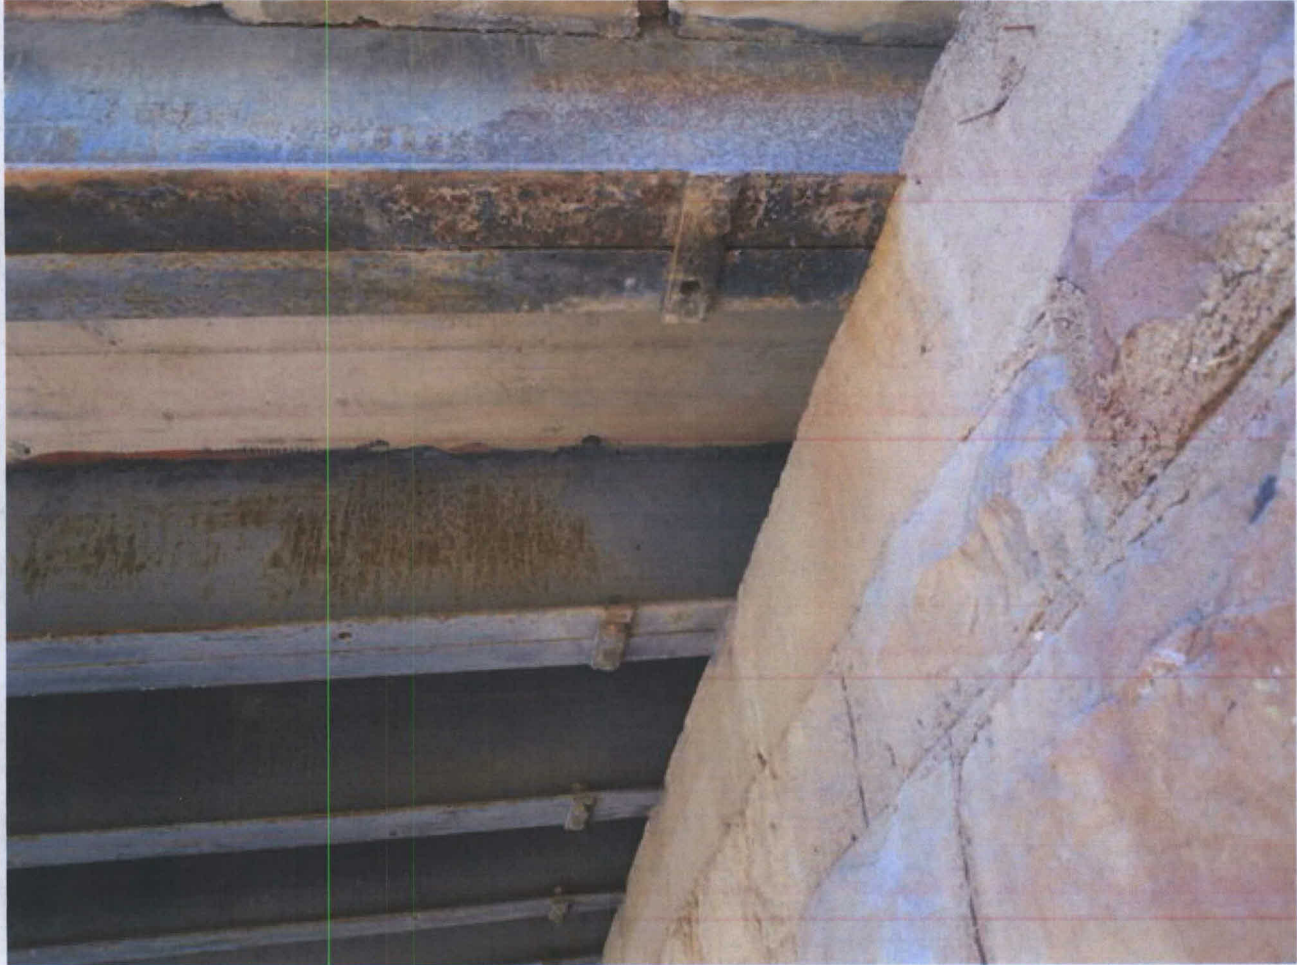
File Name : 00015-2018-08-01-Photo-e.jpg

Stone masonry walls with concrete seat on top and spread footings:
 1. The W abutment under girder 1 has up to 1/4" wide vertical crack and E abutment under girders 3 & 5 have up to 1/8" wide vertical cracks. E abutment under girder 4 has 12" x6" spall /construction void. See photo "e" and Maintenance Report.

1. E abutment under girder 4 has 12" x6" spall /construction void.

Description : E abutment crack and missing strap bolt

Replace the missing bolt in the girder 7 strap plate adjacent to the east abutment.

Repair abutment cracks and spalls.

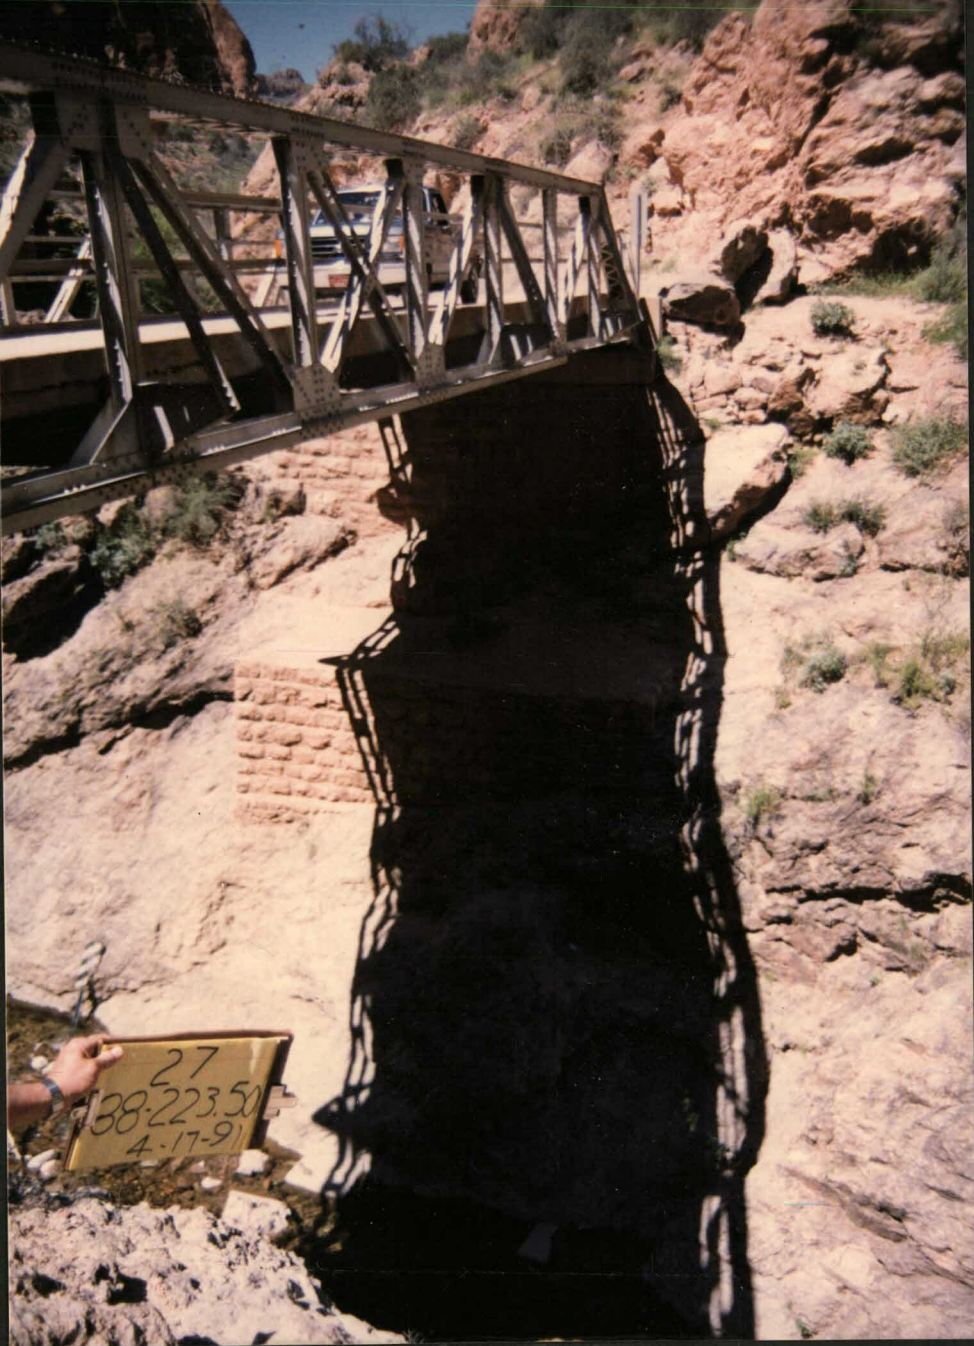
BEDROCK AT NORTH ABUTMENT

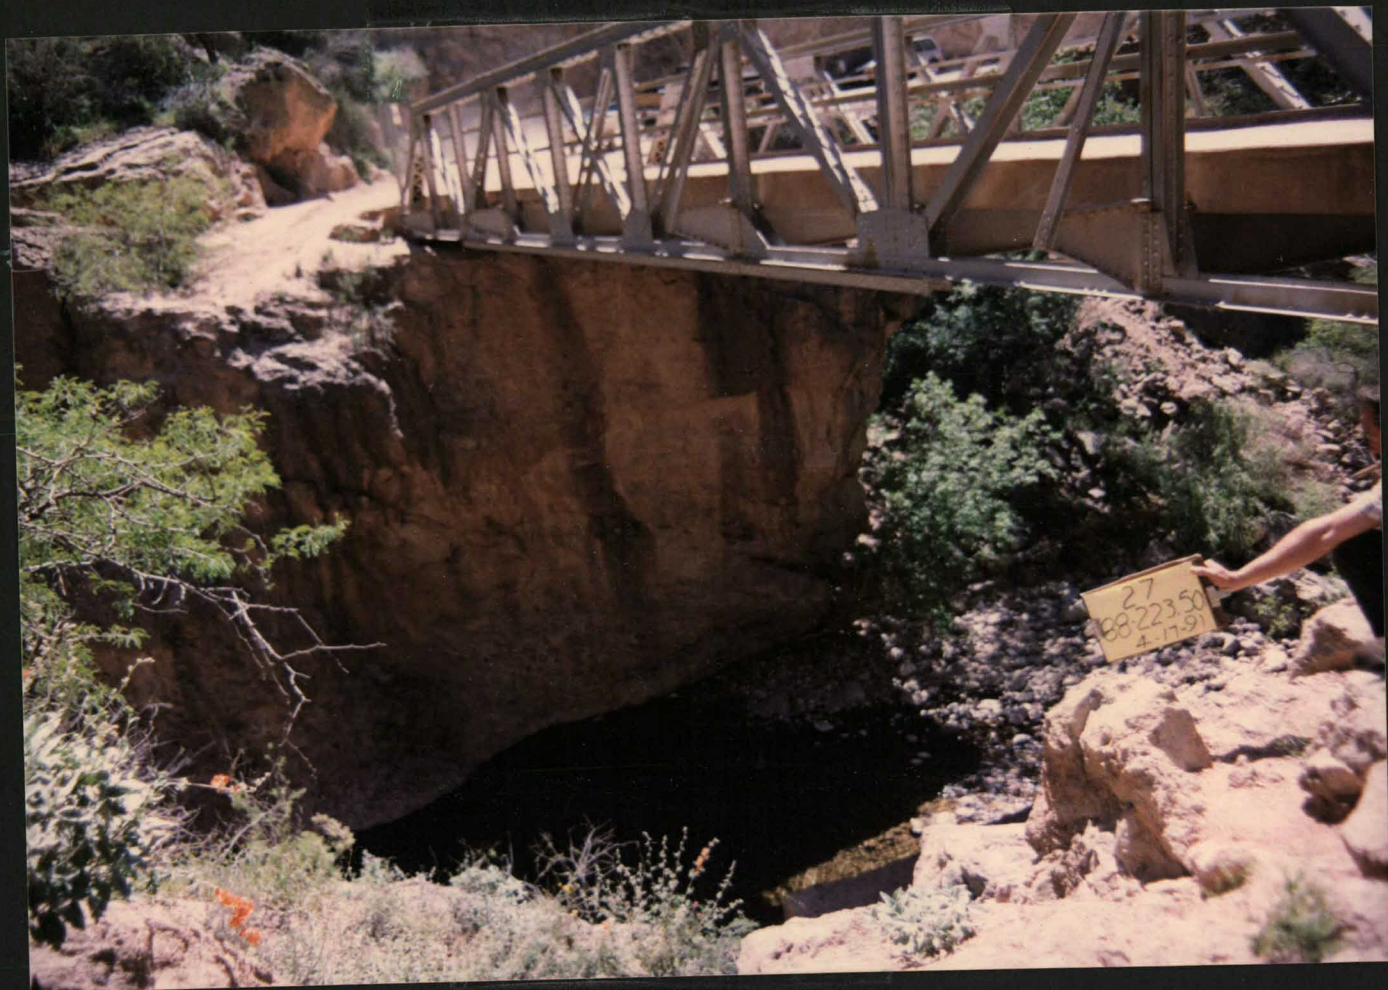
BEDROCK AT SOUTH ABUTMENT
FISH CREEK BRIDGE
SR 88 - 223.50
STRUCTURE NO. 0027 04/17/91

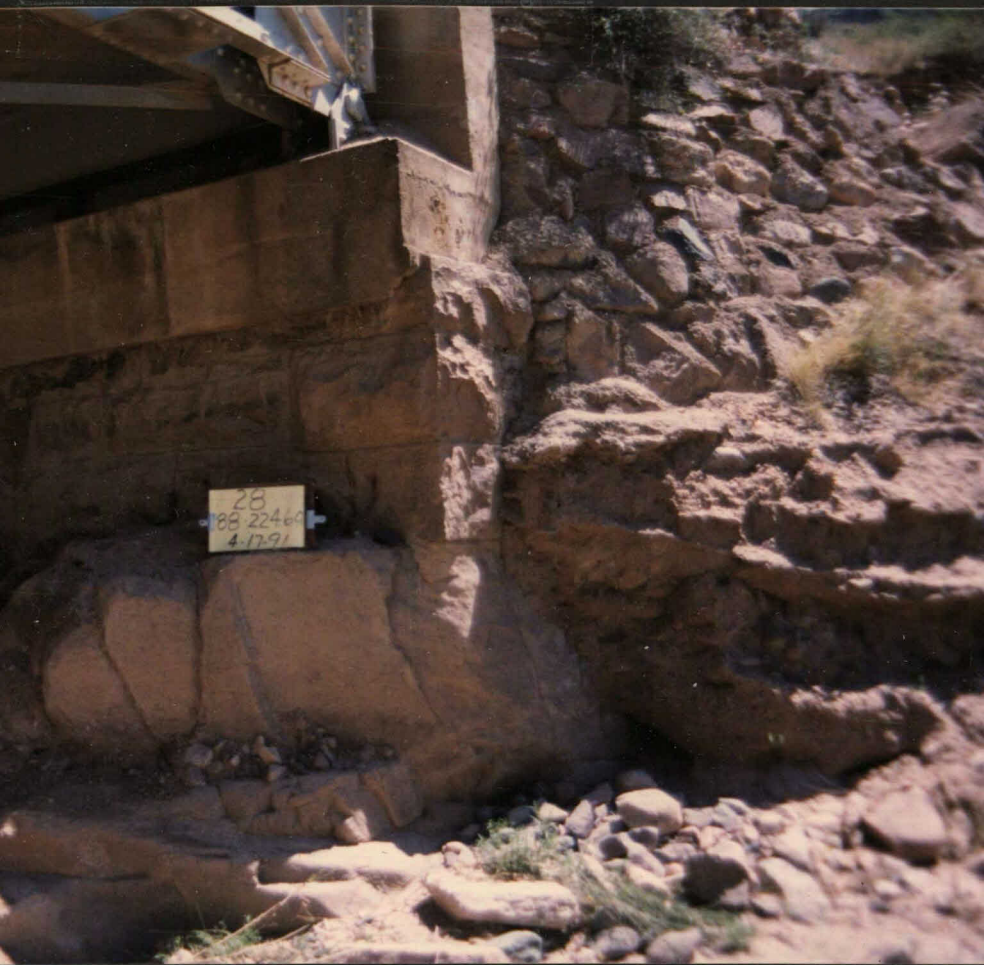
ON INSPECTION #11 (04/17/91) WE DUG ALONG THE FRONT OF THE ROCK
MASONRY WALL OF THE WEST ABUTMENT AND FOUND IT SITTING ON A BEDROCK
OUTCROPPING.

BEDROCK AT SOUTH ABUTMENT
LEWIS PRANTY CREEK BRIDGE
SR 88 - 224.60
STRUCTURE NO. 0028 04/17/91

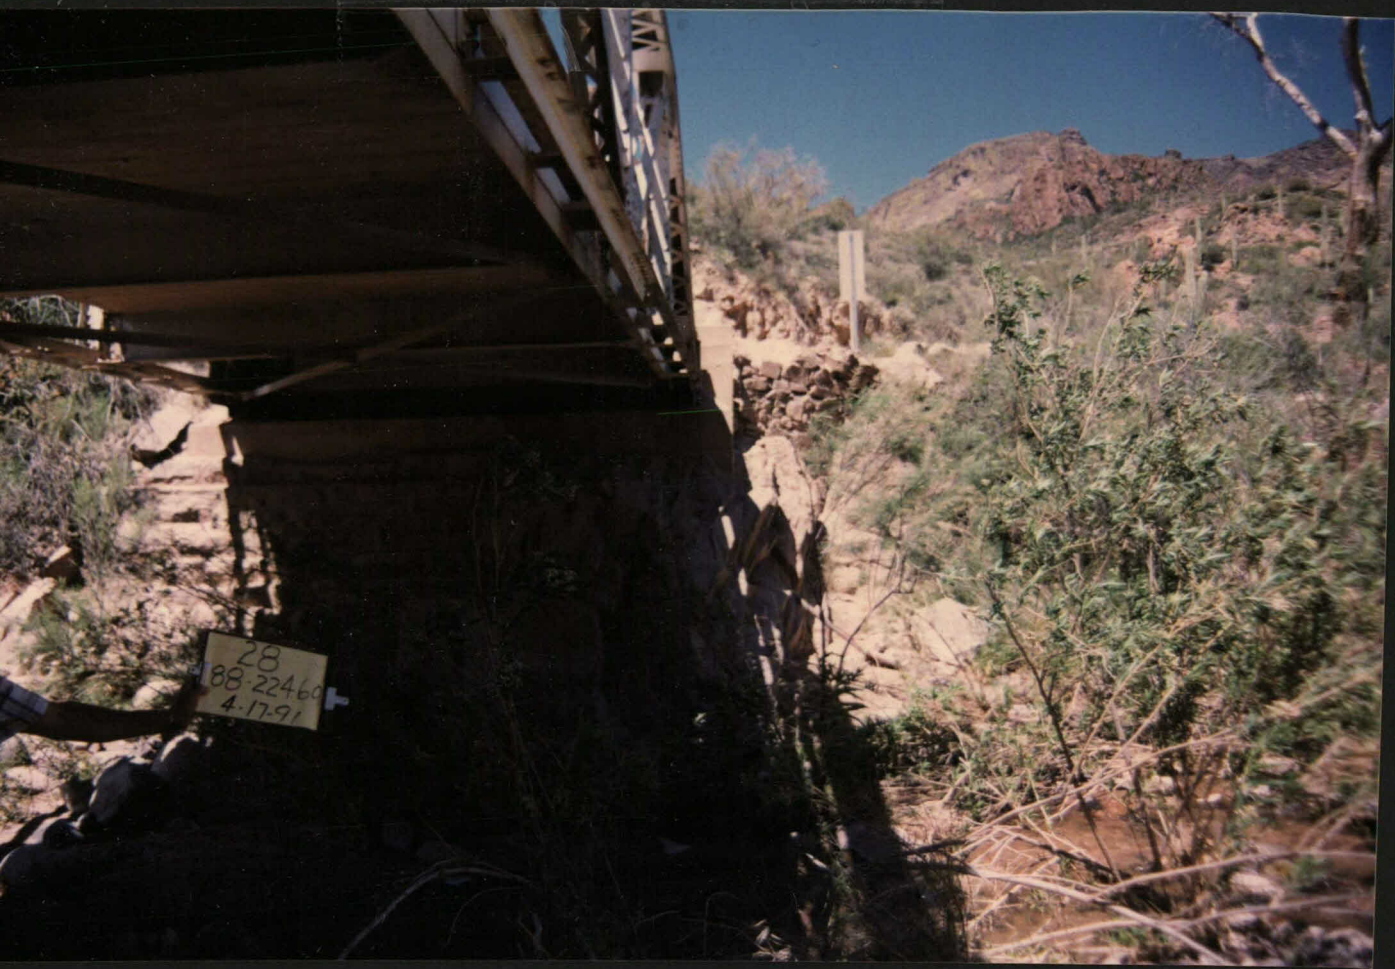
During Inspection #11 Bridge Maintenance Personnel hand dug along the west wall to confirm the foundation is on bedrock. The east abutment rests on exposed rock. No work is necessary.

BEDROCK AT NORTH ABUTMENT
LEWIS PRANTY CREEK BRIDGE
SR 88 - 224.60
STRUCTURE NO. 0028
