**MEMORANDUM**

RE: Site Review for Central District

Location: SR101L (Agua Fria) x McDowell Road Structure S-E/W

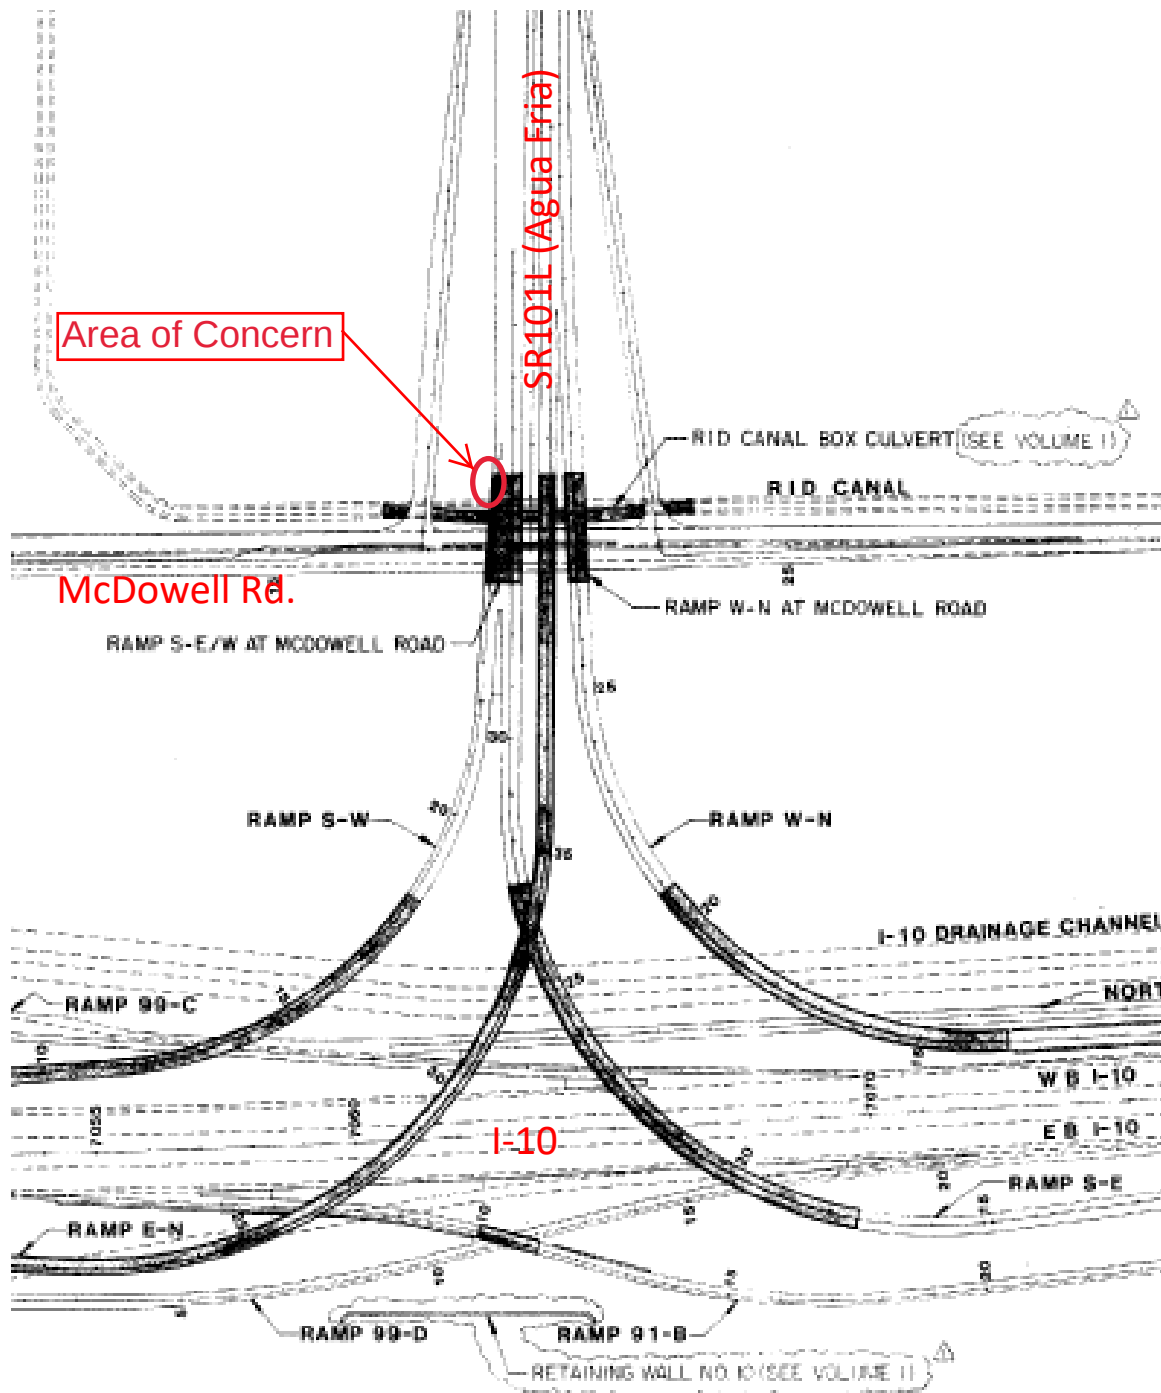
**Figure 1**

On August 17, 2022, the Central District contacted Bridge Group regarding excessive erosion from beneath the slope paving at the west side of the north abutment of the SR101L structure (S-E/W) over McDowell Road (See Figure 1). Apparently, erosion has been occurring at this location for some time and the District was considering repair by removal of the affected slabs, placement and compaction of subgrade soils, and replacement of the slope paving. The District suspected that the water was coming from a gap in the roadway between the approach slab and the approach barrier. (See email dated 08/17/22 from Mark Killian to Joselyn Valero).

General site layout showing location of Ramp S-E/W at McDowell Road, and overall system interchange. Image from record drawings for project 101L-MA-001 H457701C, Volume 3 of 3.
