Town of Miami Trail System Study

Existing and Future Conditions

DRAFT

March 5, 2025

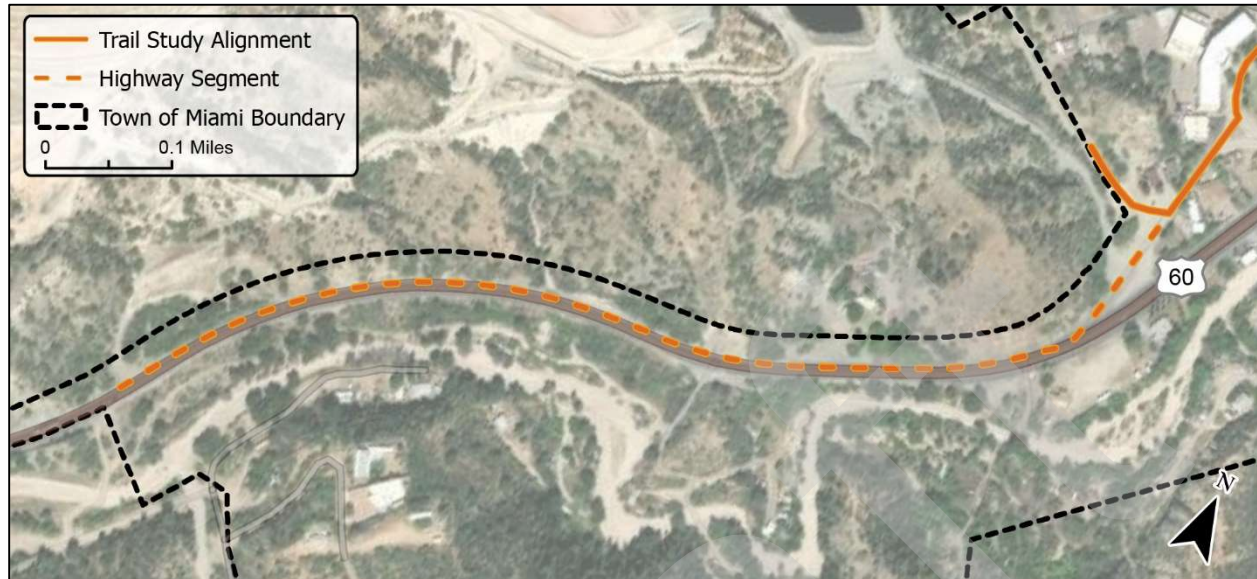
Figure 3. Town of Miami proposed trail alignment – US 60 segment

US 60 carries heavy truck traffic through Miami, including traffic associated with mining operations. As a result, pedestrian and bicycle comfort is low along the segment. The 2023 average annual daily traffic (AADT) along this segment is 9,600 (ADOT). Truck traffic is also expected to increase over the next several years as new mining operations open in the area, which will increase pedestrian and bicycle safety concerns. There are currently no bicycle or pedestrian facilities along this portion of US 60. The highway's paved shoulders are narrow (approximately 5 feet wide) north of the roadway and abut steep hillside slopes in some areas; south of the roadway, shoulders are wider (approximately 8 feet wide) with guardrail along most of the segment. There is ample ROW on both sides of US 60, with somewhat to very dense vegetation throughout the segment.

Infrastructure	Observations
Roadway	
Pavement: 35 feet wide; two 12-foot lanes; good condition	❖ Portions of US 60 are flanked by low guardrails.
Speed Limit: 45 mph	—
ROW:	❖ Typical 210 feet, varies
Sidewalk/Shoulder	
Curb: None	—
Sidewalk: None	—
Americans with Disabilities Act (ADA) Ramps: None	—
Shoulder: Unpaved	❖ Shoulder/ROW width varies along this segment. ❖ Unpaved pullout areas are located in some places but may be used for private property access.
ROW Obstructions/Constraints:	❖ Upper Hummingbird Trail connection point was not identified during field visit.
Crossings/Lighting	
Crosswalks: None	—
Streetlighting: None	—
Additional Observations	
Truck Traffic:	❖ Frequent heavy truck traffic occurs along this segment.

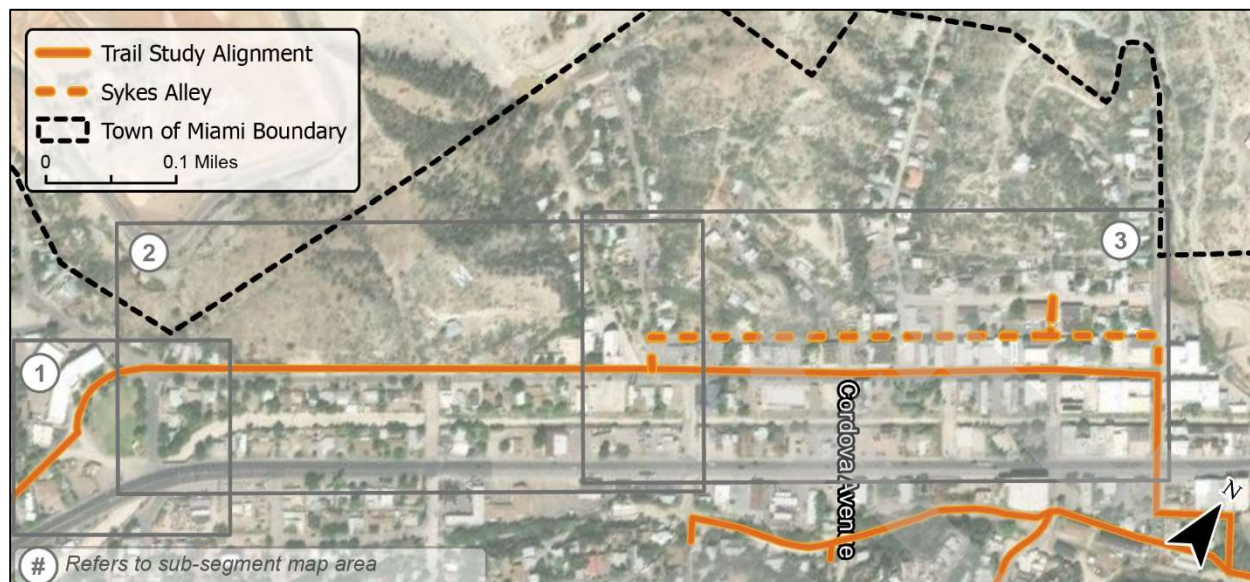
Figure 4. Town of Miami proposed trail alignment – Sullivan Street segment

Beginning at Turner Street, the trail alignment enters local roadways owned and maintained by the Town. It curves around Bullion Plaza Cultural Center and Museum before continuing east along Sullivan Street. The Bullion Plaza area has a mix of commercial and residentially zoned parcels and is a key community destination.

For the segment from Plaza Avenue to Elwood Avenue, Sullivan Street is characterized by single-lot residential development. From Elwood Avenue to Miami Avenue, Sullivan Street features commercial uses in the historic downtown core (with some residential development conditionally allowed, such as in the upper stories of multistory buildings). This segment also provides connectivity to the Keystone Stairs. Traffic along Sullivan Street is relatively low, with the AADT below 350 near Bullion Plaza, and 600 near the intersection with Cordova Avenue (in the commercial downtown core).

Sykes Alley (shown as an orange dashed line on figures) was identified as a potential alignment through this area, connecting the residential portion of Sullivan Street with the Keystone Stairs and Miami Avenue. However, the Study team's site visit revealed that Sullivan Street may be a more suitable alignment than Sykes Alley between Davis Canyon Road and Miami Avenue. The Town imagines Sykes Alley as a vibrant pedestrian path in the future, with amenities and business access—making it an attractive option for the future. Field observations for Sykes Alley are not discussed in this section, but can be found in Appendix G.

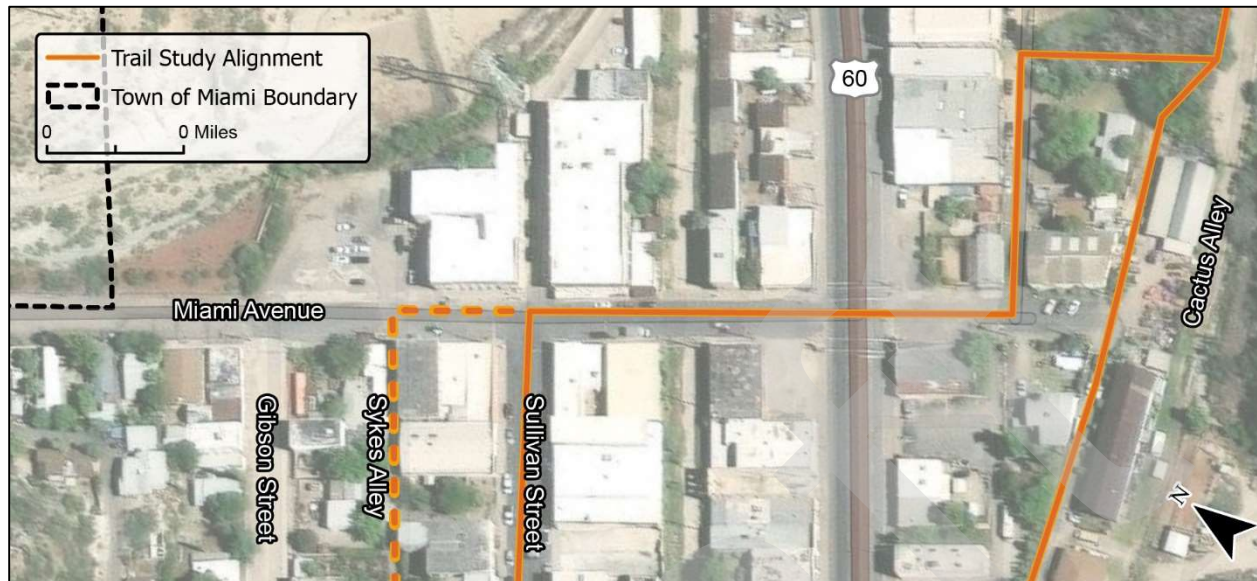
Figure 8. Town of Miami proposed trail alignment – Miami Avenue segment

The trail follows Miami Avenue from the historic downtown district, across US 60, connecting with the hillside neighborhoods south of US 60 and east to MUSD. The Miami Avenue and US 60 intersection has crosswalks and pedestrian pushbuttons to facilitate crossings. North of US 60, conditions along Miami Avenue are similar to Sullivan Street, with predominantly street-oriented commercially zoned parcels. South of US 60, Miami Avenue is lined by street-oriented commercial uses and intensive industrial uses. The AADT along Miami Avenue is 800, and the AADT along US 60 (near the Miami Avenue intersection) is 11,602.

Infrastructure	Observations
Roadway	
Pavement: 35 feet wide; two lanes; fair condition	❖ Vehicles parked on both sides of roadway.
Speed Limit: 15 mph	—
Sidewalk/Shoulder	
Sidewalk: Yes; concrete; poor to fair condition	<ul style="list-style-type: none"> ❖ Sidewalk on both sides of roadway. Some cracks present, with varying widths. ❖ 9-foot sidewalks near bridge. Sidewalk uneven where sloped bridge portion meets flat street portion. Poor condition with cracks and unevenness south of the bridge.
Curb: Yes	<ul style="list-style-type: none"> ❖ North of the Sullivan Street and Miami Avenue intersection, curb east of roadway is 17 inches high with no guardrail (not ADA-compliant). ❖ Curb across bridge varies in height over the slope.
ROW Obstructions/Constraints:	❖ Utility poles and street furniture restrict usable sidewalk space in some areas.
Crossings/Lighting	
ADA Ramps: Limited	<ul style="list-style-type: none"> ❖ Diagonal ADA ramps present only on northeastern and southeastern corners of Miami Avenue and Sullivan Street intersection. Northwestern corner has a step leading up to the raised curb/sidewalk. Southeastern corner slopes down from curb/sidewalk at slightly steep angle; area where concrete meets roadway is slightly uneven. ❖ Diagonal ADA ramps are present at the Miami Avenue and US 60 intersection. At northwestern and southeastern corners, ramp space is limited by traffic signal poles. Traffic signal box at northwestern corner further restricts space.

Crosswalks: Limited	<ul style="list-style-type: none"> ❖ Crosswalk crosses US 60 at Miami Avenue. Markings are in fair condition, but pavement in that area has cracks. ❖ Pedestrian pushbuttons at each corner.
Streetlighting: Yes	❖ Streetlights on both sides of roadway.
Streetscape Amenities	
Street Furniture:	❖ Some planters, benches, and trash receptacles are located along roadway.

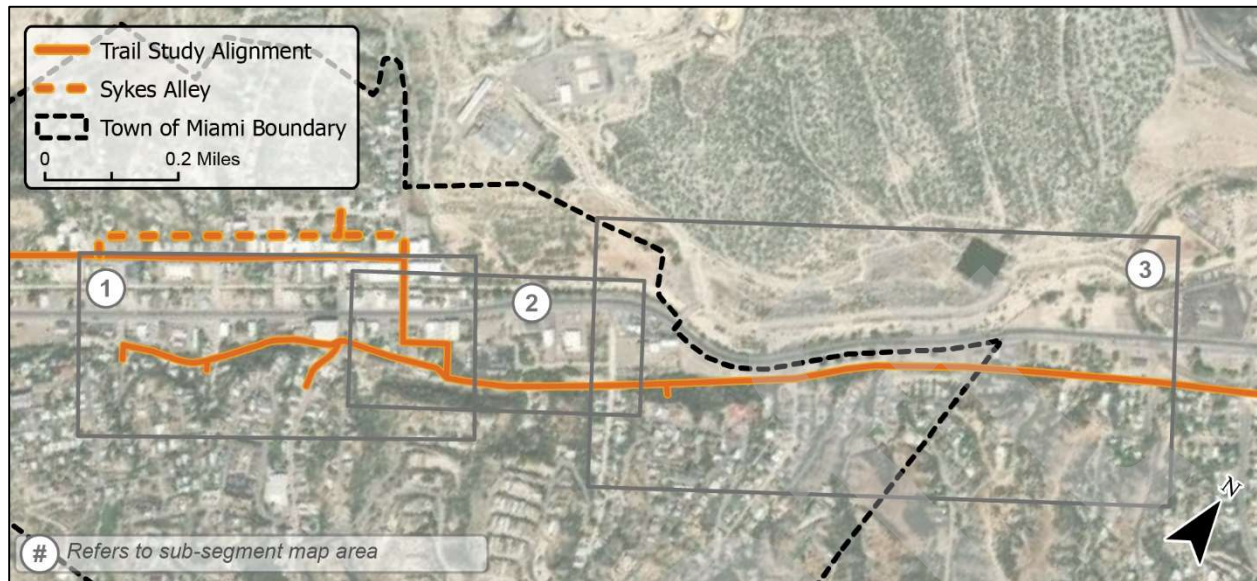
Figure 9. Town of Miami proposed trail alignment – Cactus Alley segment

South of US 60, the trail branches into two sections, traveling along railroad tracks and the associated ROW owned by AZER. Surrounding roadways are owned and operated by the Town.

West of Miami Avenue, the trail follows unpaved portions of Cactus Alley and Railroad Avenue to provide connectivity to hillside neighborhoods and three sets of historic staircases (Inspiration Stairs, Glass Canyon Stairs, and Adonis Stairs). This western portion of the trail alignment is characterized by steep, varied slopes; largely unpaved pathways with sections of failing pavement; ROW obstructions such as residential outdoor storage, vehicles, and heavy vegetation; and unclear public ROW pathways. The area is residentially zoned. The area has low traffic volumes and is almost impassable to vehicles in some places.

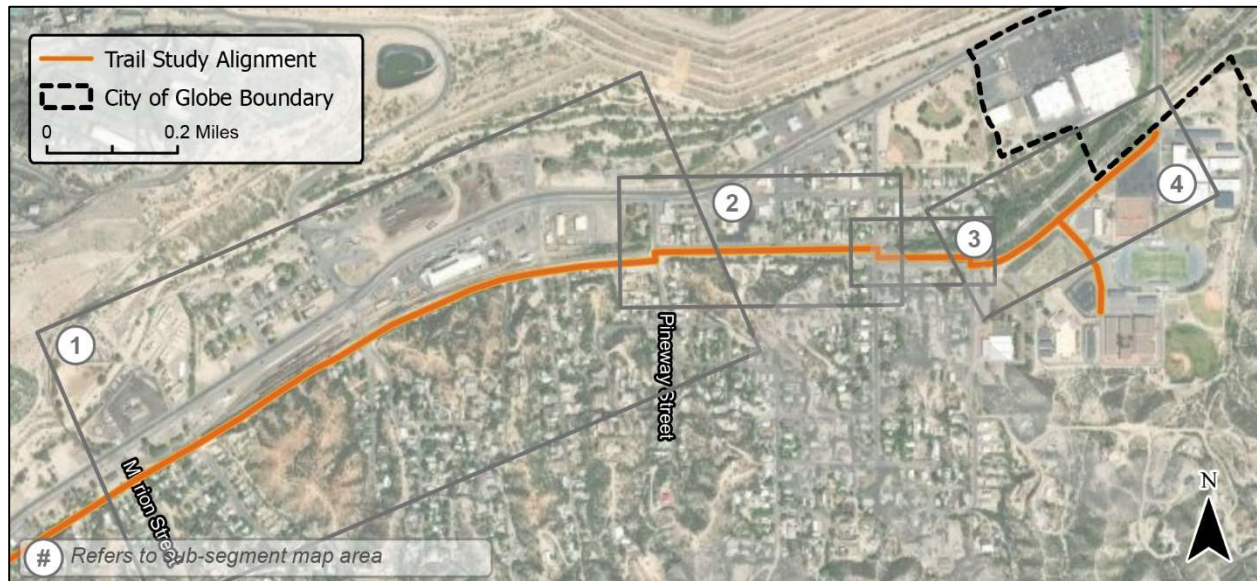
Figure 13. Town of Miami proposed trail alignment – Railroad Avenue segment

East of Marion Street, the trail continues to follow the AZER railroad tracks and paved sections of Railroad Avenue. This segment crosses through the unincorporated community of Claypool, and the entire segment area is owned and maintained by Gila County. The AZER rail line is active along this segment, with chain link fencing between the tracks and adjacent roadway between Marion and New Streets. East of New Street, there is no chain link fencing separating the railroad tracks. The AADT for Railroad Avenue near MUSD is 250.

East of Pineway Street, the trail alignment shifts between Locomotive Drive and Railroad Avenue, crossing the AZER railroad tracks at Pineway Street and Old Oak Street. The railroad crossings include flashing red lights and safety gates. This area has a mix of residential and commercial uses north of US 60, and residential neighborhoods south of US 60. Adjacent to MUSD, roadway and active transportation facilities are in fair to good condition.

During stakeholder discussions and the 2025 field visit, concerns were raised about safety along the proposed trail alignment between Marion Street and MUSD. It was noted that vacant and abandoned parcels and dilapidated properties may create an unsafe environment for pedestrians and bicyclists. No particular properties were noted; rather, the concern was framed as a planning consideration for the alignment through unincorporated Gila County.

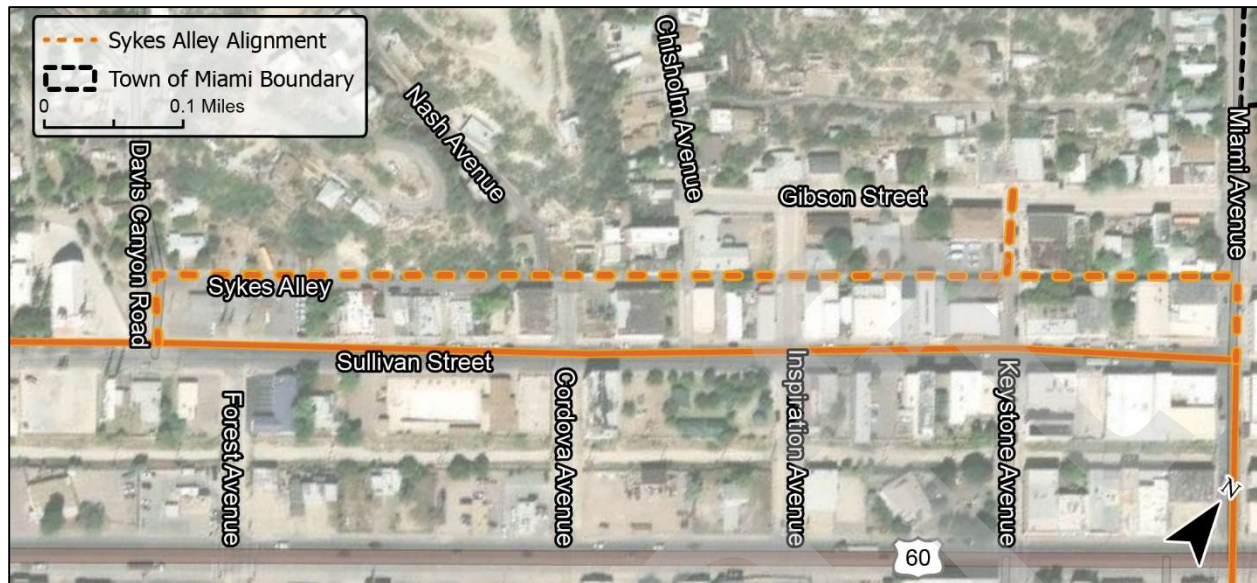
Sykes Alley – Davis Canyon Road to Miami Avenue

Sykes Alley was selected as a pathway to provide connectivity between the Sullivan Street trail section, the historic Keystone Stairs, and Miami Avenue. The path runs along the paved alleyway between Sullivan and Gibson Streets. It travels through Miami's historic downtown core, enclosed by the rear sides of commercial buildings in the area.

While Sykes Alley may serve as a route that would reduce the risk of conflict between vehicles and pedestrians/bicyclists, it is also an area that has limited street activity. Some of the properties along the alley are vacant or abandoned, and a number of properties use their rear lots for outdoor storage. With additional economic development initiatives spurred by the Town, and future investment and activation of local businesses, Sykes Alley could serve as a potential active transportation facility in the future. After discussion with the Town of Miami, the trail alignment for this Study will focus on recommending improvements along Sullivan Street, leaving Sykes Alley as a future alternative.

Infrastructure	Observations
ROW	
ROW Surface: Mostly paved	<ul style="list-style-type: none"> ❖ Poor pavement condition; uneven with patchwork, large cracks, and rutting in many places, particularly at intersections (such as Chisholm Avenue). ❖ Some areas covered in dirt, with rocky surfaces.
ROW Width:	<ul style="list-style-type: none"> ❖ Typically 30 feet between Davis Canyon Road and Chisholm Avenue. ❖ Typically 18 feet between Chisholm and Miami Avenues (desktop review).
ROW Obstructions/Constraints:	<ul style="list-style-type: none"> ❖ Utility poles and meters extend into usable path in some areas. ❖ Vacant or abandoned properties dispersed throughout the area, with broken doorways/windows/etc. fronting the alleyway. ❖ Some vehicles travel through the alleyway, which may cause safety concerns for active transportation users. ❖ Lack of striping and signs along Sykes Alley.
Crossings/Lighting

Intersection Conditions:	<ul style="list-style-type: none"> ❖ Uncontrolled intersections with minor collectors may create safety concern for users crossing Sykes Alley. ❖ At Inspiration Avenue, the intersection crossing is 35 feet across. Along this cross street, there are inconsistent sidewalks with high curbs, which may be a barrier for active transportation users traveling to local destinations. ❖ Near Miami Avenue, the alley was measured 15 feet across. Utility poles reduce the usable pathway width.
Streetlighting: Limited	<ul style="list-style-type: none"> ❖ There are varying streetlighting conditions throughout the alleyway, but most conditions are inadequate. In some areas, uncontrolled intersections are poorly lit with a streetlight at only one corner.
