Outfalls inspected FY 2020

# Dry Weather Field Screening

## Site Report Form

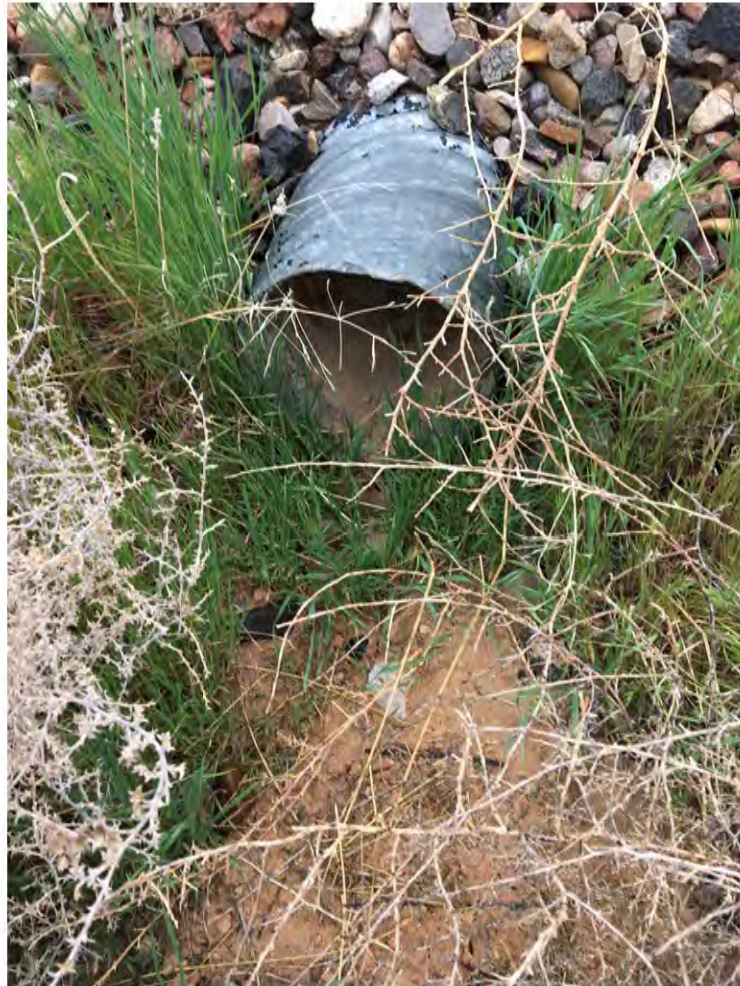
Outfall ID: 1069545

Northcentral District, Fredonia maintenance unit  
Light drizzle occurring at time of inspection, no runoff observed

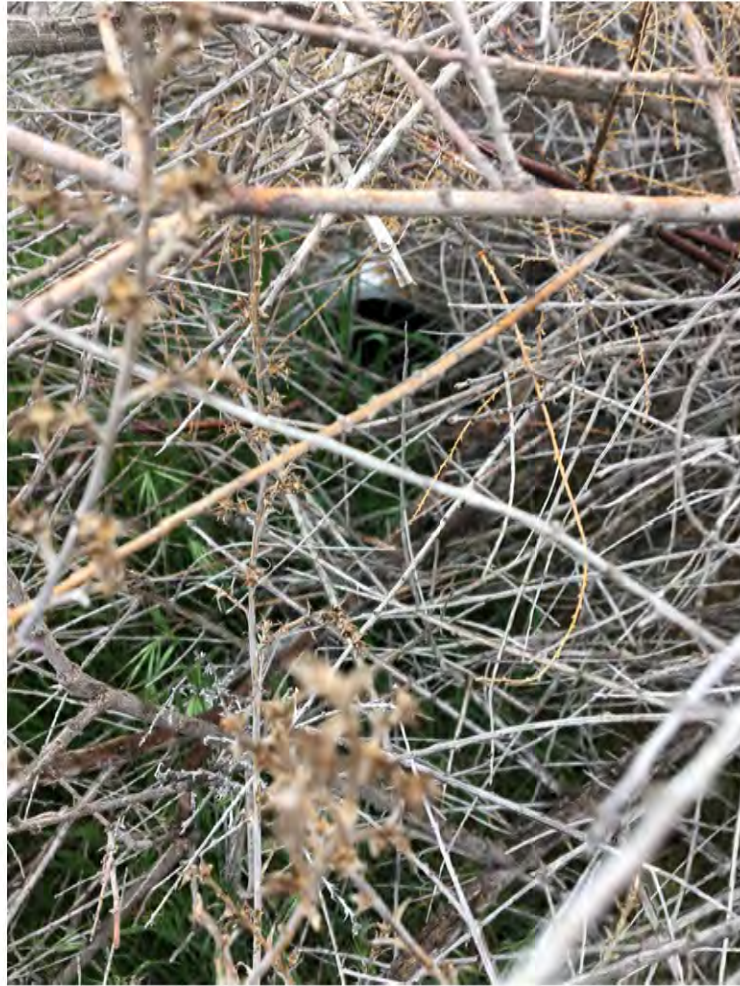
Outfall ID: 1069546

Northcentral District, Fredonia maintenance unit  
Light drizzle occurring at time of inspection, no runoff observed

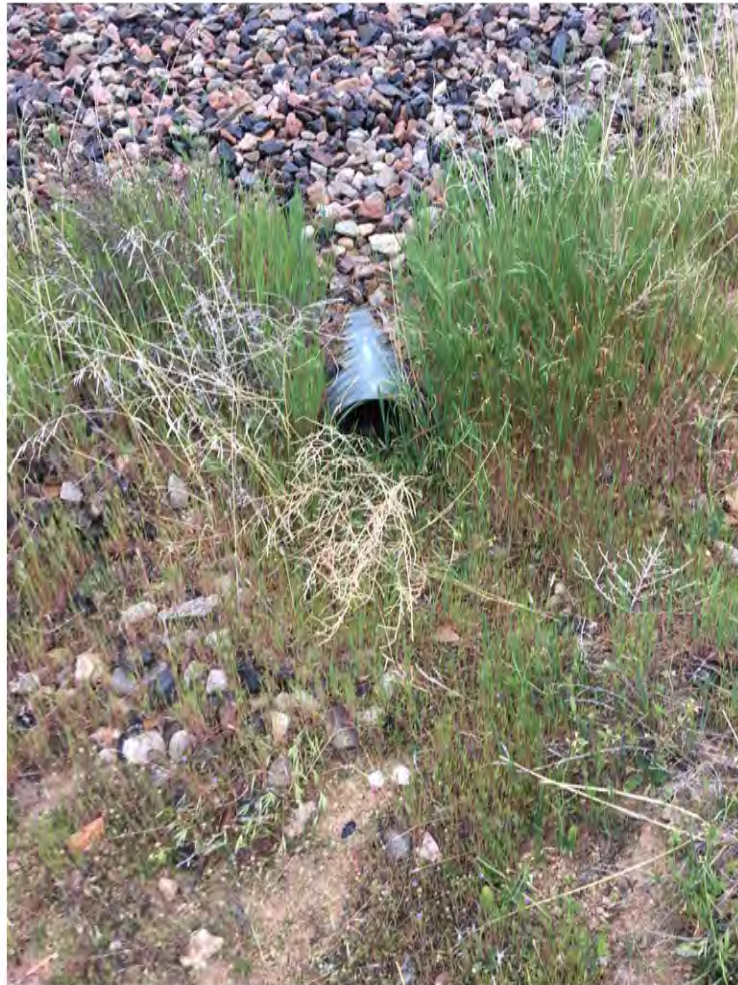
1069547

Northcentral District, Fredonia maintenance unit  
Light drizzle occurring at time of inspection, no runoff observed

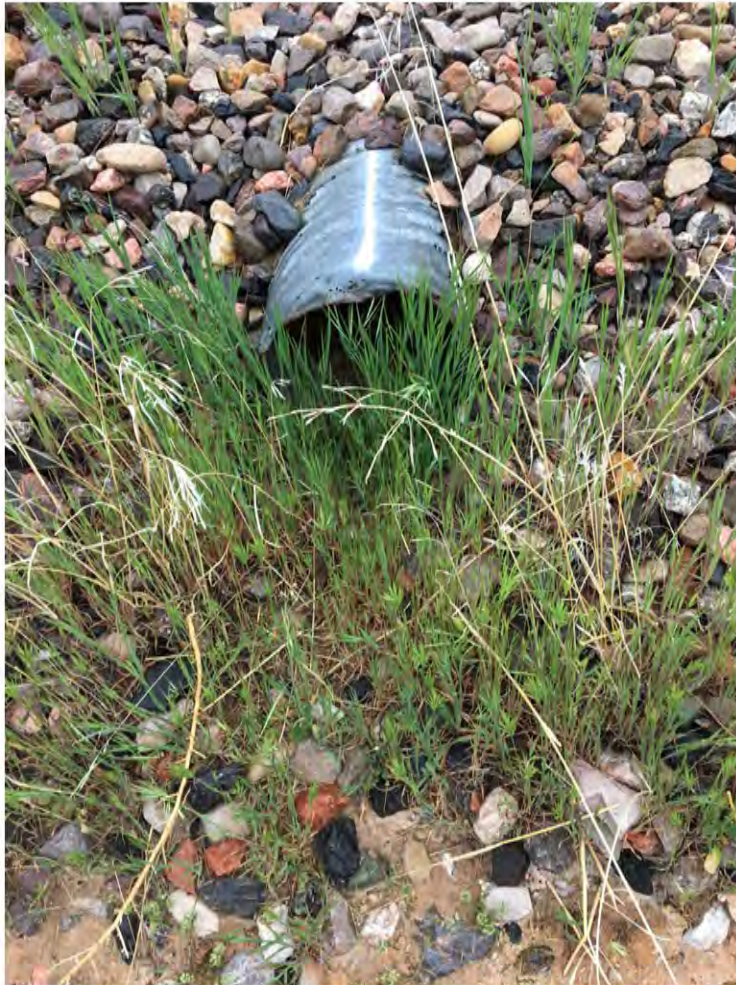
Outfall ID: 1069548

Northcentral District, Fredonia maintenance unit  
Light drizzle occurring at time of inspection, no runoff observed

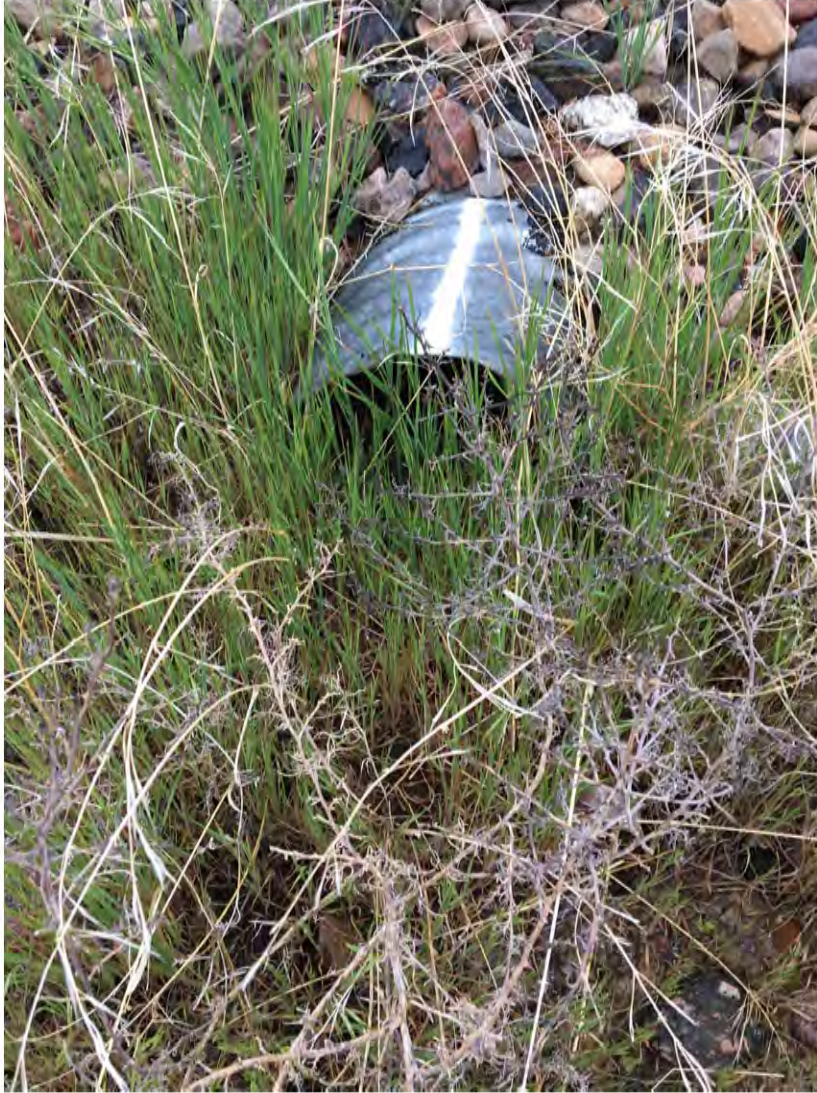
Outfall ID: 1069550

Northcentral District, Fredonia maintenance unit  
Light drizzle occurring at time of inspection, no runoff observed
