ADOT

Bridge Inspection Guidelines

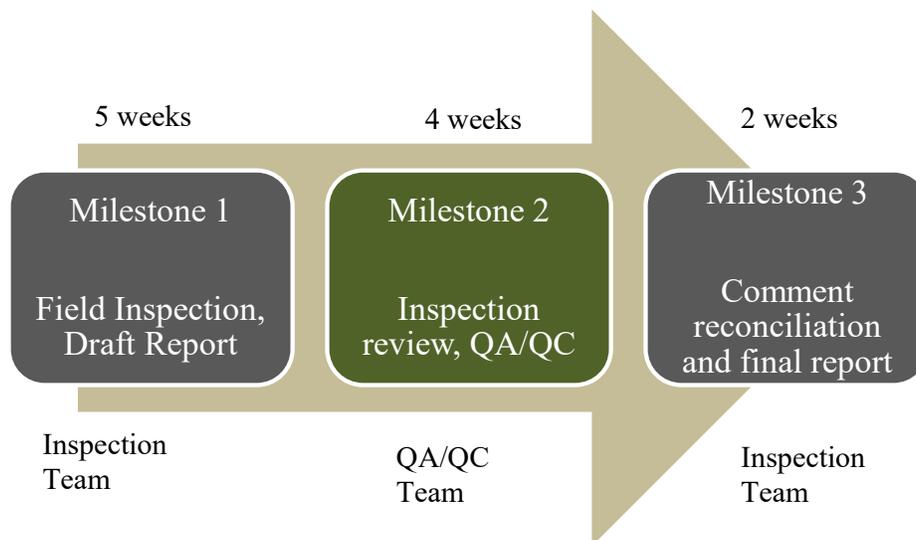
When planning an inspection, inspection teams shall assemble bridges into packets. The lifecycle of a packet consists of the following milestones:

The completion of the field inspection of the first bridge in a packet marks the beginning of the 11-week lifecycle of a bridge inspection packet. This lifecycle procedure applies to all inspections, whether performed by in-house staff or consultants, and shall be observed unless an exemption is granted by Bridge Inspection Program Manager.

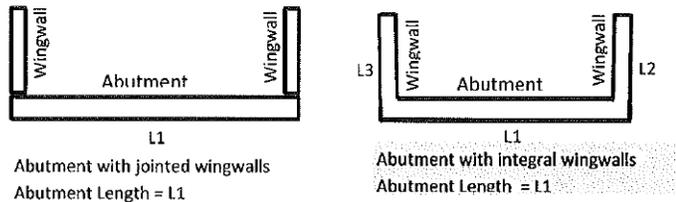
Figure 4.2.5.3 - Reinforced Concrete Abutment Walls & Wingwalls

- Reinforced concrete abutment (Element 215) length shall be inventoried without wingwalls regardless of connection type (integral or jointed).

- Reinforced concrete abutment length (Element 215) shall be inventoried excluding any integral wing walls. See Figure 4.2.5.3.
- For non-waterway bridges, if the abutment slopes are armored, they shall be evaluated as slope protection. For waterway bridges, armored slope protection shall be evaluated as bank protection.

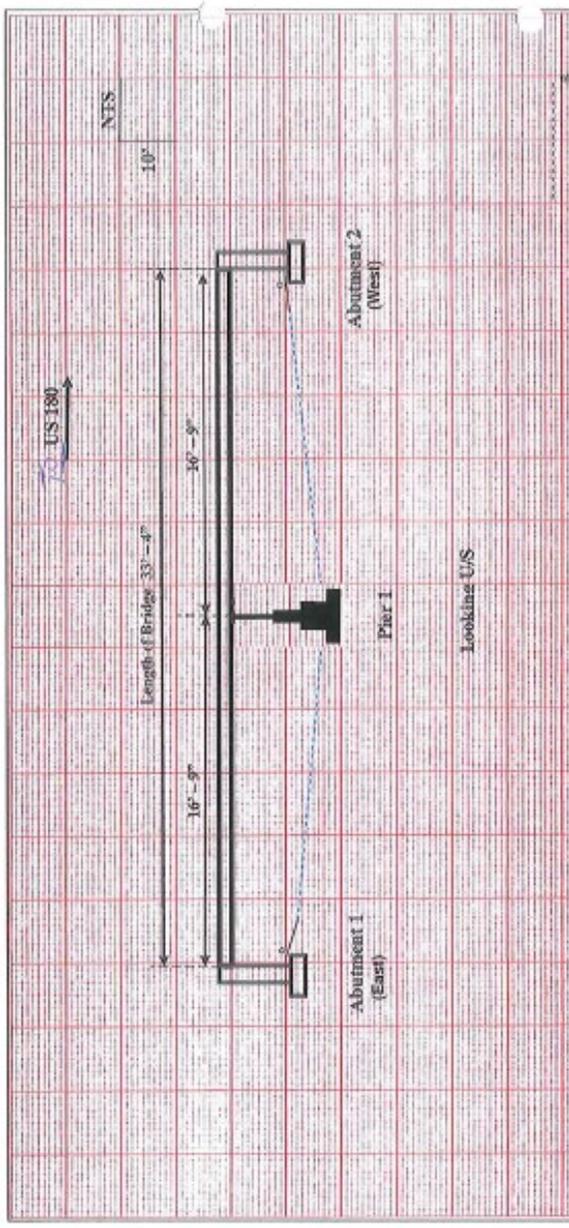
Channel Profile Diagram

Name of Structure: Little Colorado River Br.
 Structure No. 5777
 Location: Route MP _____ Springerville Globe

Insp. No.	Insp. Date	Inspector's Initial	Channel Profile Location (US or DS)	Depth at Abut. 'A1' face or at Support, 2' (HS)	Depth at 1/4 span	Depth at mid span	Depth at 3/4 span	Depth at the left side of Support 2-1	Depth at the right side of Support 2-1	Depth at 1/4 span	Depth at mid span	Depth at 3/4 span	Depth at Abut. 'A2' face or at Support, 2' (HS)
17	5/31/14		DS	9.50'				Water					9.31'
18	9/23/14		DS	9.50'				Water					9.35'

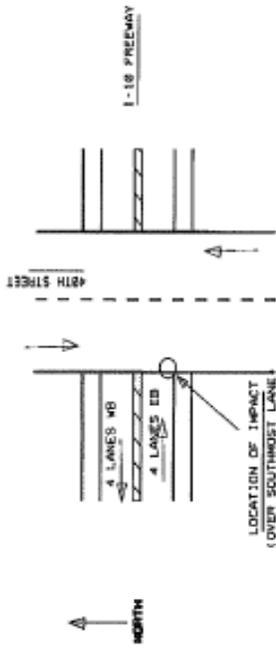
**DAMAGE TO EASTMOST STEEL GIRDER AND ASSOCIATED ELEMENTS
(STRUCTURE -2190 AT I-10 AND 40TH STREET)
ELEMENTS NOT TO SCALE**

SECTION OF APPROXIMATE TORSIONAL
DISPLACEMENT - LOOKING SOUTH

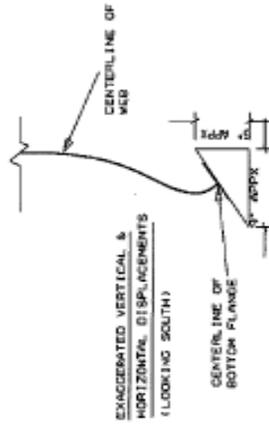
An Example of a sketch

ABOUT 10 FEET LENGTH OF LONGITUDINAL
DISTORTION WAS OBSERVED IN THE
IMMEDIATE VICINITY OF SOUTHWEST LANE

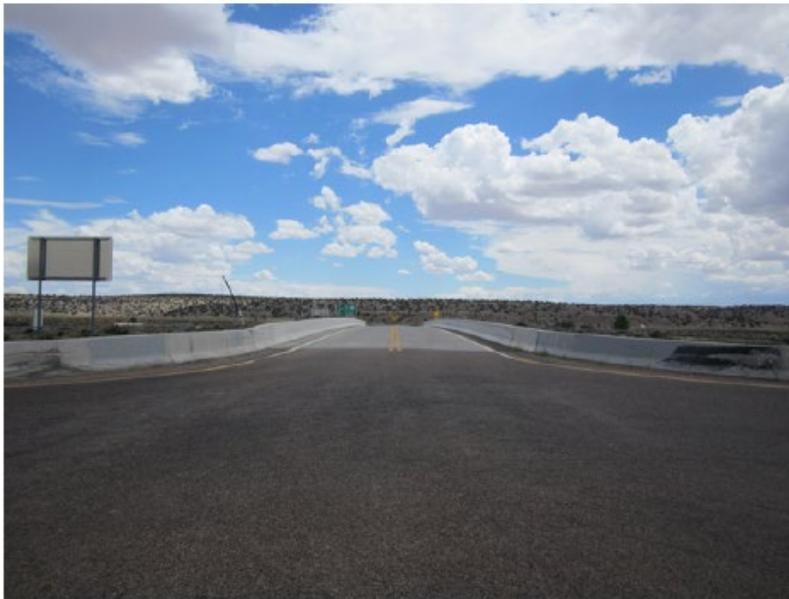
Inspection Photographs – Roadway ID

File Name : 00814-2016-07-19-Photo-a.jpg
Description : Roadway ID, looking S

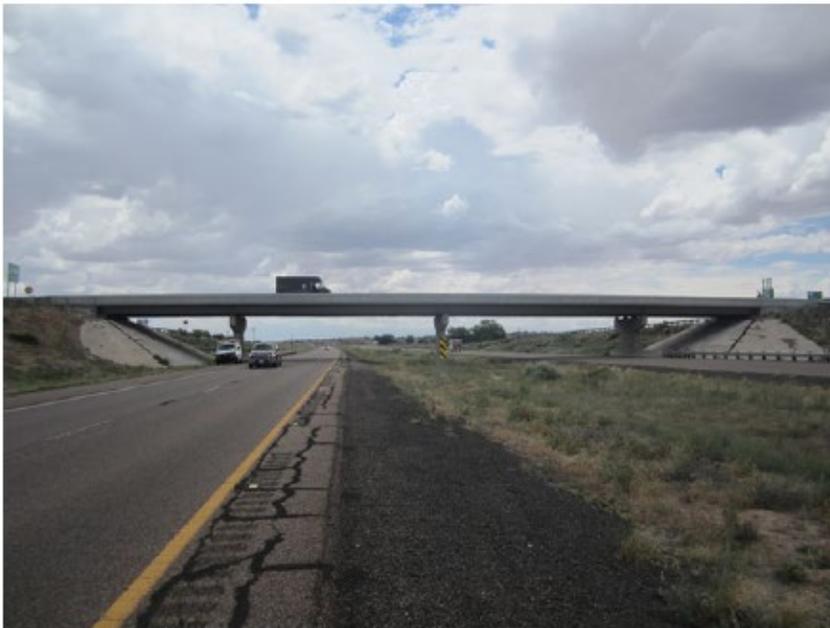
Inspection Photographs – Elevation ID

File Name : 00814-2016-07-19-Photo-b.jpg
Description : Elevation ID, looking W

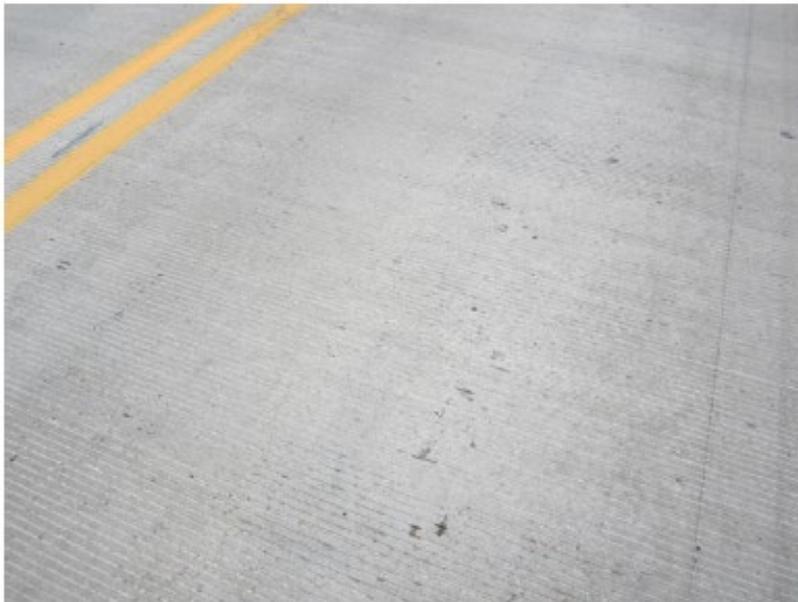
Inspection Photographs – Deck Top Condition

File Name : 00914-2016-07-19-Photo-c.jpg
Description : Deck top

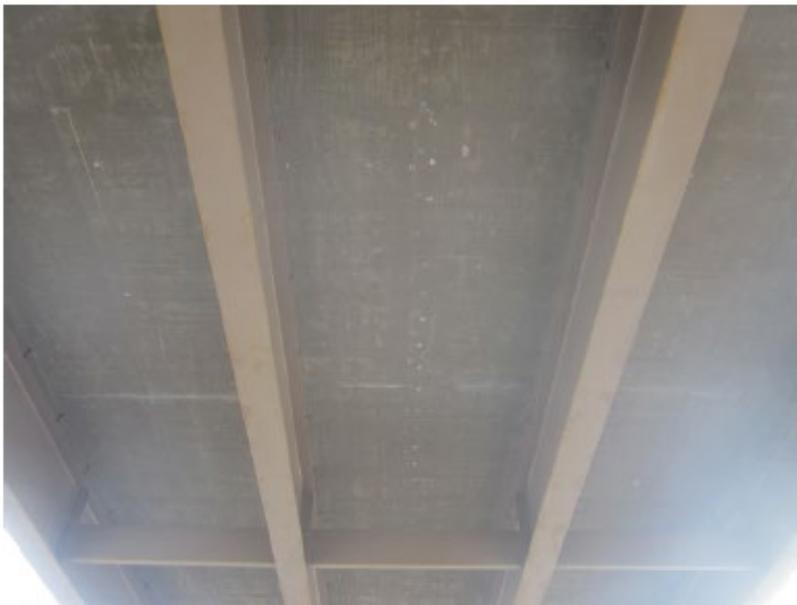
Inspection Photographs – Soffit View

File Name: 00814-2016-07-19-Photo-d.jpg
Description: Deck bottom

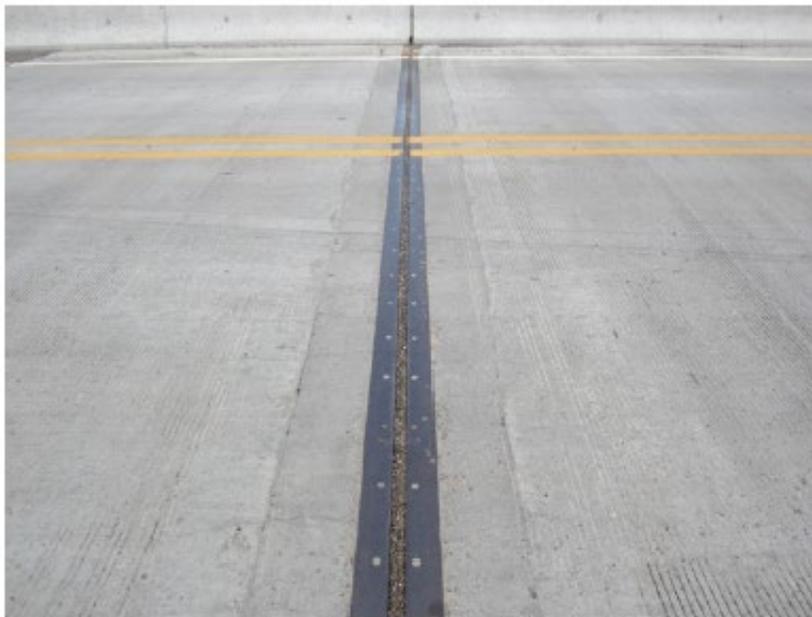
Inspection Photographs – Deck Joint

File Name : 00014-2018-07-18-Photo4.jpg
Description : Joint, typ

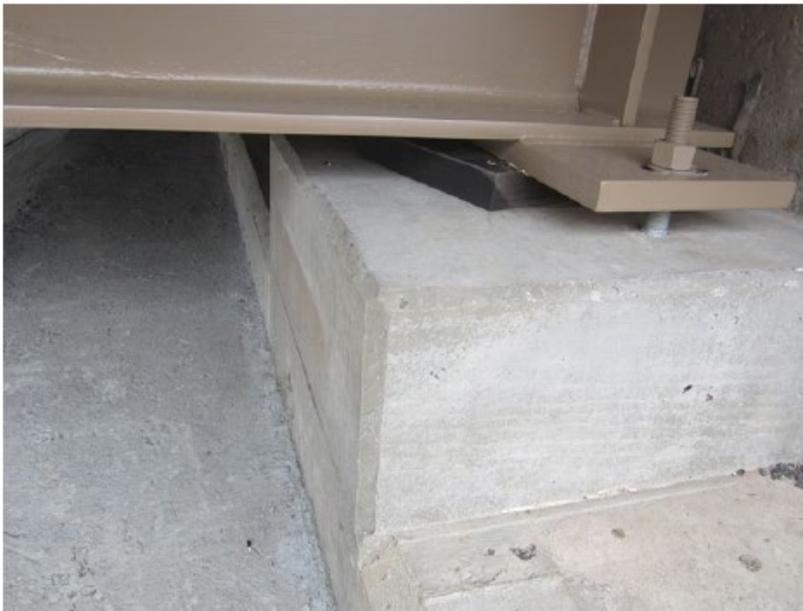
Inspection Photographs – Bearing Condition

File Name : 00814-2016-07-19-Photo-4.jpg
Description : Beam 4 bearing pad, S abut.

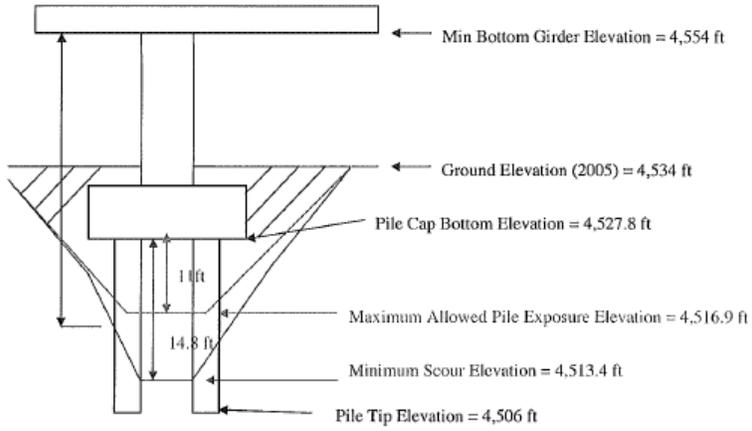
Str. No.: 1371

Minimum scour elevation shown below is based on the 50 year storm event.

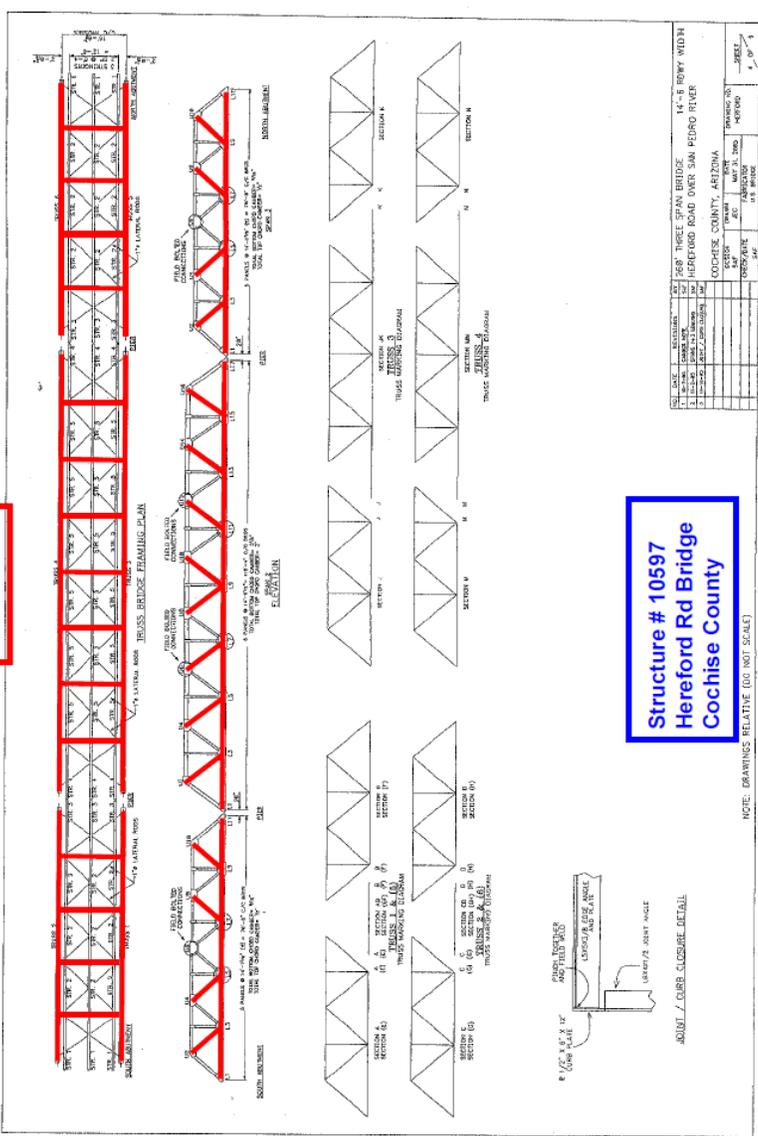
**Structure # 10597
Hereford Rd Bridge
Cochise County**

— = FCM

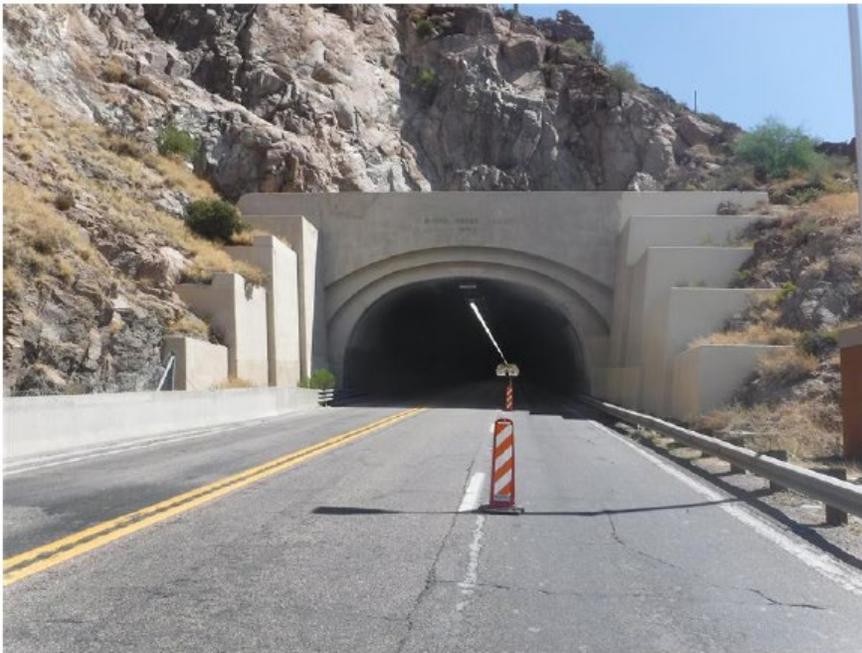
a. West portal ID looking west

File Name : 00407-2019-08-19-Photo-a.JPG
Description : West portal ID looking west

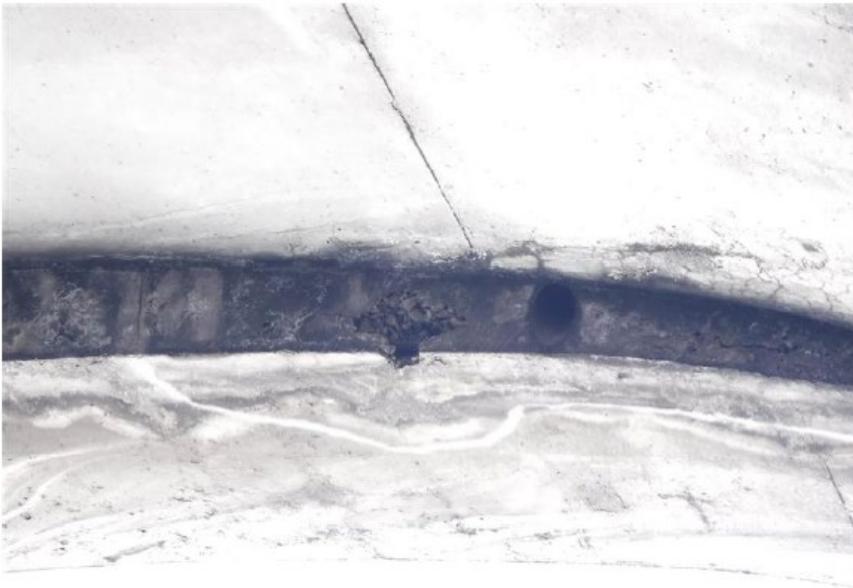
Photo m. Defects (delamination, spall, exposed rebar) in east portal liner over EB lanes

Description : Spall, delaminations, and deteriorating concrete with exposed rebar in east portal liner over eastbound lanes
