WILDLIFE FUNNEL FENCING

WILDLIFE FUNNEL FENCING AND ALTERNATIVE DESCRIPTIONS

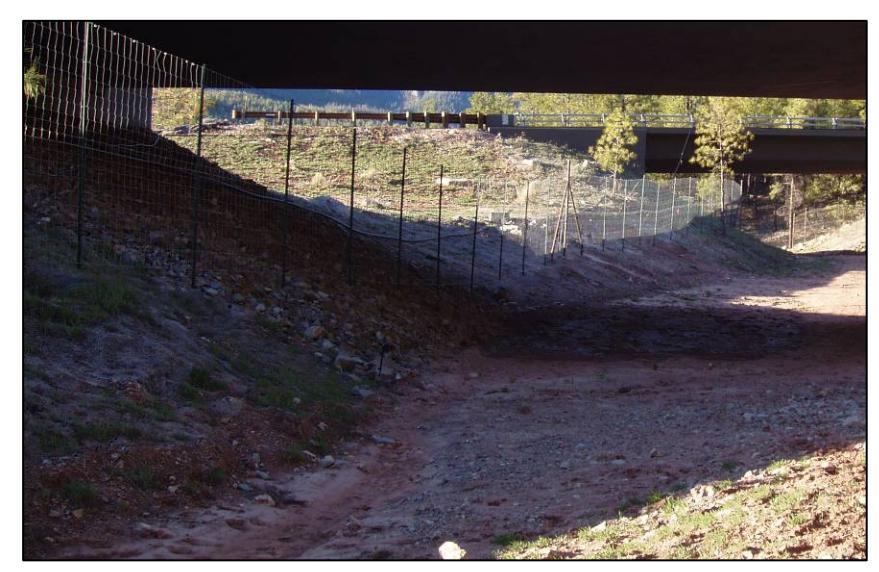
Figure 1. Standard 8-foot wildlife fence erected at a wildlife underpass along State Route 260. Note the woven wire, T-posts space 20 feet apart and metal support posts.

Designed to withstand the impact of falling small trees and limbs that occur with fence erected in Arizona's "high country" ponderosa pine forests, as well as the force exerted by large elk pushing against it, standard wildlife fence is both stout and costly. This fence design (Figure 1; <u>Detail B</u>) was engineered to minimize maintenance while being highly effective at funneling large ungulates (elk, deer, etc.) toward passage structures. This 8-foot high fence is constructed with 12¹/₂ gauge fence fabric strung on 10-foot T-posts spaced 20 feet apart and metal line posts in concrete spaced no more than 120 feet apart. Even with other fence applications along

Standard wildlife fence costs approximately \$50/lineal foot (State Route 260 in 2007), or \$528,000/mile for both sides of a highway. Unfortunately, this fence's high cost can be an impediment to its wide application of in conjunction with passage structures.

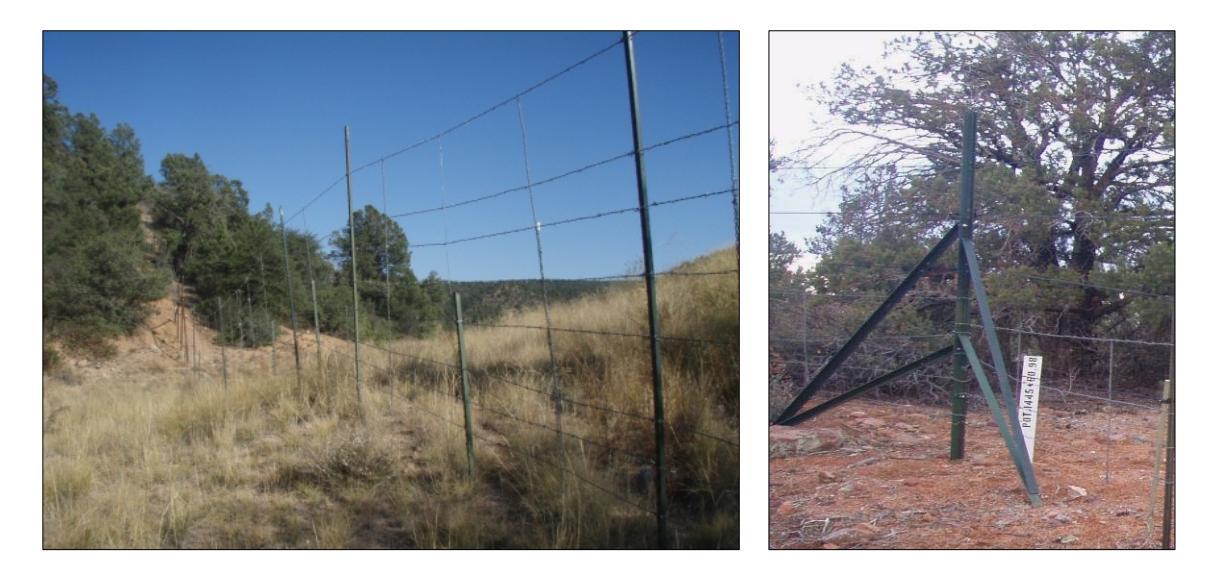
Figure 2. Application of retrofitted ROW fencing using 10-foot T-posts and barbed wire to extend the fence to 7.5–8 feet, with a metal in-line support posts for strength (left). Exiting ROW fence corner braces were raised and supported with new angle braces bolted to the upright and bedded in concrete (right). Fencing retrofitted on State Route 260.

On State Route 260, engineered modifications were made to the design in <u>Detail C</u> whereby the existing angle-metal corner braces were not replaced, but were raised and strengthened (Figure 2). Also, the amount of concrete poured at each in-line support post was reduced. These changes contributed to making this application particularly cost effective, the primary attraction with this design. These retrofit applications cost approximately \$12/lineal foot or \$126,000/mile for both sides of a highway, a quarter of the cost of the standard wildlife fence.

Extended ROW Fence with T-posts and Barbed-Wire. With this fencing type, the existing barbed-wire ROW fence is extended upward to 7.5–8 feet using new 10-foot T-posts and barbed wire (Figure 2; <u>Detail C</u>). Existing ROW fence corner braces must be extended upward with new angle supports welded or bolted to the existing upright and bedded in concrete (Figure 2). This retrofit application has the widest applicability and is the most cost-effective. In the 2.5 years that this fence type has been in place along State Route 260, it has held up very well and presented no maintenance issues.

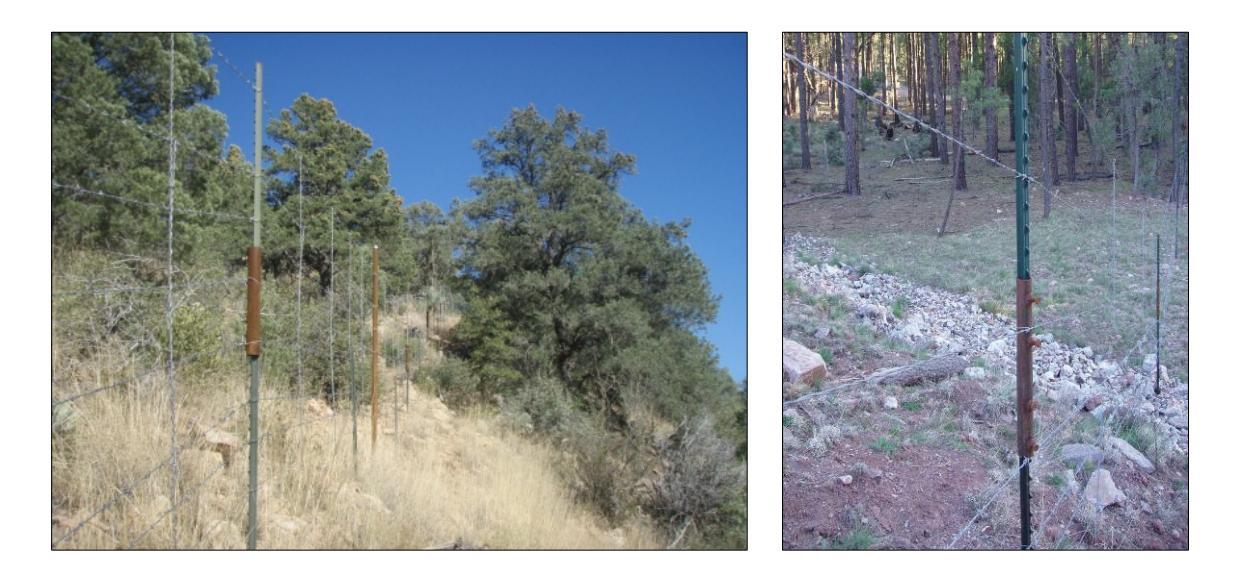
Figure 3. Application of retrofitted ROW fencing using T-post sleeve extensions and barbed wire to extend the fence to 7.5–8 feet, with a metal in-line support post for strength (left). Close-up of the T-post sleeve extending the existing T-post upward with bolts securing T-posts in place (right). Fencing retrofitted on State Route 260.

Extended ROW Fence with T-post Sleeves and Barbed-Wire. In this application, the existing ROW fence is extended upward to 7.5–8 feet using T-post sleeve extensions and barbed wire (Figure 3; <u>Detail D</u>). On State Route 260, sleeves were mass produced at a machine shop, yet their cost still exceeded that of new 10-foot T-posts. However, this application is attractive on rocky and/or steep slopes where it may be difficult to install new T-posts.

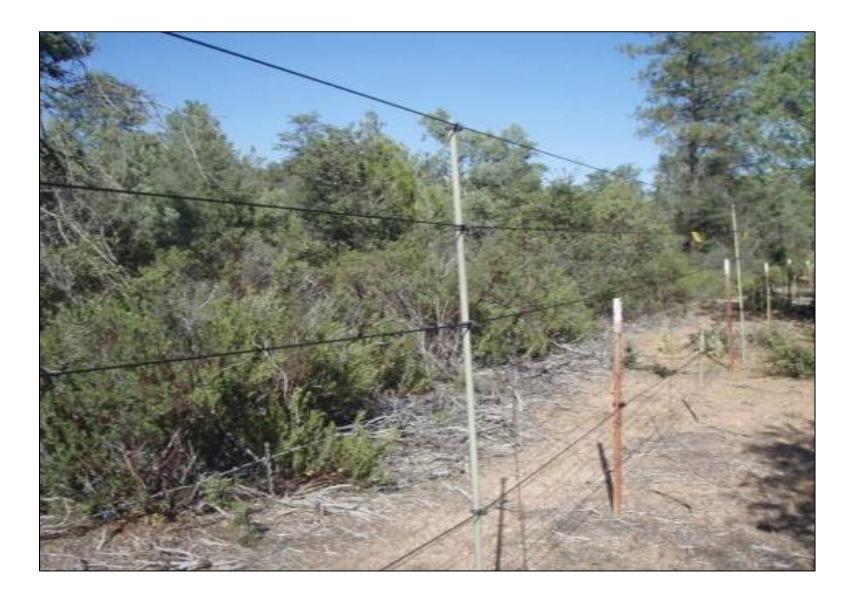
Figure 4. Application of modified ROW fence raised to 8 feet with ElectroBraidTM braided rope electric fence and fiberglass posts, with an electrified "kicker" mounted on the outside of ROW fence T-posts. Fencing retrofitted on State Route 260.

Electric Fence (Experimental). Along State Route 260, ElectroBraidTM braided electric rope fence with imbedded copper wire was used to raise the existing ROW fence to 8 feet. Electrified rope was affixed to 10-foot fiberglass poles with an electrified "kicker" attached to the ROW fence T-posts (Figure 4). Fencing was powered by a 12-volt solar panel system on one side of the highway and by 110-v power drop on the other; both applications proved reliable and no safety issues (fence is ULTM approved) were encountered (Gagnon et al. 2009). This fence is experimental in nature, and similar applications elsewhere have proven effective (Seamens and VerCauteren 2006). One advantage of electric fence is that wildlife species prone to climbing over other fencing types (e.g., black bear) are deterred from doing such with electrified fence.

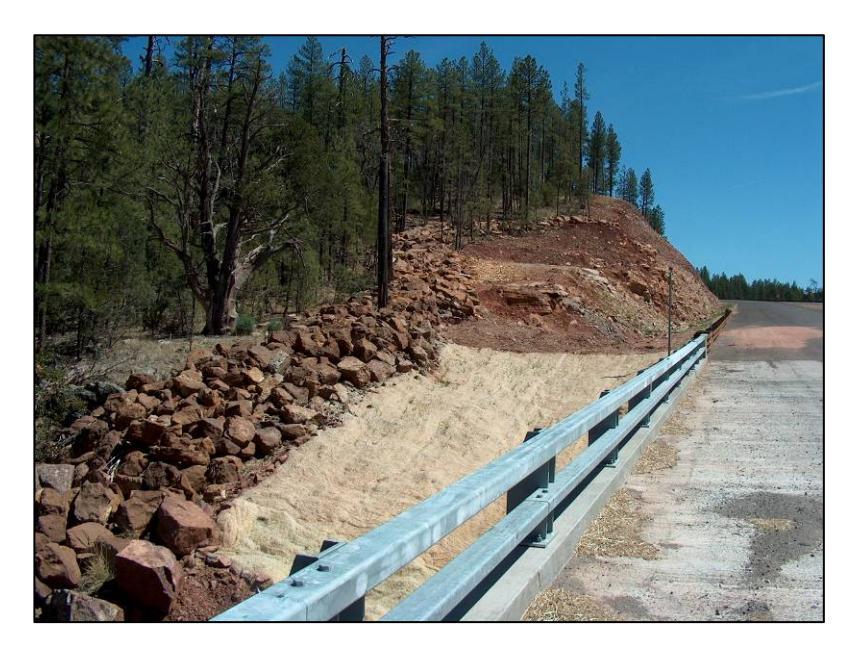
Figure 5. Application of "elk rock" rip-rap in a swath to deter ungulate passage into the highway ROW. In this instance along State Route 260, elk rock was tied into a wildlife underpass.

Elk rock was designed as an alternative to fencing along State Route 260, primarily to eliminate the need for continuous maintenance (Figure 5, <u>Detail E</u>). It entails boulders 18–24" in diameter laid into a rip-rap swath approximately 12–20 feet wide to create a barrier to ungulate and other

animal movement, thus deterring their crossing of the highway and funneling them toward passage structures. A critical element of the application is that no gaps be left between the boulders such that animals may pick their way through and ultimately establish travel routes; where such is done, elk rock proved to be an effective alternative to fencing (Dodd et al. 2007*a*). Such an application is especially attractive where large amounts of rock material must be disposed of during construction activities, and it also presents an attractive visual alternative to fencing (Figure 5). On the down side, the high costs of hauling and arranging the boulders into tight swaths with heavy equipment and operators is an expensive proposition, costing as much as \$65/lineal foot or approximately \$686,000/mile for both sides of a highway.

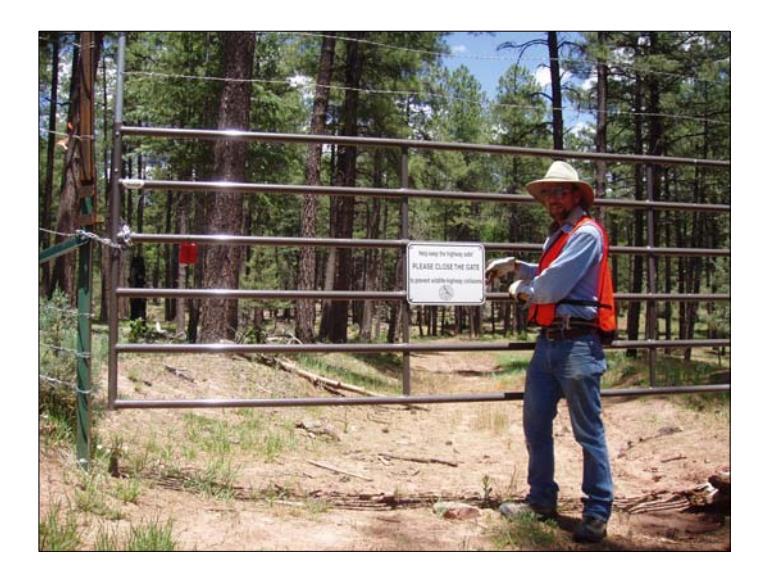
Figure 6. Modified 6-foot Powder River gate installed on a lateral access along State Route 260. Gate was raised to 8 feet with a barbed-wire stinger above the top rail to preclude animals from entering the fenced ROW. Note the sign imploring users to close the gate.

Where funnel fencing along highways crosses lateral road access points, some type of measure is needed to prevent wildlife encroachment through the fence into the fenced corridor. Depending on the lateral road standard and traffic volume, various approaches can be taken. In low volume situations, gates may be appropriate. On State Route 260, 6-foot Powder River gates with barbed-wire stringers across the top, mounted on metal posts provided gated access while precluding wildlife encroachment into the fenced ROW (Figure 6). Signs were erected on the SR 260 gates alerting users to close the gates to maintain highway safety.

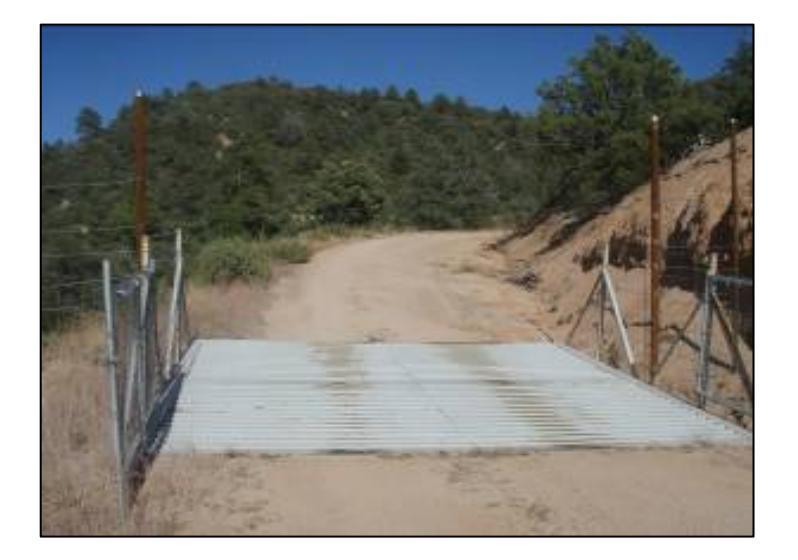
Figure 7. Double-wide cattle guard installed at a lateral access point along State Route 260 to prevent elk encroachment into the fenced ROW.

Cattle guards present an option for securing higher volume roadways while preventing wildlife encroachment should a gate be inadvertently left open; however, they are costly. Elk and deer can readily jump over single-width cattle guards, necessitating that double-wide cattle guards be installed as was done on a lateral access road off State Route 260 (Figure 7; Gagnon et al. 2009). As an alternative to cattle guards, electrified mats (ElectroMatsTM) constructed of recycled plastic decking material into which electrical conducting bars are mitered have shown promise in various applications in Alaska, New Mexico (Interstate-40) and even a lateral road off State Route 260. An electric mat is planned for implementation across State Route 260 to secure the

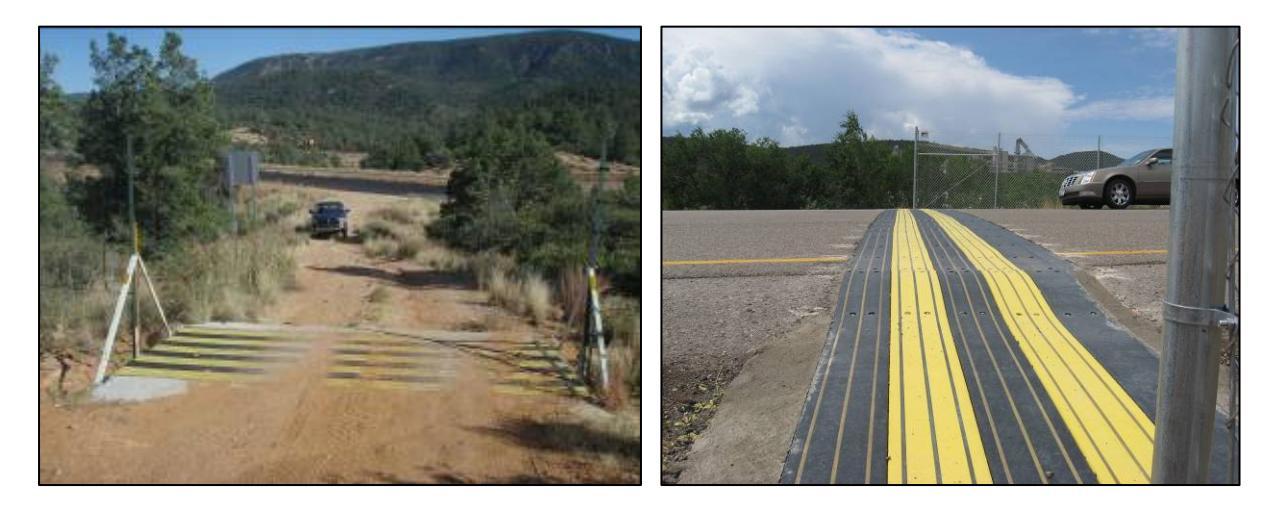
Figure 8. Electrified mats (ElectroMats^{TM)} installed along lateral access roads as an alternative to gates and cattle guards on a low volume access road off State Route 260 (left) and an on-ramp on Interstate-40 in New Mexico.

wildlife crosswalk, and this approach is being considered for on- and off-ramps associated with an enhancement project along Interstate-17. Mats are laid flush with the pavement surface and are attached to large cross members bedded in concrete (Figure 8). They may be powered by AC (power drop) or DC (small solar panels) power, and can be turned off during the day or have crosswalk-type push button switches installed to minimize conflicts with crossing pedestrians. They do not need to be wider than a standard cattle guard due to animal aversion to approaching or jumping them associated with the electrical current.
