## Arizona Department of Transportation Annual Report for MS4 Permit AZS0000018-2015

Reporting Period: July 1, 2018– June 30, 2019

## Part 3: Narrative Summary of Stormwater Management Program Activities

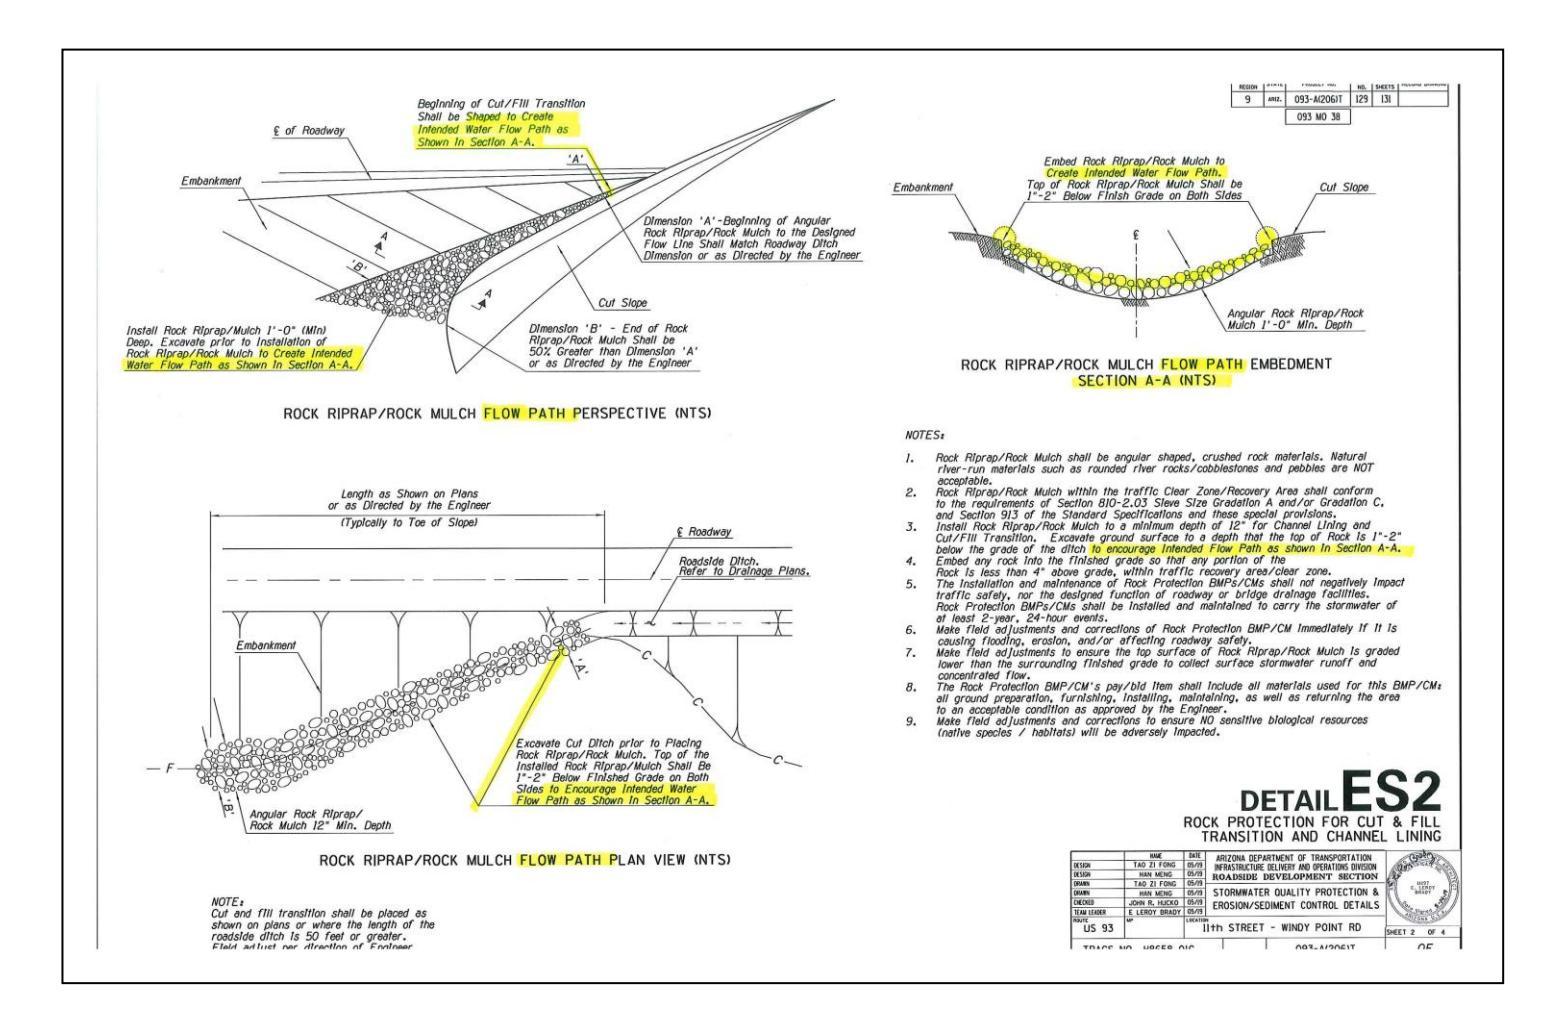
Engineering detail "ES2 – Rock Protection for Cut & Fill Transition and Channel Lining" (below) was revised to more clearly depict the intended flow path for rock protection structural BMPs in the erosion control and final stabilization plans for highway construction projects. The revised detail (see below) better informs contractors and field inspectors to ensure that the controls are installed properly and effectively.

Two modifications to existing control measures were developed during the current reporting period, the first consisting of a revision to the standard detail drawing for erosion control plans and the second is to the water quality specification for seeding operations.
