## HISTORIC PROPERTY INVENTORY FORM

# Side Hill Viaduct

BRIDGE

Clayton B. Fraser, Principal

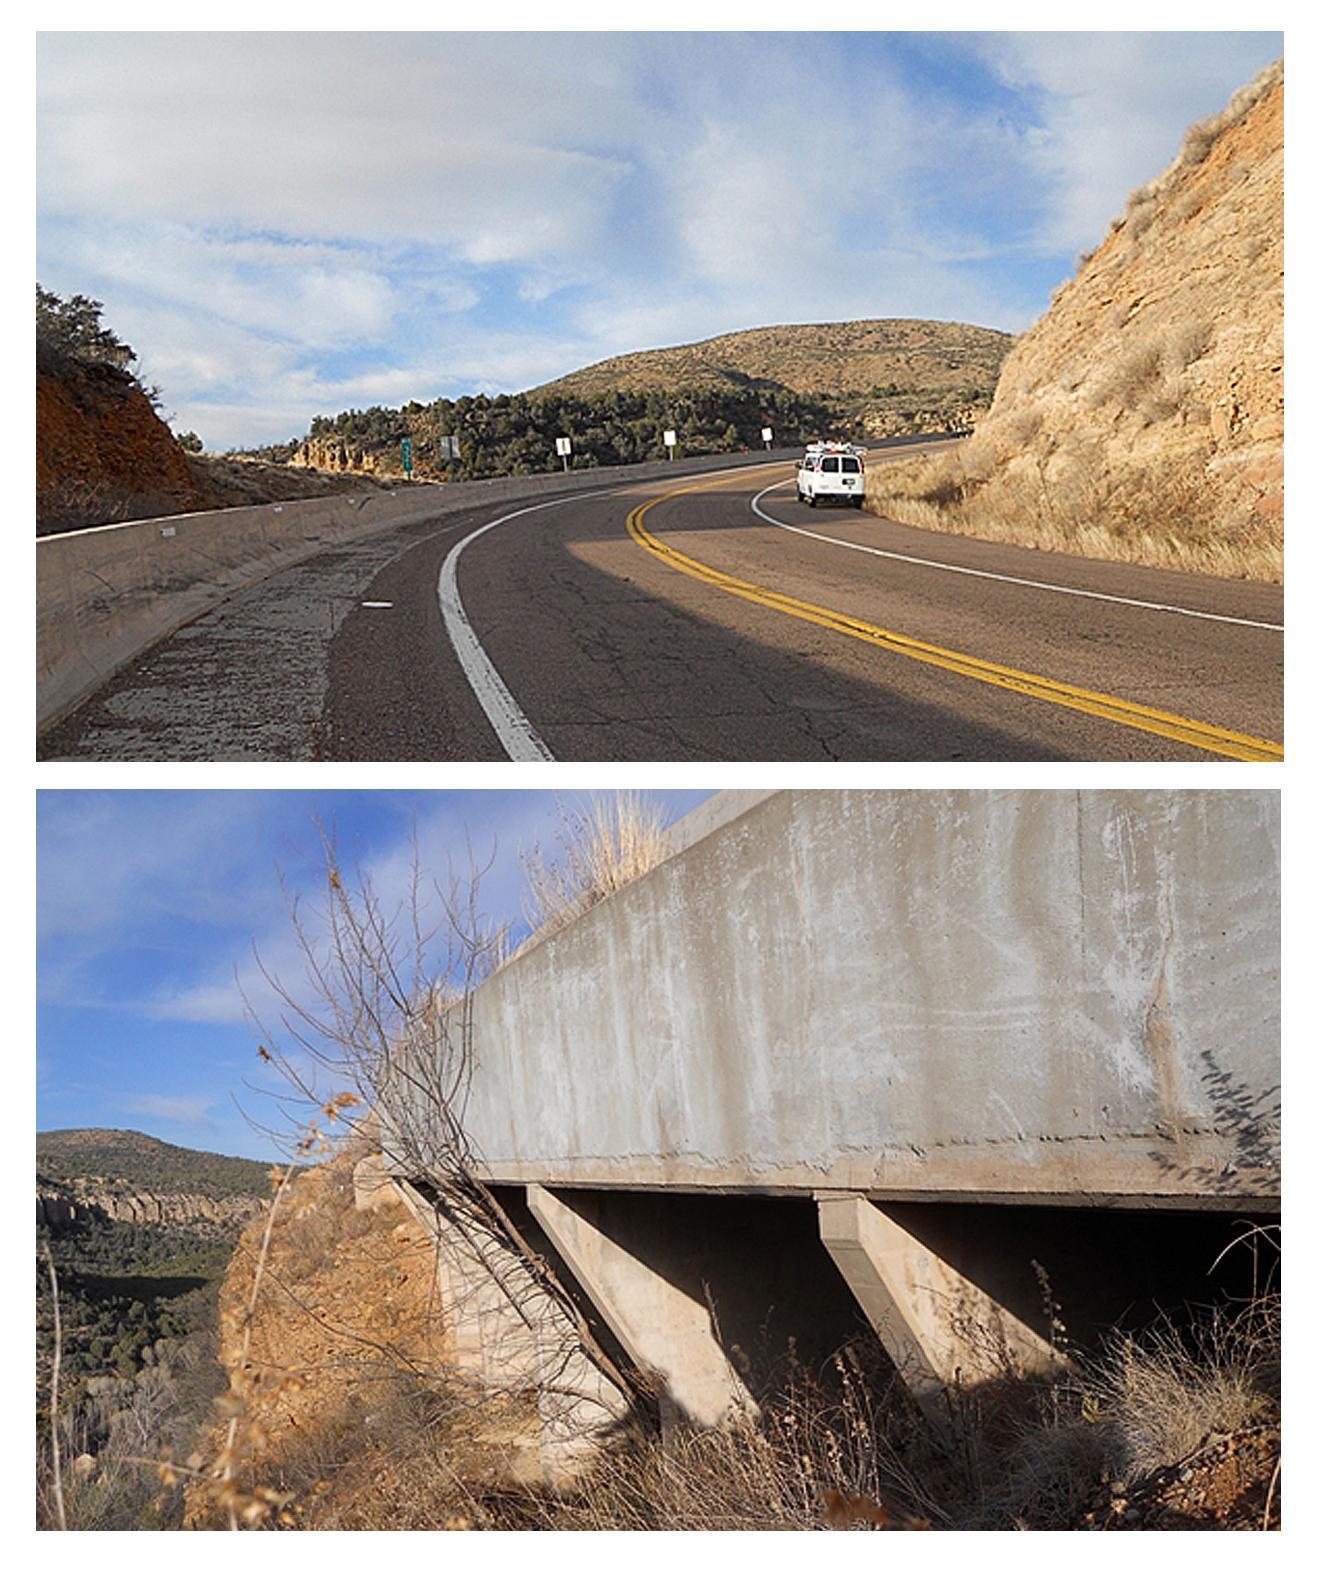
Structure No. 00145

view direction: northeast; northeast photo no.: DSCF5400 DSCF5401

AHD designated the construction of this viaduct—along with 3.2 miles of adjacent roadway—as Federal Aid Project 105-D and late in 1935 awarded the contract for the work to Harry J. Hagen. Under the supervision of AHD resident engineer A.F. Rath, the Globe contractor began work on the road soon thereafter. By May the Hagen crew had completed over half of the construction; by October the project was reported complete. The Side Hill Viaduct has since carried mainline traffic, with the replacement of its original guardrails with steel Thrie beams and later with concrete Jersey barriers as the only significant alteration.

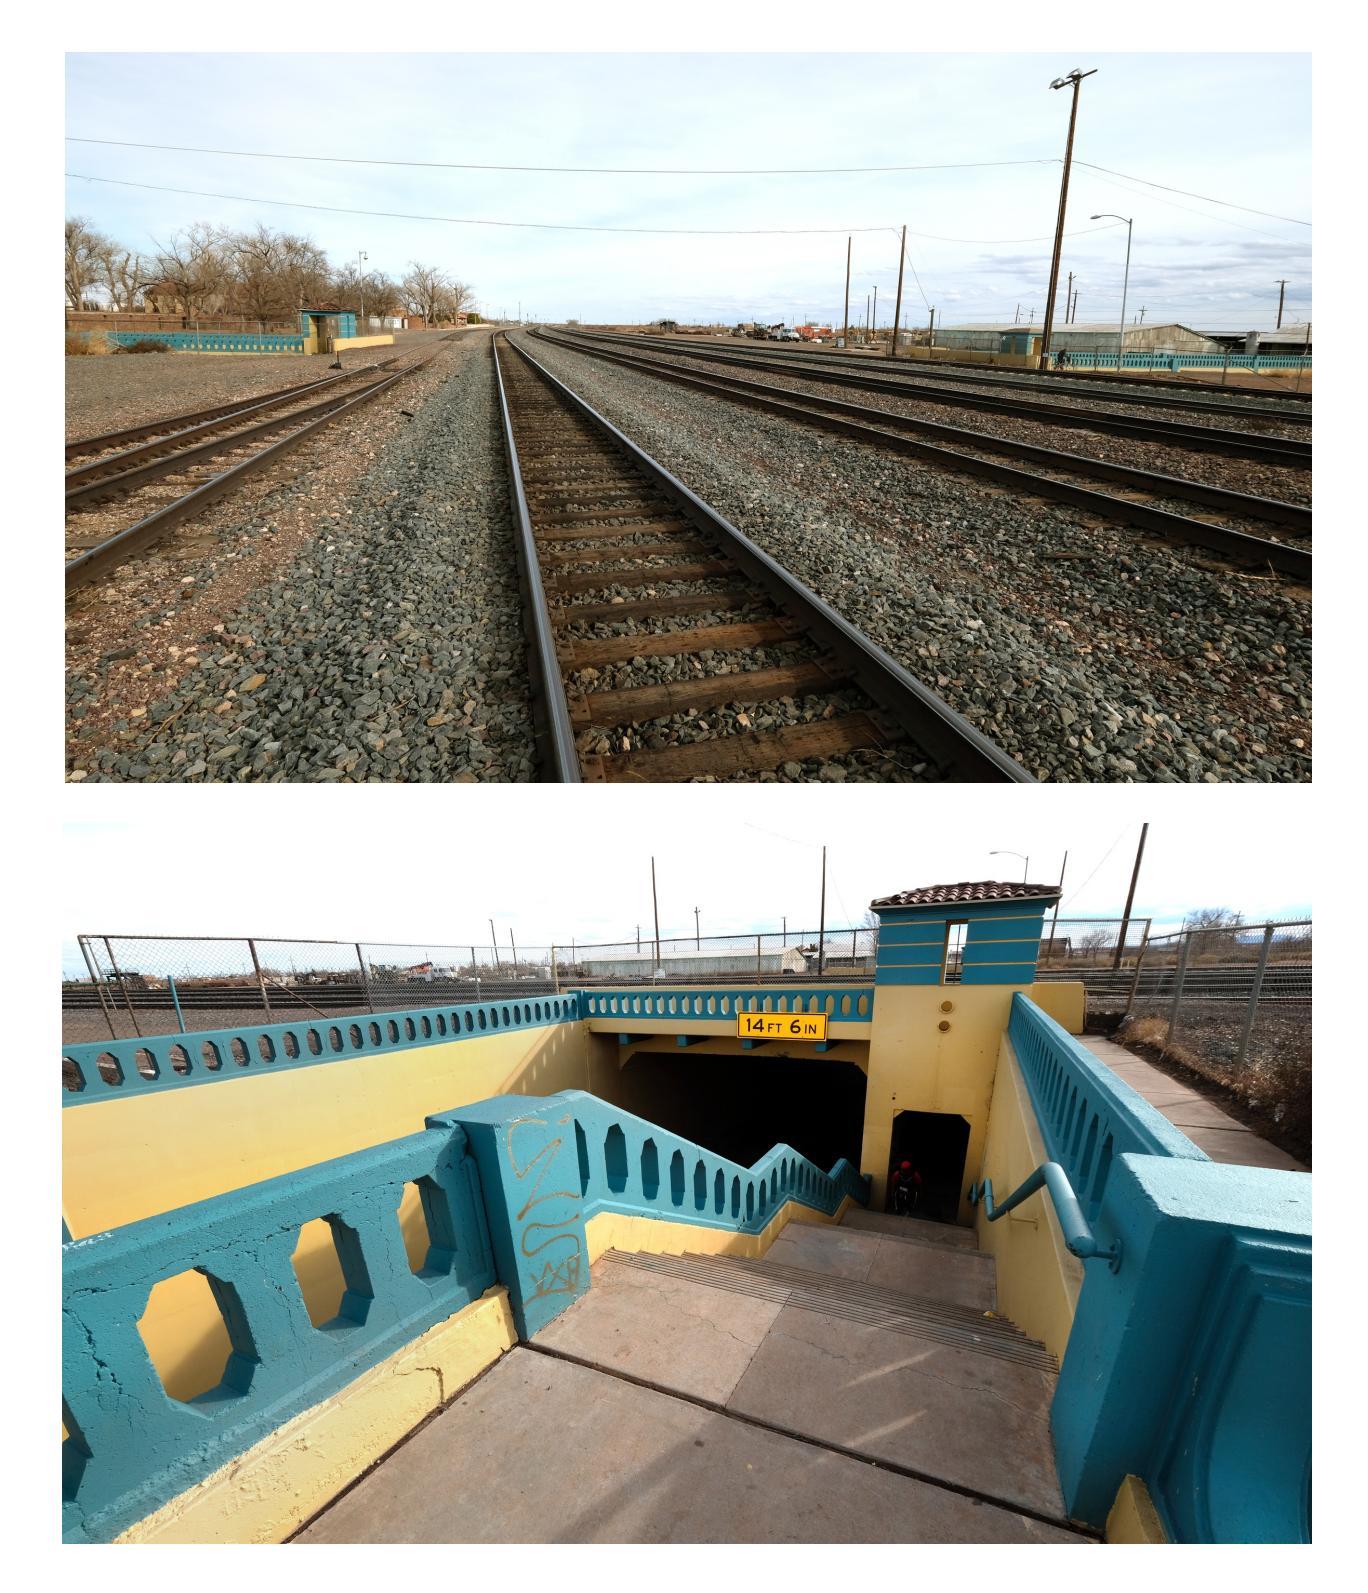
date of photo.: March 2018 view direction: northwest northeast photo no.: DSCF6562 DSCF6566

The contract went to the R.C. Tanner Construction Company for an estimated \$150,000. With several other highway projects then underway, the Phoenix contractor was slow in beginning this structure, and as a result the work dragged through the summer. Tanner recruited heavily from the relief rolls for labor, using about 70,000 man-hours to build the structure. With its long approaches and decorative architecture, the Winslow Underpass was massive, consuming almost 300 cubic yards of concrete and 360,000 pounds of reinforcing steel. Tanner's men completed it in November, and it was formally dedicated before throngs of well-wishers on December 1, 1936. The Winslow Underpass has functioned unaltered since.

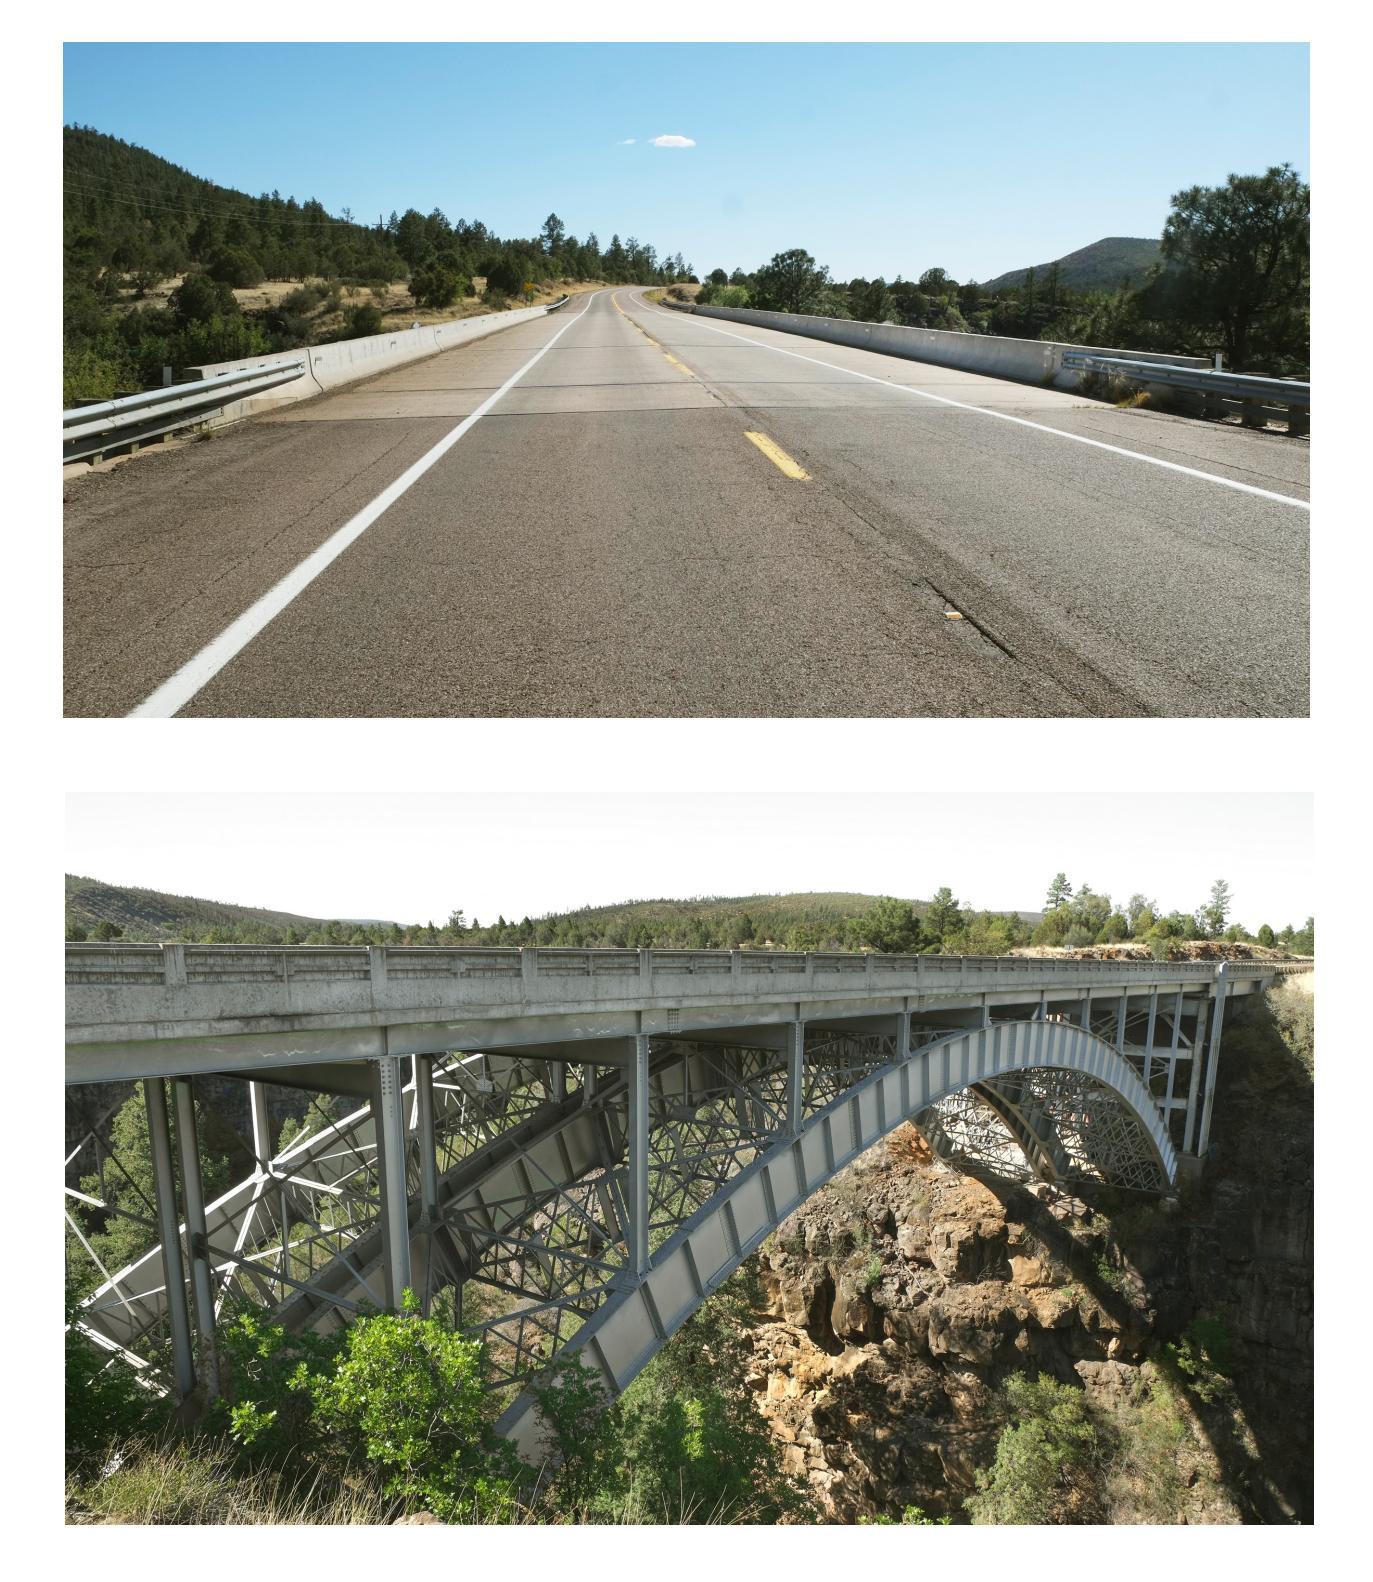
view direction: southwest north photo no.: DSCF5403 DSCF5407

The Arizona Highway Department initially surveyed the route for U.S. 60—the Globe-Springerville Highway—in 1930-1931. The heavy construction of the highway progressed northward from Globe in sections, and by 1936 the work had reached nearby crossings of Cedar Canyon and Corduroy Creek, some 70 miles northeast of Globe. For these rugged, steep-walled canyons, AHD engineers designed identical steel deck arches similar to the recently completed Salt River Canyon Bridge [00129]. As delineated by the highway department, each bridge featured a two-hinge, riveted steel, girder ribbed deck arch that extended 180 feet between pins. The arch sprang into massive concrete pedestals set on spread footings and was flanked by steel stringer approach spans. The 50-foot-wide concrete deck was bounded on both sides by steel guardrails, with decorative Art Moderne pylons at the four corners. AHD designated them Federal Aid Project 105-E and in August 1936 awarded a construction contract for both bridges to the Pleasant-Hasler Construction Company of Phoenix for \$118,000. The contractors began work immediately on the concrete abutments and arch pedestals and had the bridges 20 percent complete before suspending work for the winter. Using over 200 tons per bridge of superstructural steel fabricated by Bethlehem, Pleasant-Hasler worked slowly the following spring and summer, completing the project in September 1937. The bridges carried mainline traffic for over 50 years, but their relatively narrow width impeded ADOT plans to four-lane the highway at this point. To address this need for extra deck width, ADOT in 1993 moved the superstructure of the Corduroy Creek Bridge beside the Cedar Canyon Bridge and installed it on new concrete arch pedestals. The two structures now function as a single, wide bridge.

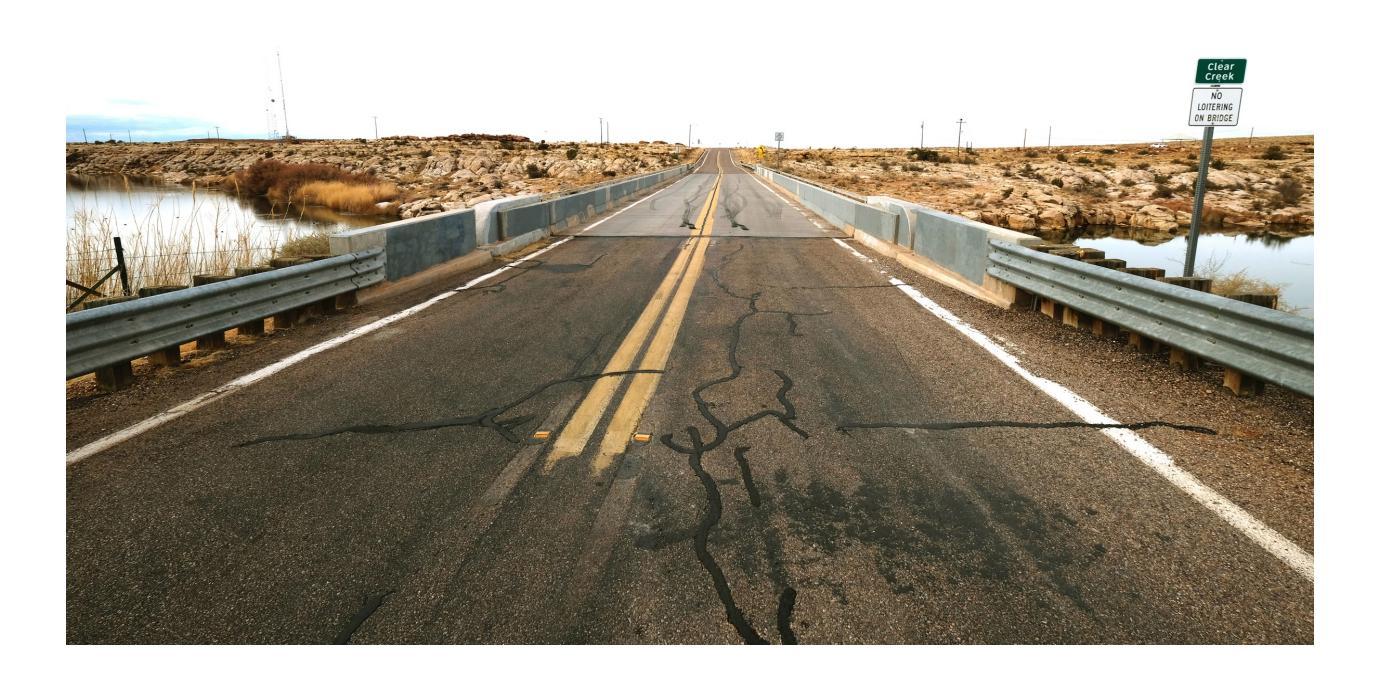
view direction: SOUth West

After World War II the Arizona Highway Department resumed its extensive highway program, improving existing routes across the state and replacing bridges where necessary. Part of this effort entailed the upgrading of a county road that extended southeast of Winslow and replacing the existing truss bridge over Clear Creek with an all-new steel structure. As delineated by the AHD bridge department, the new Clear Creek bridge would be a 130-foot, two-hinged, girder-ribbed deck arch that sprang from concrete pedestals on solid rock. The central three-ribbed arch was approached on both sides by shorter steel stringer spans, the aggregate length of which equaled the length of the earlier truss at 167 feet. With a radius of 148 feet and an arch rise of only 15 feet, the welded steel arch ribs carried a series of wide flange columns, which carried wide flange floor beams and stringers and the 28-foot-wide concrete deck. The highway department designated this project as S 50(2) and on October 26, 1949, let the contract for its construction to Western Constructors of Phoenix. The Western crew first moved the existing truss to one side for use as a construction detour and then began construction on the concrete arch pedestals. The men worked through the winter building this small-scale arch, completing it the following year. Since that time, the Clear Creek Bridge has carried traffic on this secondary state highway, in essentially unaltered condition.
