# **STATEWIDE STORMWATER & EROSION CONTROL STUDY** *Final Report September 2020*

*Prepared For:* Arizona Department of Transportation Multimodal Planning Division

Prepared By: Michael Baker International 2929 N. Central Avenue, Suite 800 Phoenix, Arizona 85012

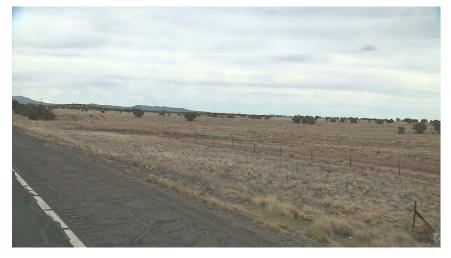
Figure 7: Westbound, Northern View

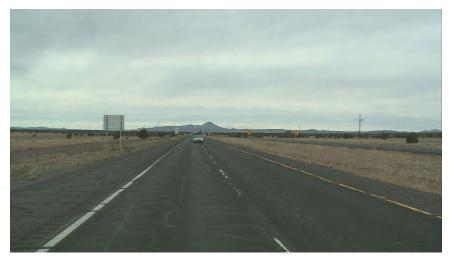
Figure 8: Eastbound, Rear View

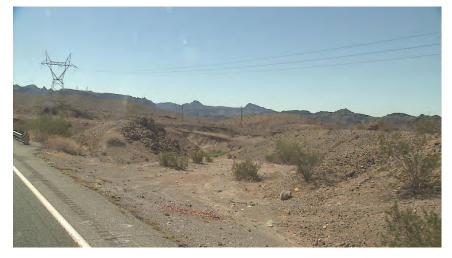
Figure 11: Southbound, Western View

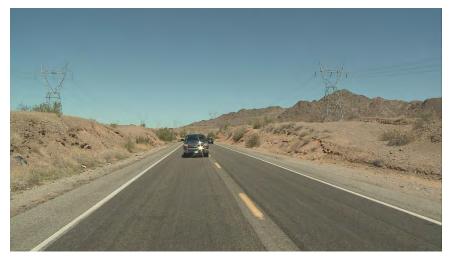
Figure 12: Southbound, Rear View

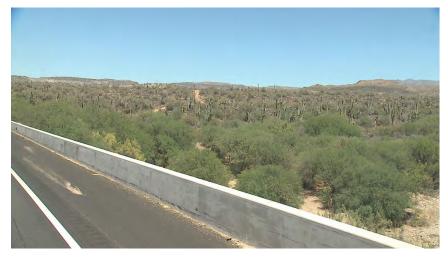
# Figure 19: Northbound, Eastern View

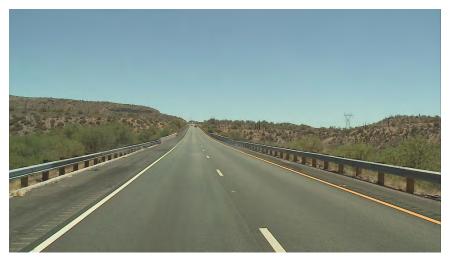
Figure 20: Northbound, Rear View

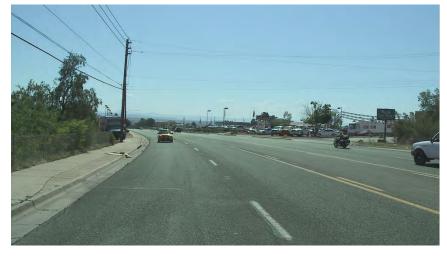
Figure 24: Eastbound, Rear View

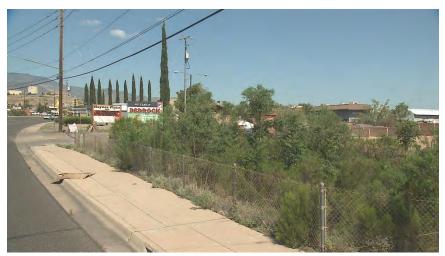
Figure 25: Eastbound, Northern View

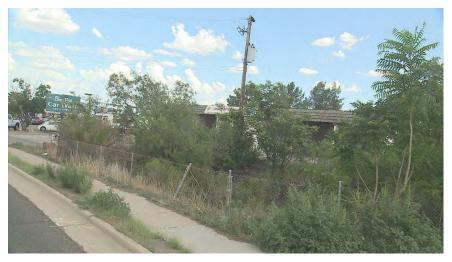
Figure 26: Westbound, Southern View

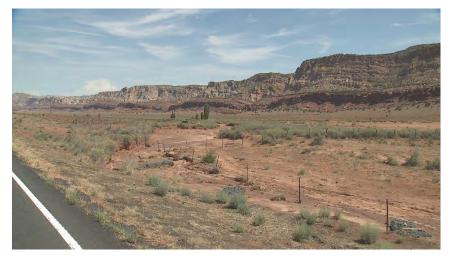
# Figure 28: Northbound, Eastern View

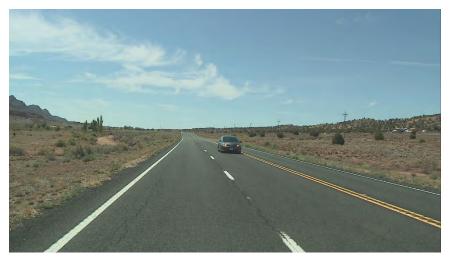
Figure 29: Northbound, Rear View

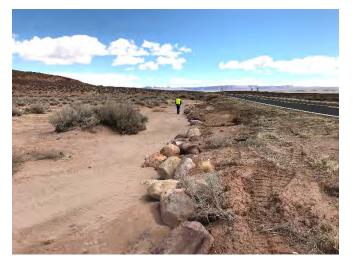
Figure 34: Northside of Roadway, Eastern Facing (Picture Provided by ADOT)

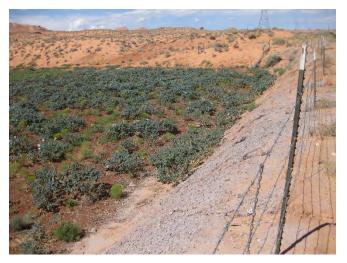
Figure 38: Westbound, Southern View

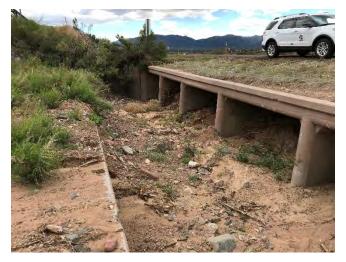
Figure 41: Hog Wash Inlet (Picture Provided by ADOT)

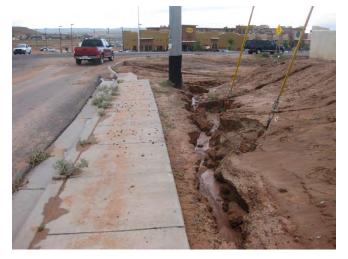
Figure 45: Eastern View, from Peshlakai Avenue (Picture Provided by ADOT)

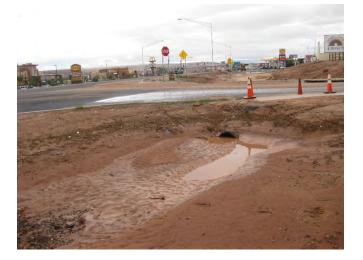
Figure 46: Southbound View (Picture Provided by ADOT)

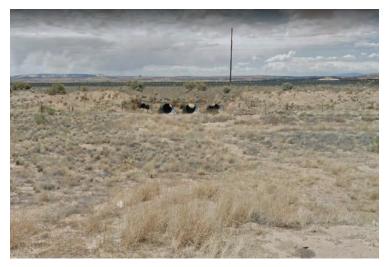
Figure 49: Northern View at Railroad Tracks (Picture Provided by ADOT)

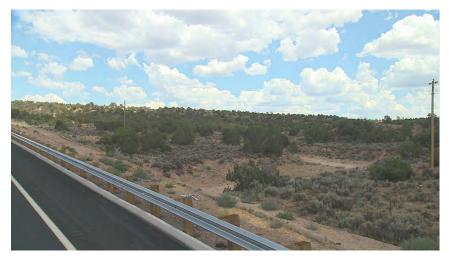
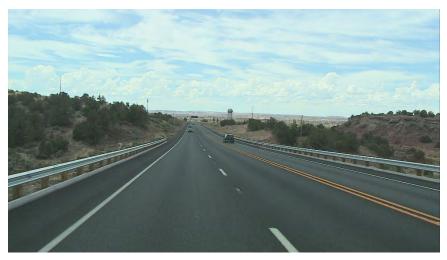
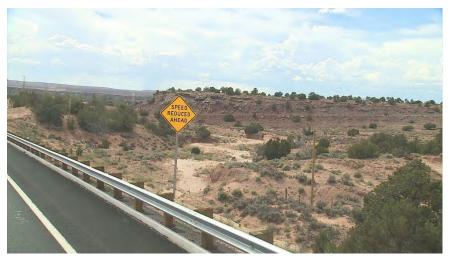
Figure 64: Eastbound, Southern View (MP 447)

- a. Failed stabilization/erosion control
- b. Facility overtopping or embankment protection
- c. Slope washout
- d. Poor soil conditions
- e. Undersized infrastructure
- f. Improper construction/installation
- g. Additional negative impacts downstream
- h. Other

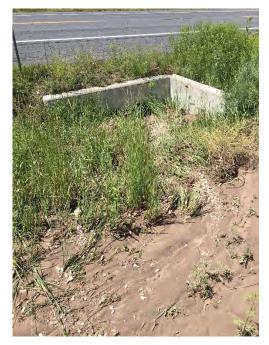
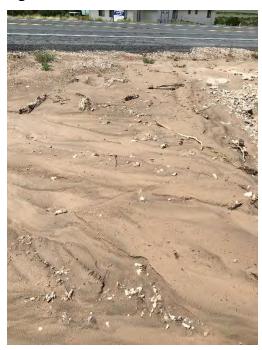
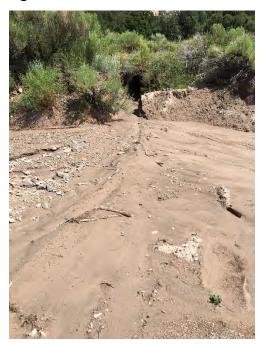
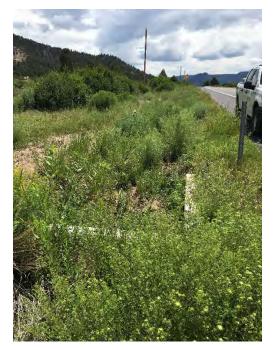
Figure 71: US 180 at MP 415

- a. Failed stabilization/erosion control
- b. Facility overtopping or embankment protection
- c. <u>Slope washout</u>
- d. Poor soil conditions
- e. Undersized infrastructure
- f. Improper construction/installation
- g. Additional negative impacts downstream
- h. Other

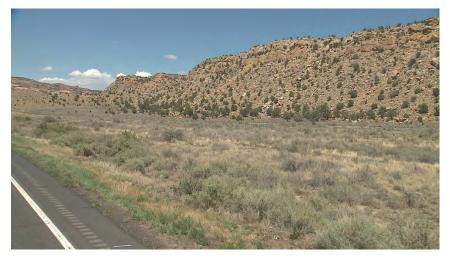
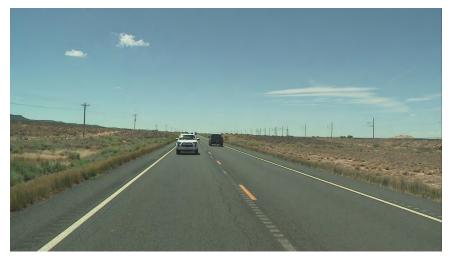
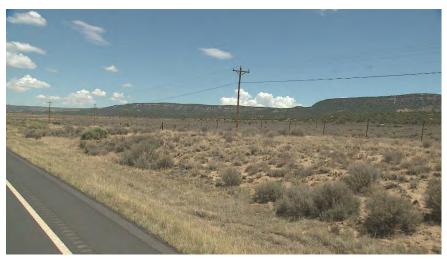
Figure 77: Northbound, Eastern View (MP 377)

- a. Failed stabilization/erosion control
- b. Facility overtopping or embankment protection
- c. Slope washout
- d. <u>Poor soil conditions</u>
- e. Undersized infrastructure
- f. Improper construction/installation
- g. Additional negative impacts downstream
- h. Other

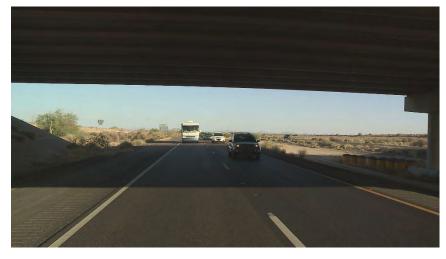
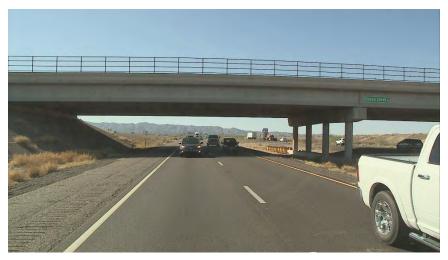
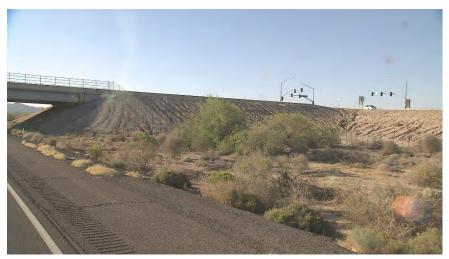
# Figure 103: Northbound, Rear View

| Project<br>Identifier | Route | МР | Issue | Construction/<br>Maintenance <sup>1</sup> |
|---|---|--|--|---|
| В | I-10 | 163.9 - Queen Creek TI | Unstable slopes, extreme rutting and pole foundations exposed. | Construction |

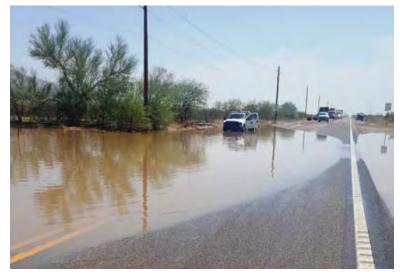
Figure 107: MP 43.58 Roadway Flooding and Closure 2018 (Picture Provided by ADOT)

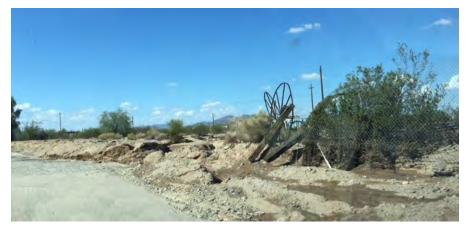
Figure 126: Debris in Sand Tank Wash

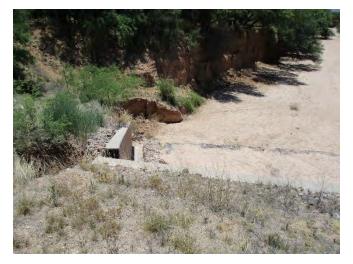
Figure 173: Outlet Box Culvert Wingwall Erosion

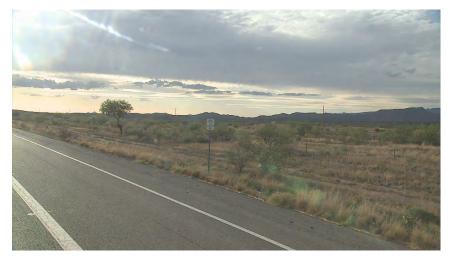
Figure 180: Westbound, Northern View (MP 290)

Has the problem led to road closures? No, but water has been found on the roadway and has the potential to worsen without proper mitigation.

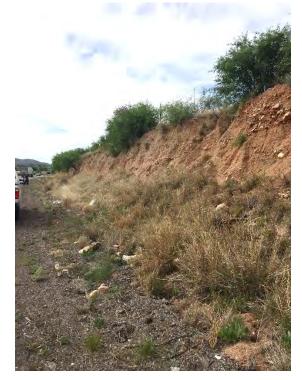
Figure 184: Slope Erosion at MP 8.9-9.1

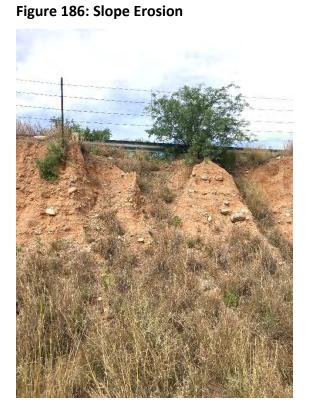
Figure 185: Slope Erosion
